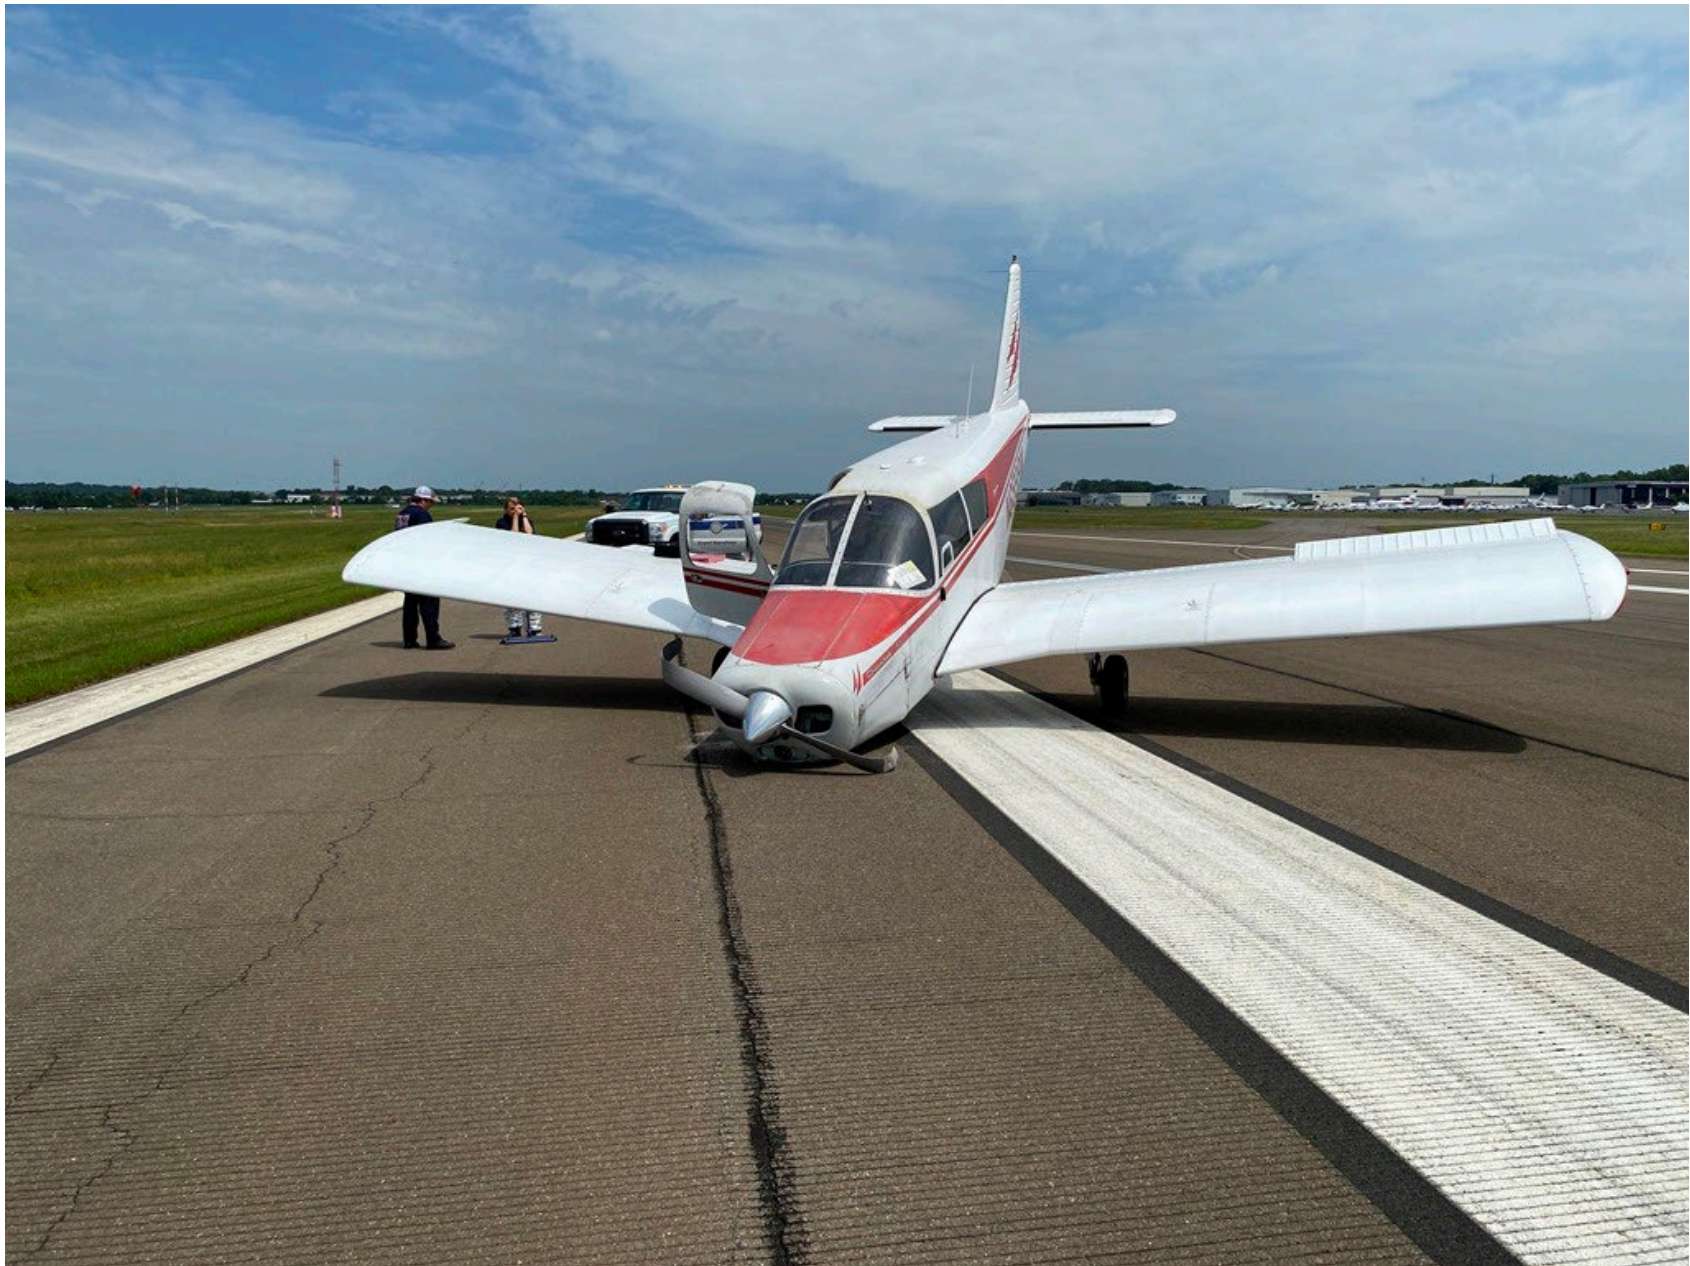
**Photo 1 – Front View of Airplane on Runway at HEF (FAA)**

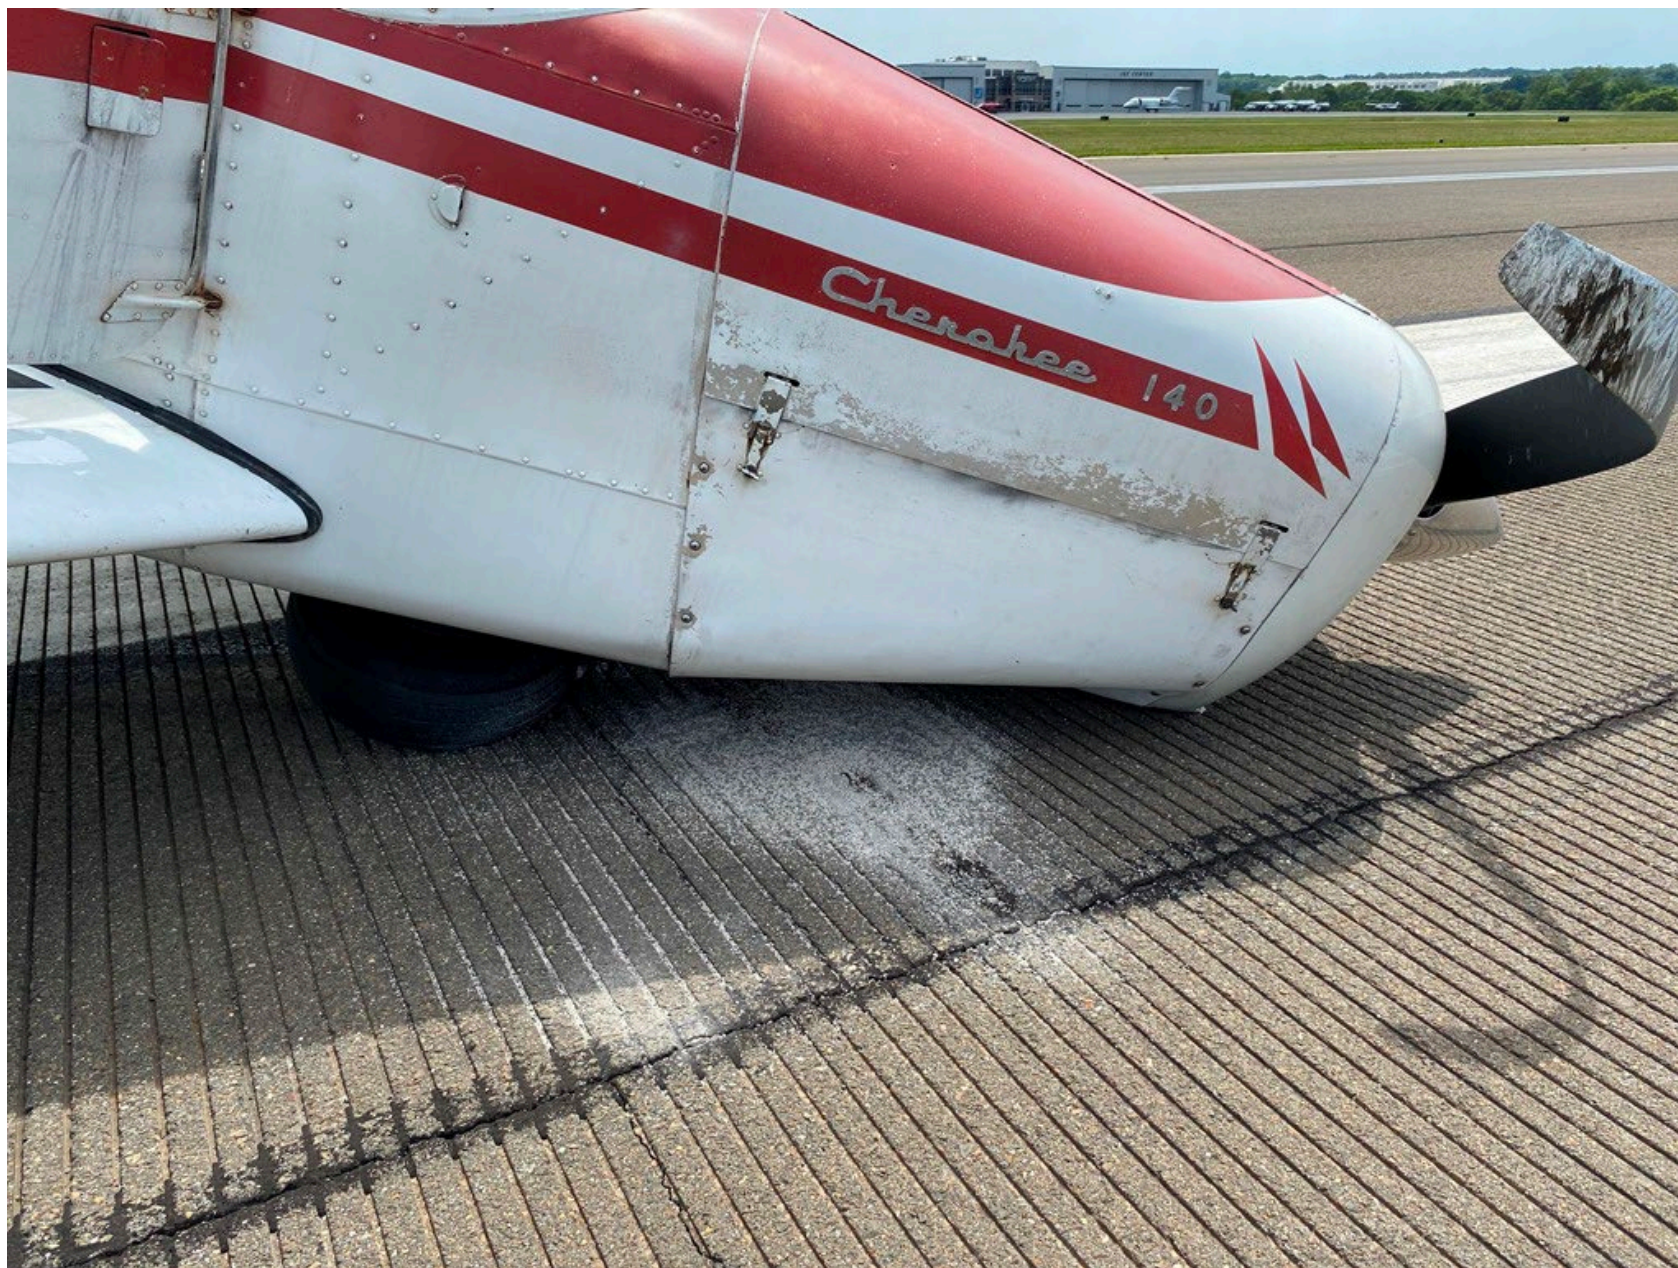
**Photo 2 – External Damage to the Forward Engine Area on Right Side (FAA)**

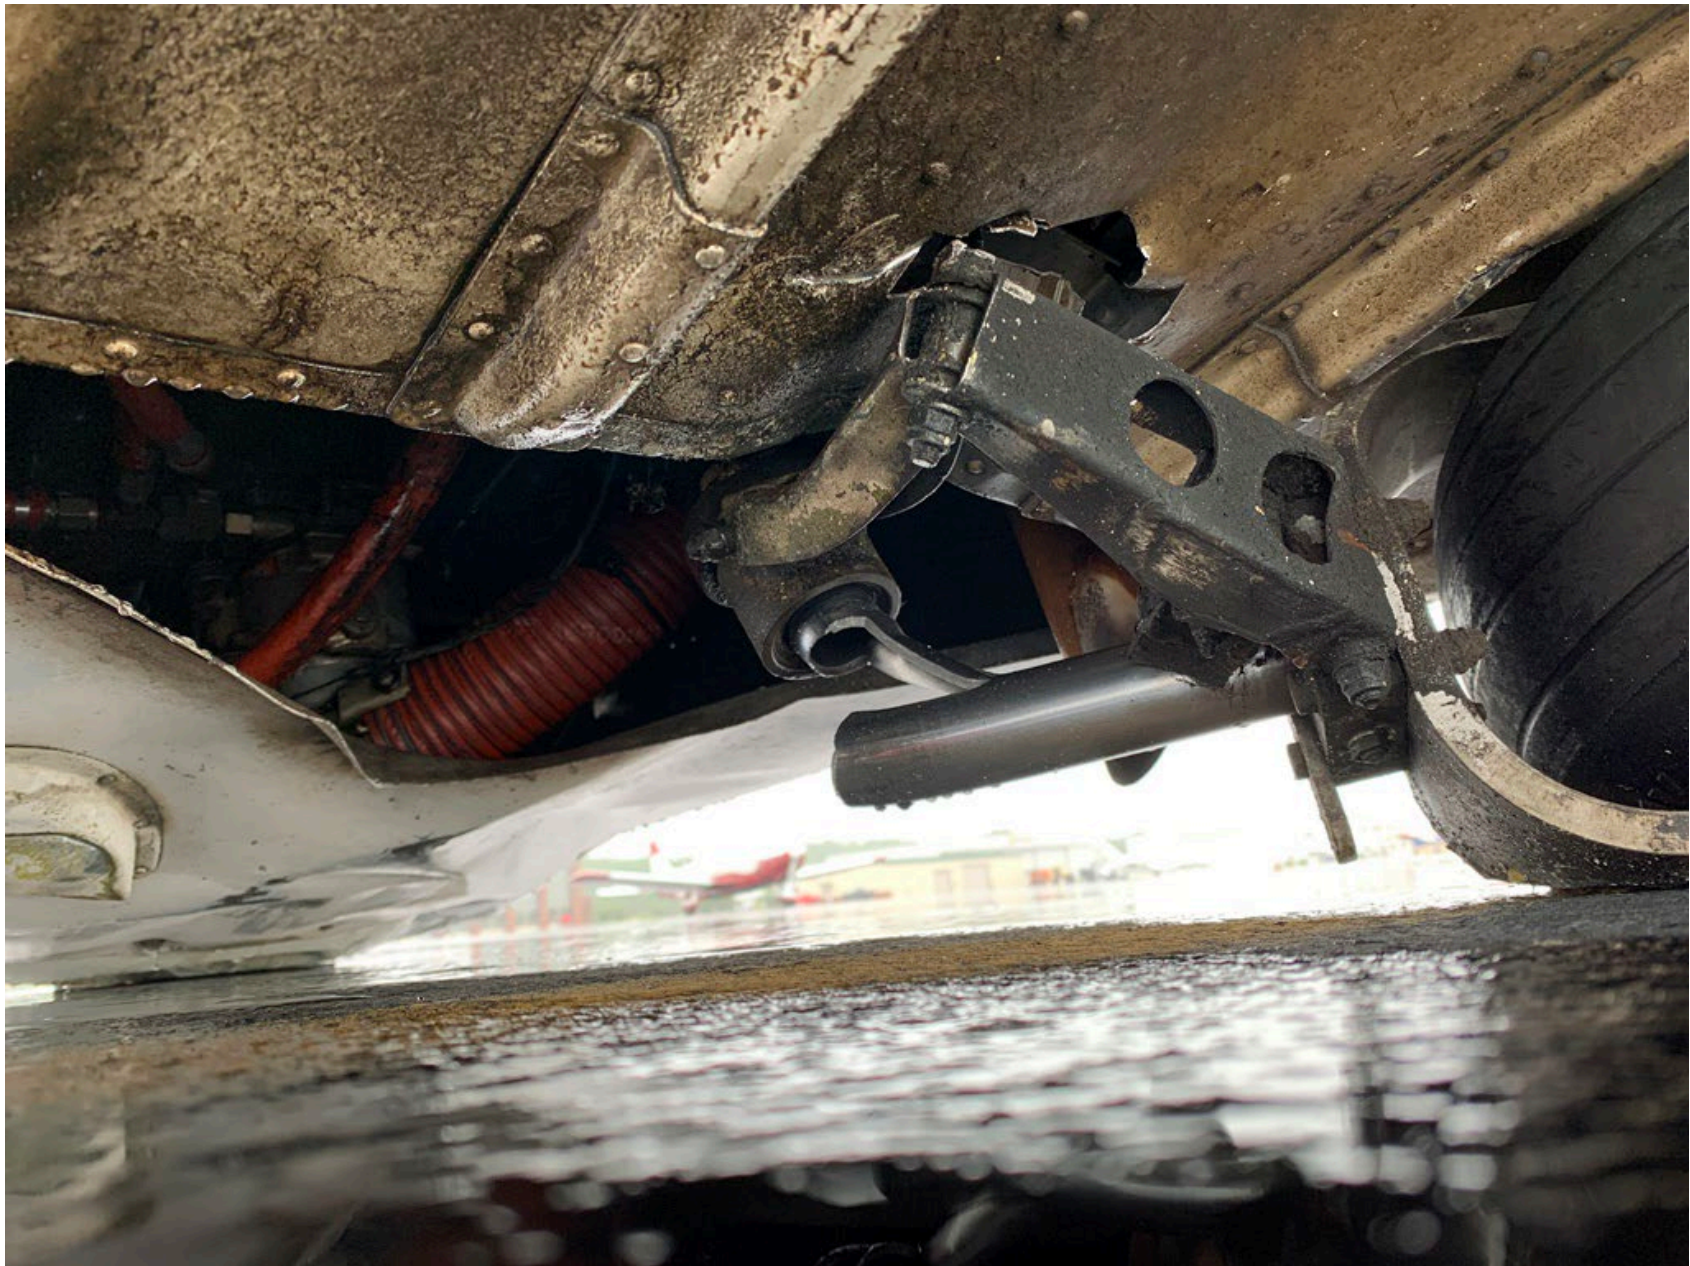
**Photo 3 – Damage Aft of the Firewall (FAA)**
