# National Transportation Safety Board

ERA22LA291

## **AIRFRAME AND ENGINE EXAMINATION FACTUAL REPORT**

Location: Warm Springs, Georgia  
Date: June 26, 2022  
Time: 1410 Local  
1810 UTC  
Airplane: Piper PA-24-250, N14FC

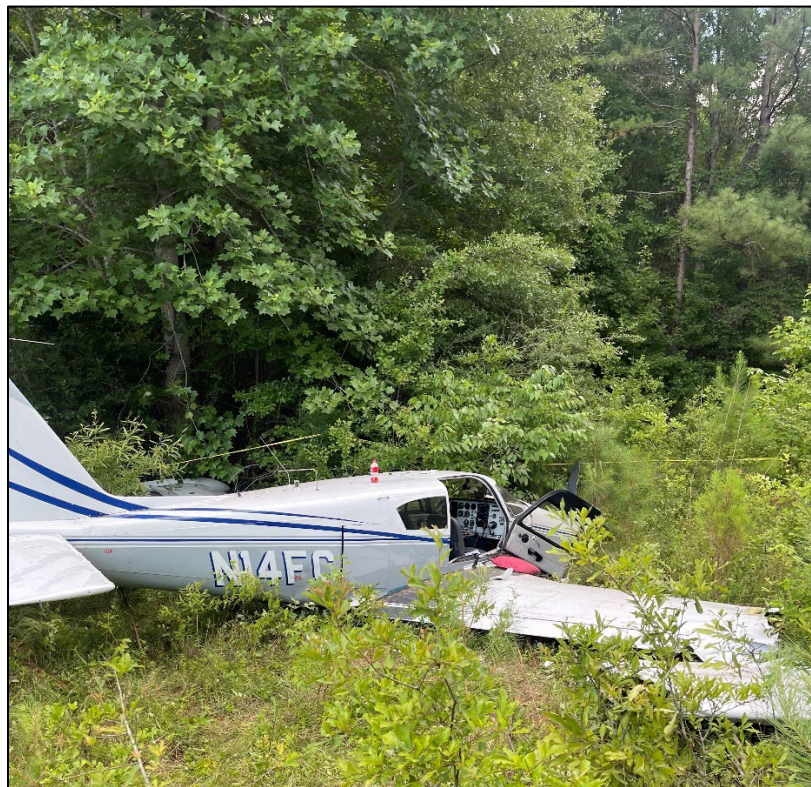
**Figure 1: View of the airplane at the accident site (FAA Photograph)**

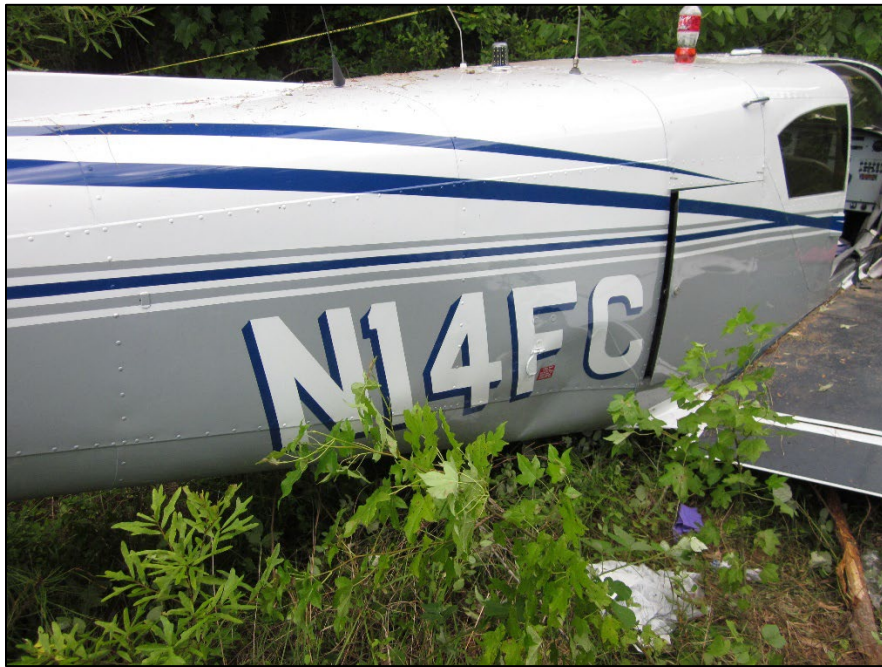
**Figure 2: View of the airplane at the accident site (FAA Photograph)**

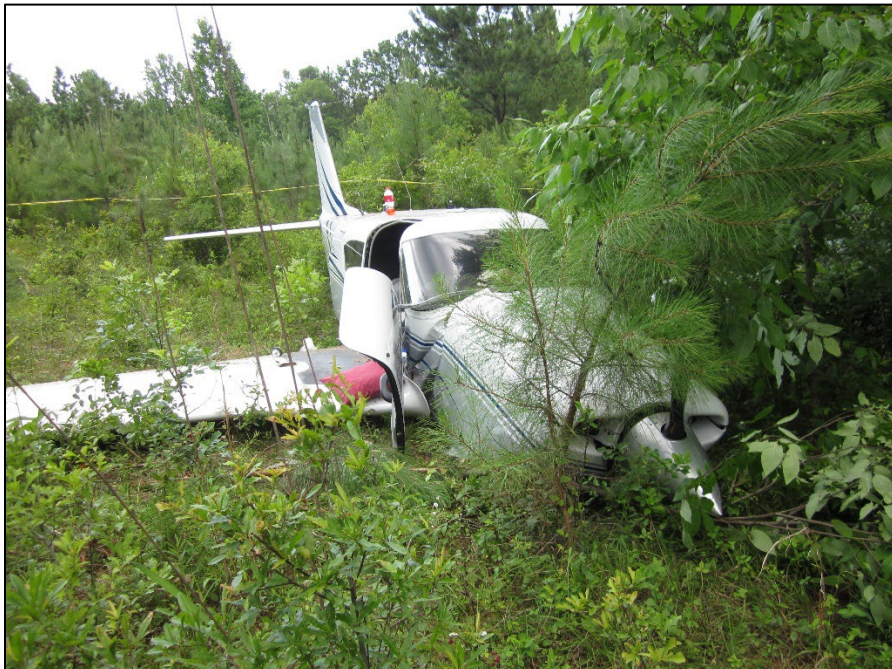
**Figure 3: View of the airplane at the accident site (FAA Photograph)**

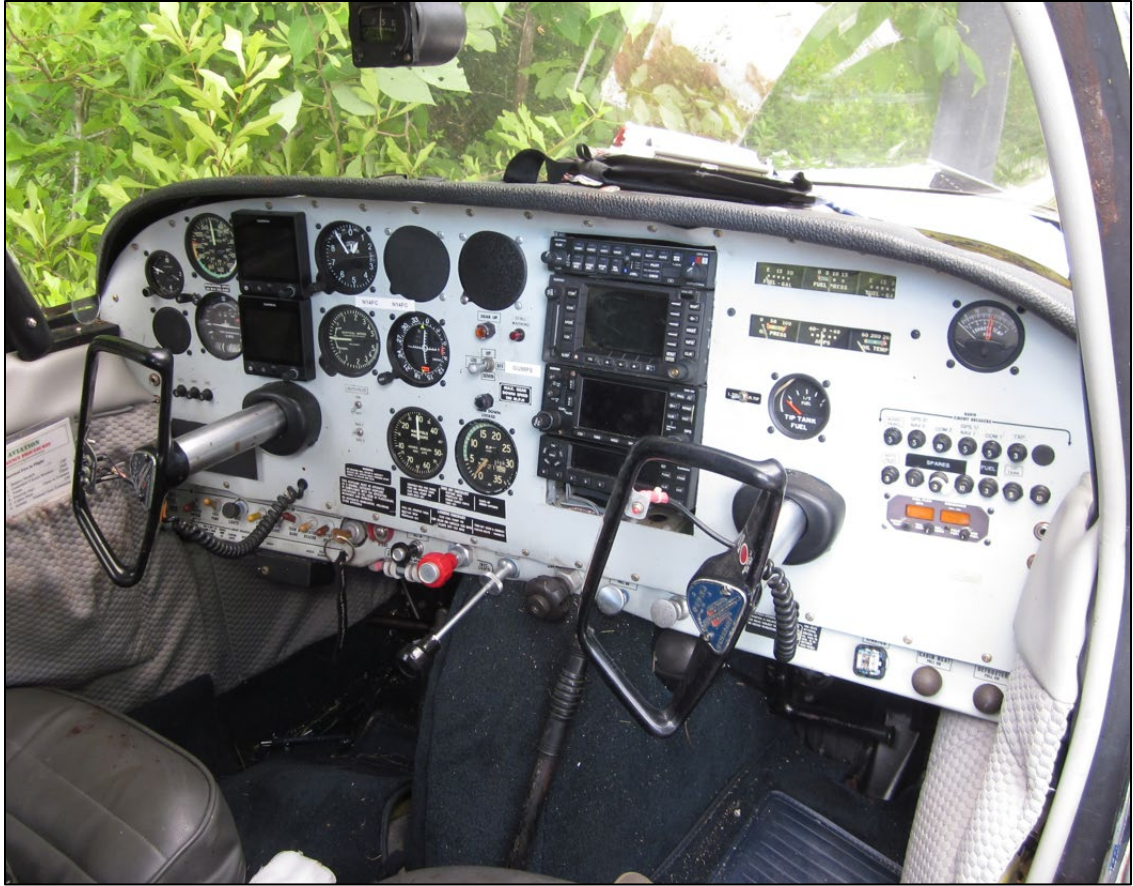
- Magneto Switch: Off
- Pitot Heat: Off
- Beacon: Off
- Turn and Bank Switch: On
- Landing Light: Off
- Electric Fuel Pump: Off
  - Note: FAA stated pump was on on-scene and he shut it off.
- Radio Master: Off
- Battery Master: Off
- AP: Off
- Gear Selector: Off
- Flap Lever: Stowed/0°
- Propeller Control: Forward/Fine Pitch
- Mixture Control: Forward/Rich
- Throttle Control: Aft/Closed Idle
- Tachometer Reading: 3721.8

**Figure 4: Overview of the cockpit at the accident site (FAA Photograph)**

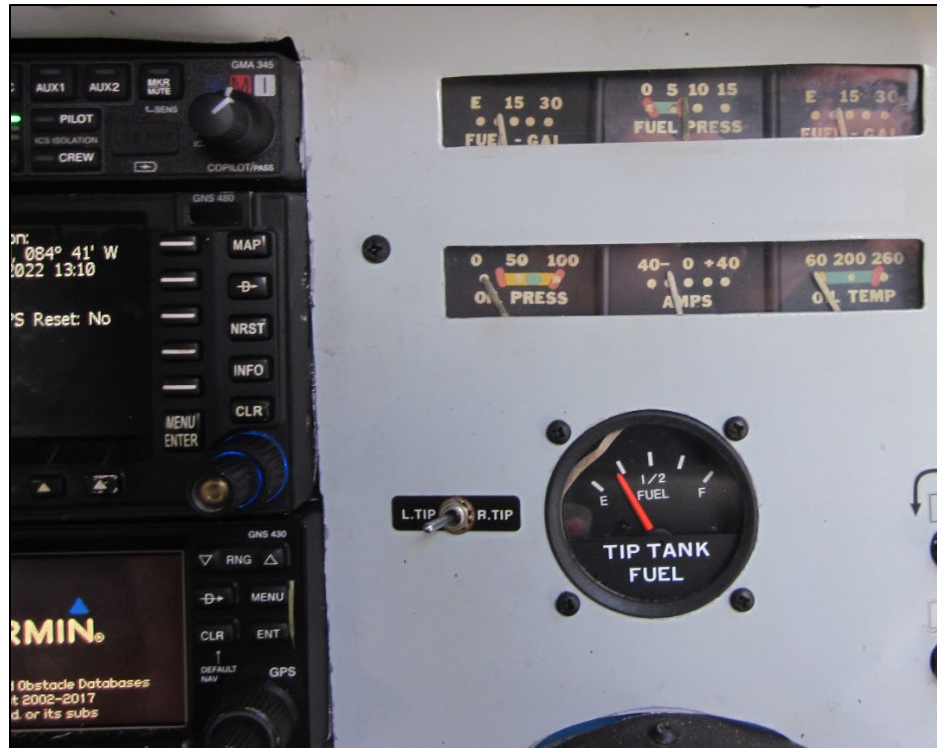
**Figure 5: View of the fuel instrumentation, with power turned on to the aircraft (FAA Photograph)**

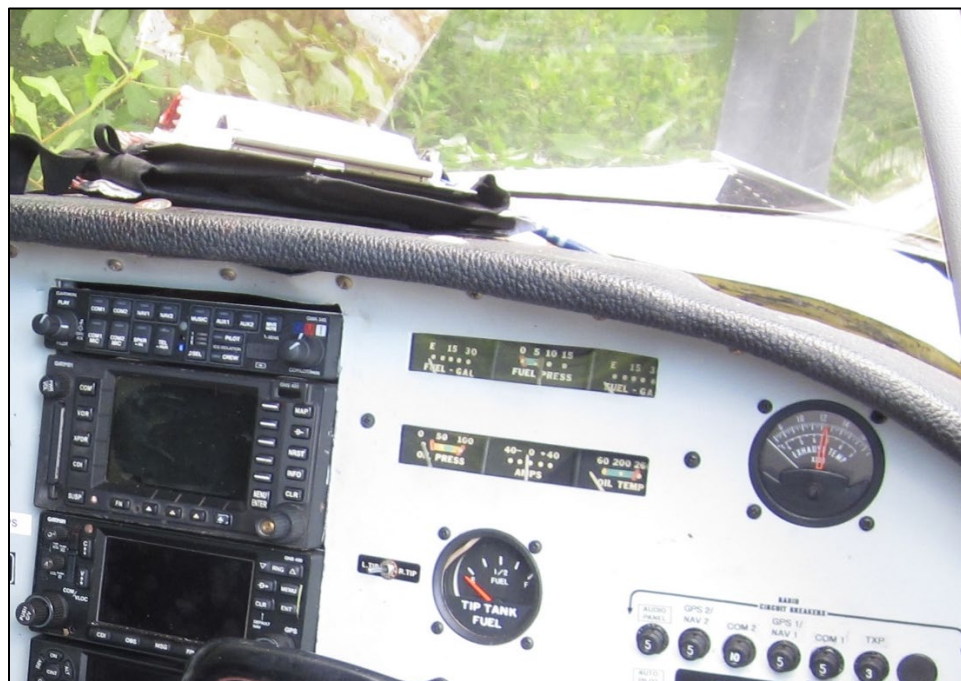
**Figure 6: View of the fuel instrumentation with power turned off to the aircraft (FAA Photo)**

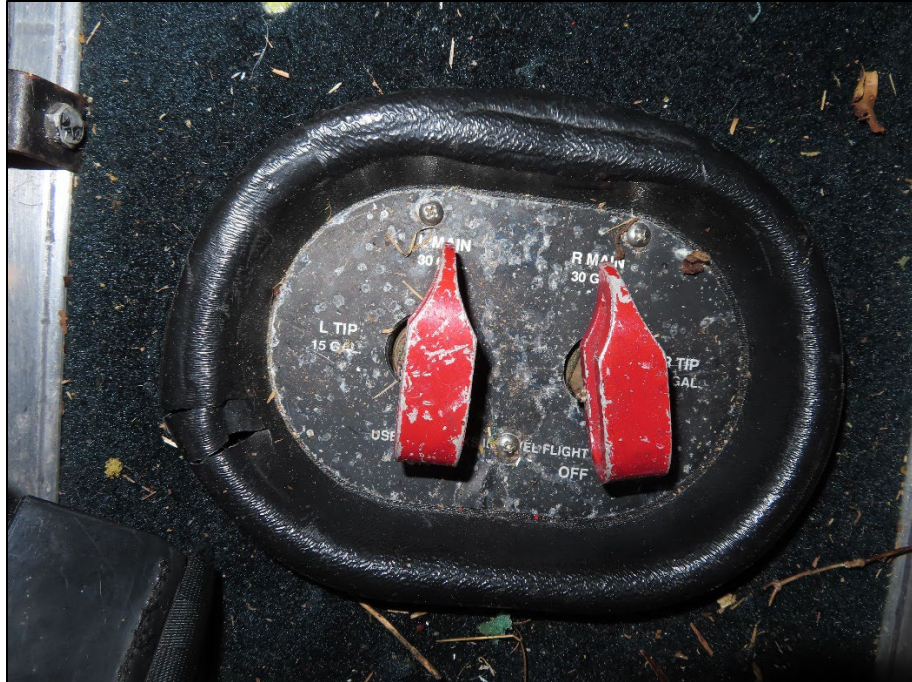
The left- and right-wing fuel selectors were in the "Main" positions and was confirmed during field test with low-pressure air; no fuel was observed within the fuel lines during the field test. Fuel was observed within the lines during field test with fuel selectors in the "Tip Tank" position. Both fuel selectors were determined to be functional during field test.

**Figure 7: Fuel selector as found postaccident (FAA Photo)**

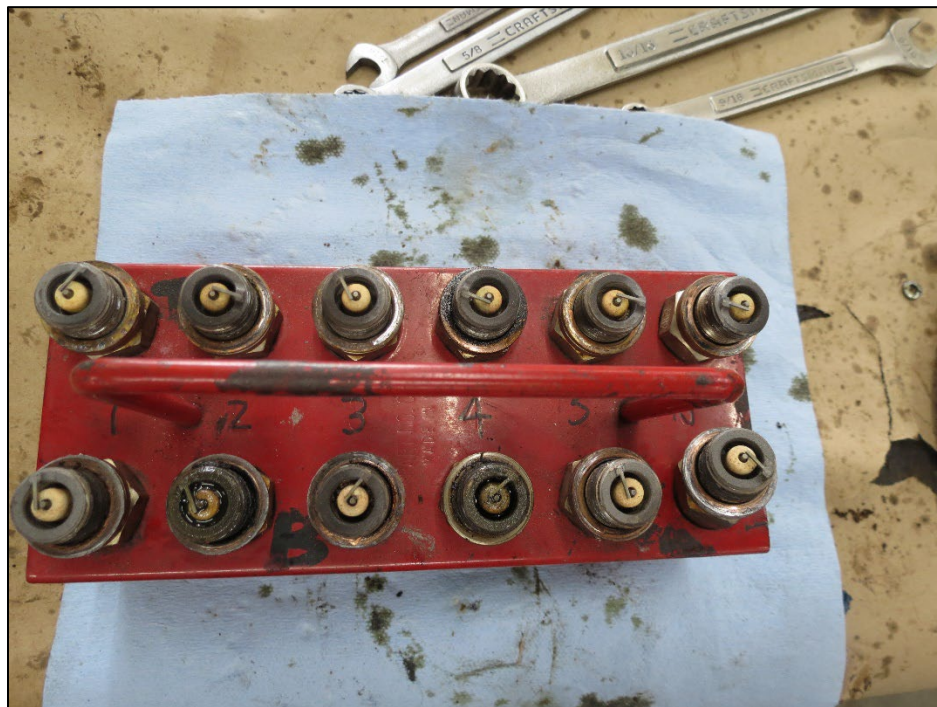
Both magnetos remained attached to the engine and no damage was noted. Both produced spark from all ignition towers when they were removed and rotated by hand. The spark plugs were undamaged and displayed normal combustion signatures.

**Figure 8: View of top and bottom spark plugs**

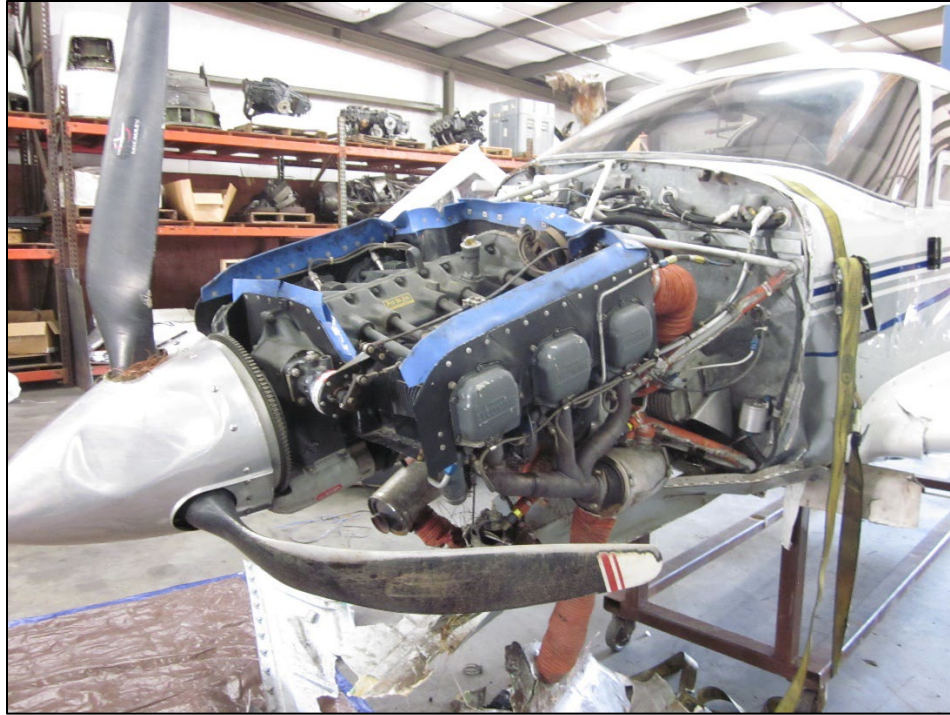
The propeller was a McCauley B3D32C412-C, with controllable pitch. The propeller remained attached to the engine crankshaft flange. The propeller spinner remained attached to the propeller and was impact damaged. The propeller blade labeled "A" was rotated about 90 degrees in the hub, with the blade leading edge forward. No bending of the blade was noted. The propeller blade labeled "B" was rotated in the hub about 30 degrees and was bent aft about 20 degrees at about 8 inches outboard of the hub.

The blade shank snap rings were dislodged from the propeller hub. The propeller blade labeled "C" was curved aft about 80 degrees and exhibited leading edge paint abrasion. The blade shank snap rings for that blade were also dislodged from the hub. The propeller governor remained attached to the engine and no damage was noted.

**Figure 9: Overview of the engine and propeller**

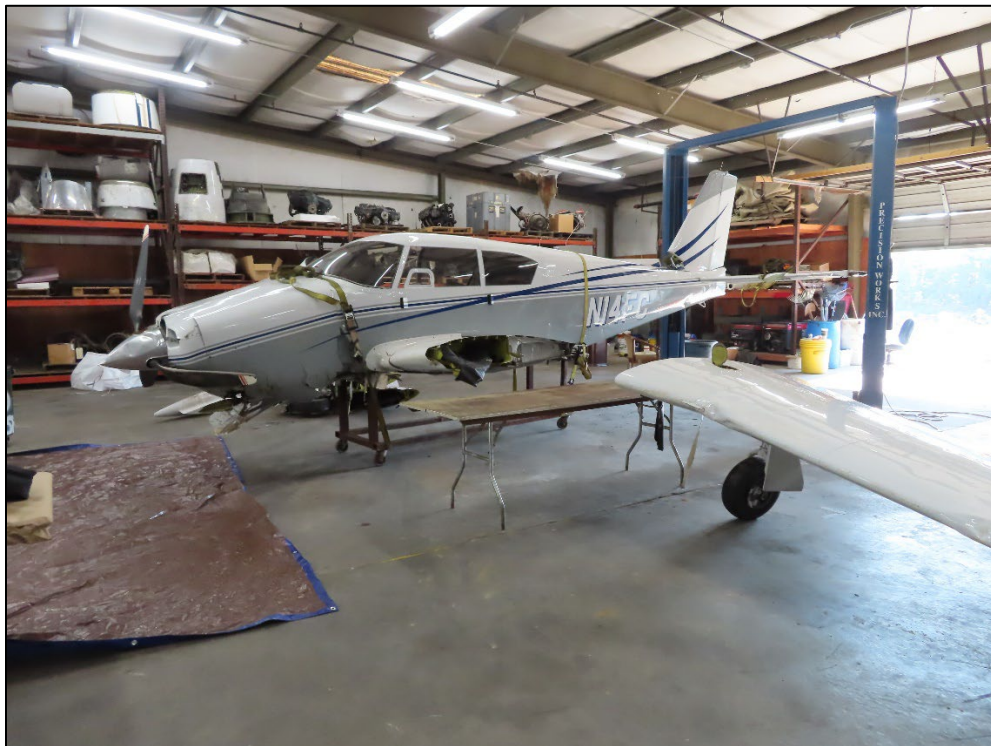
The left wing remained attached to the fuselage and was separated about 14" from the wing root by recovery personnel. Leading-edge impact damage was noted to the wing. The lift detector was determined to be functional during field test. Impact damage was noted to the pitot head and its port was obstructed with an organic material consistent to that of wood. The main gear exhibited impact damage and its actuator cable was retracted consistent with the gear in the "up/retracted" position.

**Figure 10: Overview of the left wing and fuselage**

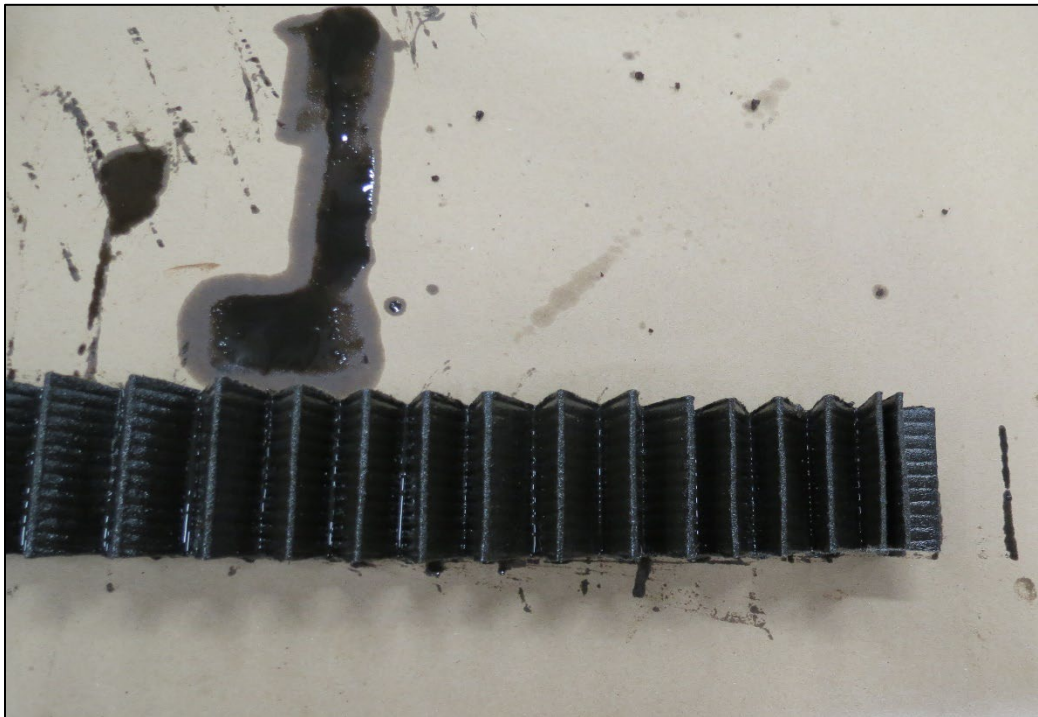
Oil was observed in the engine. The oil sump quick drain was impact damaged. No oil level was observed on the oil dipstick. No metallic debris was observed in the oil suction screen or the engine oil filter.

**Figure 11: View of the oil filter**

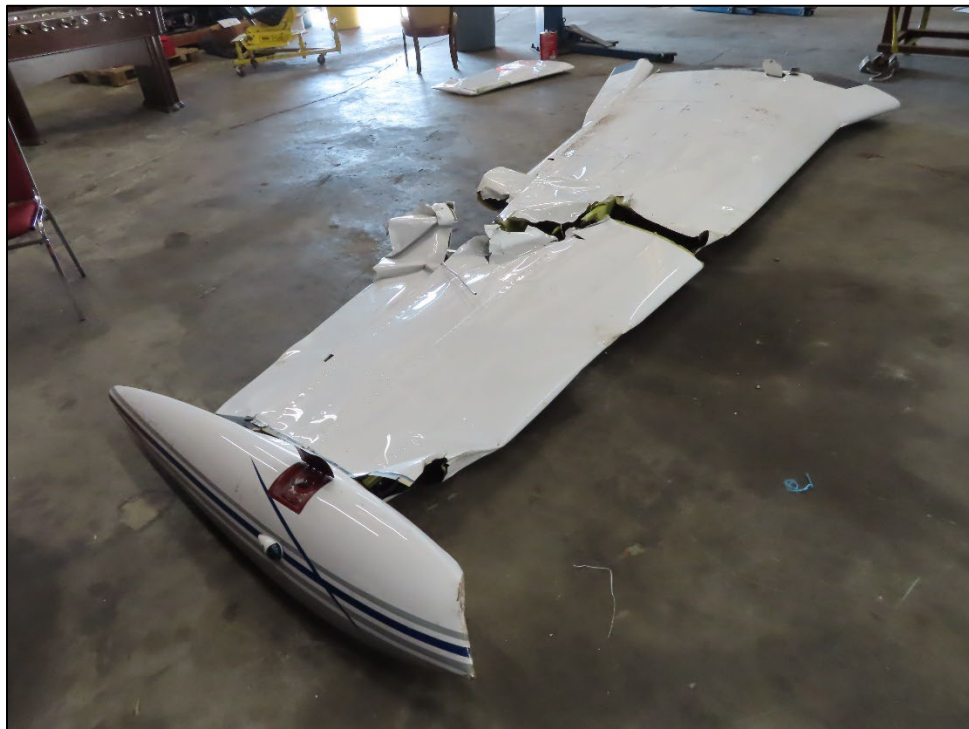
The right wing was separated by recovery personnel about 12" from the fuselage and was impact separated about 10' from the wing-root with impact damage noted to the wing. The main gear was impact damage and its control cable was retracted consistent with the gear in the "up/retracted" position. The flap remained attached to its mounts and was recovery separated about 17" from the fuselage; the flap was observed in the "up/0°" position. The aileron remained attached to its mounts and impact separated in two sections. The aileron control rod remained attached to its mounts and the aileron control cables were cut at the wing-root area by recovery personnel; flight control continuity was established.

The wingtip fuel tank was separated from the wing with impact damage noted. Its fuel line was pulled from its attach point with no fuel was observed within and its fuel cap was seated to its receptacle. The main fuel cell was breached from recovery separation of the wing; its filler cap was separated from its receptacle, and its pick-up screen and vent were clear of obstruction. Fuel line continuity was established from the firewall to the pick-up screen during field test with low-pressure air.

**Figure 12: View of the right wing**

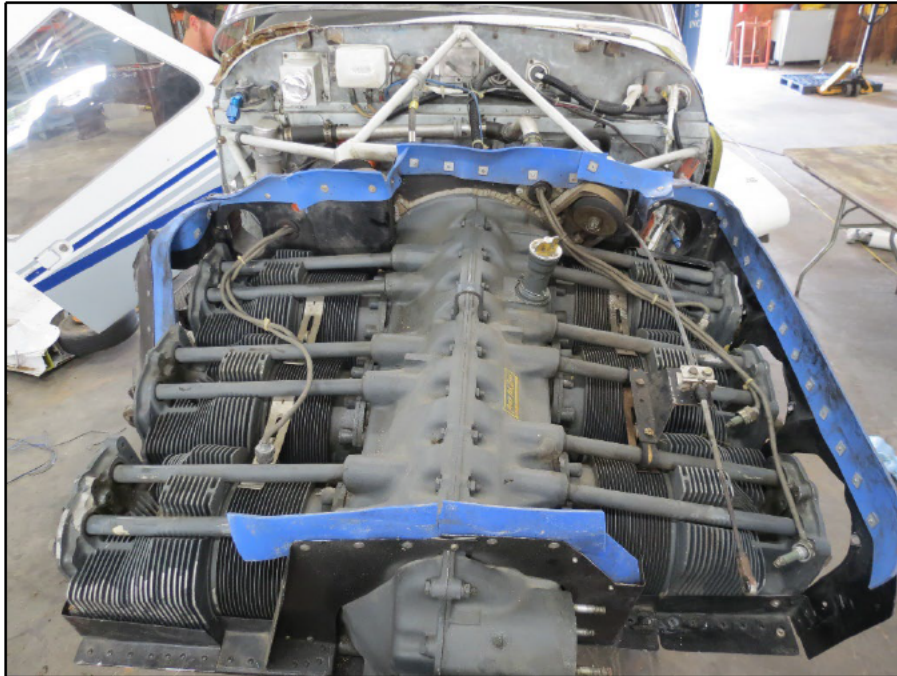
**Figure 13: Overview of the top of the engine**
