**NTSB ERA22LA296**

N7215D, American Champion 8KCAB

Photo Array

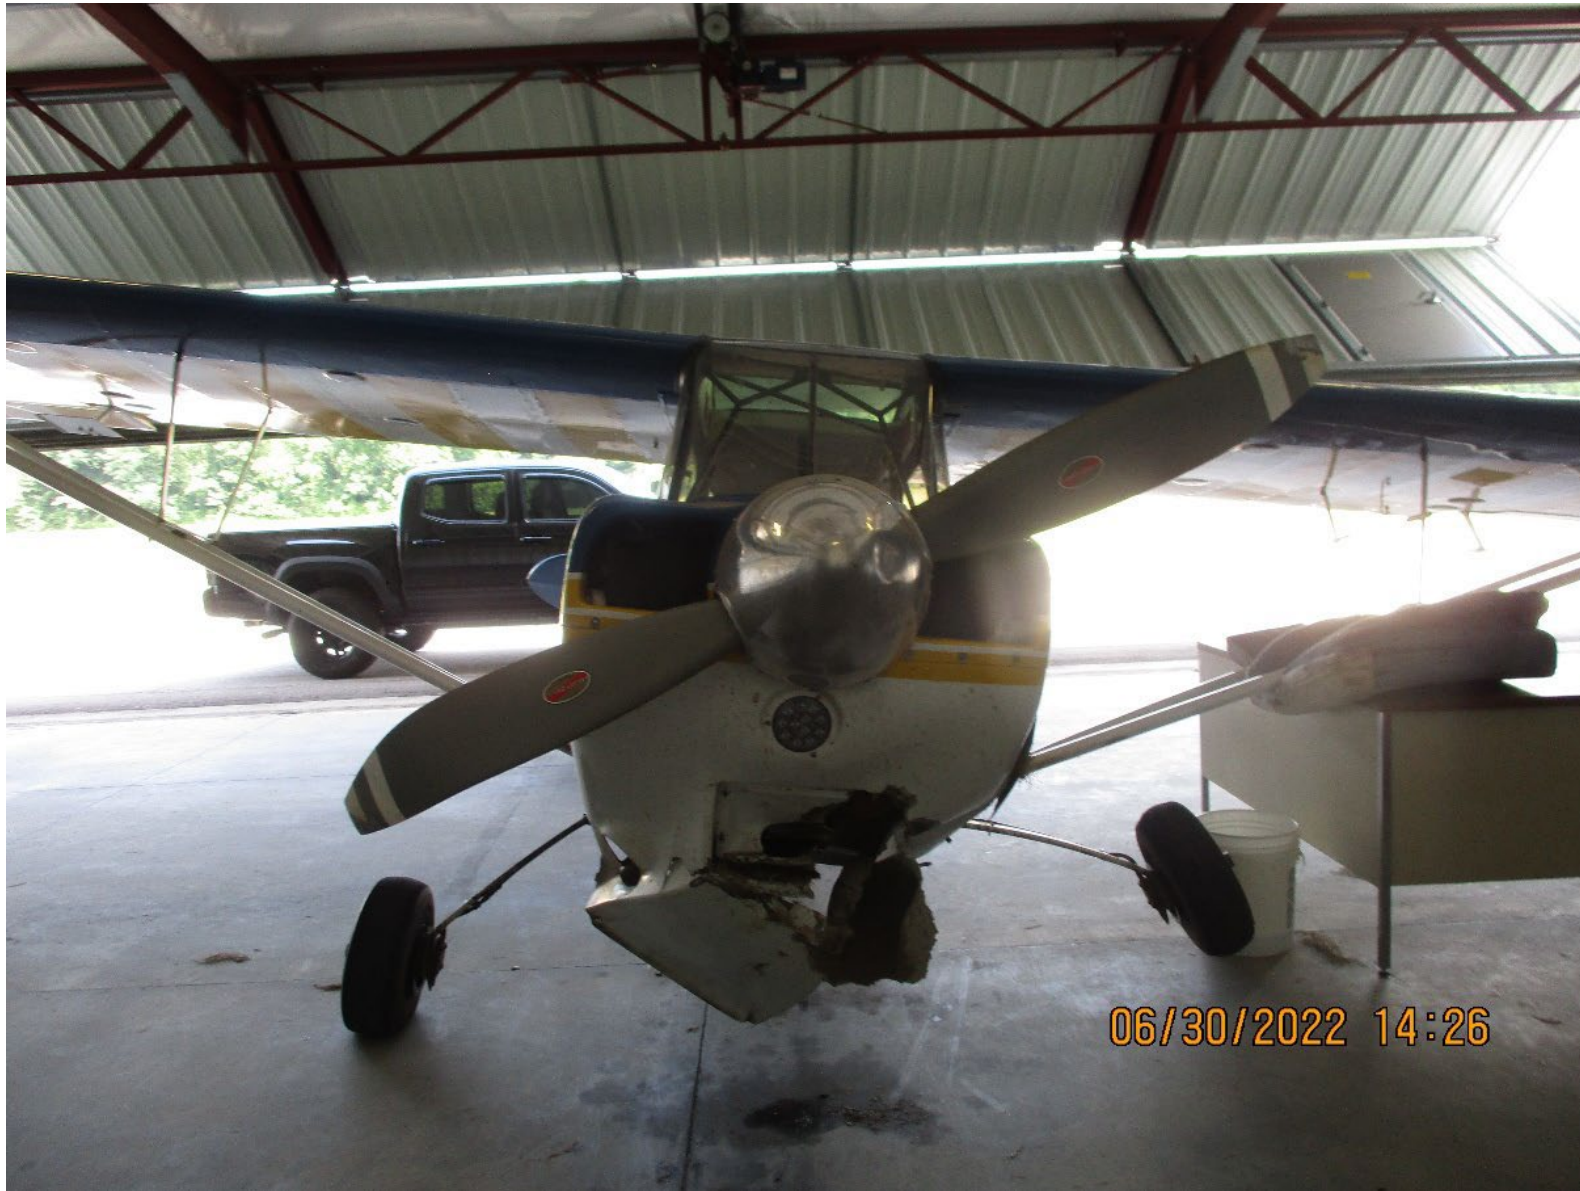
Photo 1: Accident airplane, forward view of airplane in hangar. (Photo Courtesy of FAA)

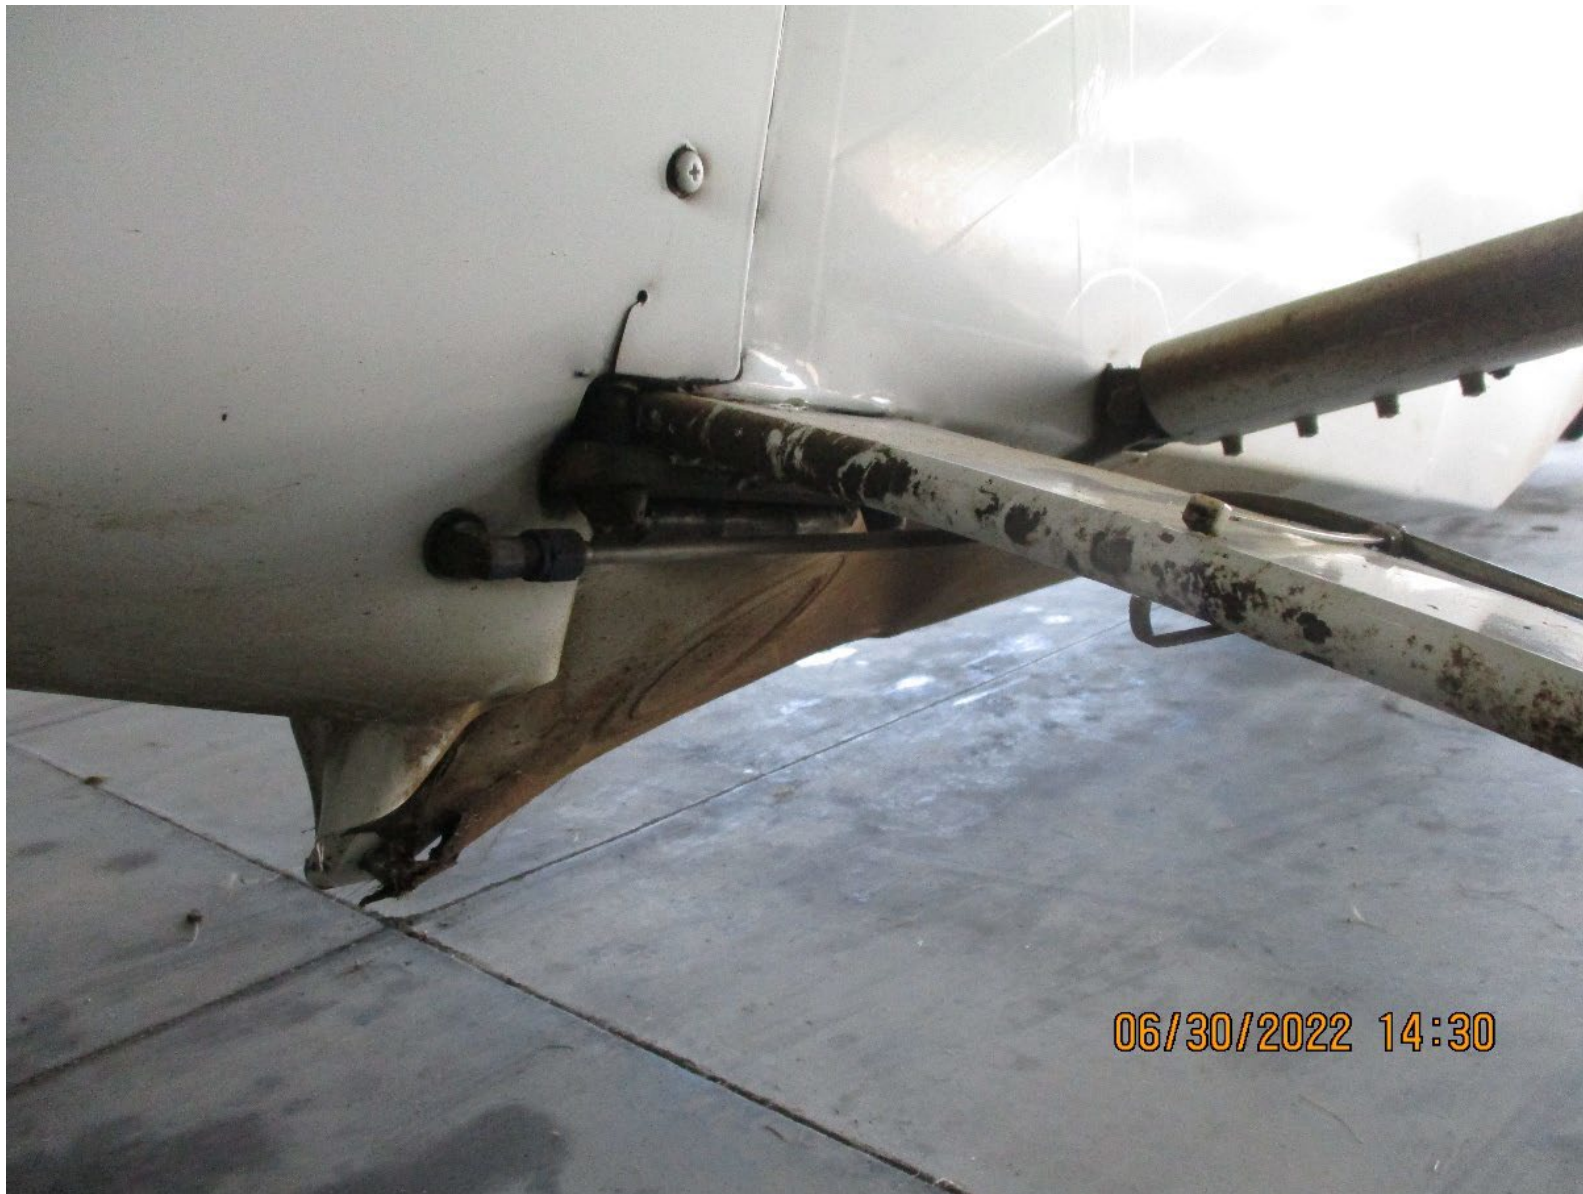
Photo 2: Accident airplane, left wheel strut damage, forward view. (Photo Courtesy of FAA)

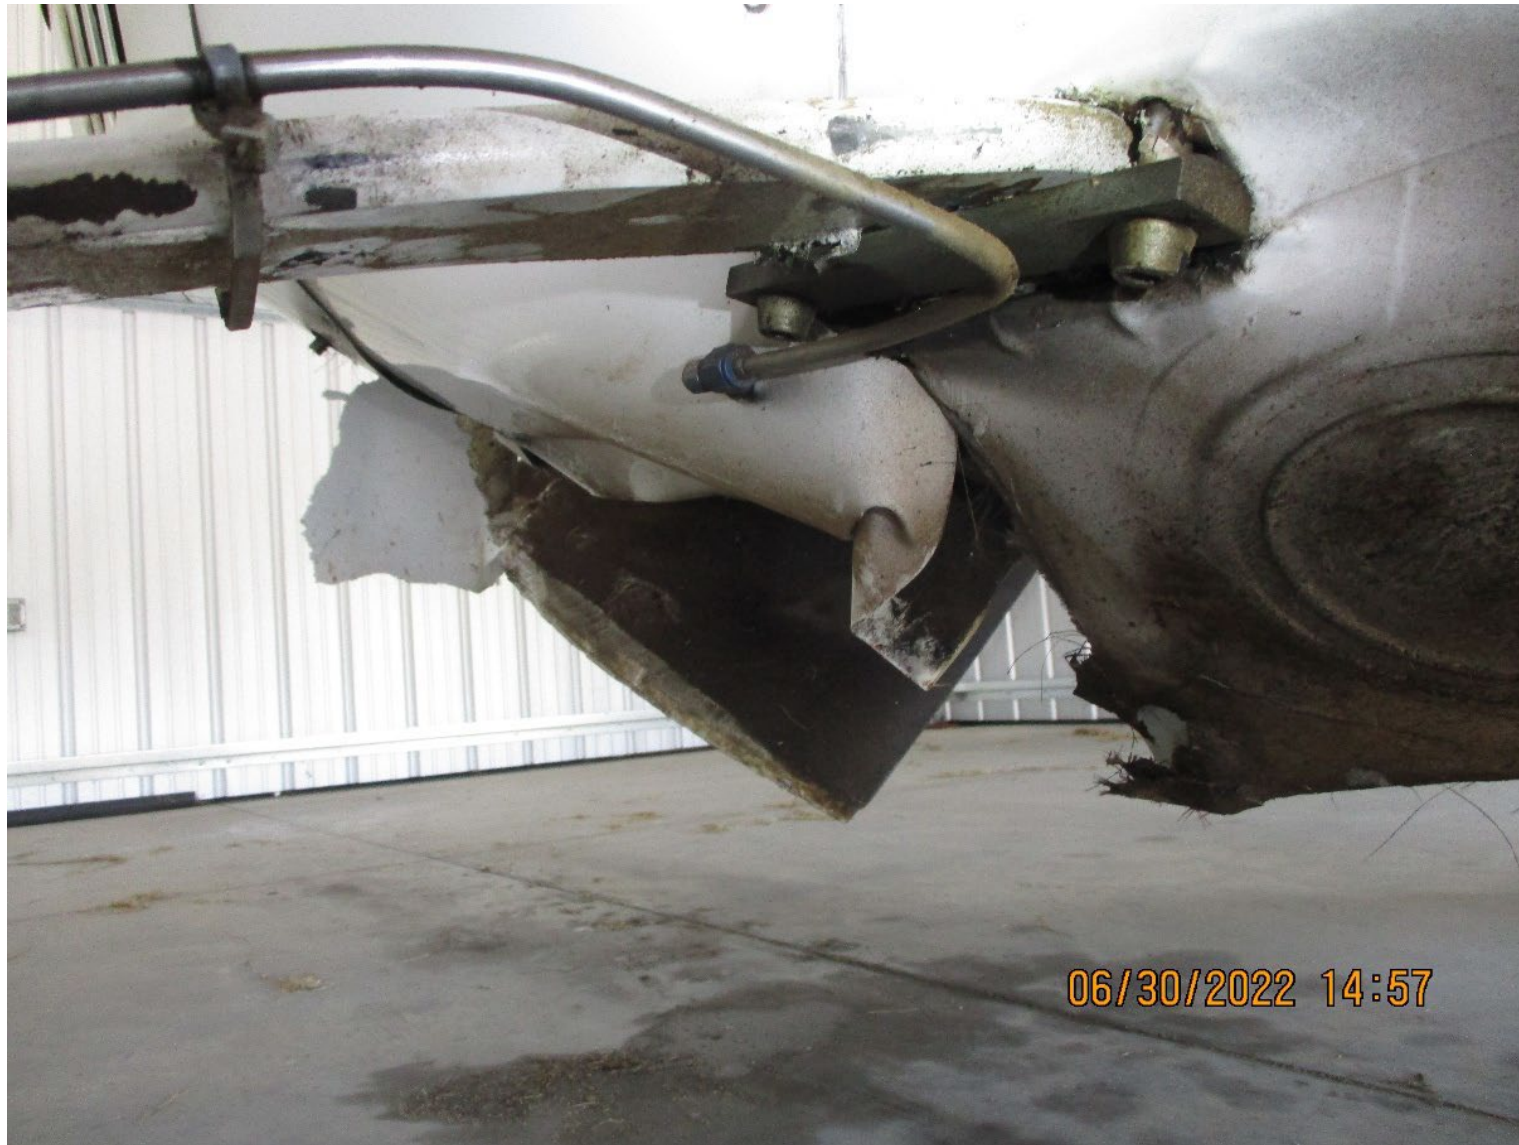
Photo 3: Accident airplane, left wheel strut damage, aft view. (Photo Courtesy of FAA)

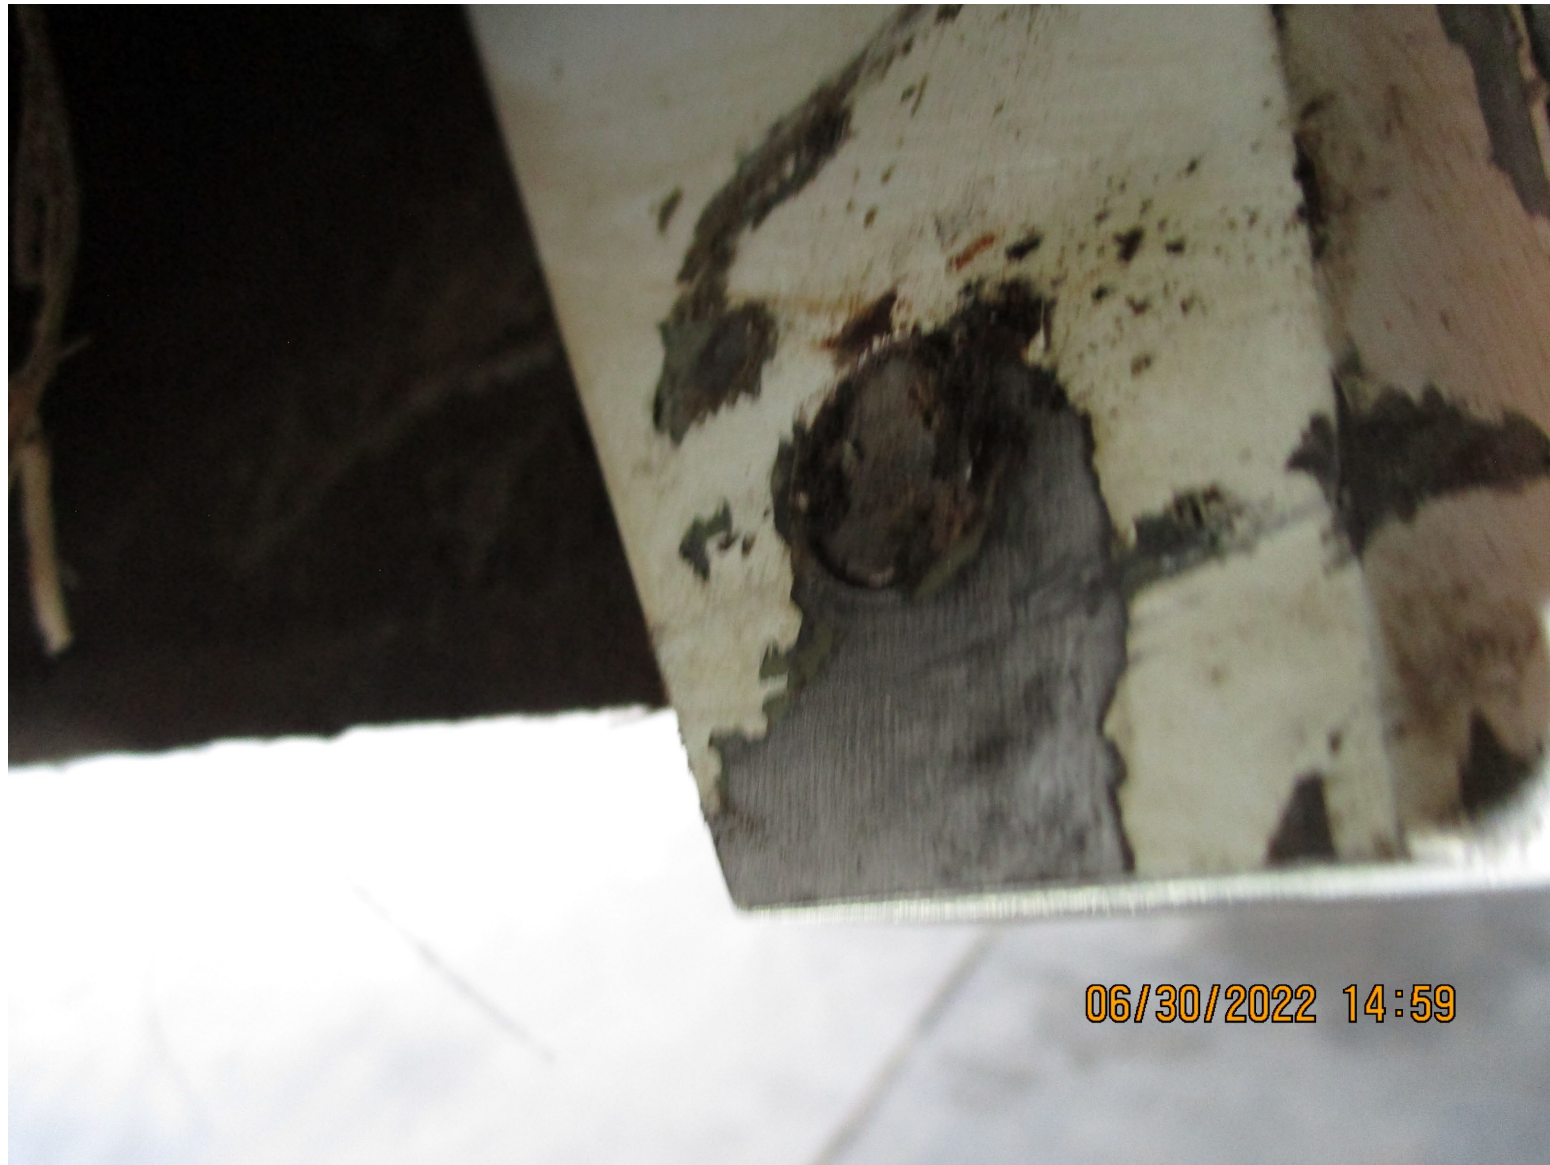
Photo 4: Accident airplane, sheared left main landing gear through bolt. (Photo Courtesy of FAA)

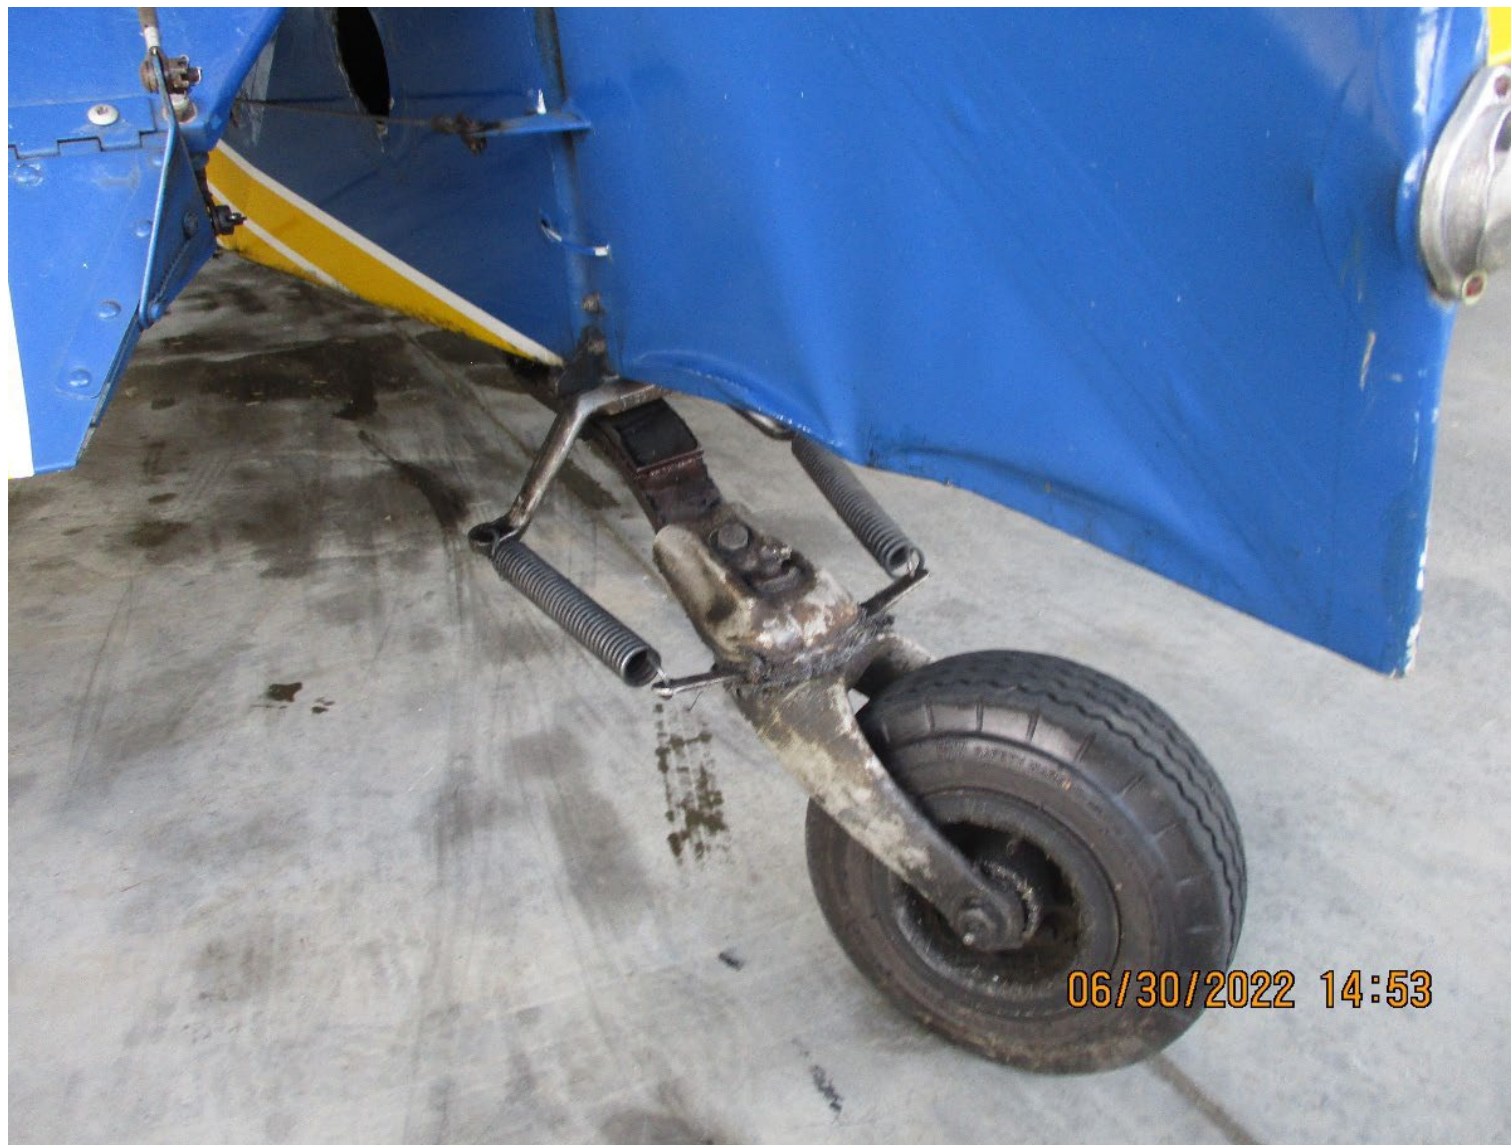
Photo 5: Accident airplane, rudder damage. (Photo Courtesy of FAA)

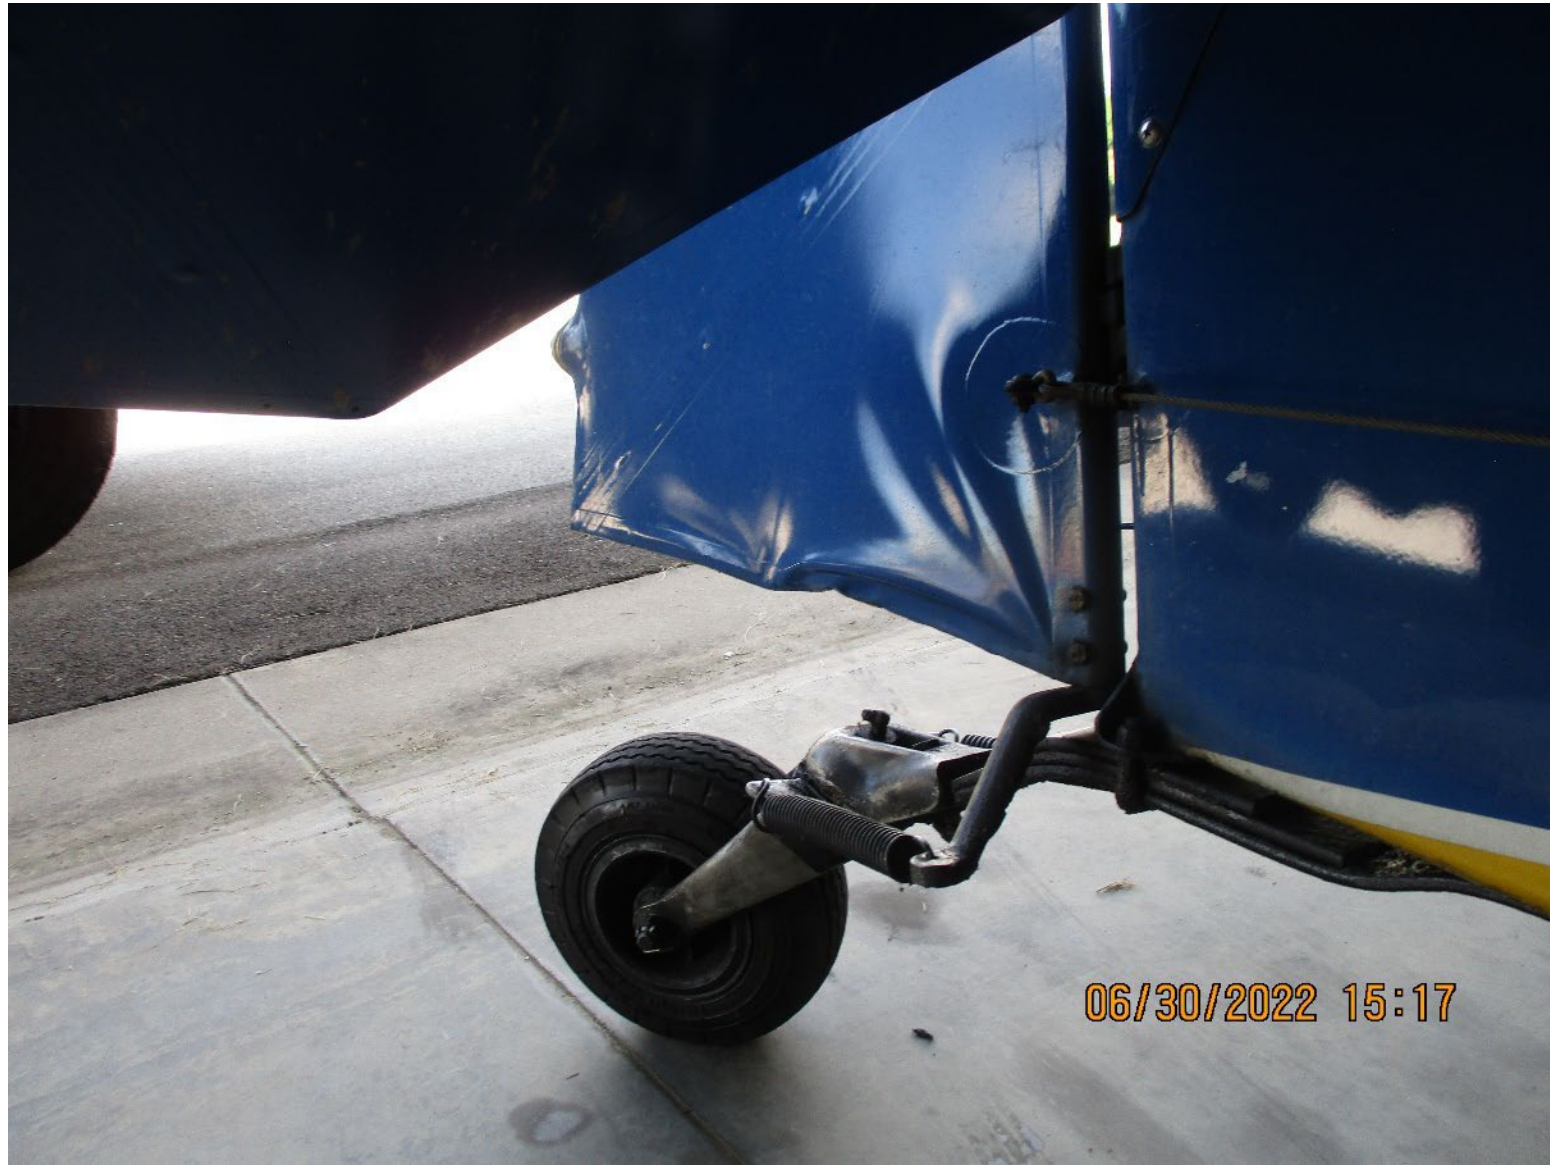
Photo 6: Accident airplane, rudder damage. (Photo Courtesy of FAA)
