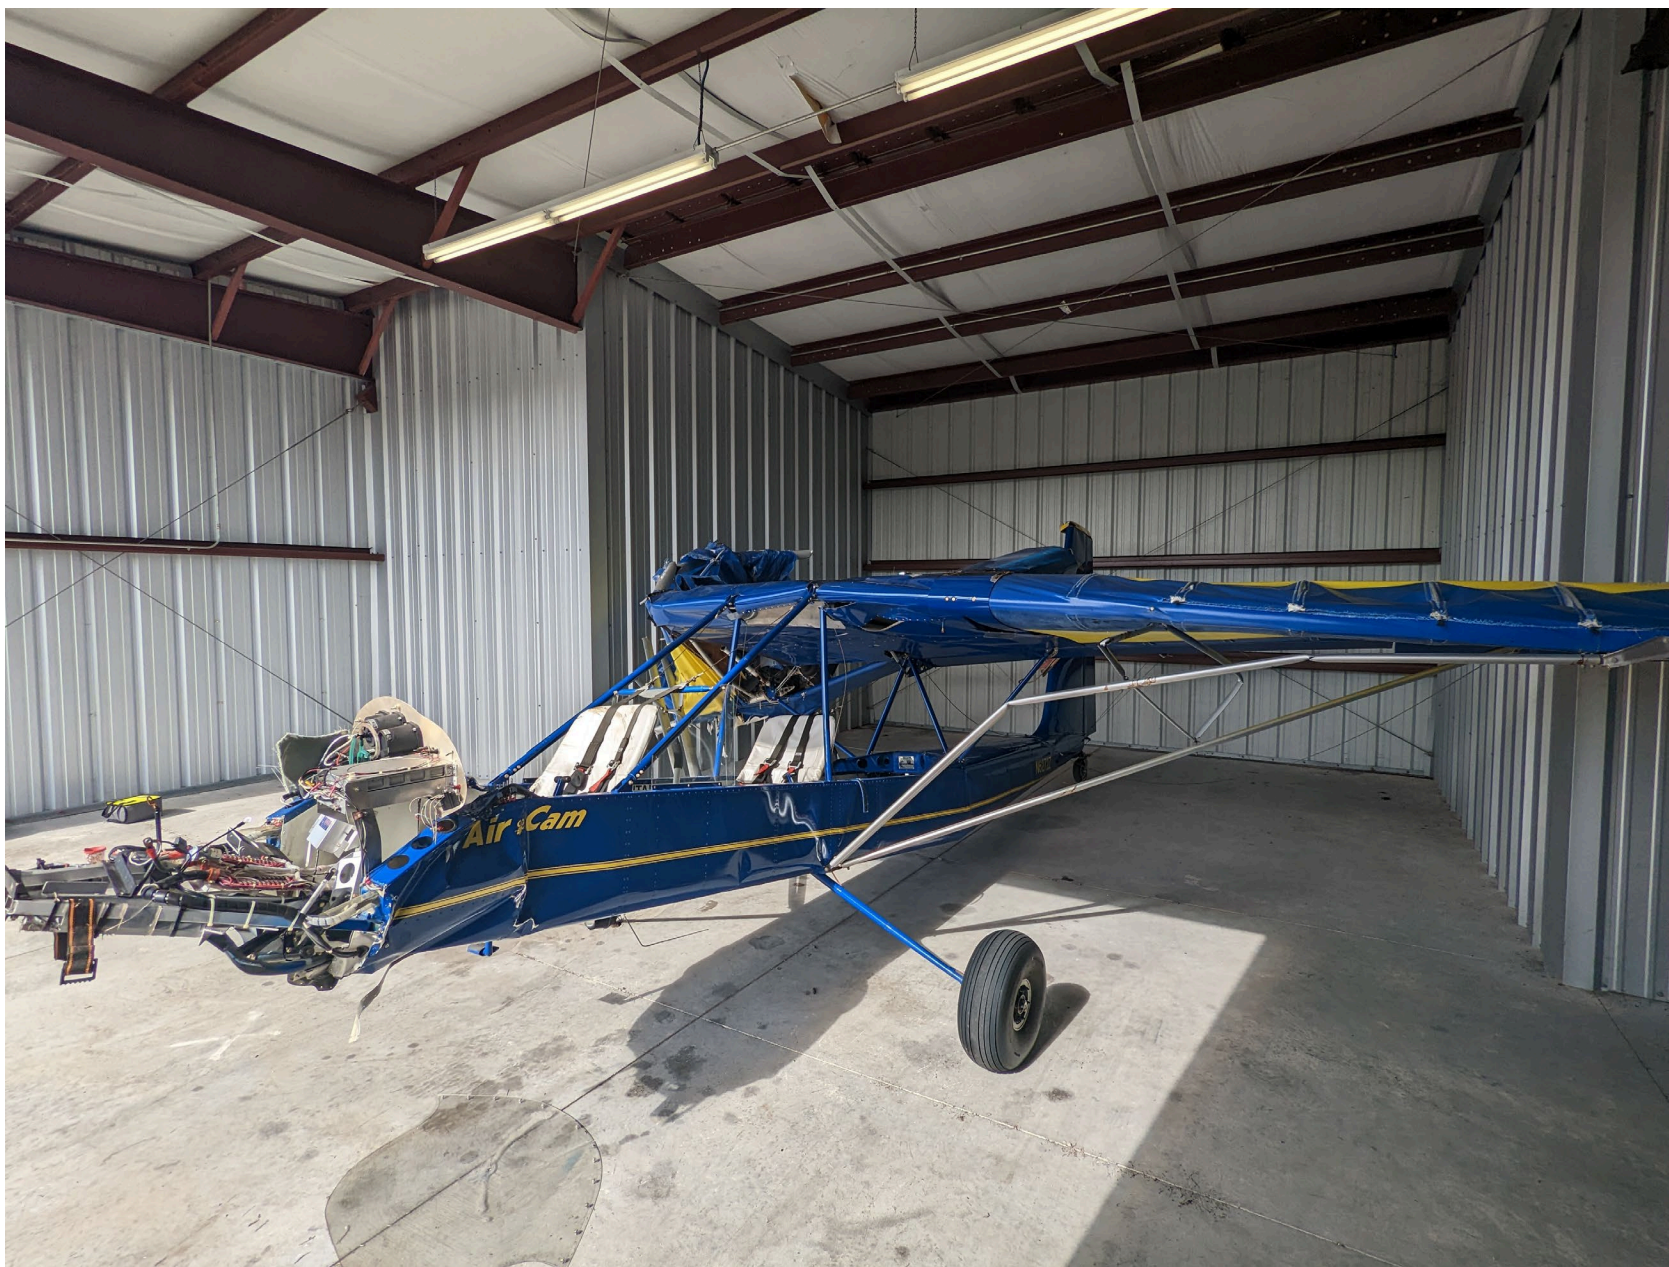
**Photo 1 – Digital Photograph From Lockwood Aviation. Left Forward Quartering View of the Wreckage Following Recovery.**

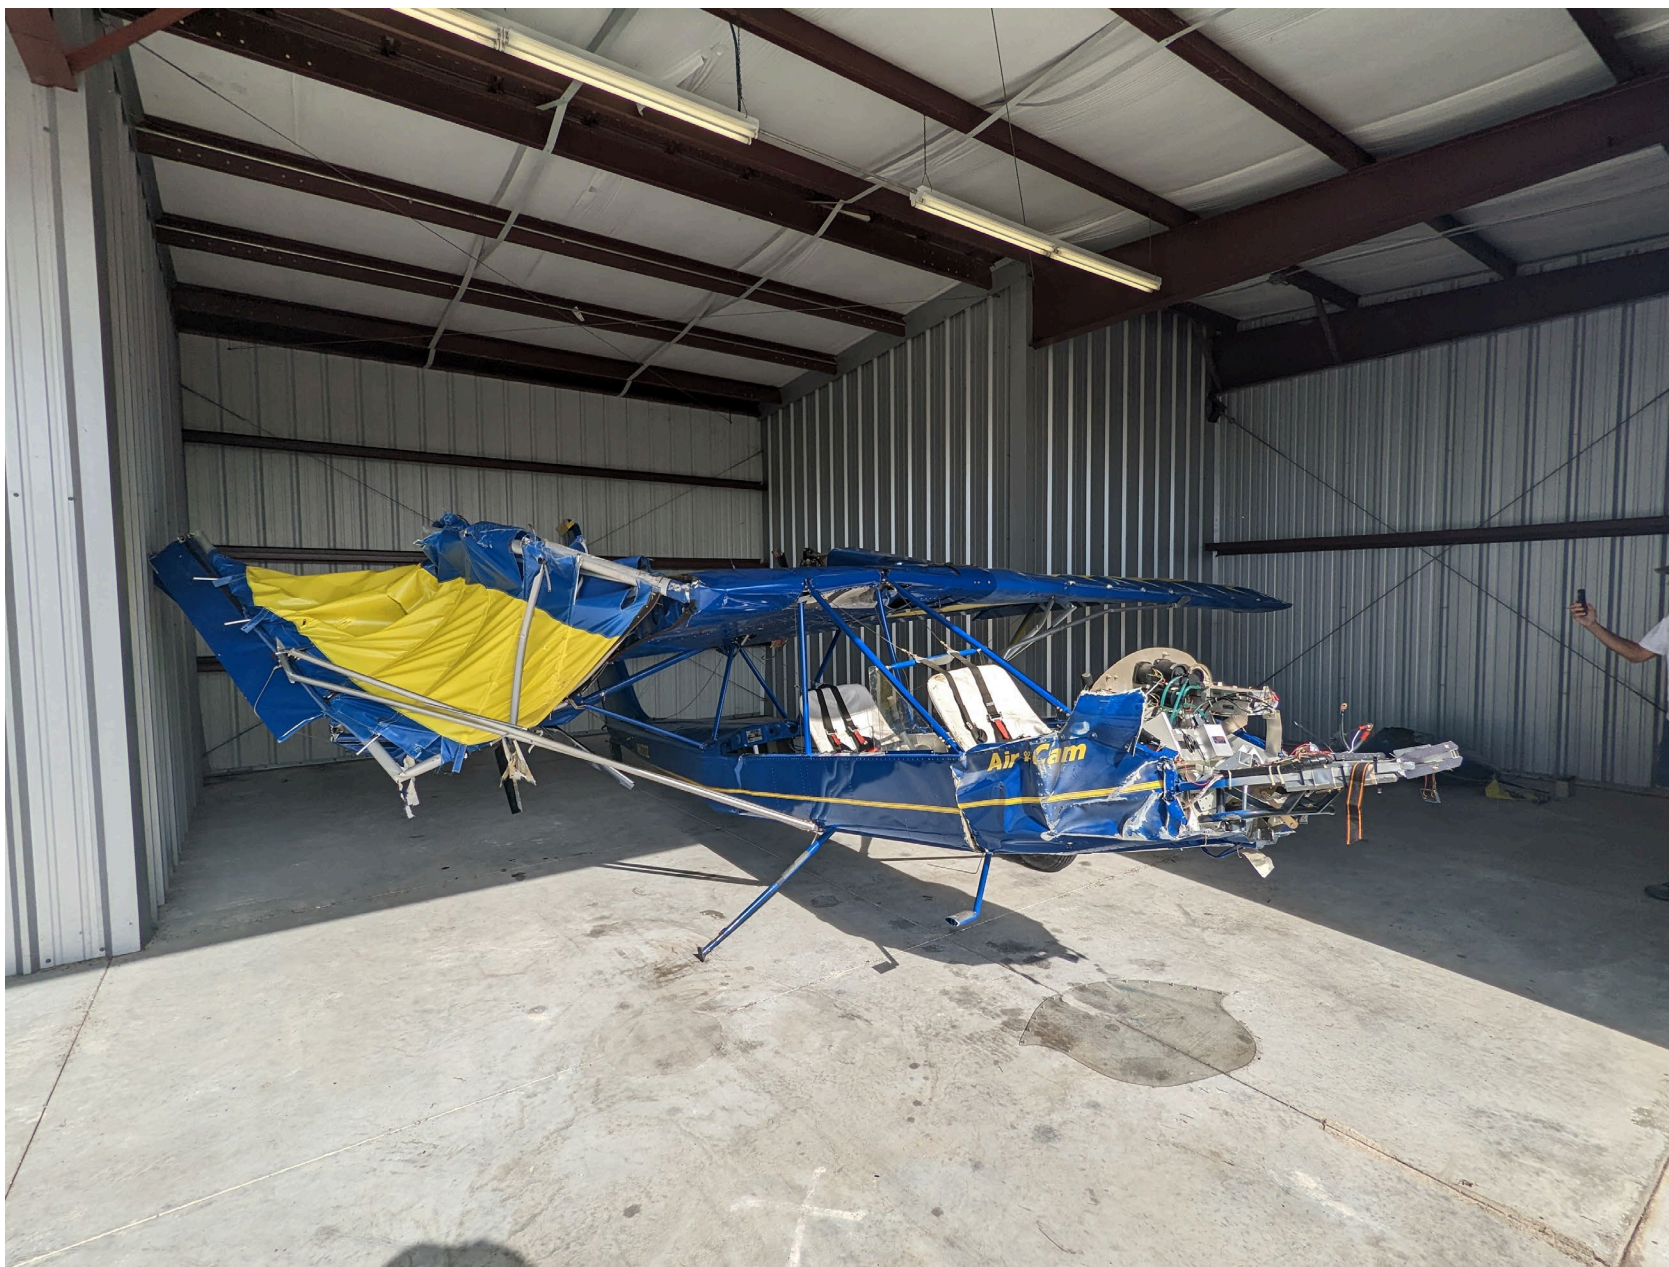
**Photo 2 - Digital Photograph From Lockwood Aviation. Right Forward Quartering View of the Wreckage Following Recovery. Note the Structural Damage to the Right Wing.**

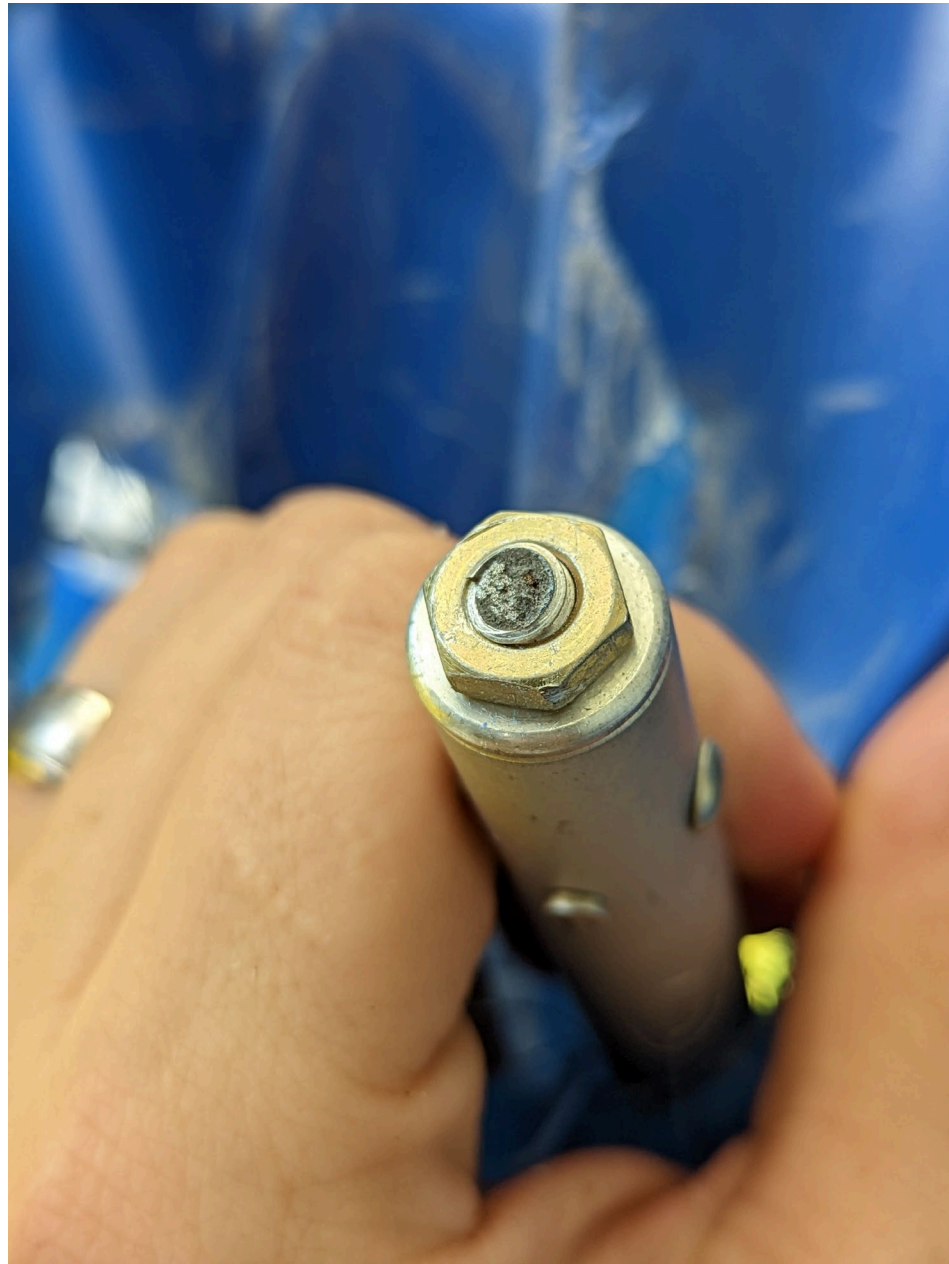
**Photo 3 - Digital Photograph From Lockwood Aviation. View Showing the Impact Damaged Right Aileron Rod End.**
