## Memorandum For Record

**Date: November 8, 2022**  
**NTSB Accident Number: ERA22LA299**

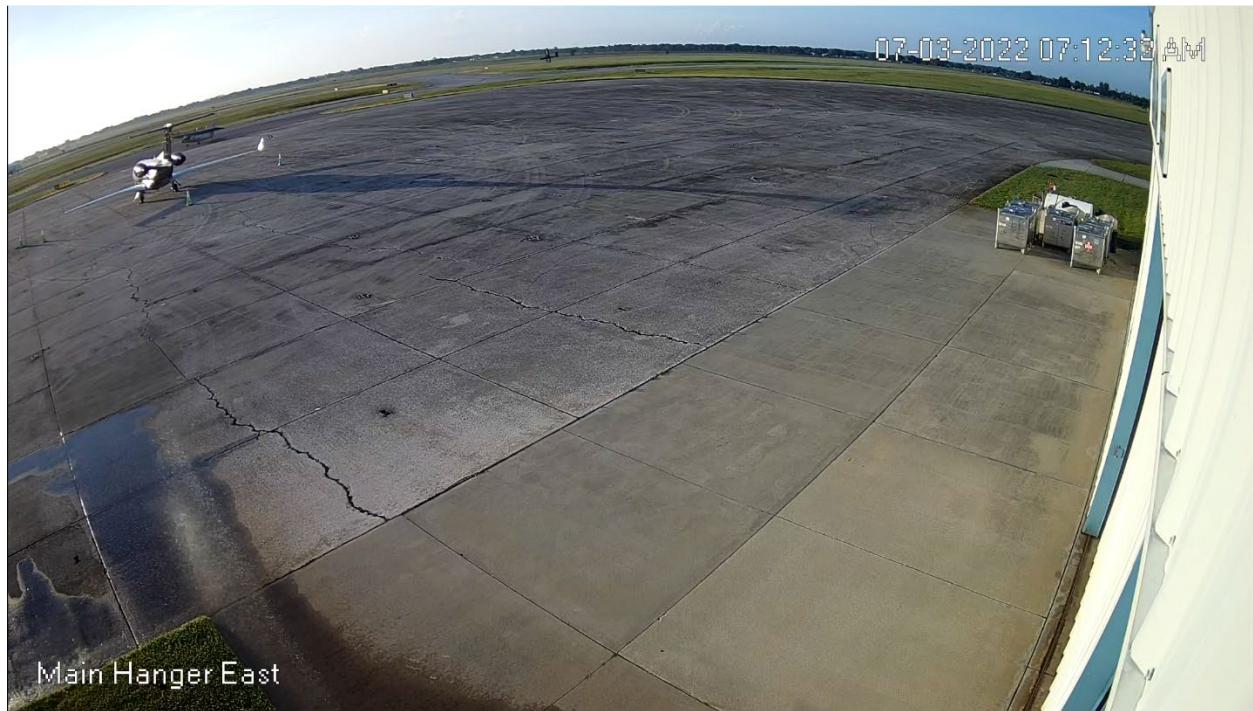
Figure 1: ScreenShot from video taken at 32 seconds elapsed time. Note the airplane in a right bank at first ground contact.

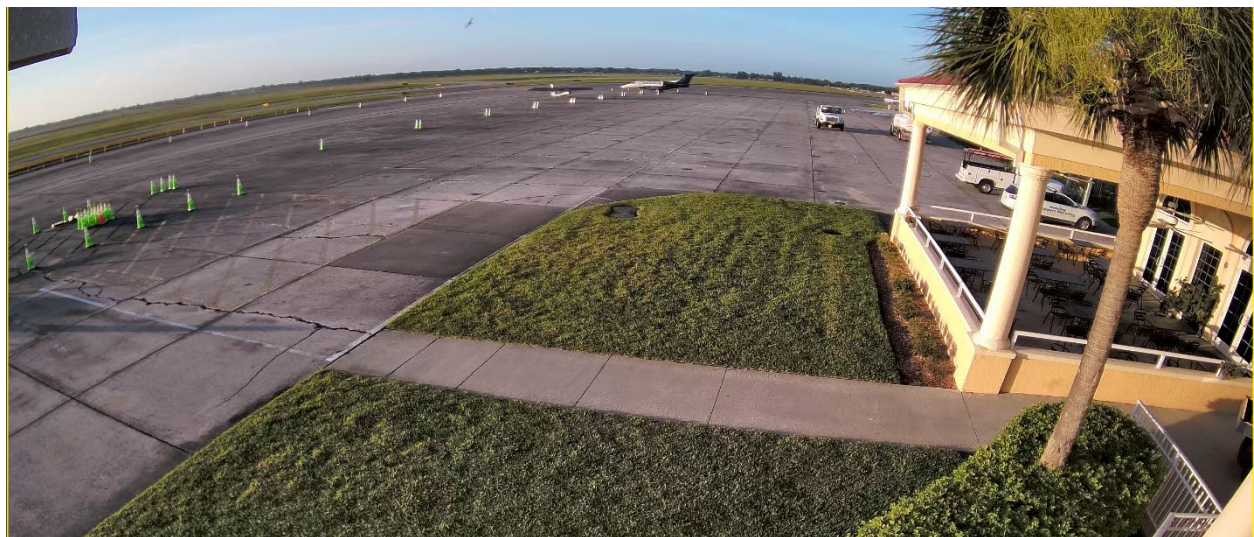
Figure 2: ScreenShot from video taken at 1 minute 54 seconds elapsed time. Note the airplane in a right bank.

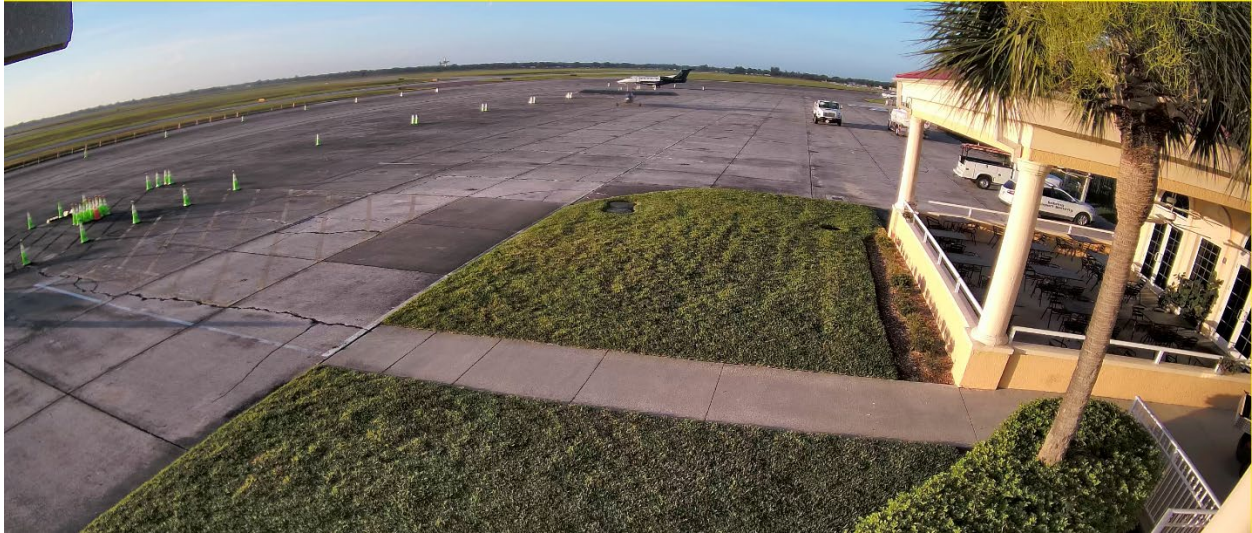
At about 39 seconds elapsed time of the 4 minutes 0 second long video the airplane just came into view from behind the building flying what appeared to be a base leg for runway 01. The flight continued on what appeared to be the base leg while descending and about 1 minute 13 seconds elapsed time the airplane appeared to be close proximity to runway 01. At 32 seconds elapsed time of the 1 minute 19 seconds long video, the airplane was in a right-wing low attitude and the right wingtip was in contact with the ground (Figure 1). The video depicted a cloud followed by the airplane making a climbing right turn. The airplane went out of view of the camera at 46 seconds elapsed time. At 1 minute 54 seconds elapsed time of the 4 minutes 0 second long video while several wing spans above the runway while in a northerly heading, the bank angle increased (Figure 2). The airplane began a right descending turn completing nearly a 720° turn while descending (Figure 3), impacting the ground at 2 minutes 5 seconds elapsed time.

Figure 3: Screenshot from video taken at 2 minutes 3 seconds elapsed time. View depicts the airplane in a right bank just before second ground contact.
