# National Transportation Safety Board

ERA22LA301

## WRECKAGE EXAMINATION

Location: Cleveland, Georgia  
Date: July 8, 2022  
Time: 1305 EDT  
1705 UTC  
Airplane: Kolb Firestar II airplane, N6136Y

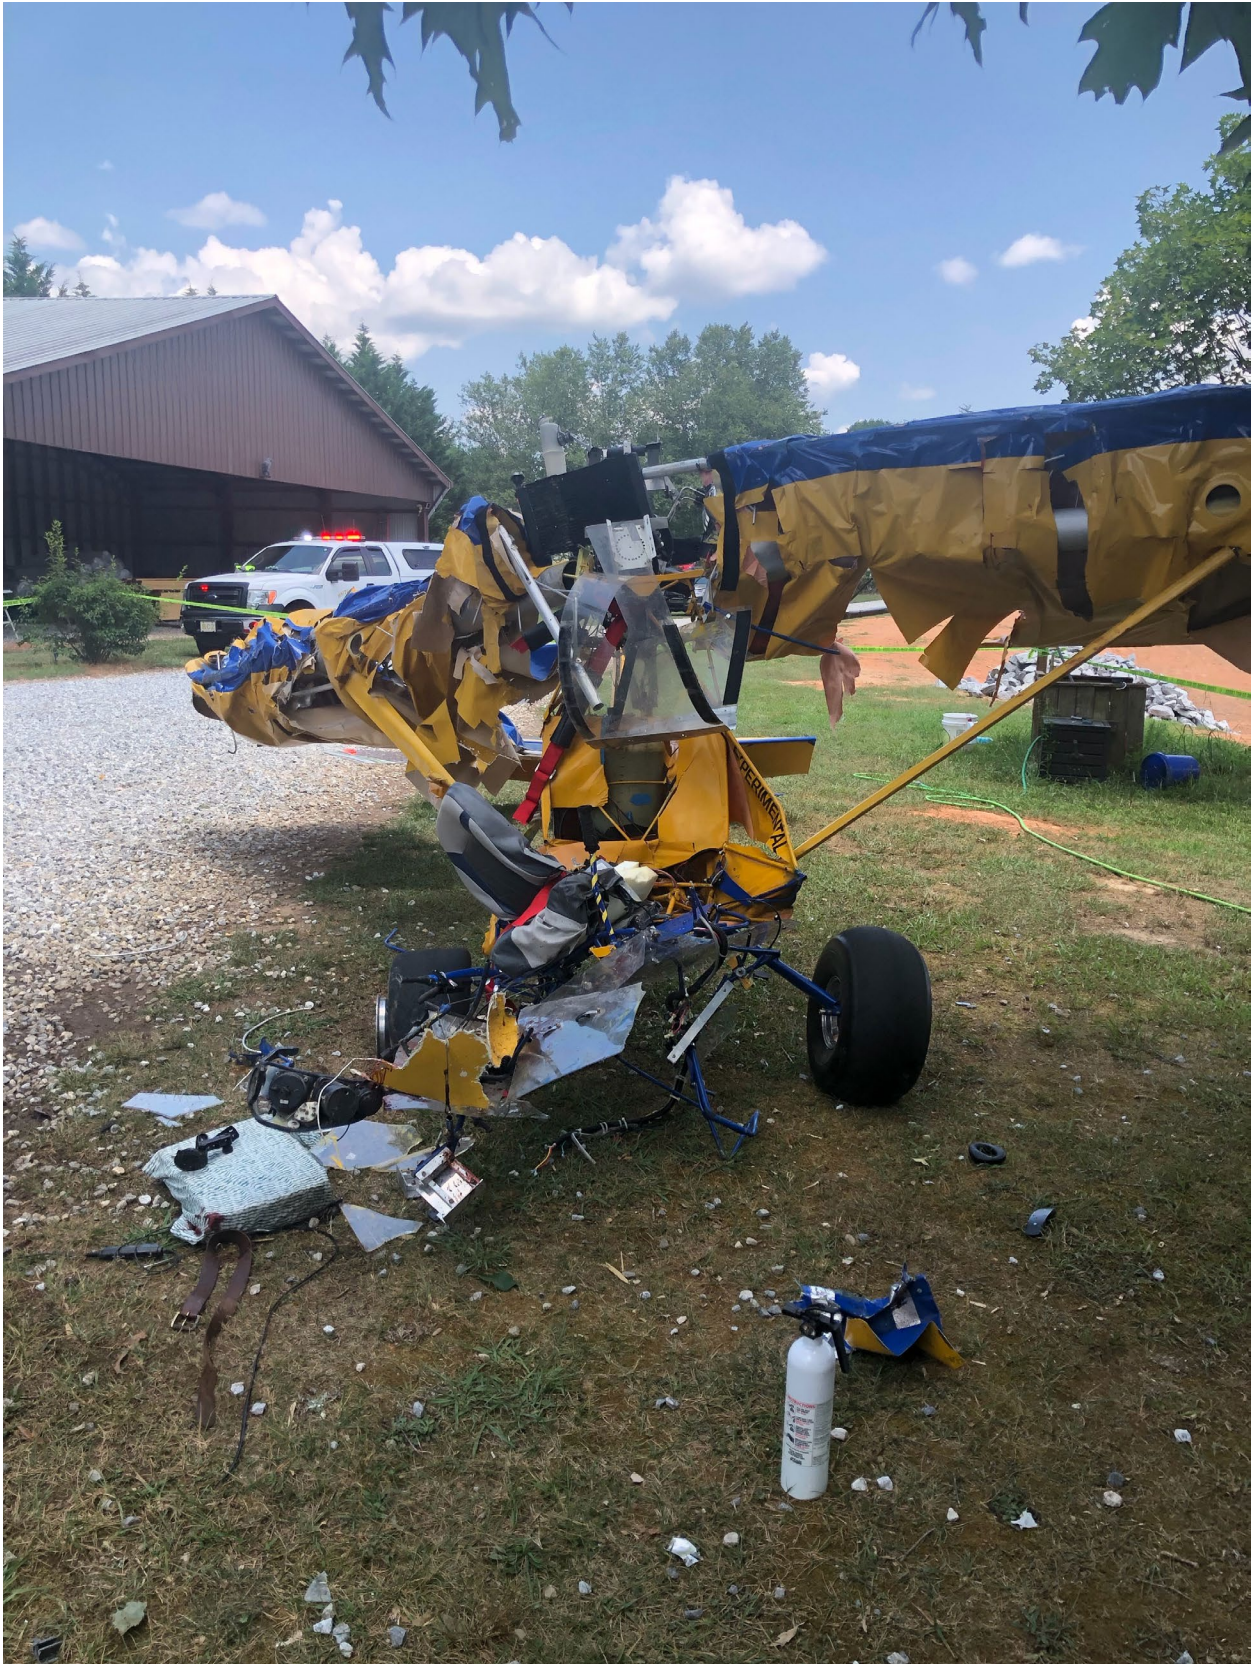
The experimental airplane was constructed of mostly tube and fabric and sustained extensive damage from impact. The cockpit area was crushed. Both wings remained attached to the fuselage but were pushed aft with extensive leading-edge damage.

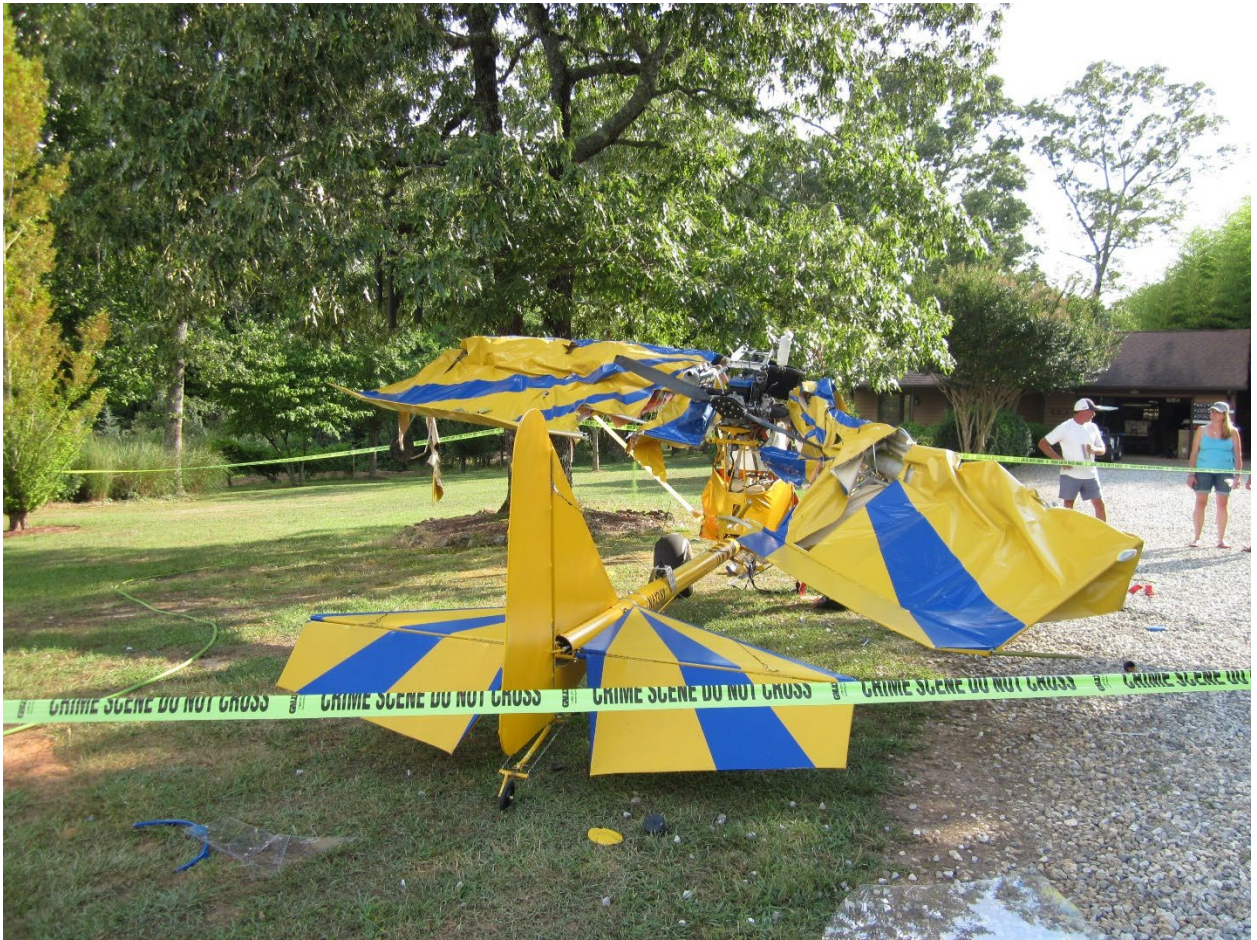
The tail section exhibited minor damage. An FAA inspector responded to the accident site and reported flight control continuity for the left wing, and tail section; however, the right aileron was fractured. A section of the right aileron push/pull tube had separated from the airplane was located in the grass near the wreckage. The section of fractured aileron tube was retained and further examined by the NTSB Investigator-in-Charge. Visual examination of the fractured ends of the tube were consistent with overload.
