# National Transportation Safety Board

ERA22LA302

## EXAMINATION

Location: Center Cross, VA  
Date: July 8, 2022  
Time: 1530 EDT  
1930 UTC  
Airplane: Air Tractor AT-502B; N50075

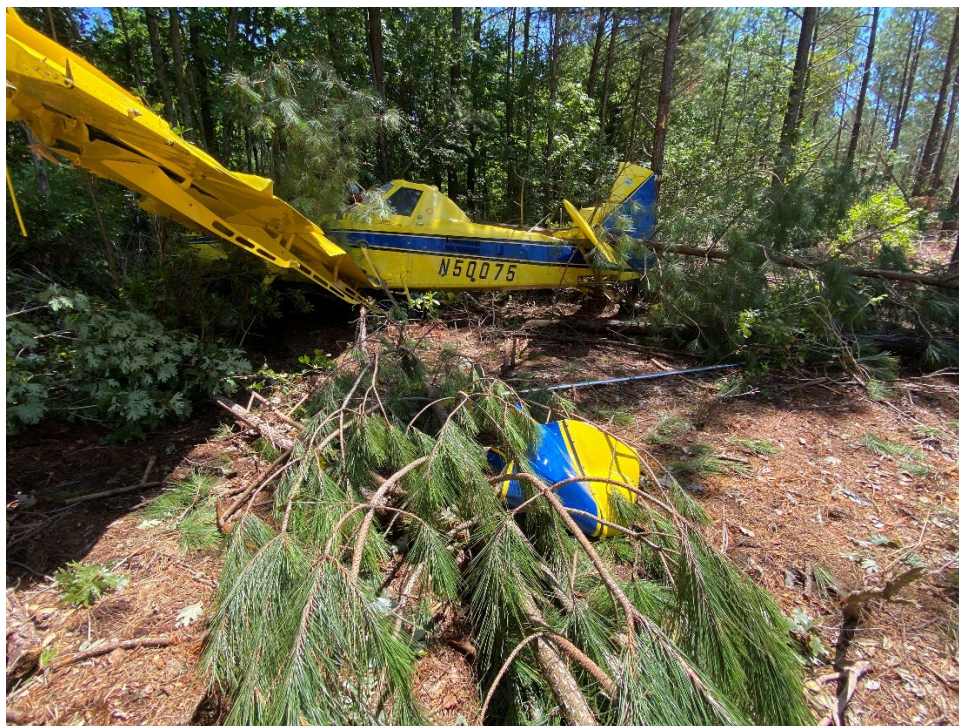
The investigative team did not travel to the accident site for this examination. The airplane was recovered by AMF aircraft Recovery in Springfield, Tennessee. Aircraft had attempted an emergency landing after a loss of engine power in a harvested forest area at coordinates 37°47'41.898"N, 076°46'34.265.

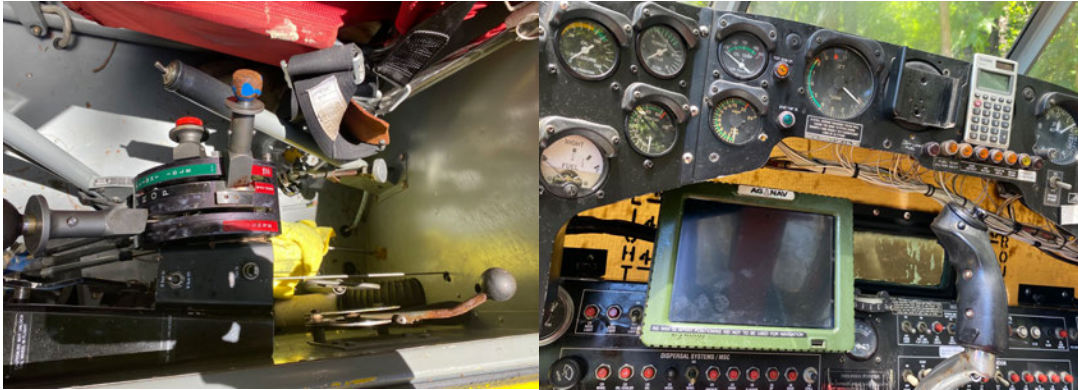
The cockpit, instrument panel, seat and lap/shoulder harness were intact, and all gauges were functional. The engine control levers for throttle, prop and fuel were functional; verified engine and propeller control continuity with no binding from the cockpit and engine.

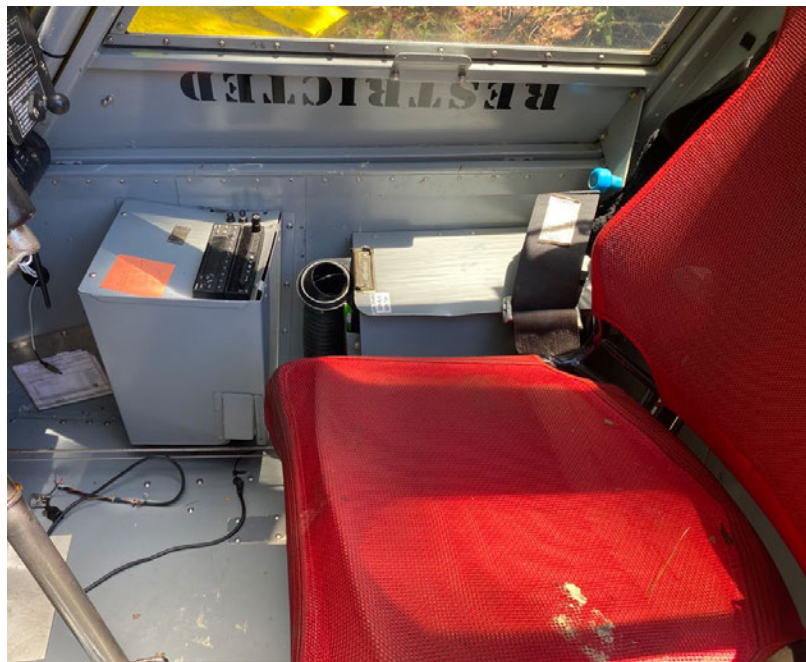
Cockpit and the surrounding structures were intact. There was no deformation, and the seat and shoulder harnesses were intact and functional. Survivable with minor injury sustained.
