**NTSB ERA22LA306**

N7883P, Piper PA-24

Photo Array

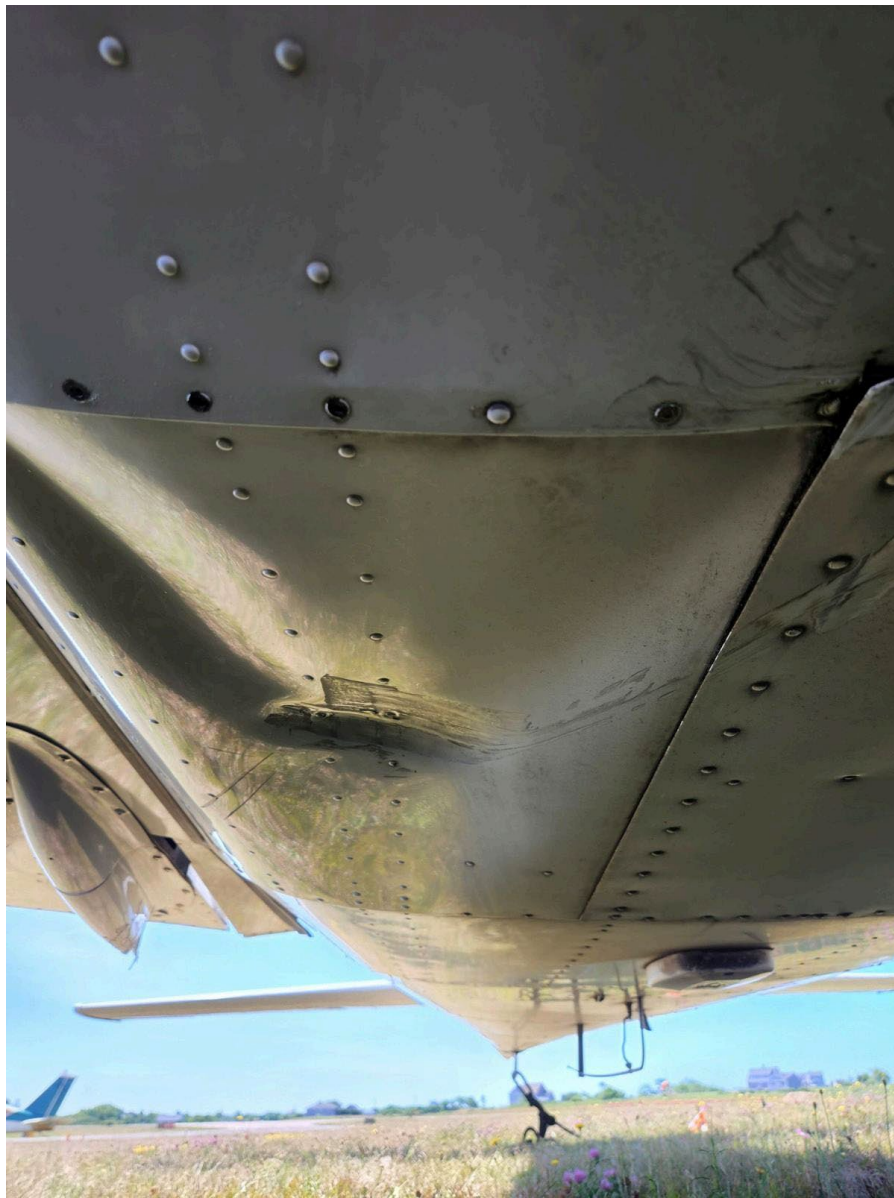
Photo 1: Damage to the airplane's fuselage (Photo Courtesy of FAA)

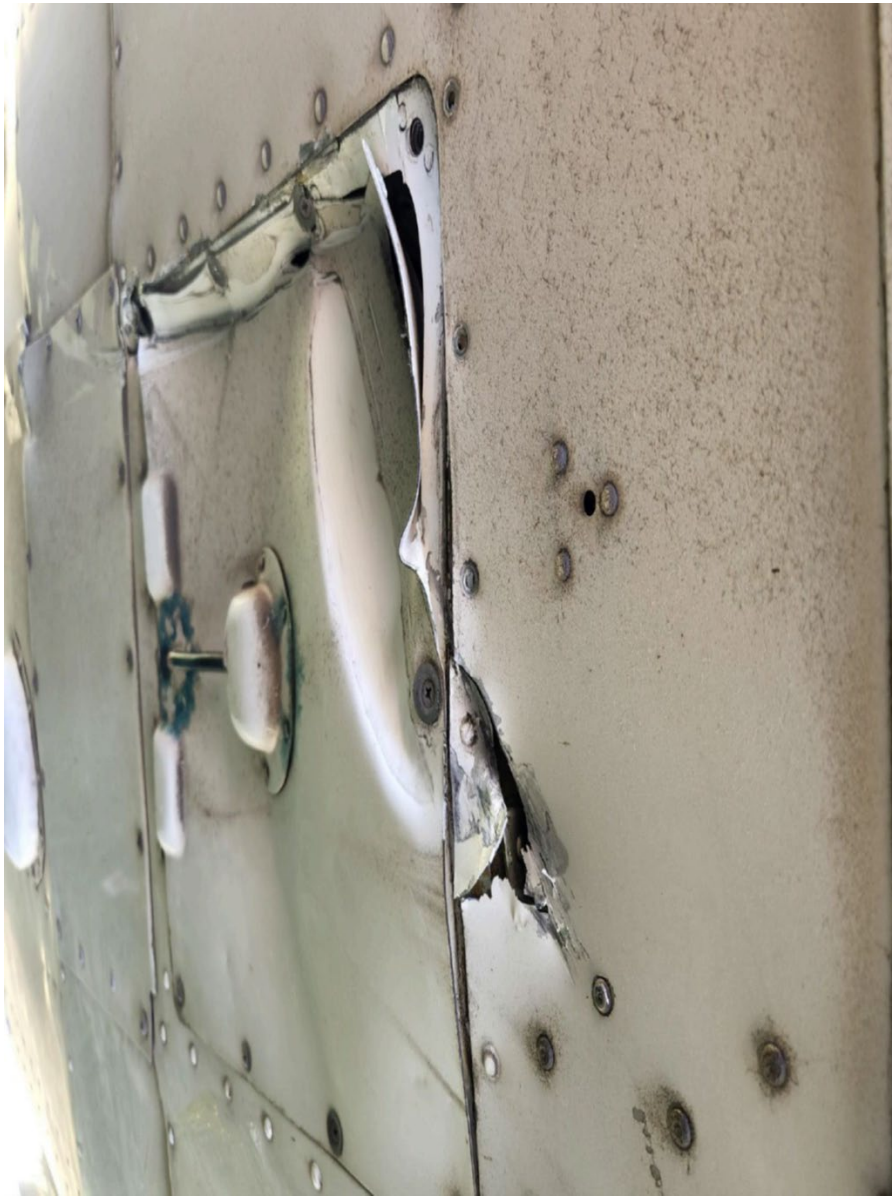
Photo 2: Damage to the airplane's fuselage (Photo Courtesy of FAA)

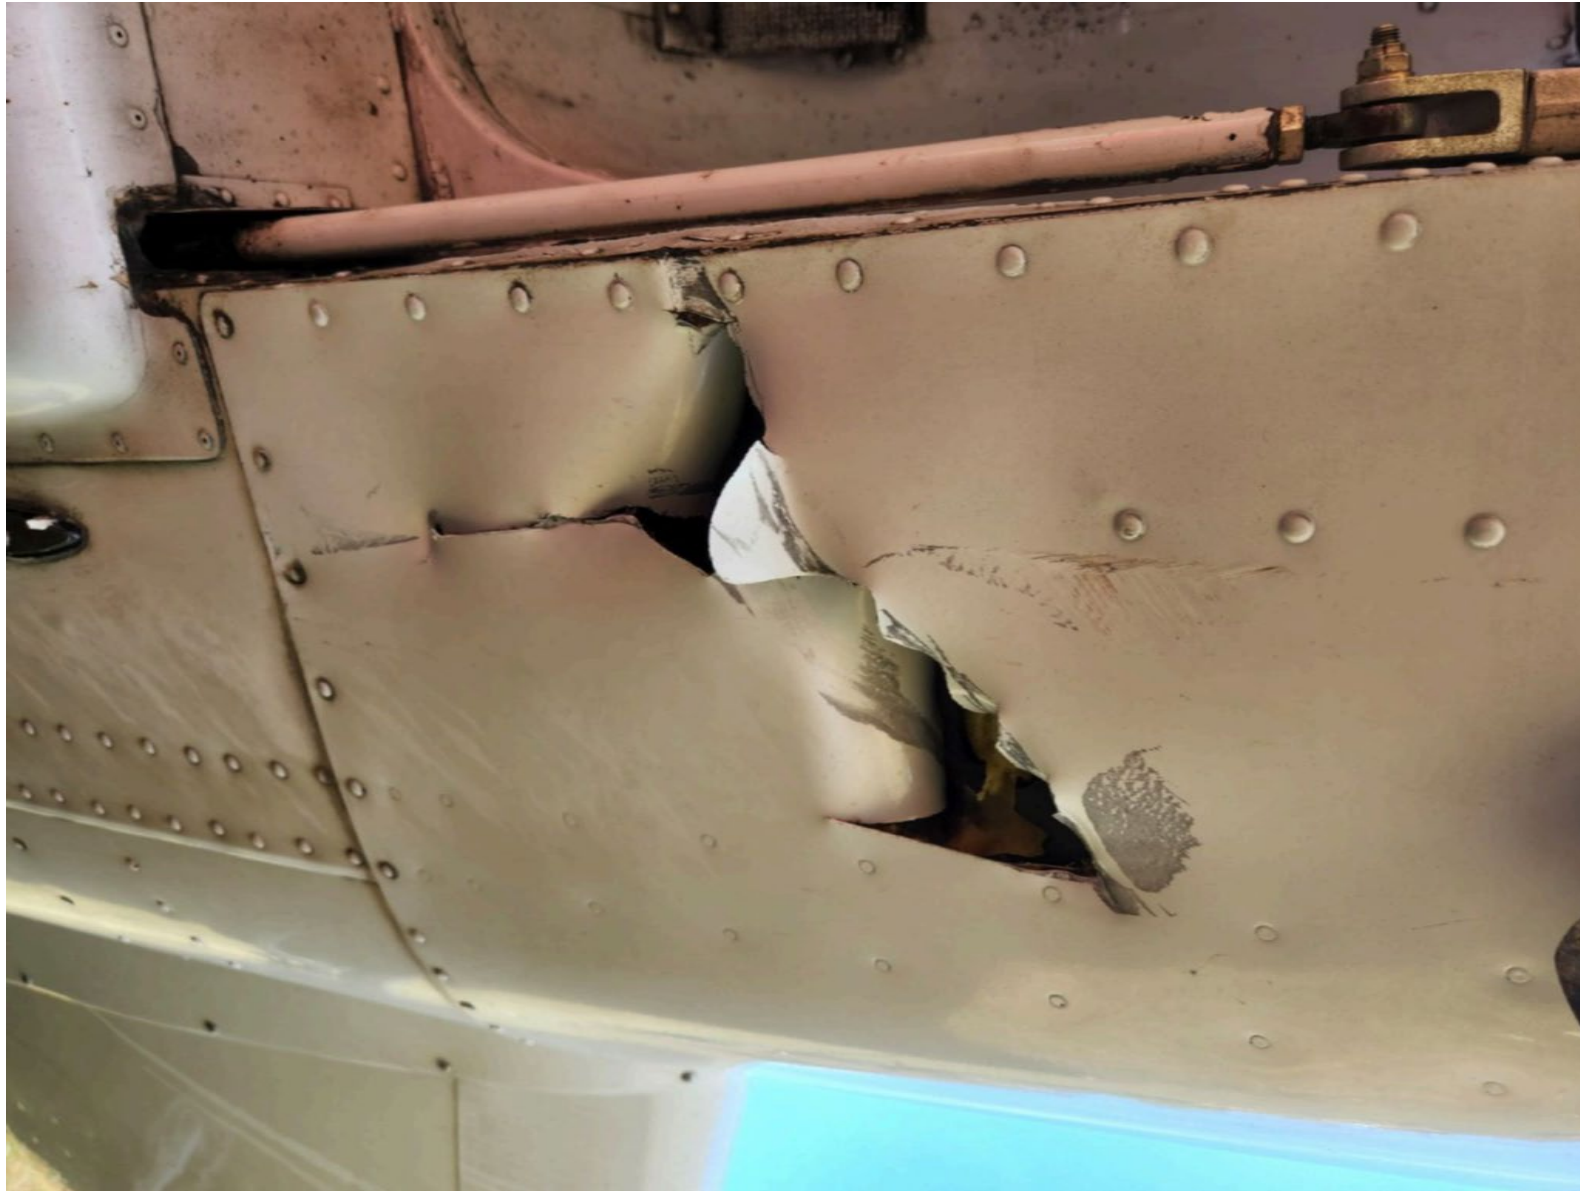
Photo 3: Hole in the airplane fuselage abeam the nose landing gear tunnel wall (Photo Courtesy of FAA)

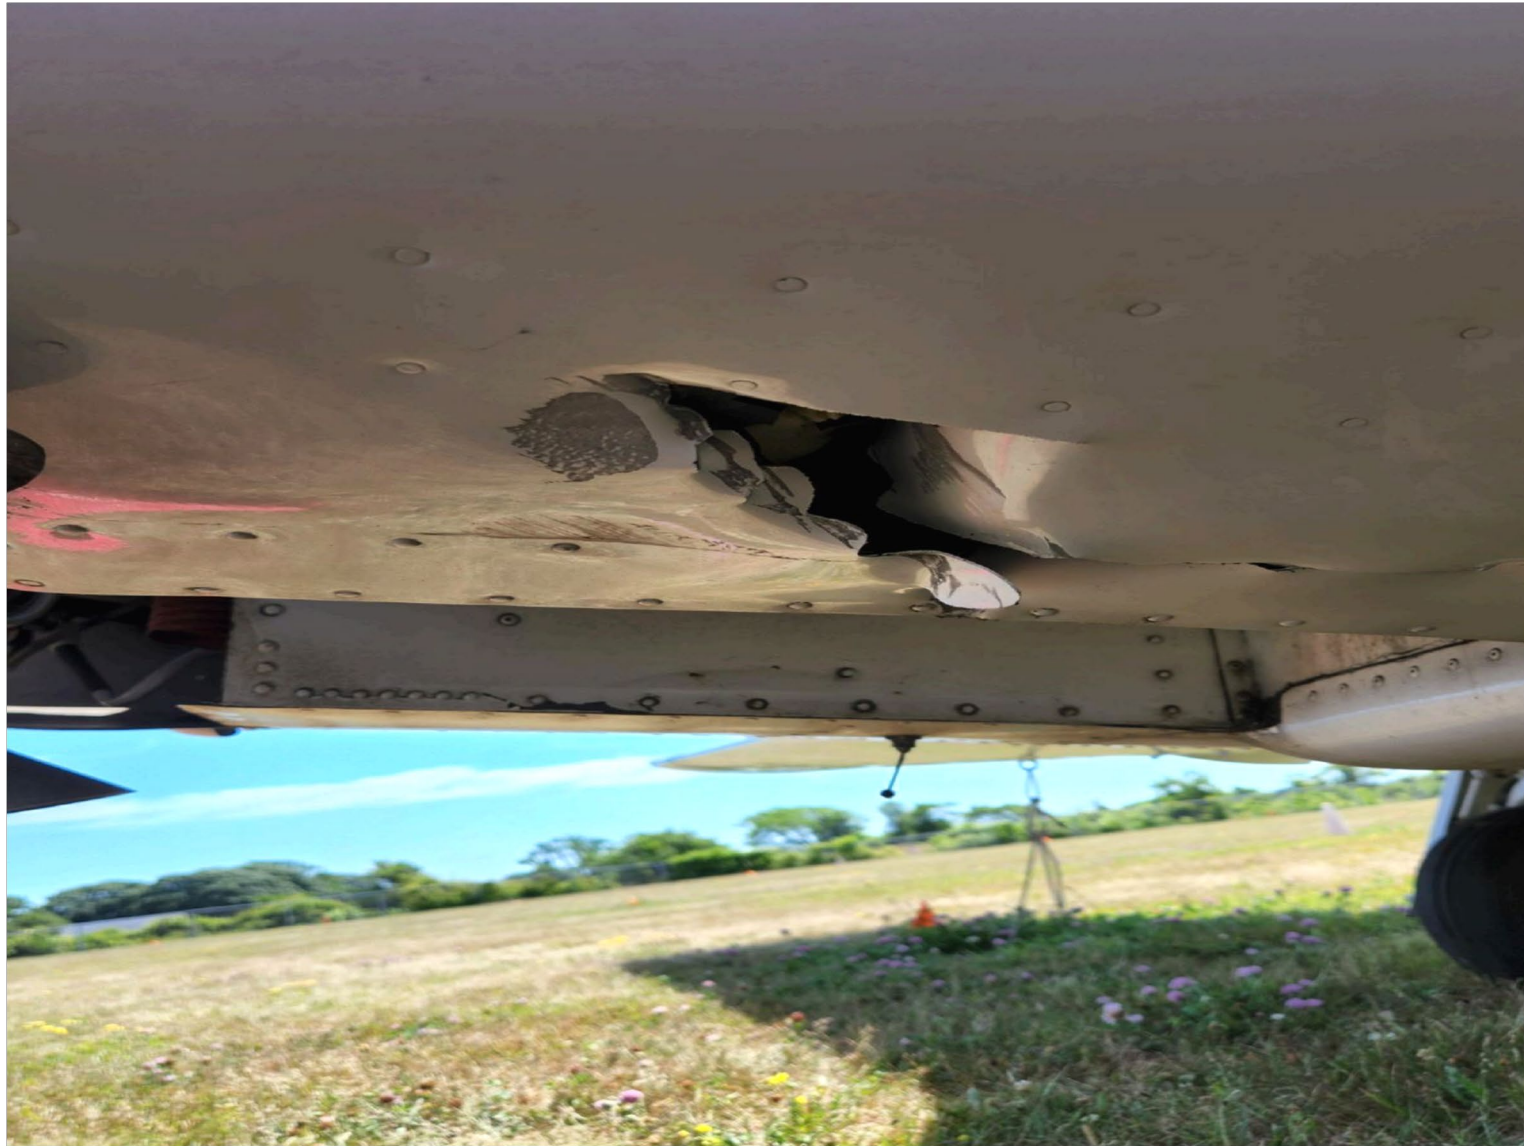
Photo 4: Damage to the airplane's fuselage (Photo Courtesy of FAA)
