ERA22LA307

## INVESTIGATION PHOTOGRAPHS

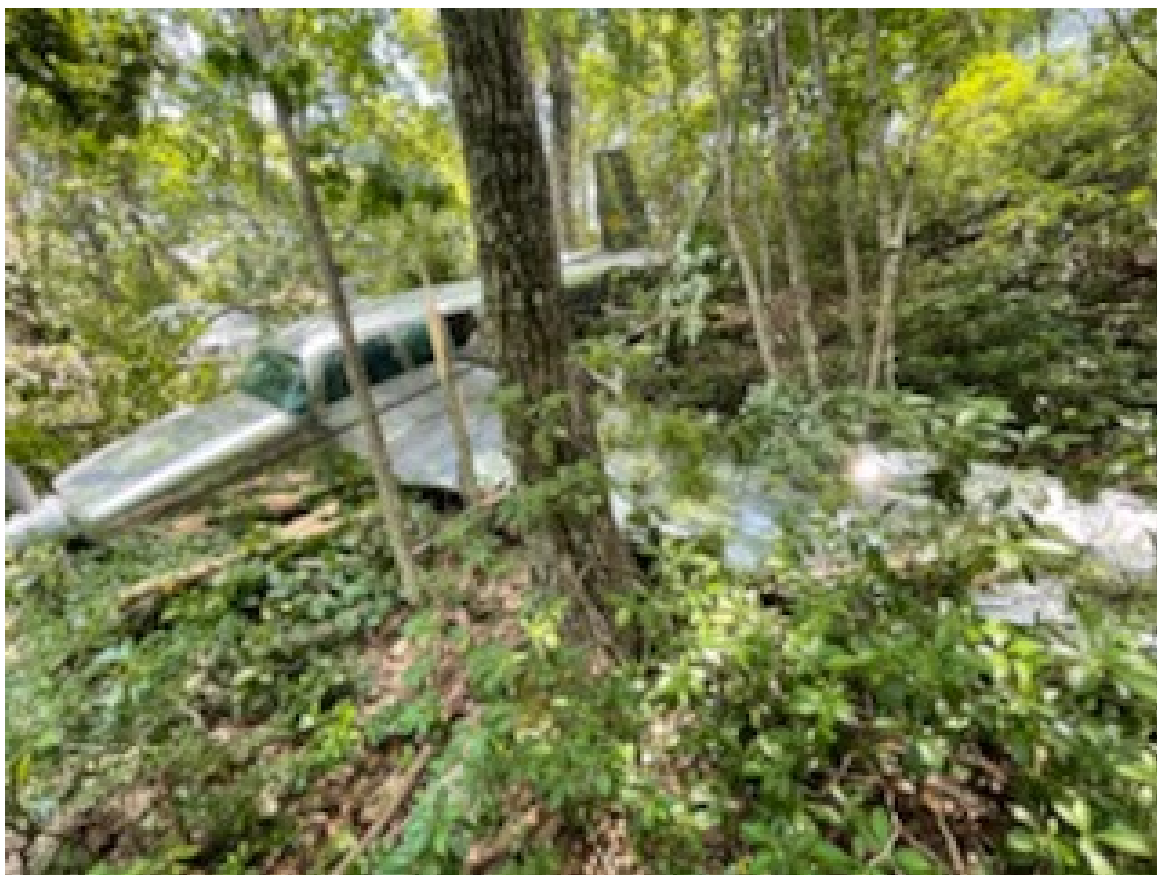
**Photograph 1 - Postaccident view of wreckage (Courtesy of FAA)**

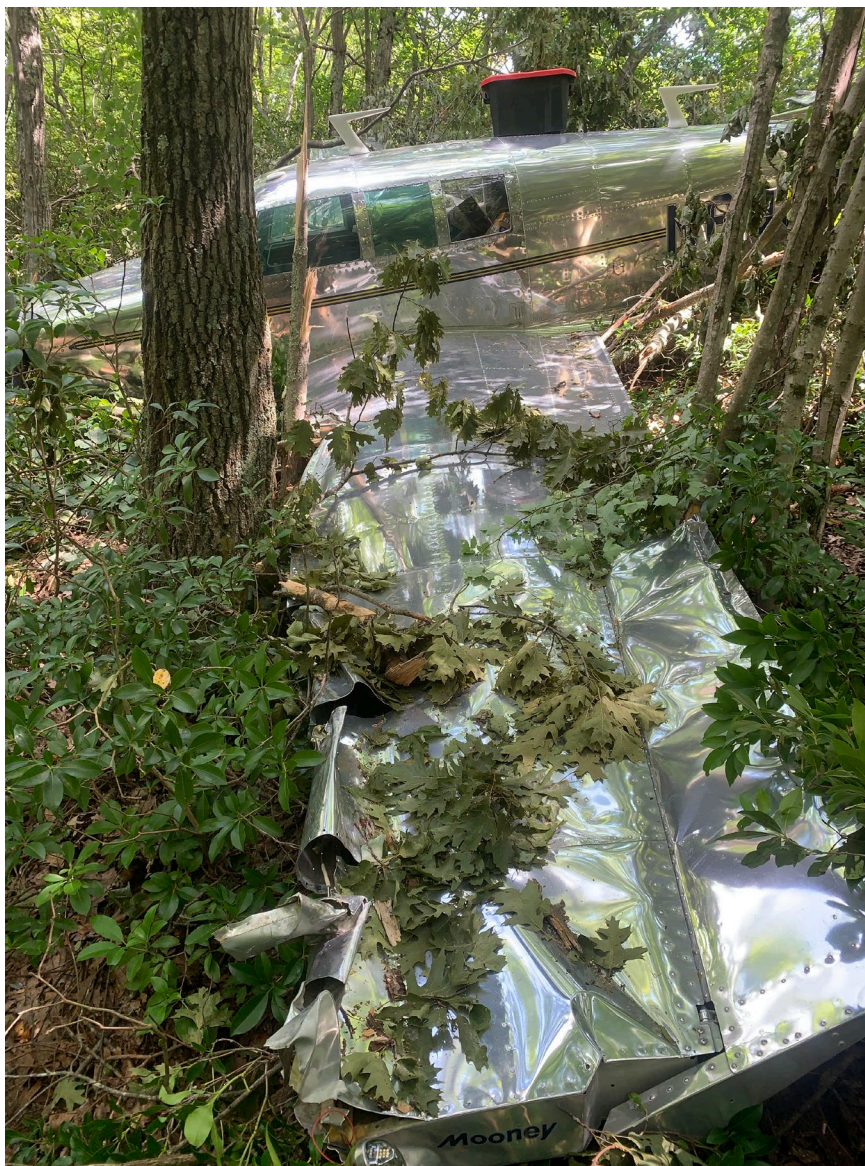
**Photograph 2 - Postaccident view of wreckage (Courtesy of Anglin's Aircraft Recovery)**

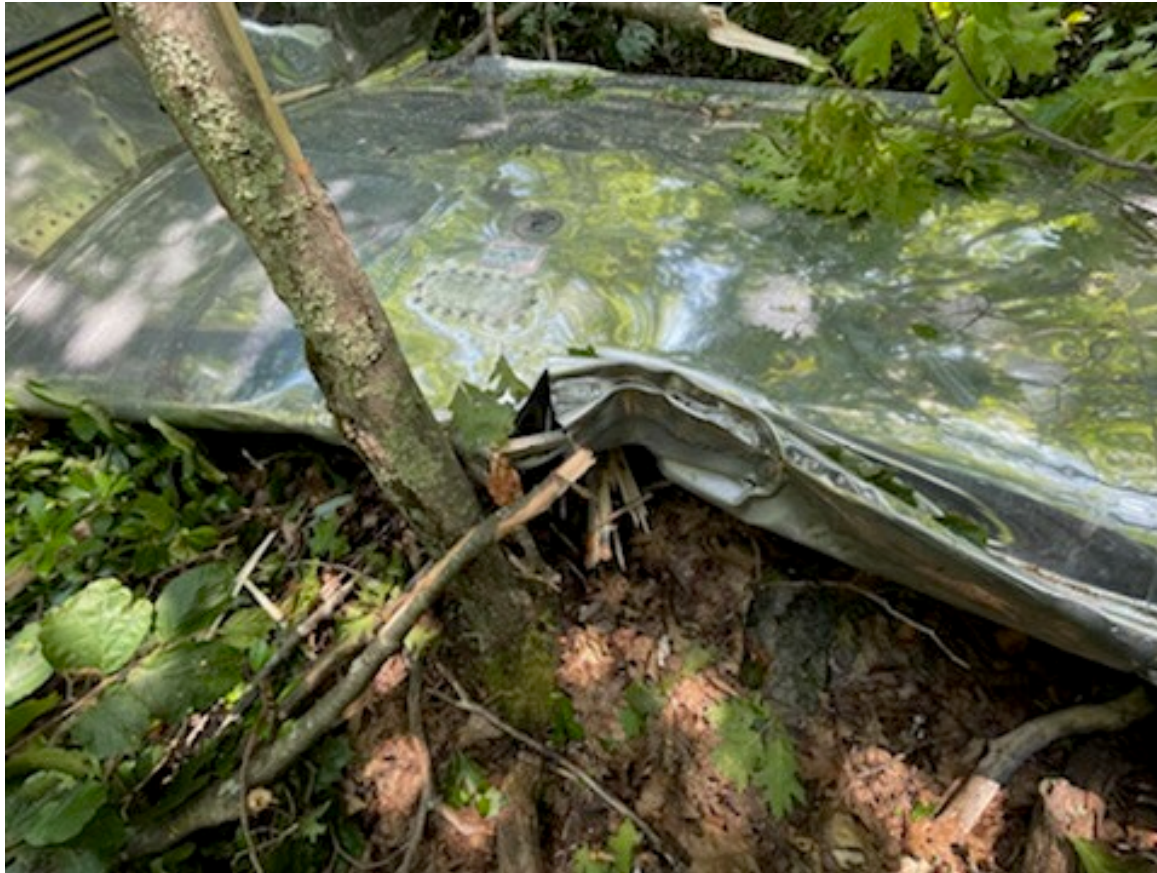
**Photograph 3 - Impact damage to left wing (Courtesy of FAA)**

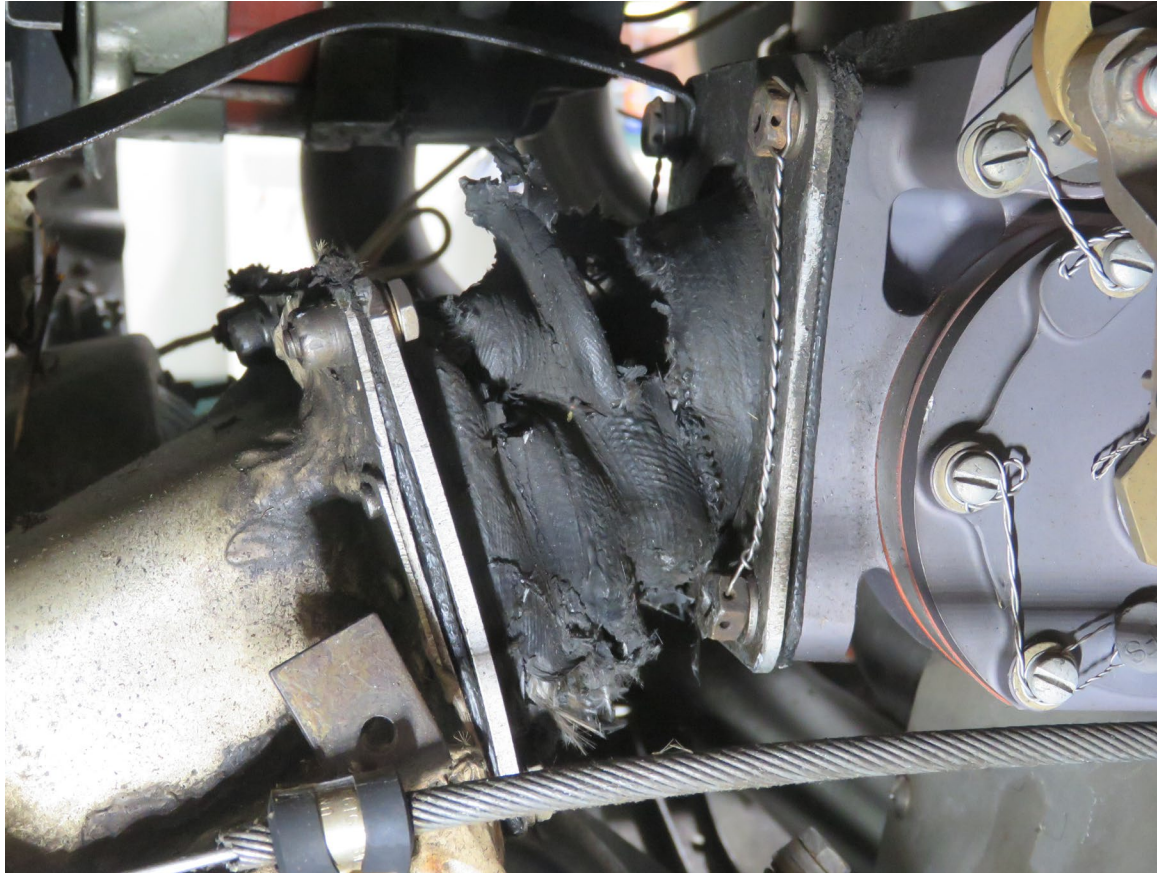
**Photograph 4 - Deteriorated fuel injector airbox boot (Courtesy of Lycoming)**

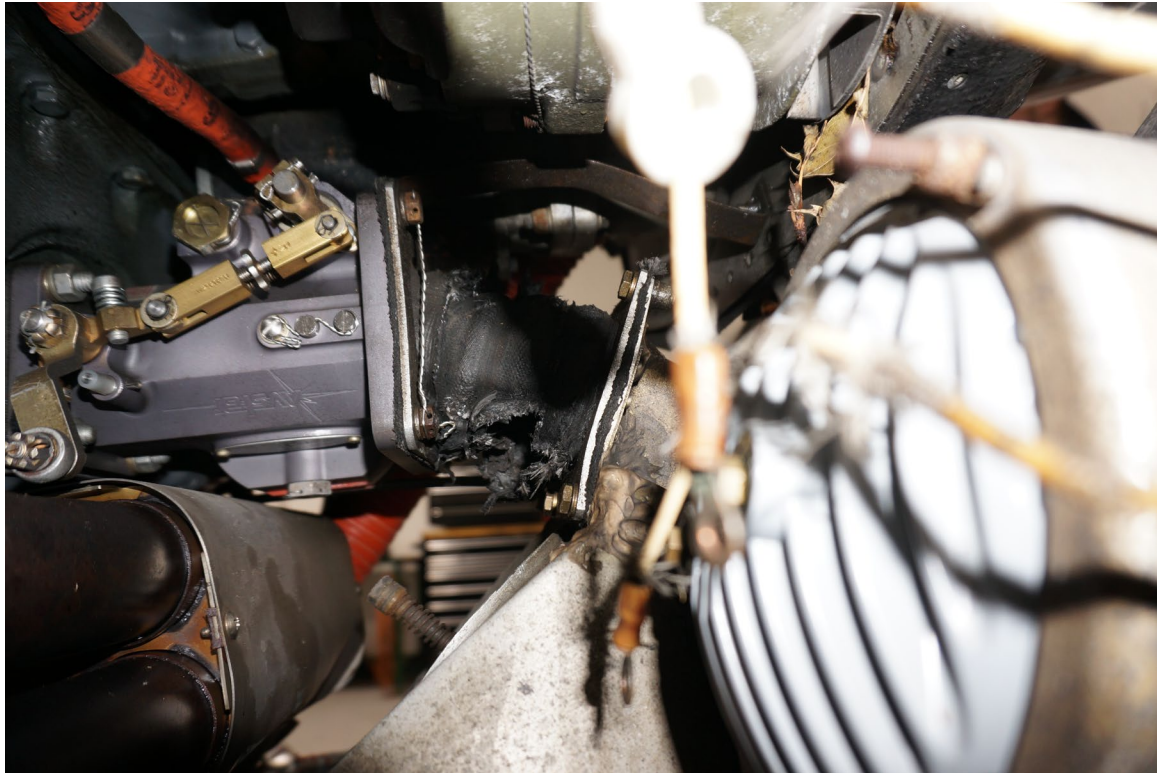
**Photograph 5 - Deteriorated fuel injector airbox boot**

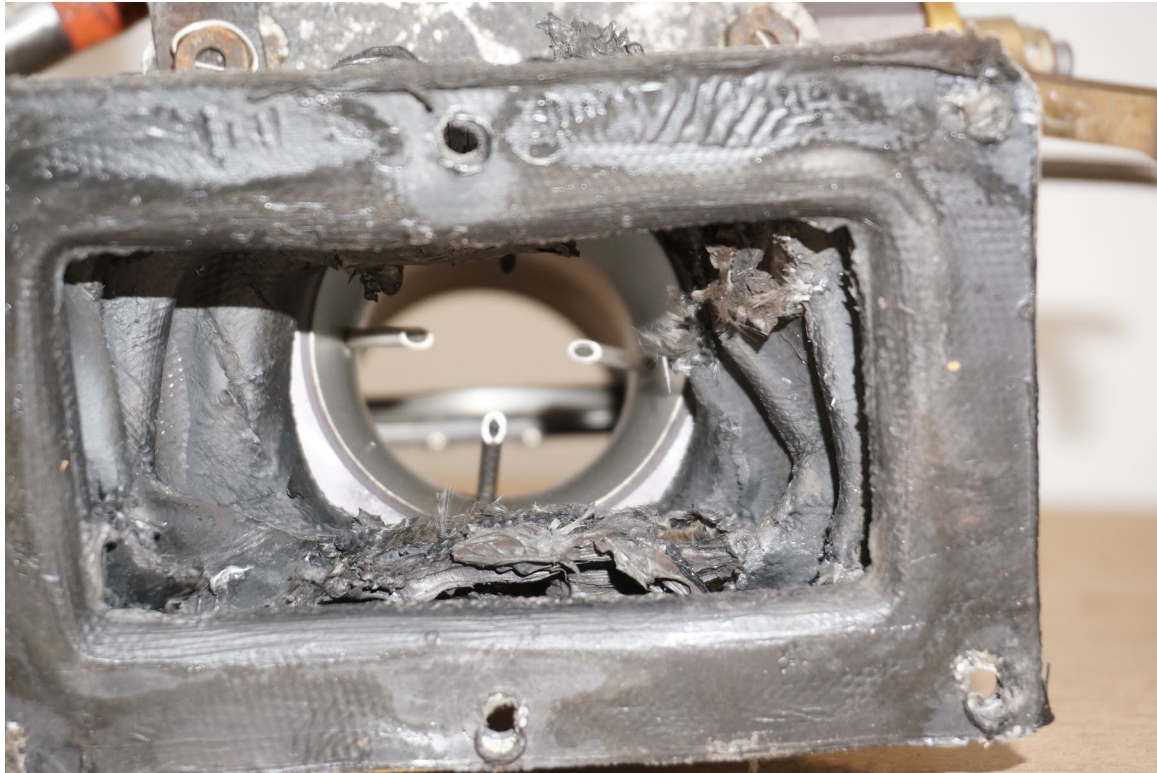
**Photograph 6 - Deteriorated fuel injector airbox boot**
