# National Transportation Safety Board

ERA22LA220

## ENGINE EXAMINATION

Location: Pittstown, New Jersey  
Date: July 13, 2022  
Time: 1157 EDT  
Airplane: Cessna 150, N8761G

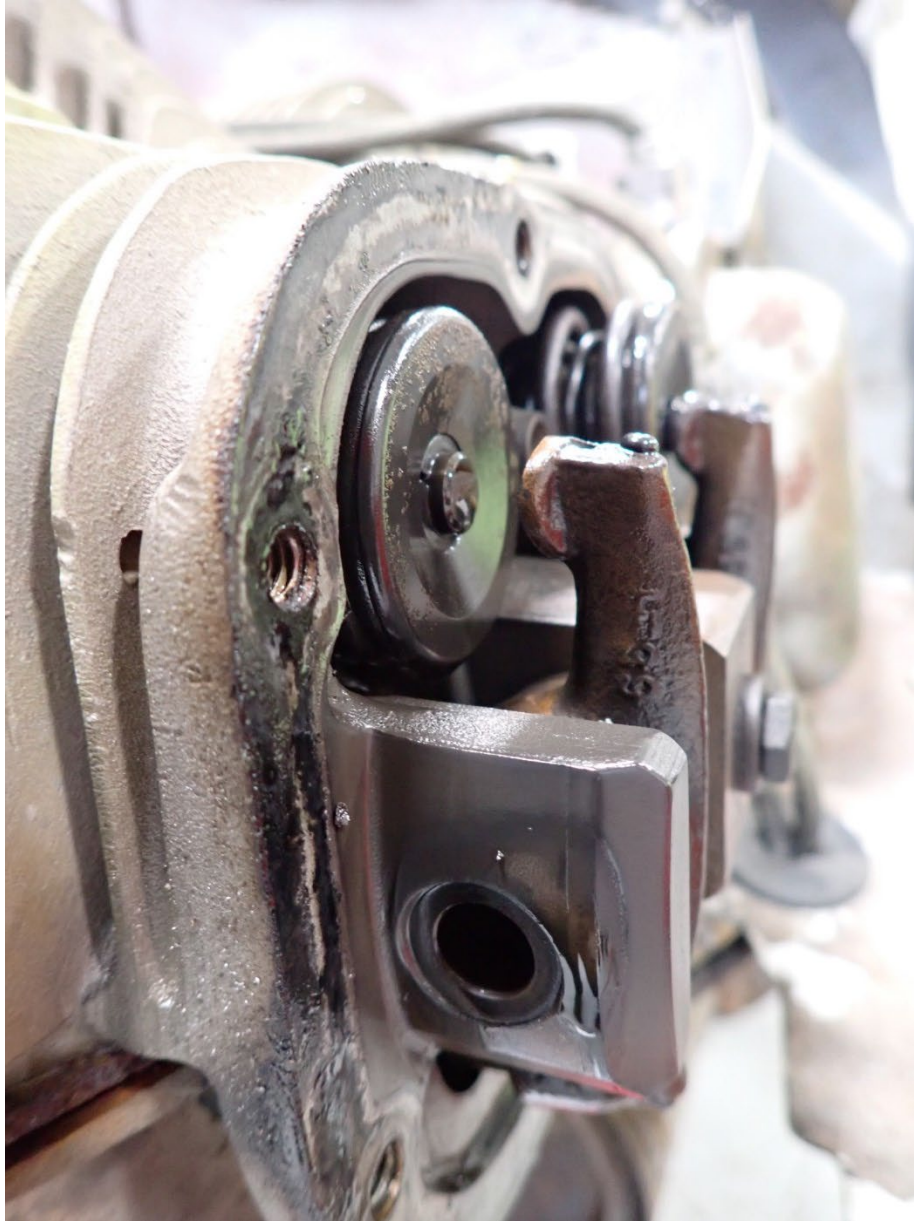
- Thumb compression/suction check. Cylinder Nos. 1, 3, and 2 were confirmed. No compression or suction was observed on cylinder No. 4.
- Cylinder No. 4 valve cover removed, and exhaust valve was found to be stuck in place. The valve could not be unset and remained in the fully open position even after striking the assembly with a rubber mallet. The valve nor spring, rocker and pushrods were not subjected to impact or heat damage.

**Figure 1 View of cylinder No. 4 exhaust valve.**

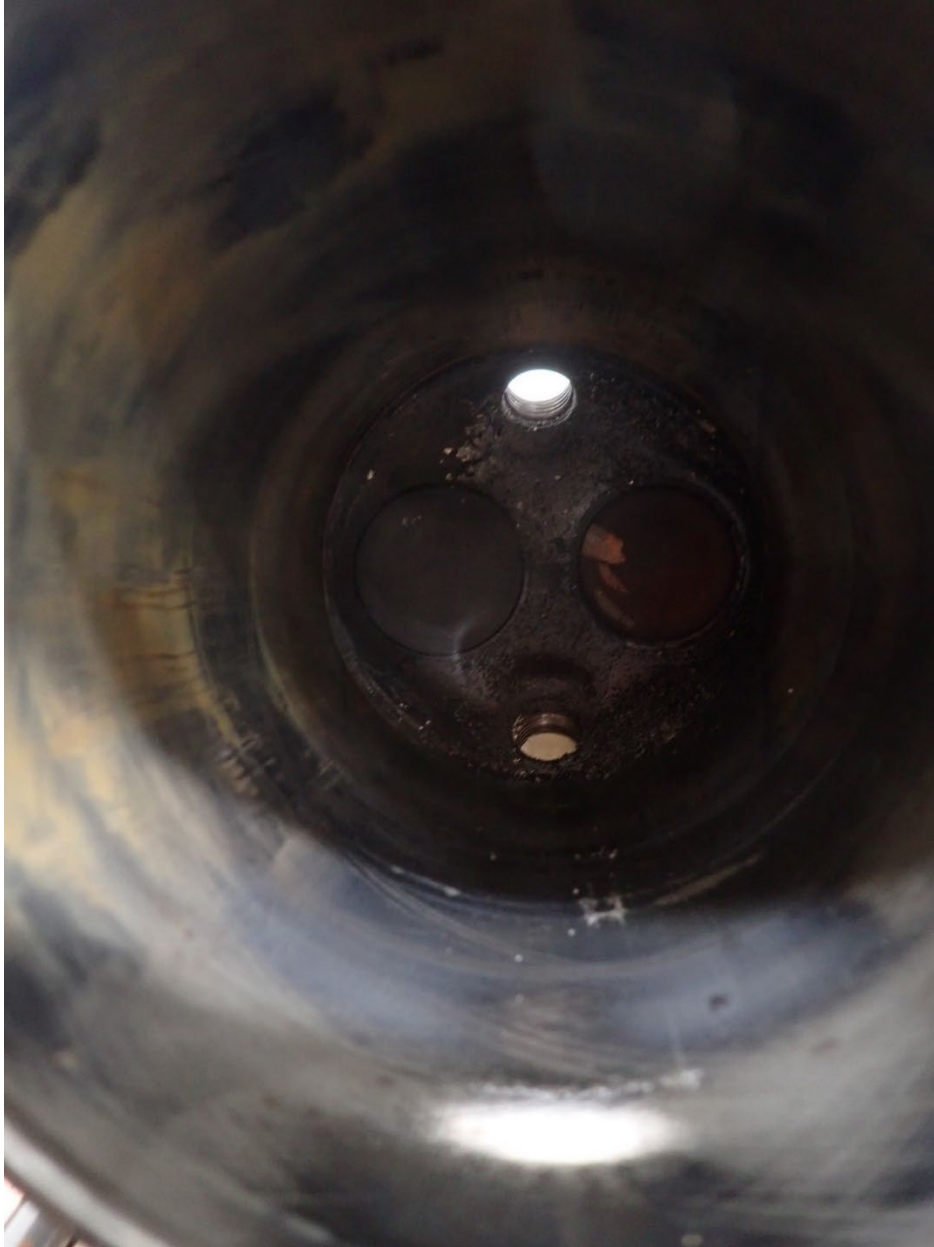
**Figure 2 View of the interior of cylinder No. 4, the exhaust valve on the right and remained in the closed position.**

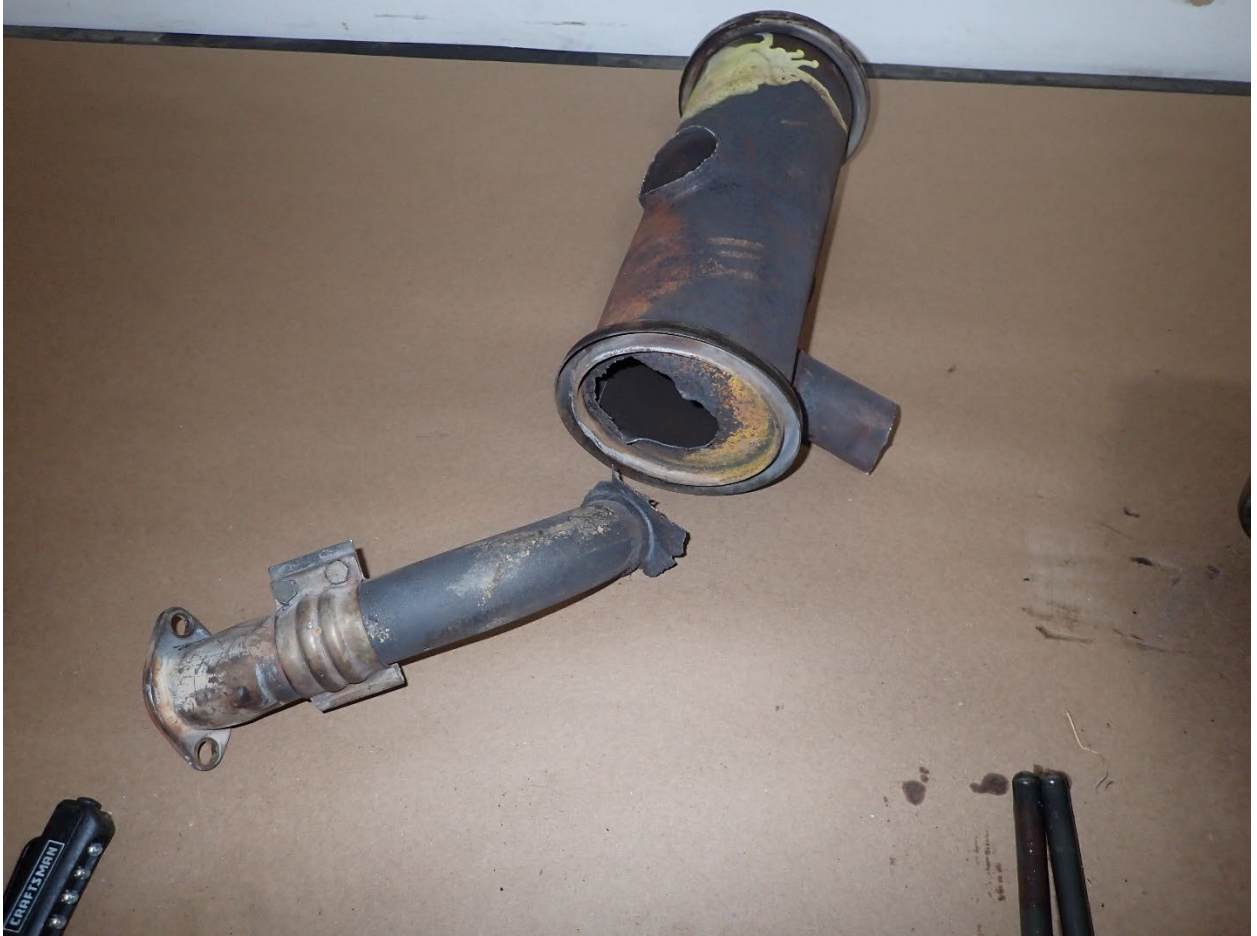
- Exhaust manifold exhibited signs of pitting and corrosion and broke away easily from the muffler.
- Damage present around the left aft attachment point.

**Figure 3 View of the exhaust manifold and muffler.**
