ERA22LA309  
N9556H, Cessna 172M,  
Lancaster, Ohio, June 22, 2022

N9556H Wreckage Examination Requested Items:

**INSPECTION CHECKLIST**

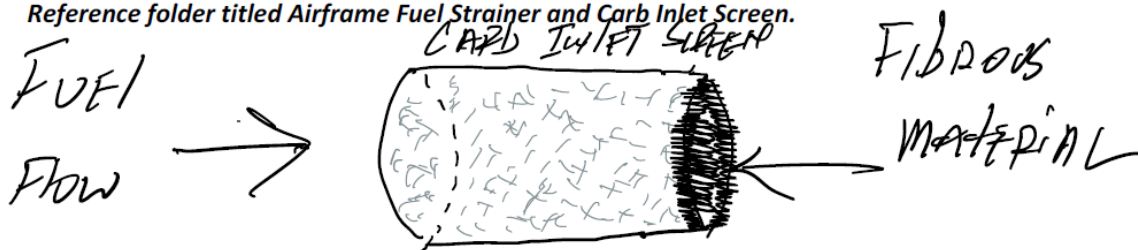
***Reference folder titled Airframe Fuel Strainer and Carb Inlet Screen.***

To recap, the aircraft has been tilting roughly 15 to 20 degrees to the right for several weeks. This has caused all the fuel to move into the right wing. No fuel was able to be obtained from the left wing sumps. The right wing sump showed no contamination and had the color and consistency of 100LL. The fuel selector valve had been damaged in the impact and would not rotate from center position. The fuel sump handle had been damaged due to the crash and would not sump fuel. The fuel strainer was disassemble and fuel was drained from the strainer. This fuel had the color and consistency of 100 LL. However, it contained a small amount of black particulates. Inspection of the screen assembly did not show any black particulates adhering to the screen. However, there was a small amount of fibrous material on the screen and dark discoloration on the bottom of the bowl. In addition, the standpipe had significant damage to the lower portion. Perhaps this is the source of the black particulates. Fuel was removed from the carburetor. It too had the color and consistency of 100 LL. However, it too had a small amount of black particulates. An inspection of the carburetor screen filter did not show any black particulates adhering to the screen. However, there was a significant amount of fibrous material pack at the end of the screen filter opposite the direction of fuel flow.
