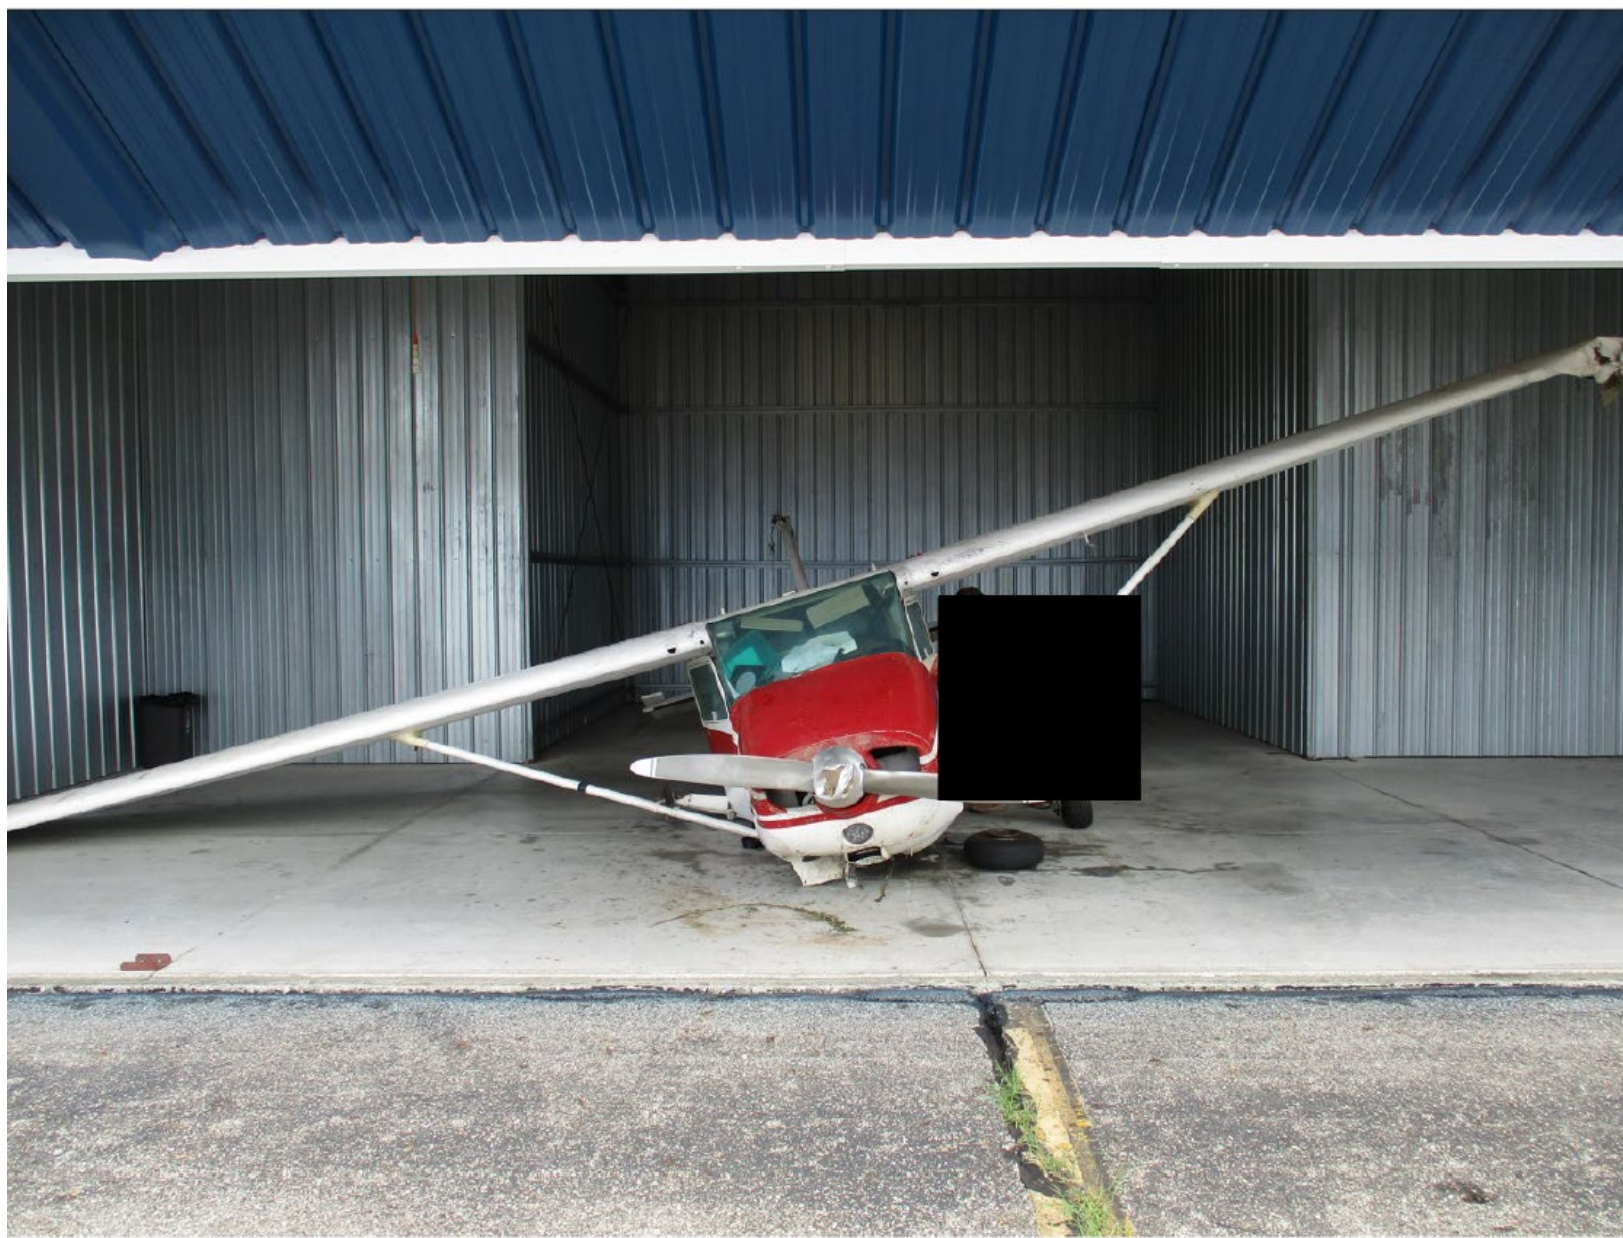
**Photo 1 – FAA Digital Photograph. Frontal View of the Airplane Following Recovery. Redaction is Individual.**

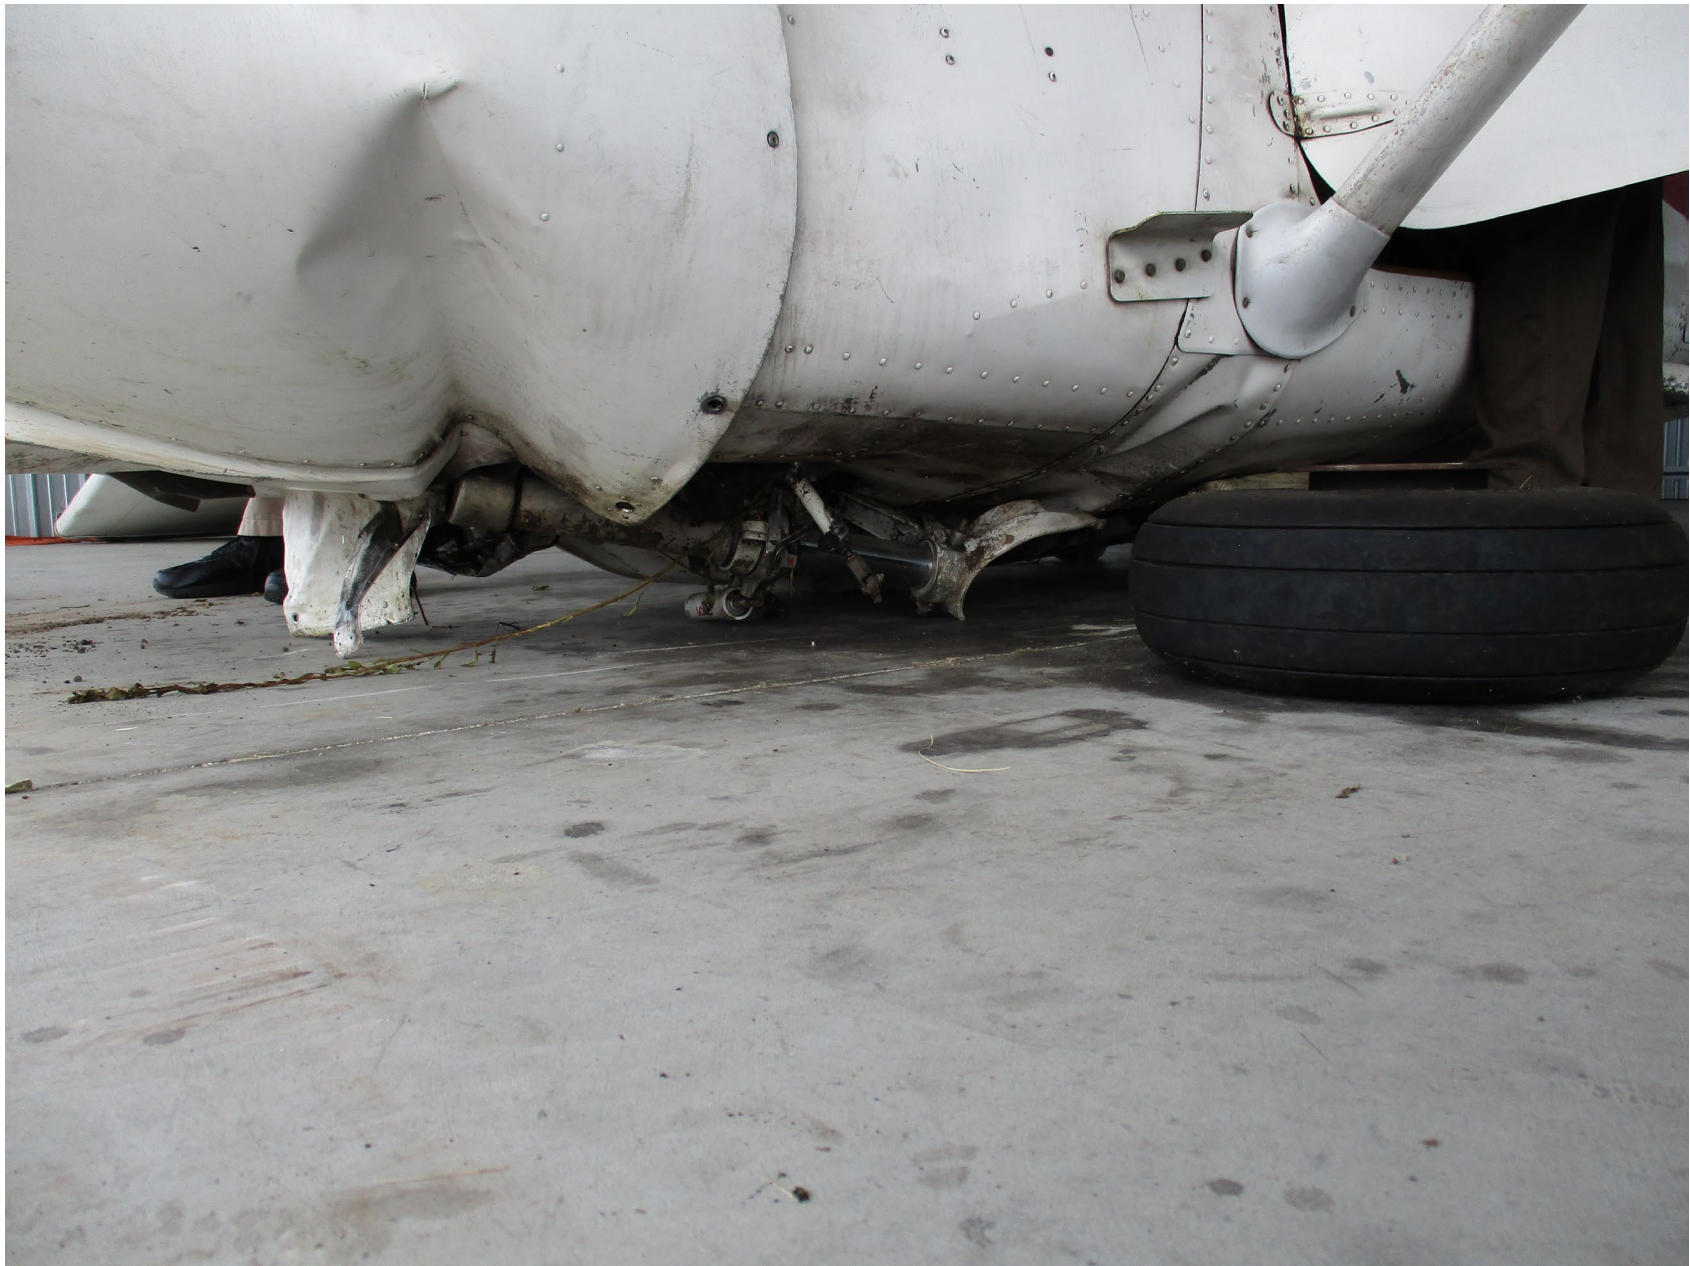
**Photo 2 - FAA Digital Photograph. Left Forward Quartering View of the Lower Left Front part of the Fuselage. Note the Compression Buckling in the Structure Adjacent to the Left Wing Lift Strut Lower Attach Point.**

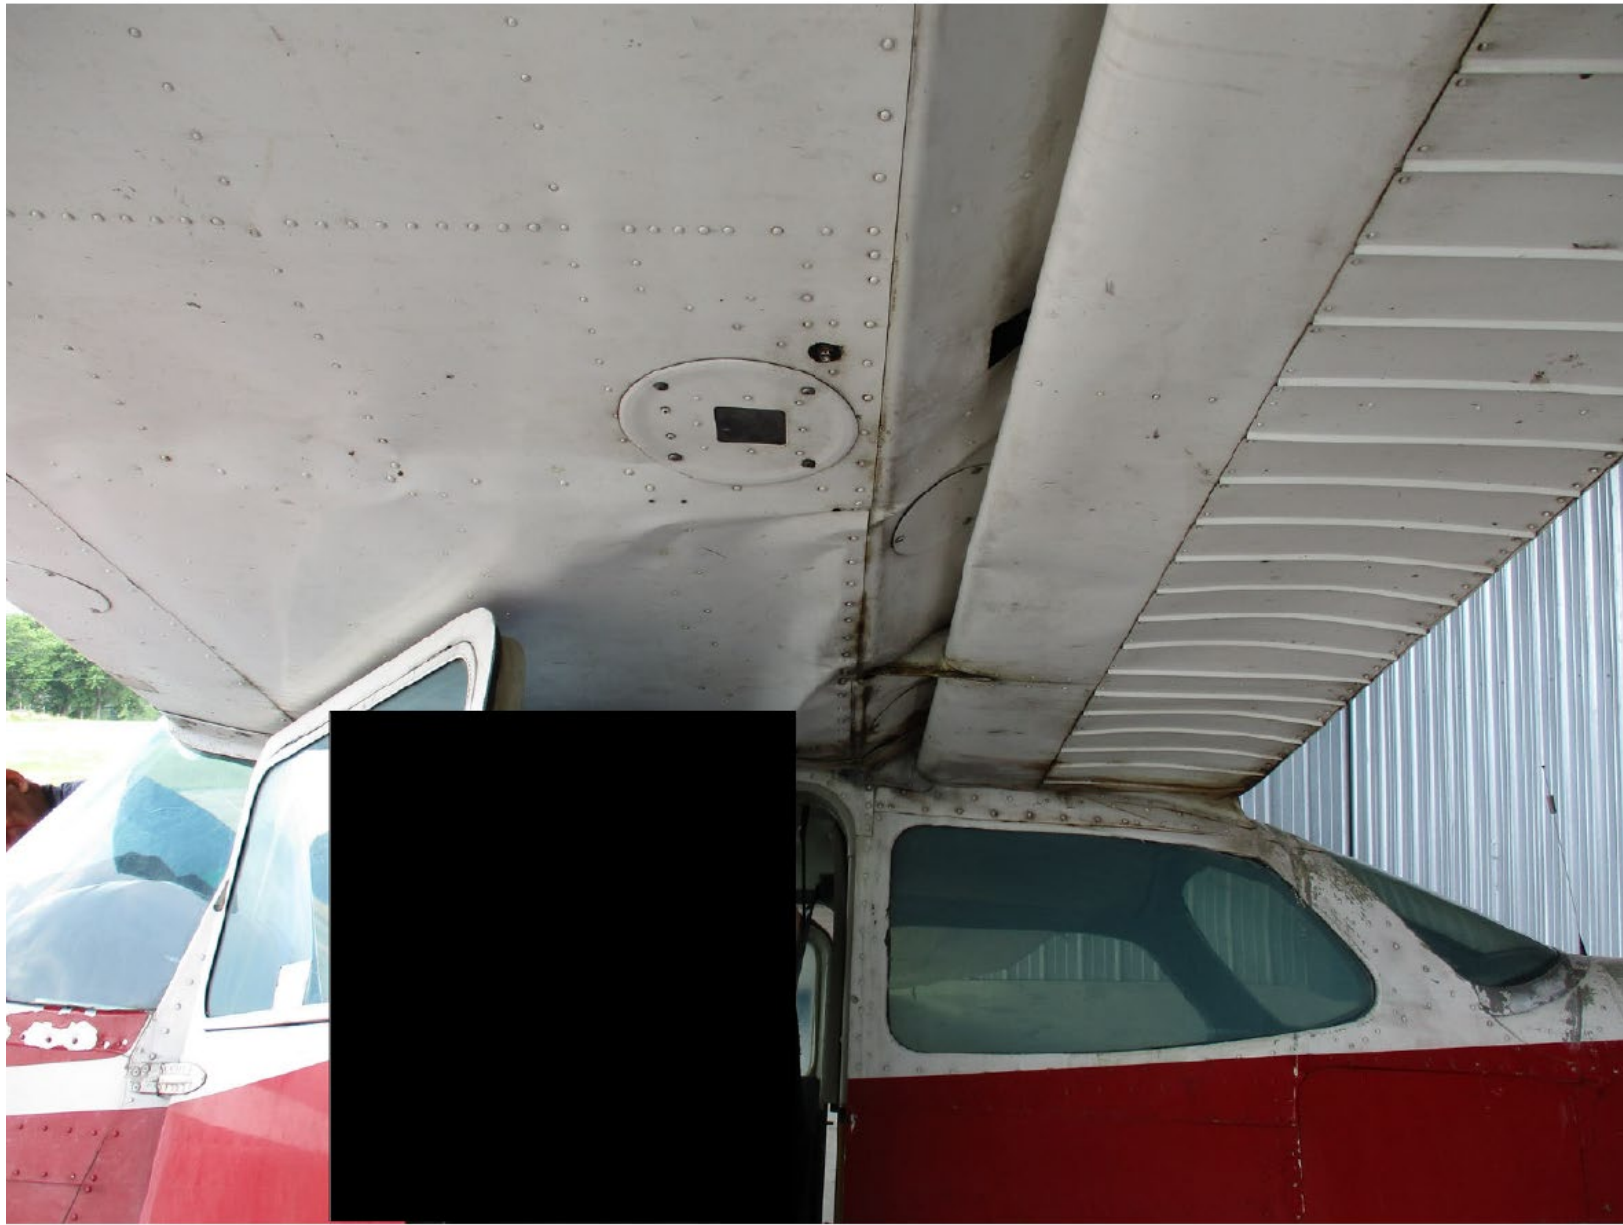
**Photo 3 - FAA Digital Photograph. Left Side View of the Fuselage and Lower Portion of Left Wing. Note the Compression Buckling on the Left Wing Lower Wing Skin Adjacent to the Aft Spar. Redaction is Individual.**

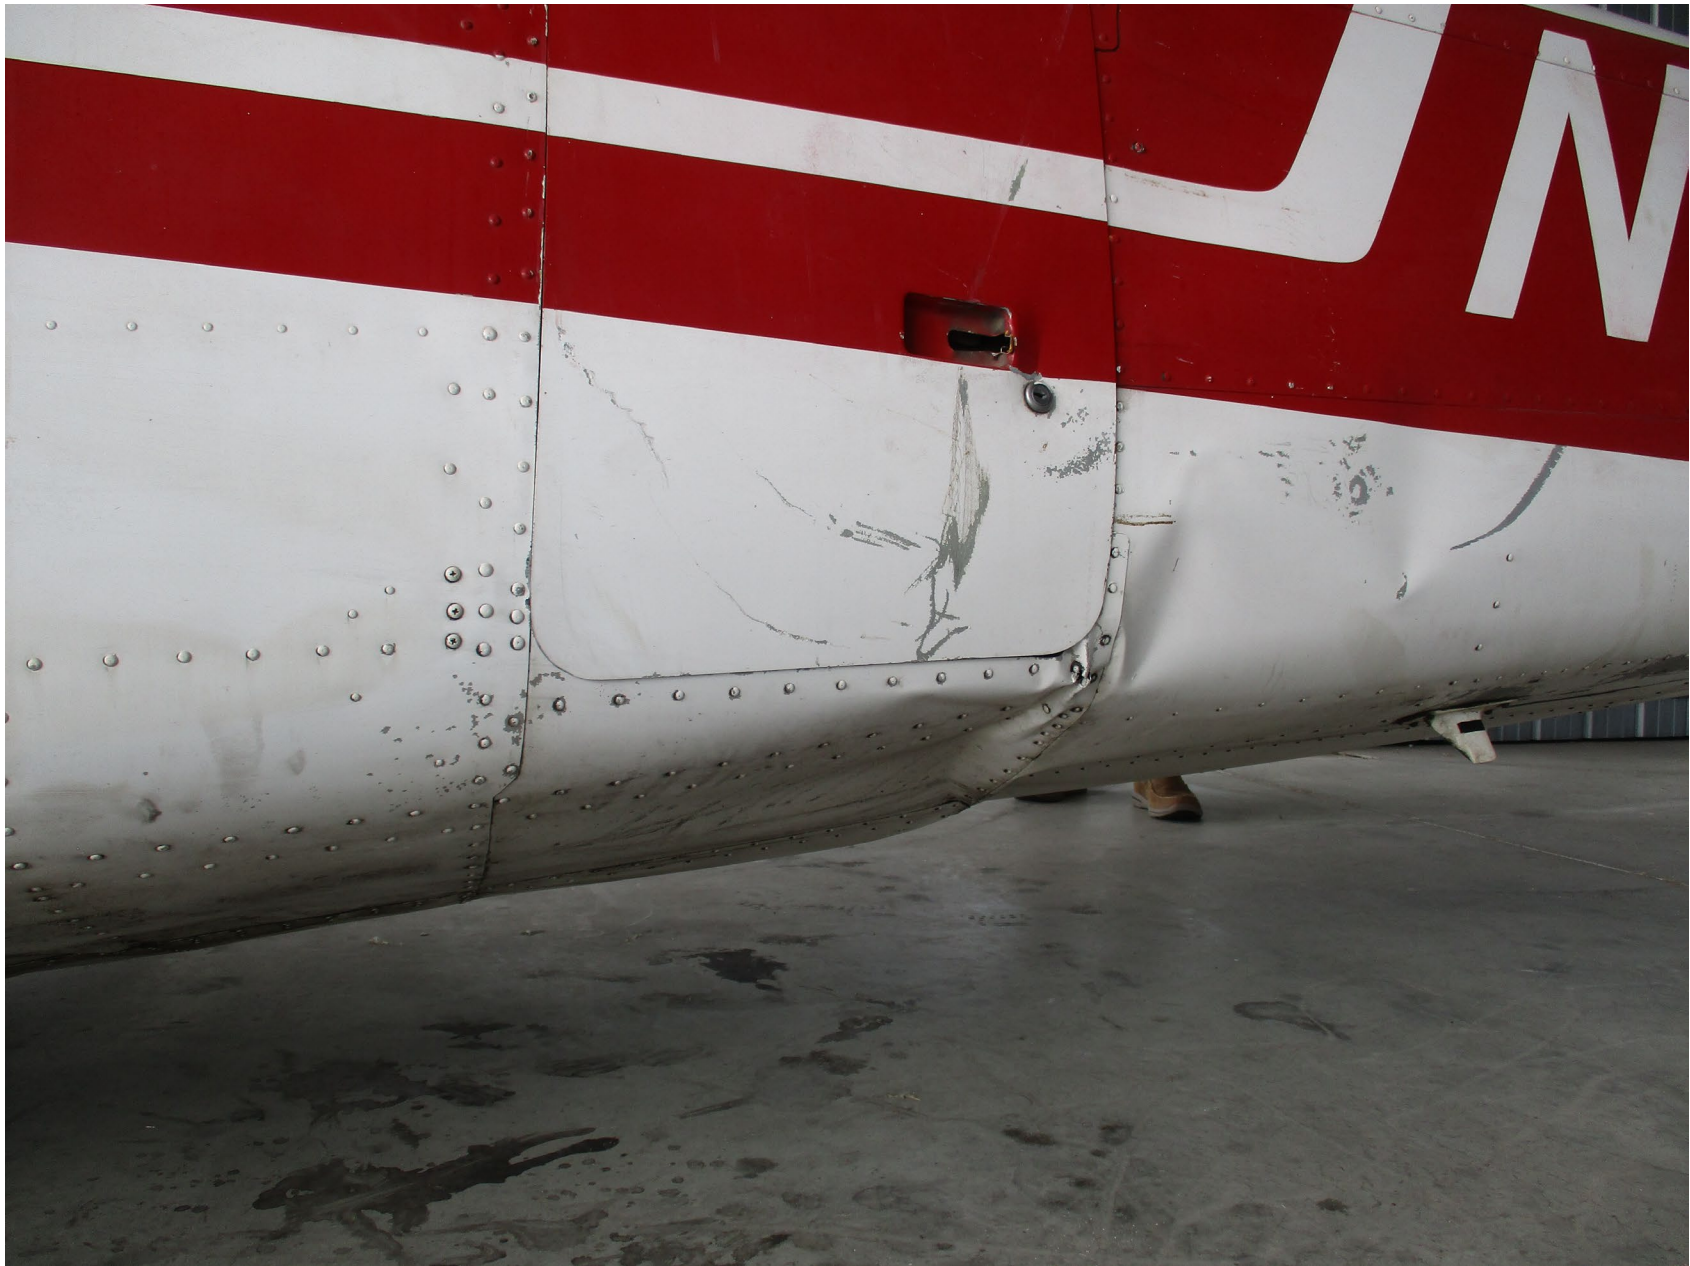
**Photo 4 - FAA Digital Photograph. Left Side View of the Left Side of the Fuselage. Note the Compression Buckling adjacent to Door and Lower Portion of the Fuselage.**

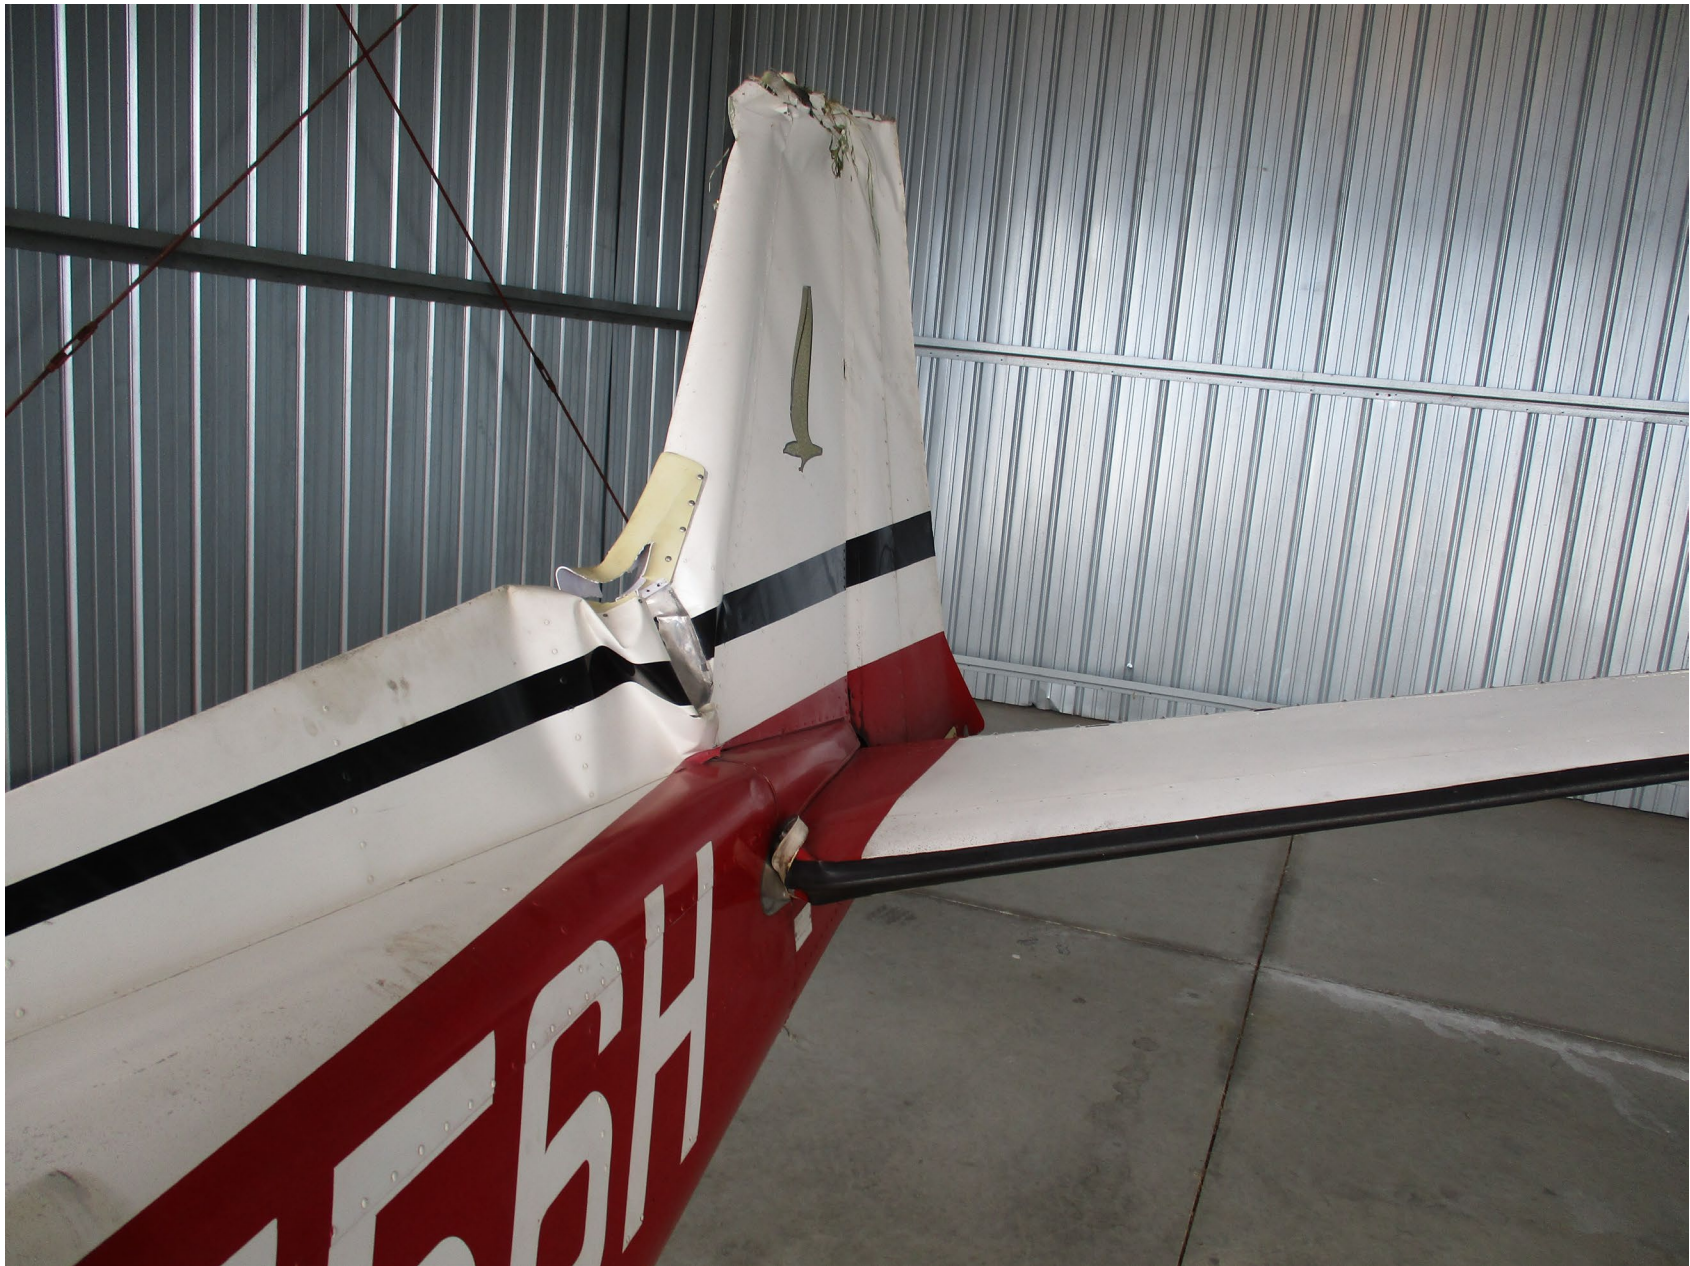
**Photo 5 - FAA Digital Photograph. Left Side View Depicting the Aft Empennage, Portion of Left Horizontal Stabilizer, Vertical Stabilizer and Rudder. Note the Damage to the top Part of the Vertical Stabilizer.**

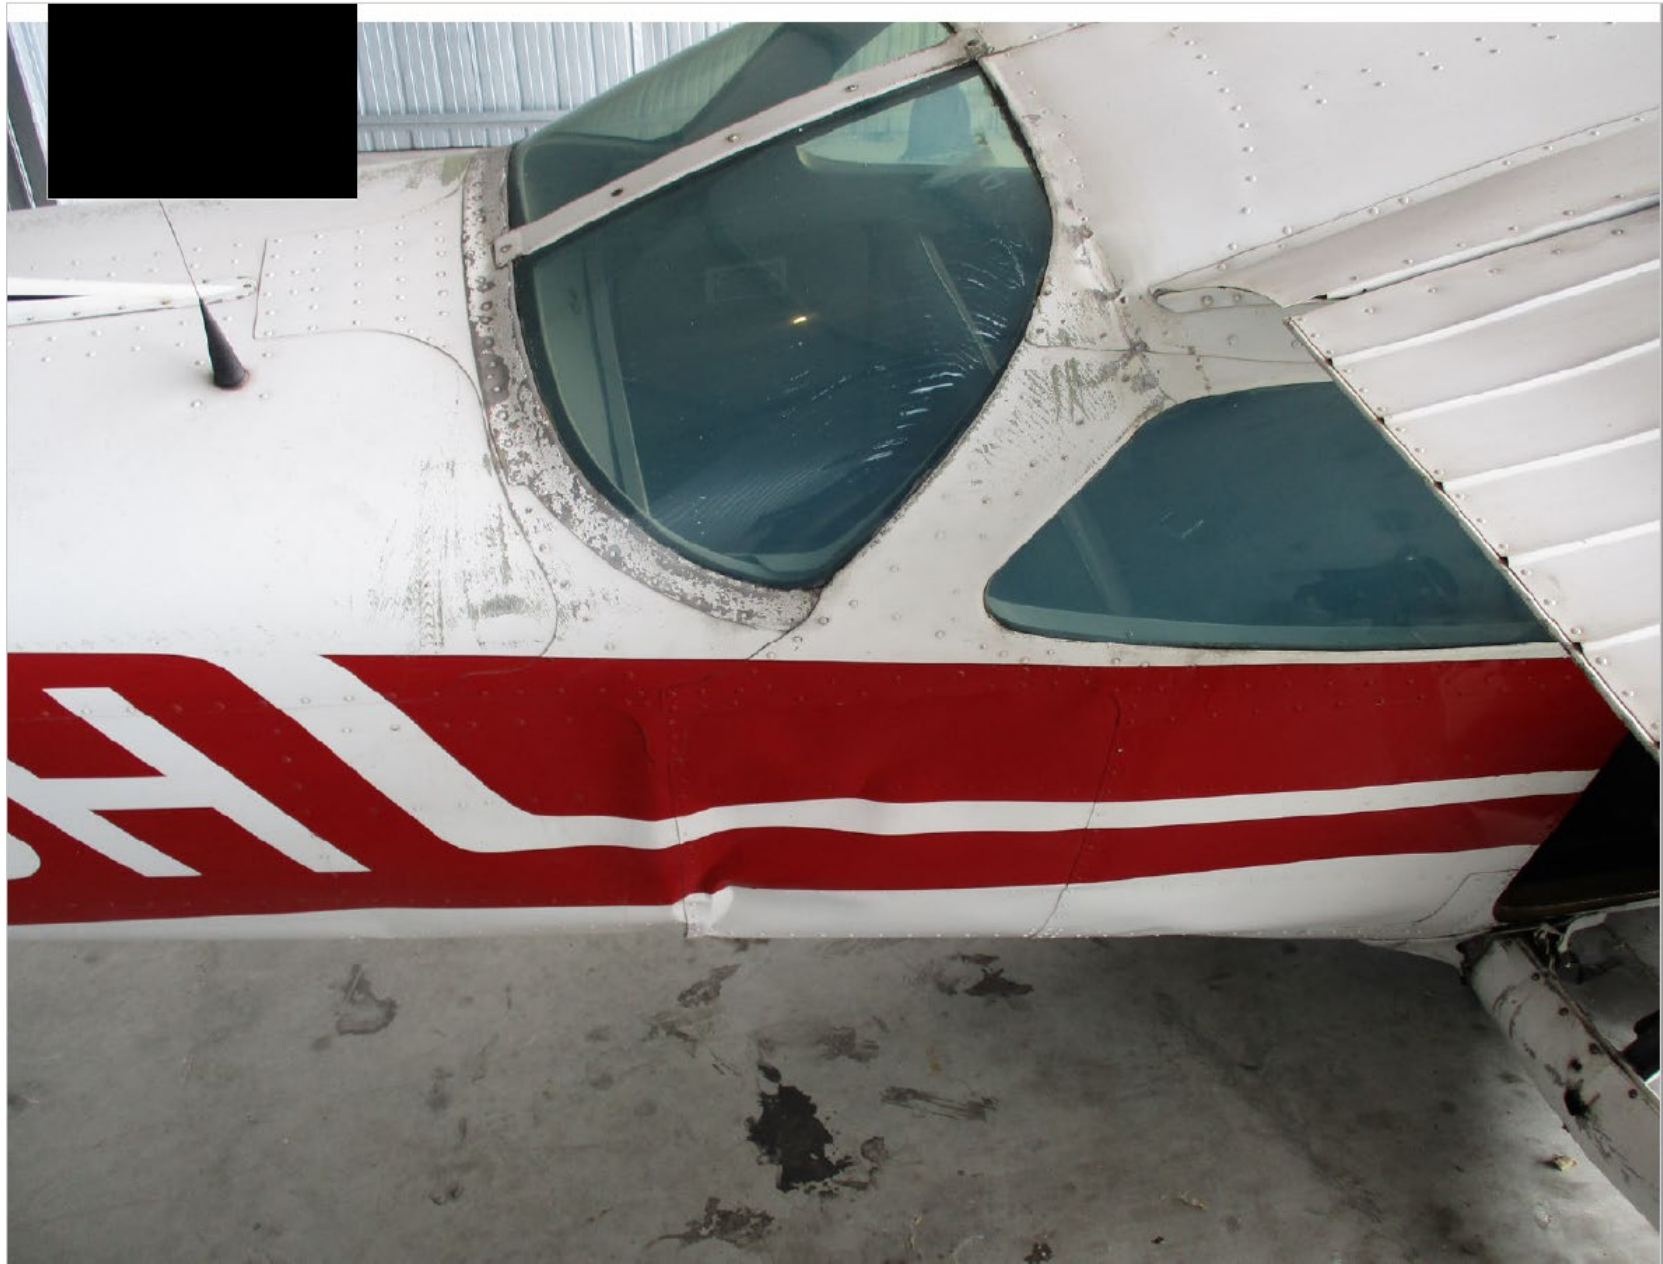
**Photo 6 - FAA Digital Photograph. Right Side View of a Portion of the Fuselage. Note the Compression Buckling. Redaction is Individual.**

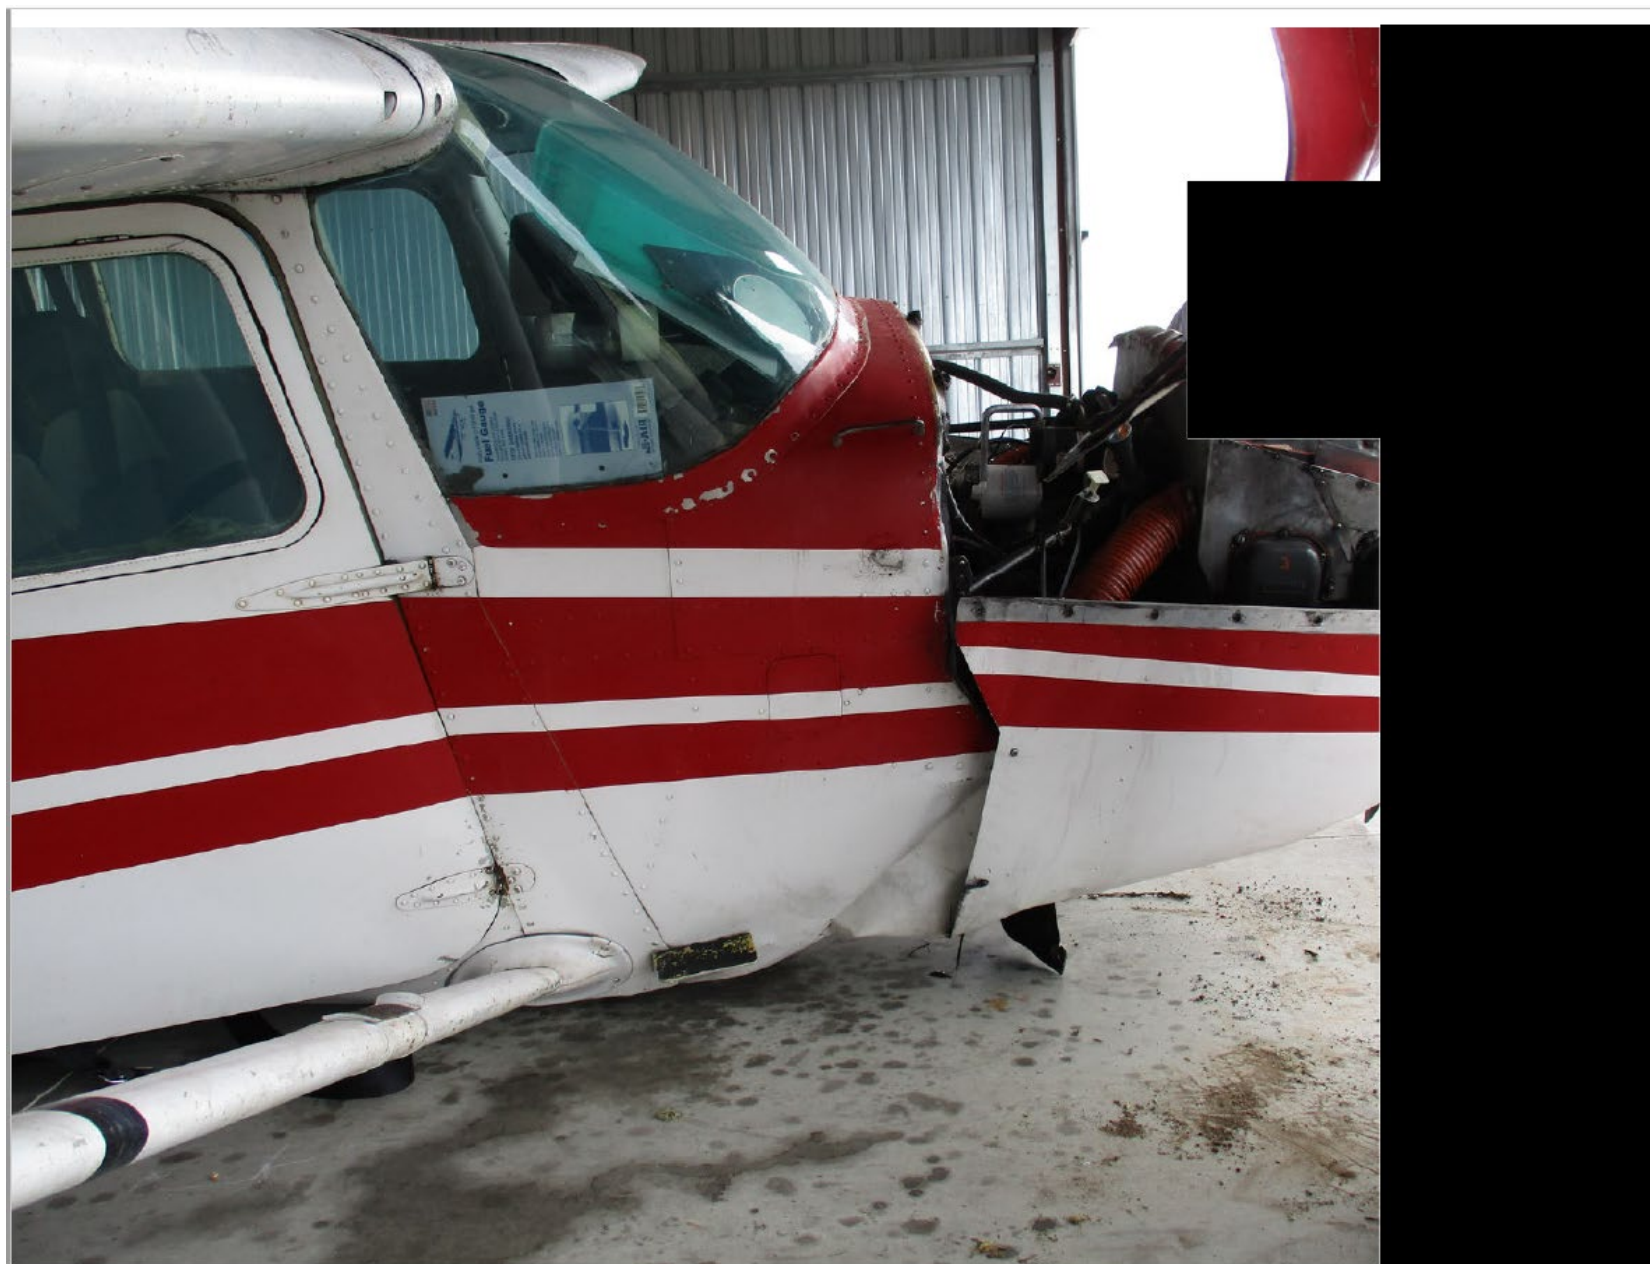
**Photo 7 - FAA Digital Photograph. Right Side View Depicting a portion of the fuselage and Upper Part of the Right Wing, and Entire Portion of the Upper Part of the Left Wing. Note the Compression Buckling on the Upper Portion of the Left Wing near the Wing Root Area. Redaction are Individuals.**

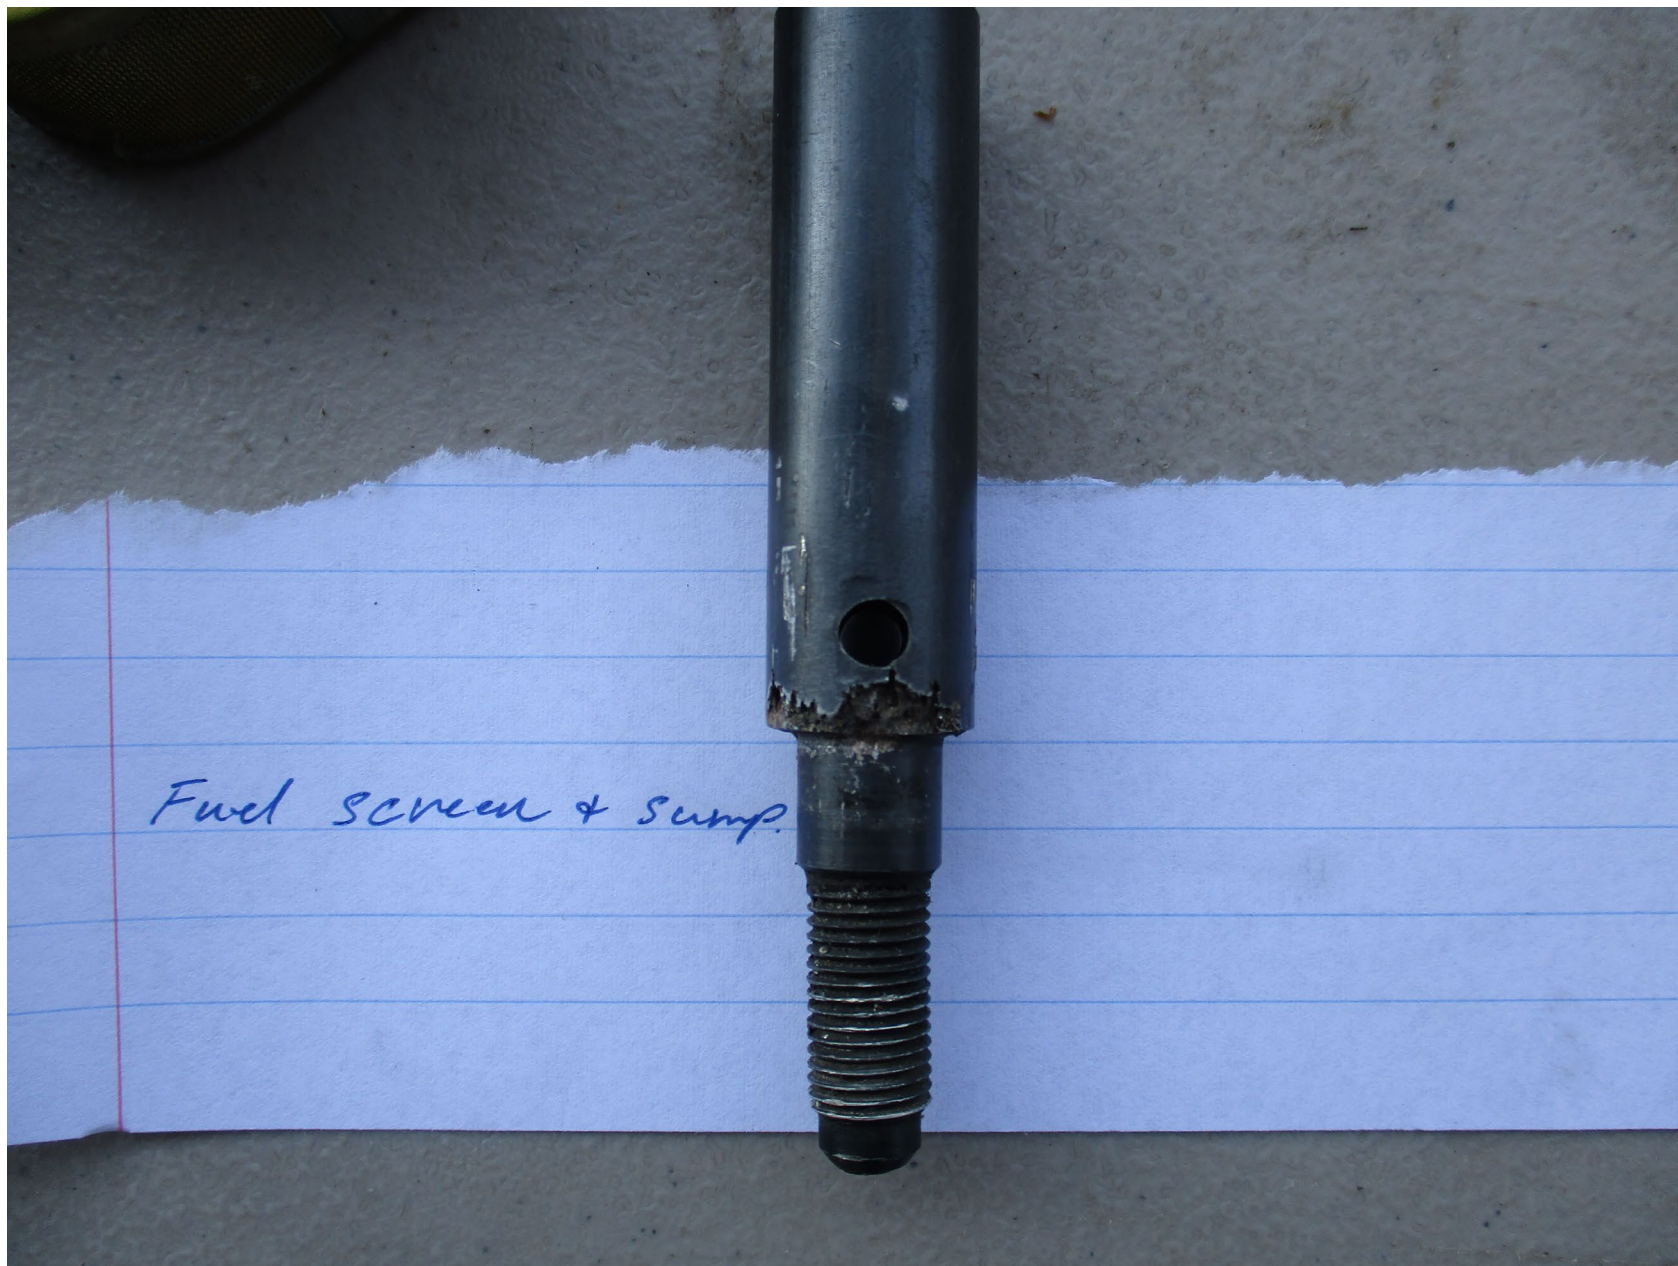
**Photo 8 - FAA Digital Photograph. View of the StandPipe From the Airframe Fuel Strainer. Note the Color of the Coating (Black) and area of Missing Coating.**

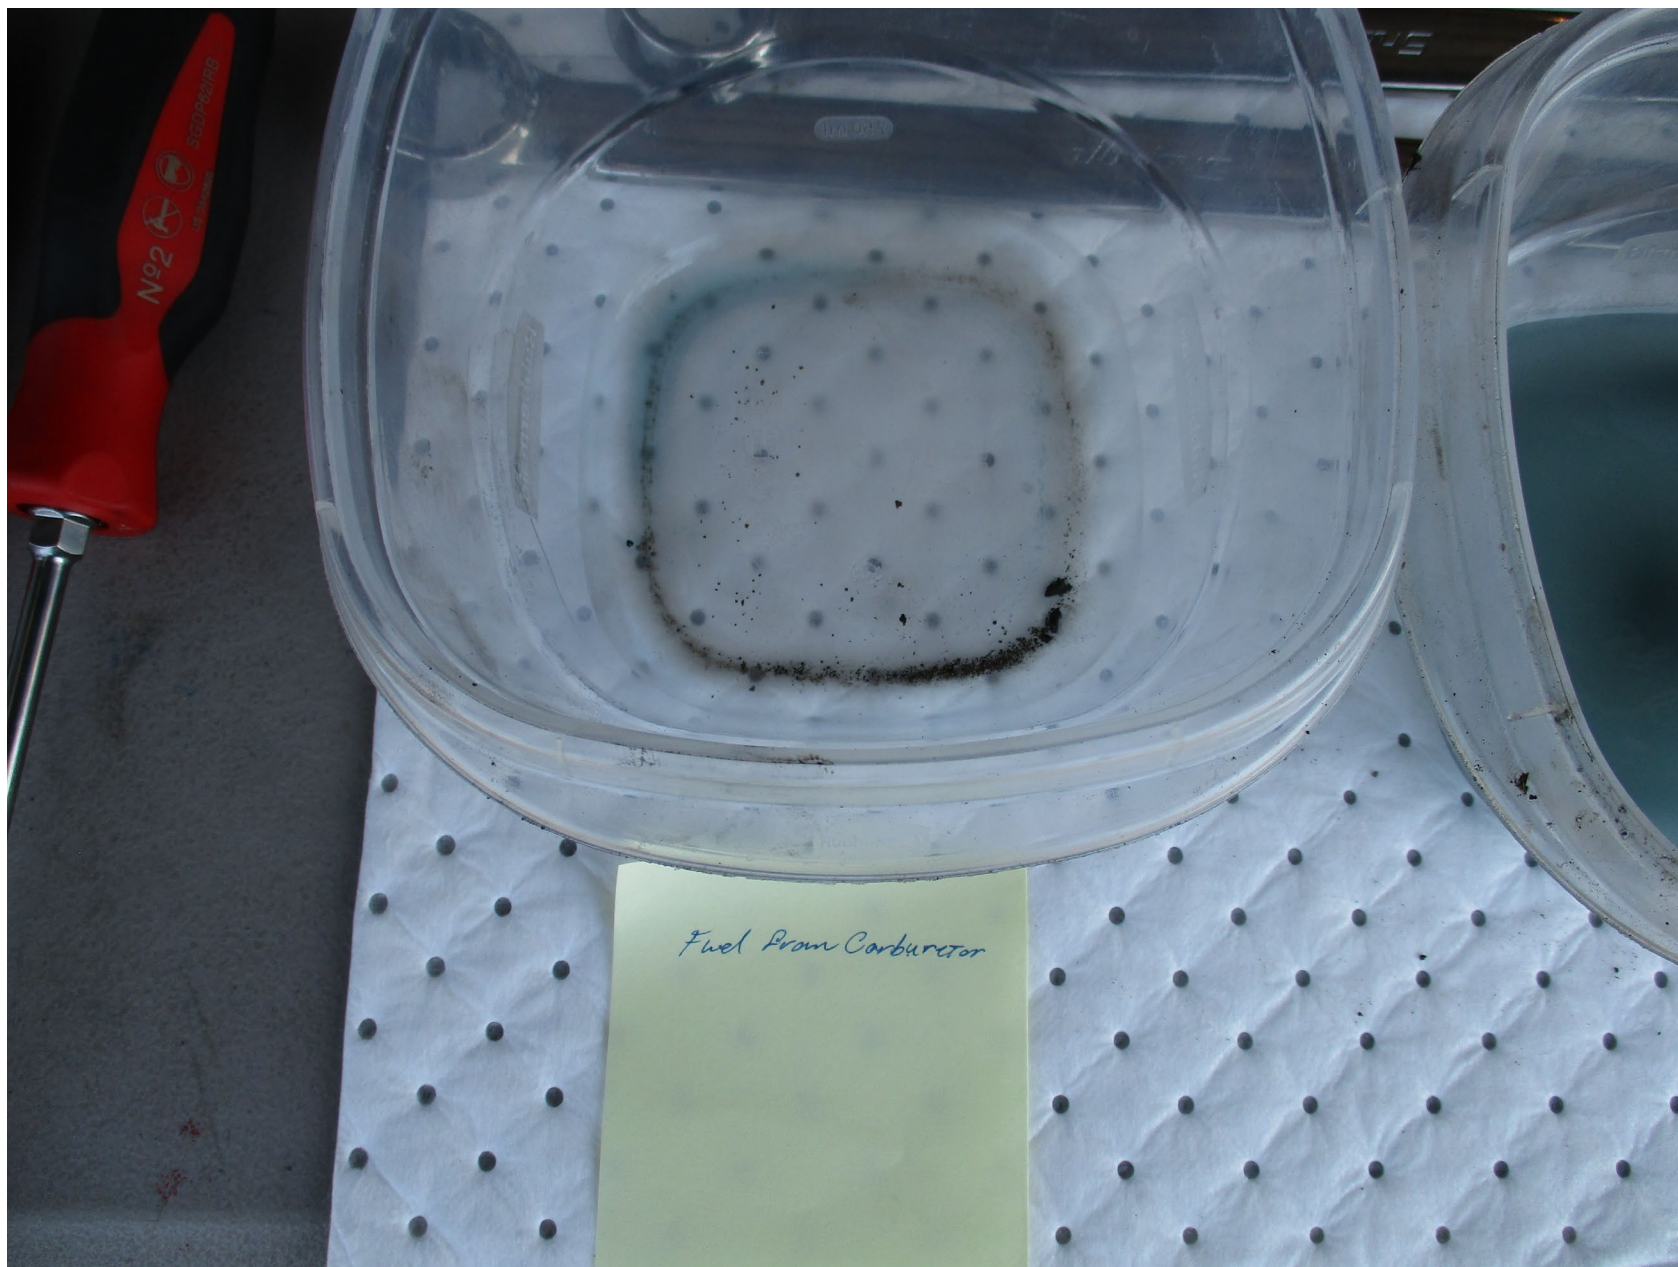
**Photo 9 - FAA Digital Photograph. View of the Fuel Drained From the Carburetor. Note the Contaminants (Black Particulates).**

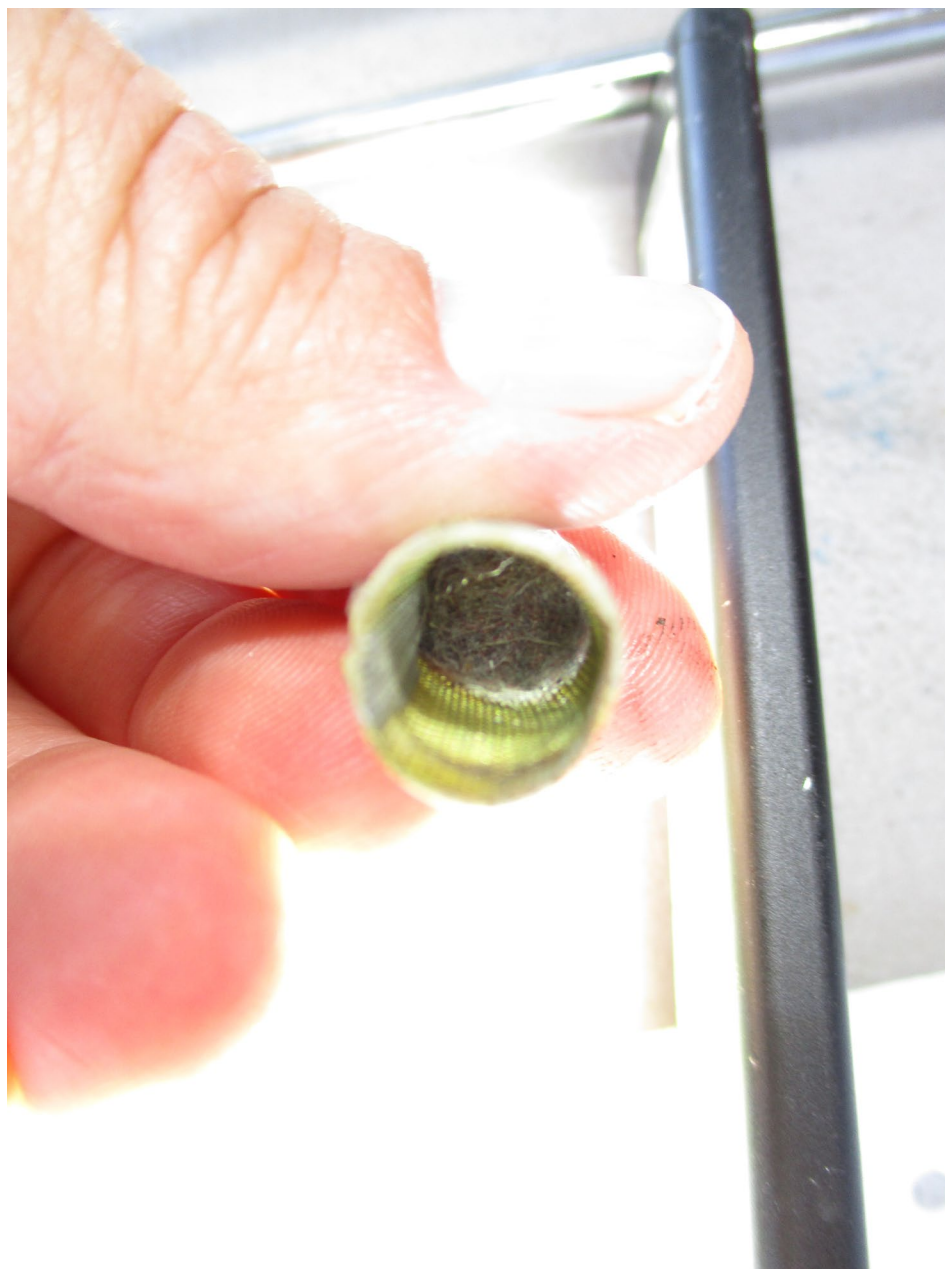
**Photo 10 - FAA Digital Photograph. View of the Carburetor Inlet Screen. Note the Material Inside the Screen at the End.**

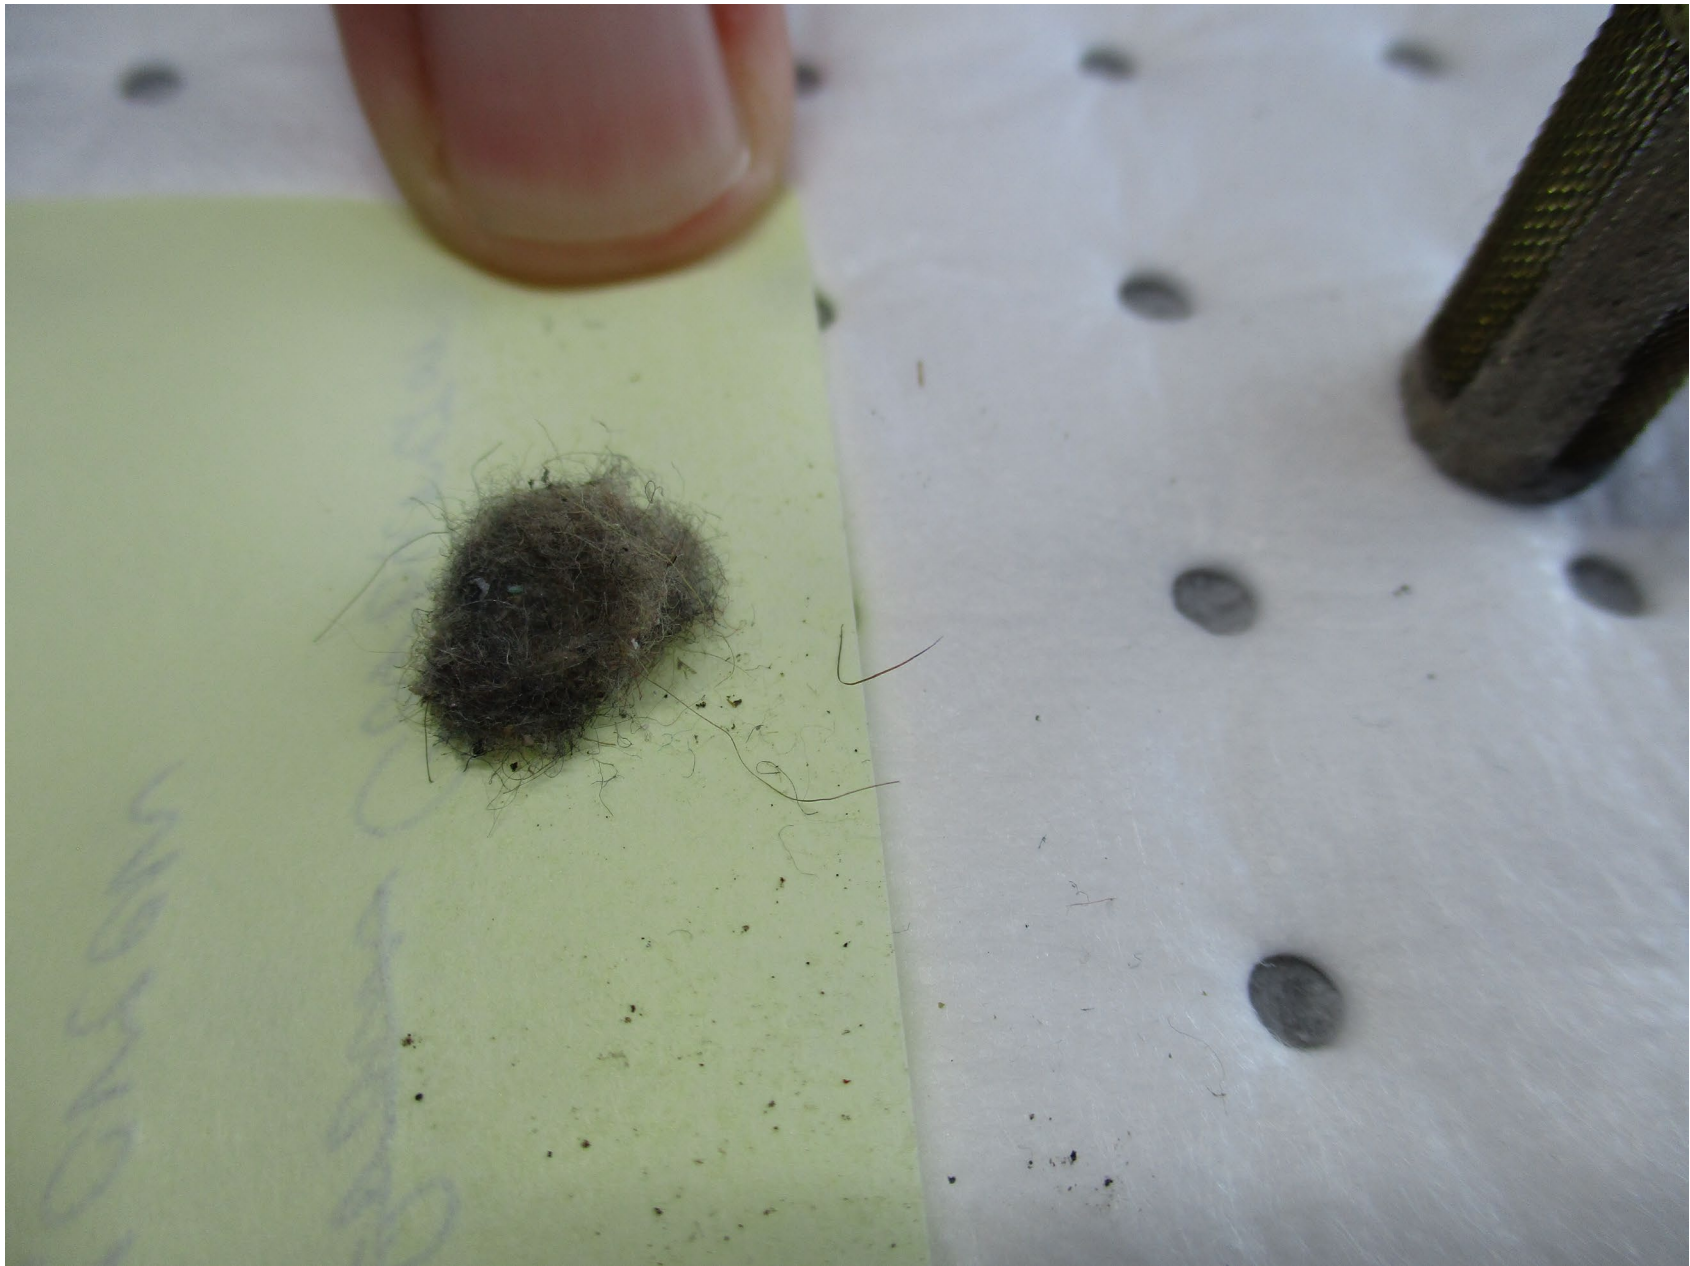
**Photo 11 - FAA Digital Photograph. View of the Material removed From the Carburetor Inlet Screen.**
