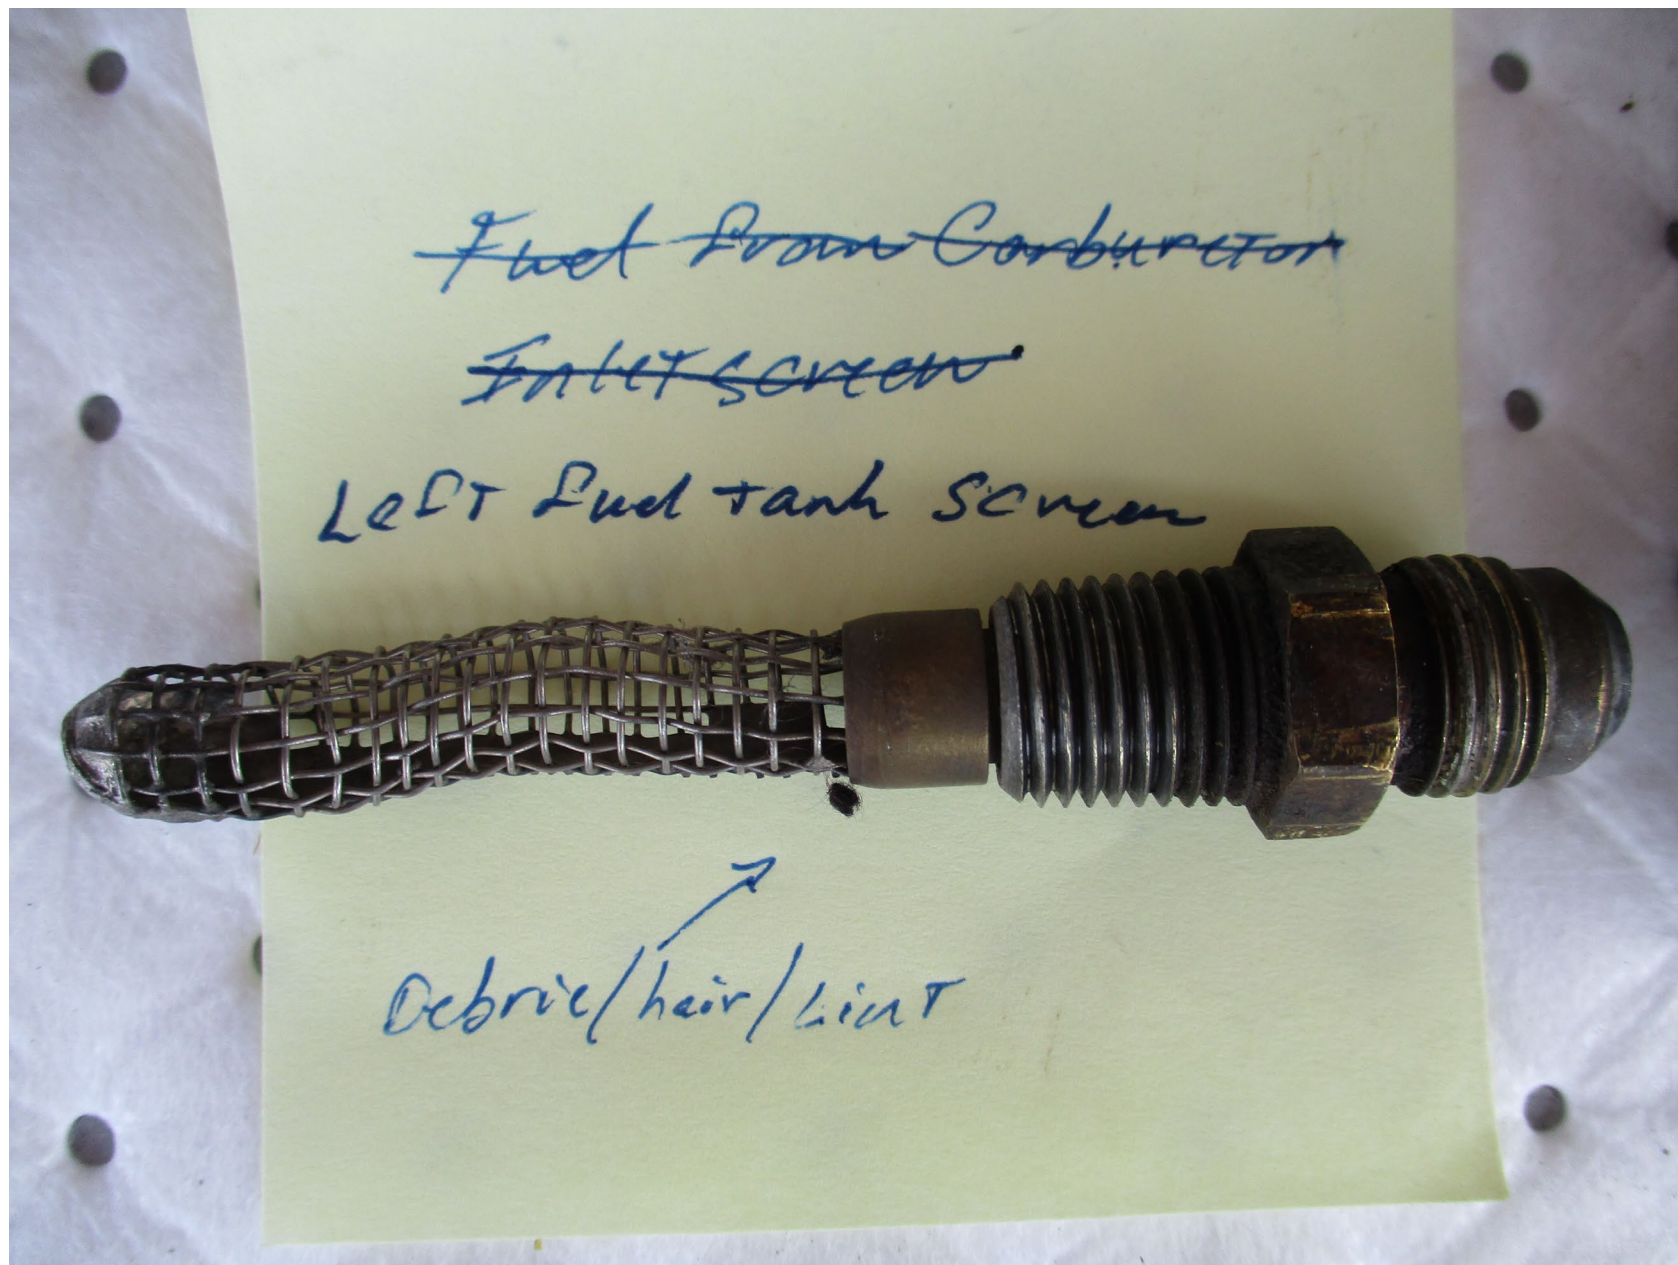
**Photo 12 – Annotated FAA Digital Photograph. View of the Left Fuel Tank Strainer. Note the debris Near the End of the Screen Close to the Outlet Fitting.**

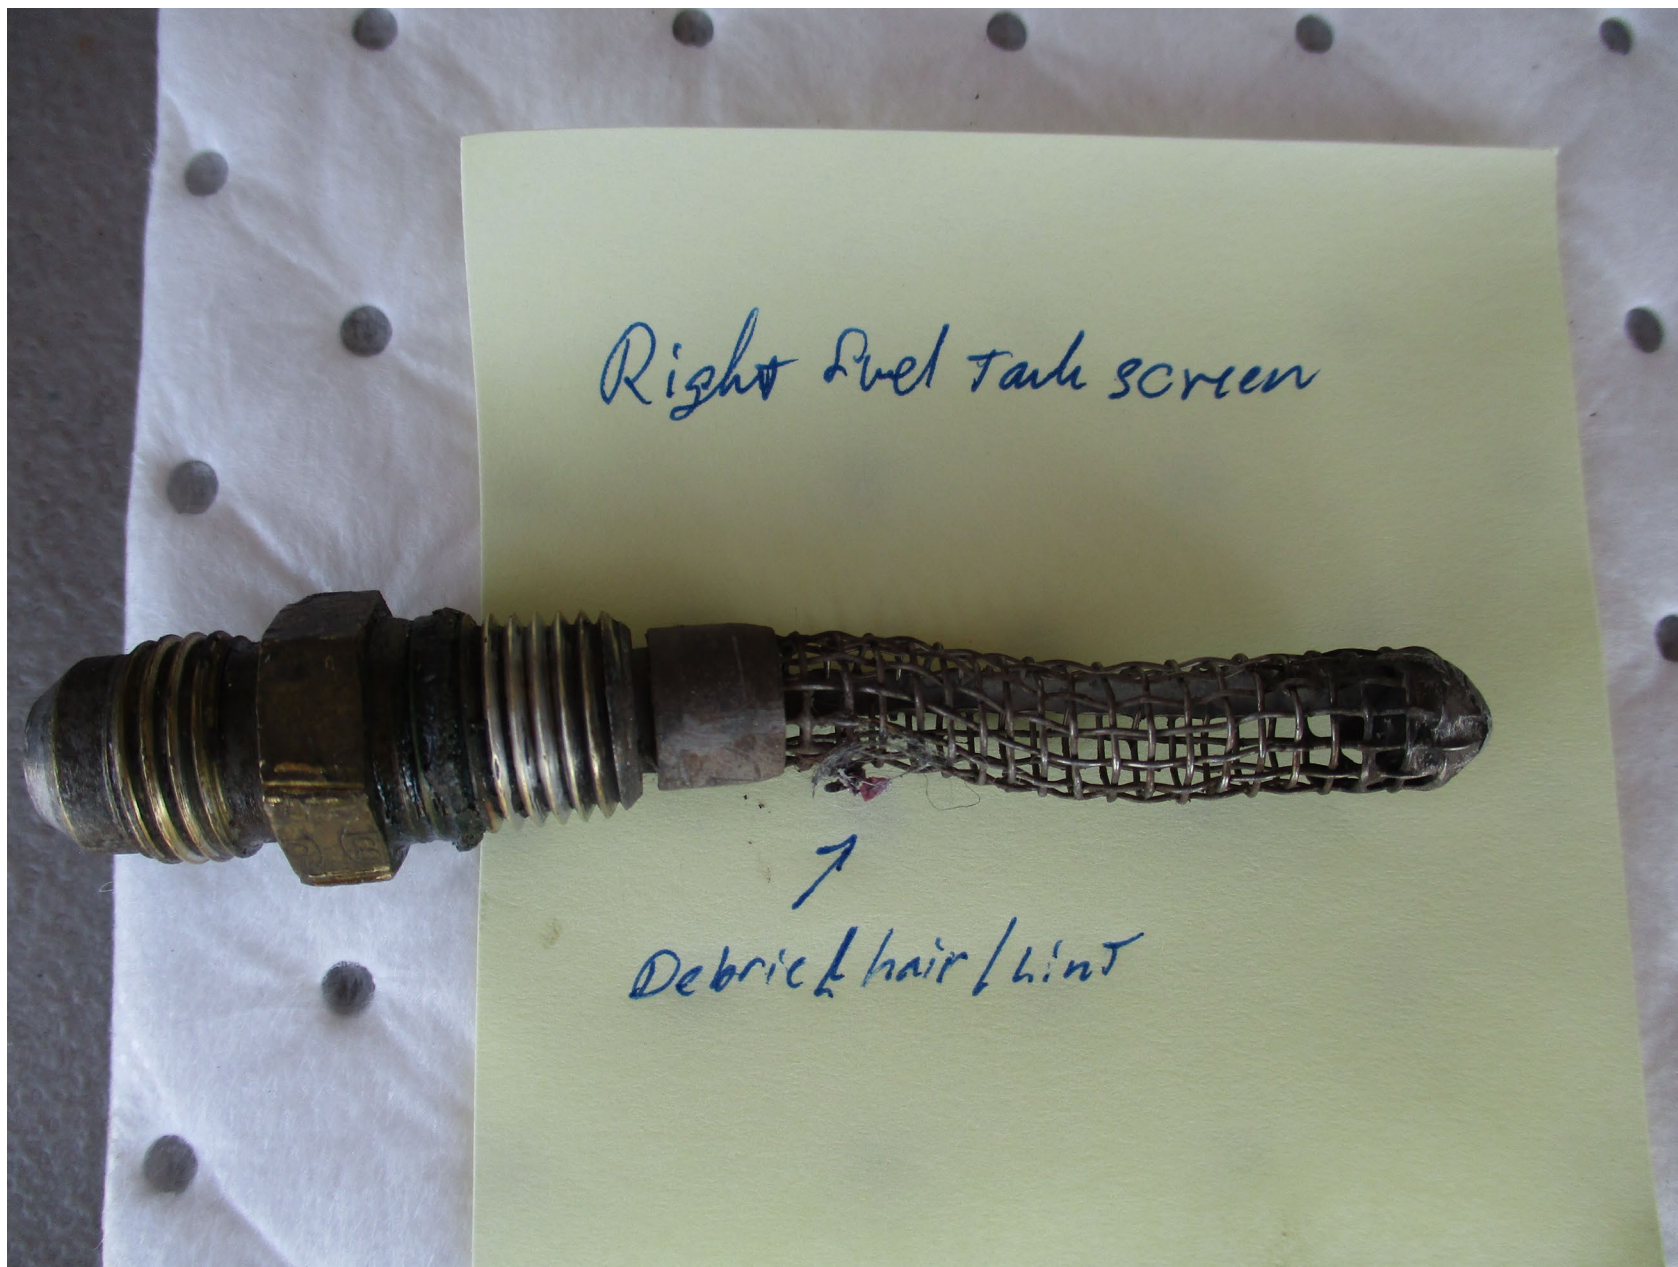
**Photo 13 - Annotated FAA Digital Photograph. View of the Right Fuel Tank Strainer. Note the debris Near the End of the Screen Close to the Outlet Fitting.**

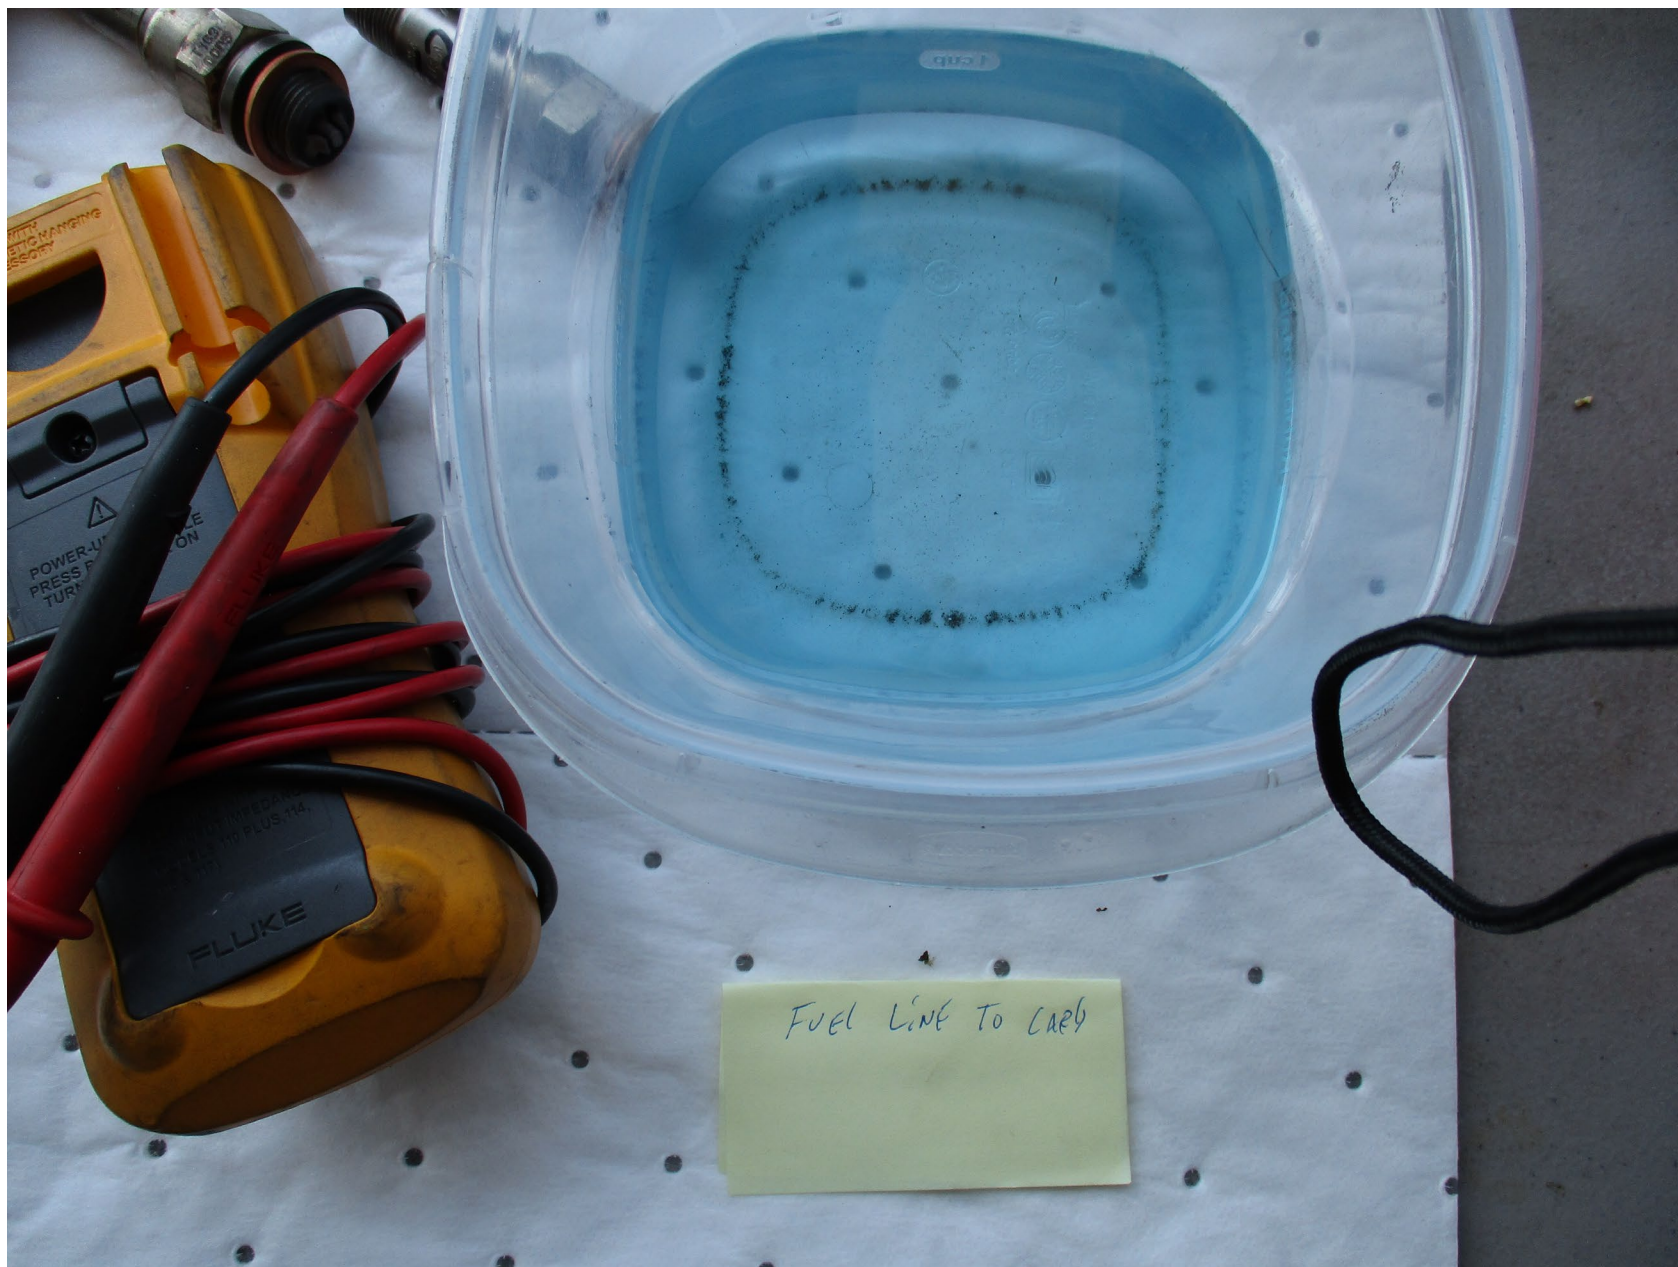
**Photo 14 - Annotated FAA Digital Photograph. View of the Fuel Drained From the Fuel Line to the Carburetor. Note the Contaminants (Black Particulates).**
