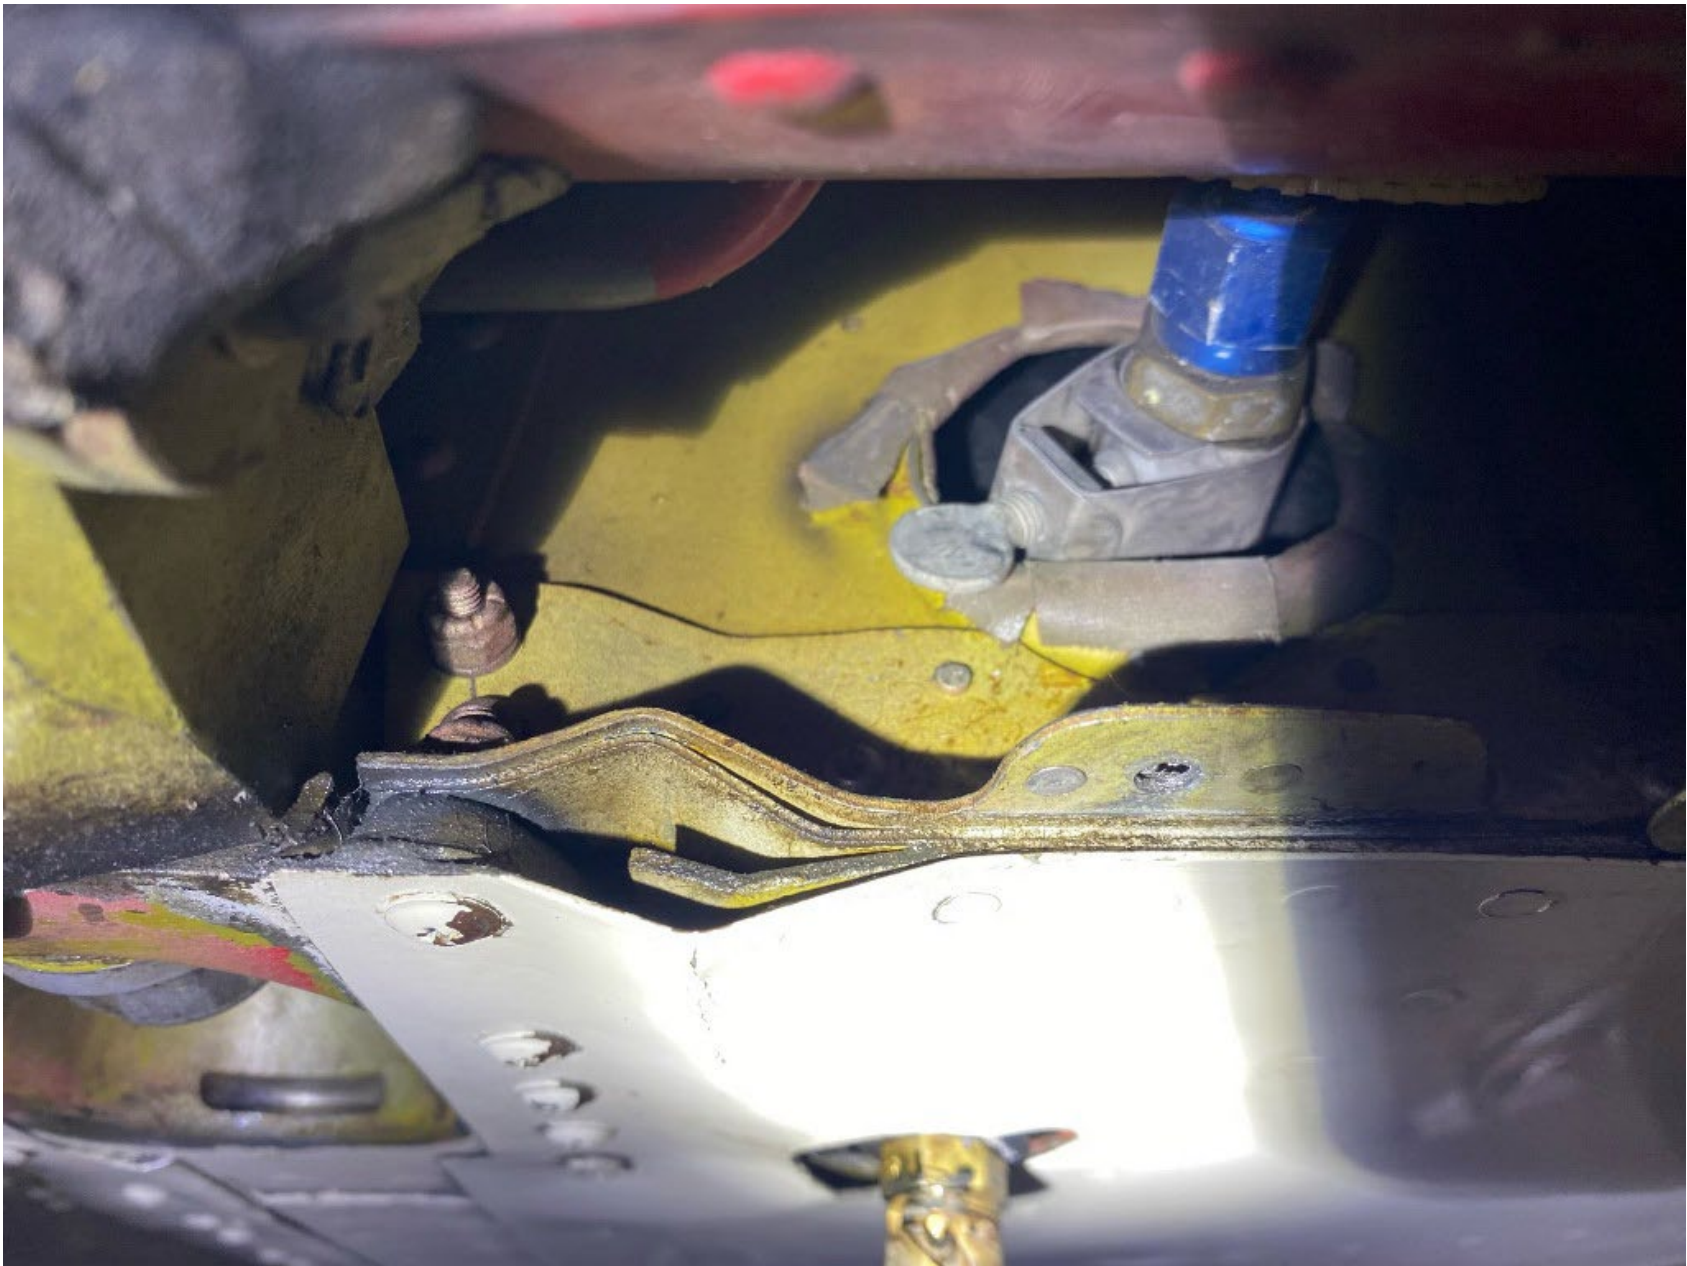
**Photo 2 – Wrinkling of Lower LH Wing Structure**
