# National Transportation Safety Board

ERA22LA312

## VIDEO STUDY

Location: Russell, Pennsylvania  
Date: July 14, 2022  
Time: 1940 eastern daylight time (EDT)  
Aircraft: Flightstar II-SC, N6116U

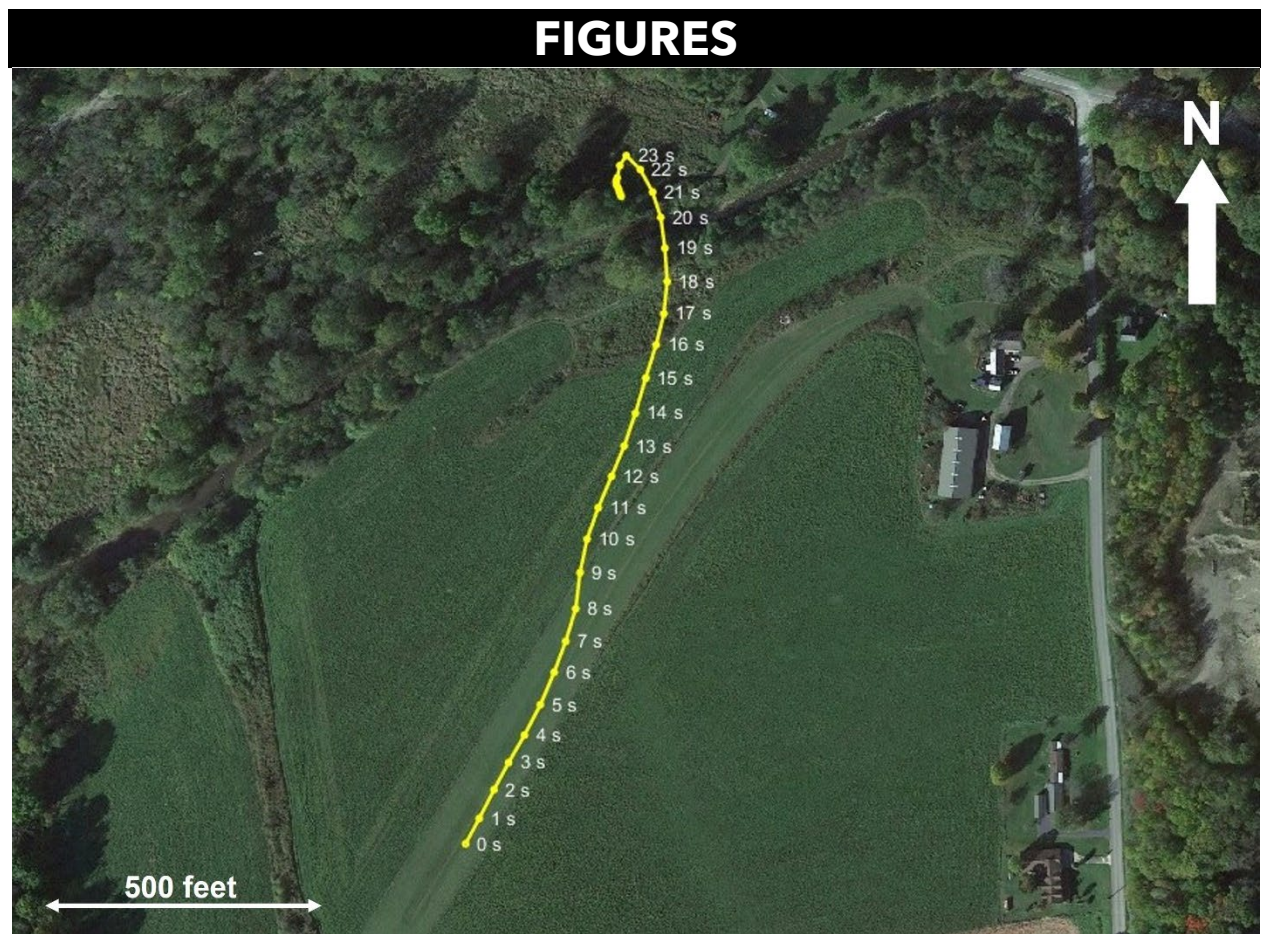
**Figure 1.** Aerial view of the accident area (the numbers are seconds past 19:37:55)

Figure 1 shows a frame from the analyzed video. The gray rectangles in the figure mask the images of the pilot and the passenger. A GPS device in the airplane recorded the ground track of the airplane and its altitude during the flight at the rate of once per second. The camera and the GPS device were not time-synchronized. Figure 2 shows the ground track of the airplane superimposed on an aerial image of

the accident scene. The numbers along the ground track are seconds elapsed since 19:37:55, the time of the first airplane location recorded by the GPS device.

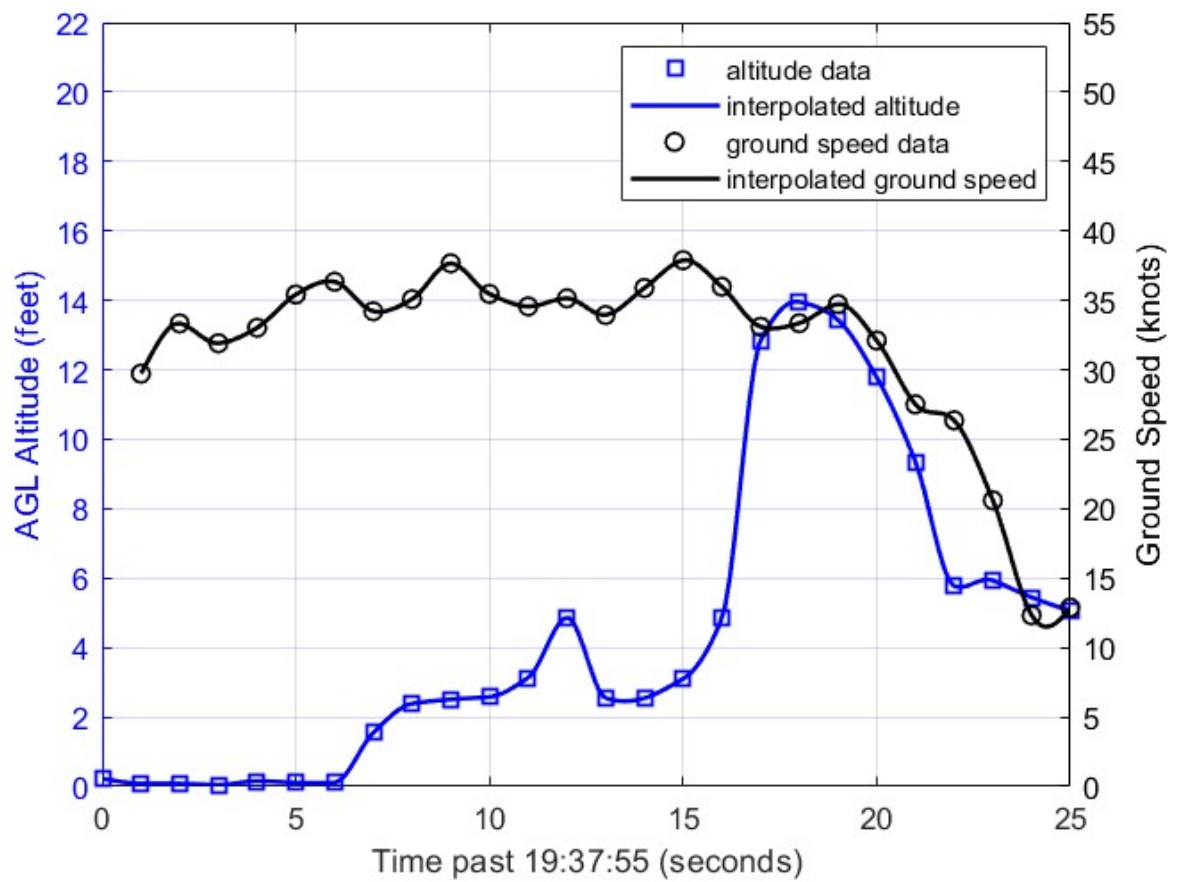
**Figure 3.** Airplane ground speed and AGL altitude

Figure 3 shows the ground speed and the altitude derived from the recorded GPS data. The ground speed was computed by dividing the distance between two adjacent GPS ground locations by the elapsed time that was one second. There were 44 GPS locations resulting in 43 ground speed estimates. However, as is evident in Figure 2, at time 25 seconds the airplane was already past the time when it impacted trees. Therefore, only the first 25 seconds are shown in Figure 3. The fluctuations of the ground speed are due to the finite accuracy of the GPS ground locations.

The altitude shown in Figure 3 was adjusted to be the altitude above ground level (AGL) relative to the altitude recorded when all three airplane tires were still on the ground during the takeoff roll. Both the ground speed and the AGL altitude in Figure 3 show steep declines past time 19 seconds that corresponds to time 19:38:14.

Figure 5 shows that shortly after the elevator deflection, at about time 20 seconds, the wing angle of attack reached  $21.5^\circ$  and it peaked at  $22^\circ$  at time 21.3 seconds. Figure 3 shows that past time 19 seconds, both the ground speed and the altitude were rapidly declining, consistent with wing stall. The last video frame, at time

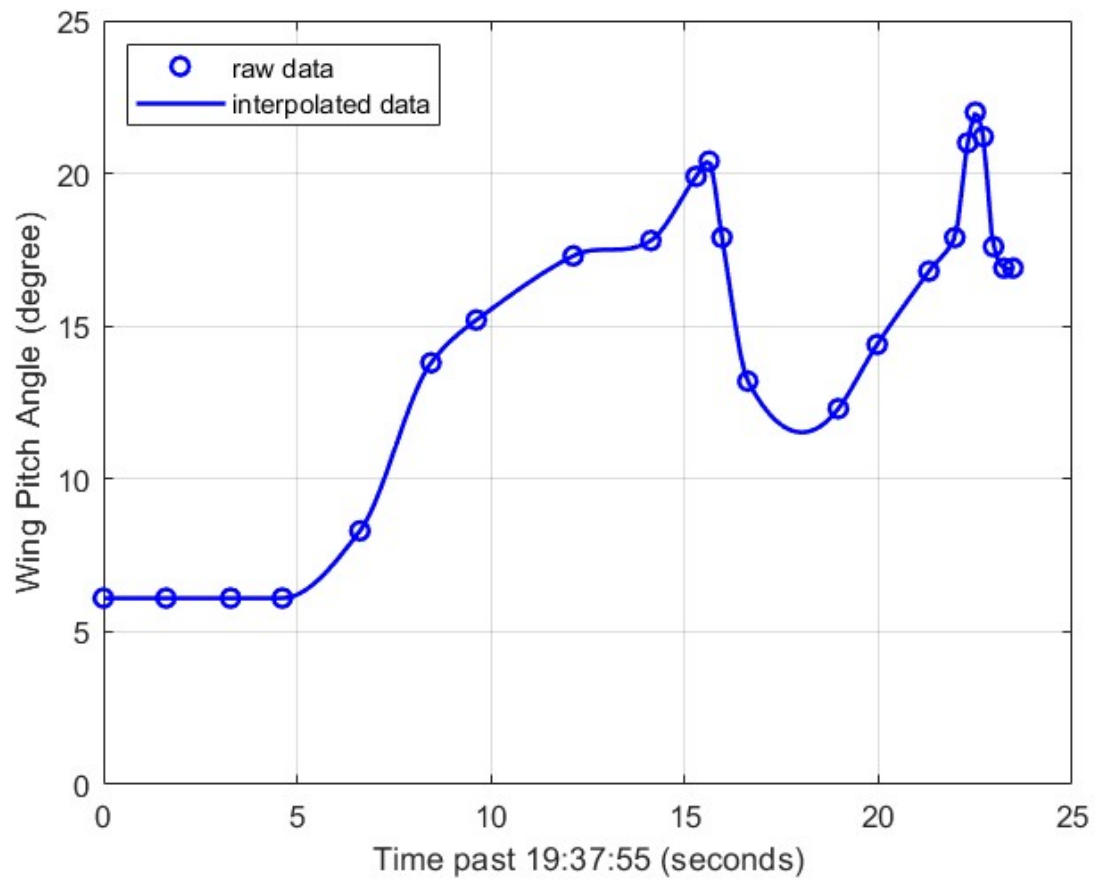
**Figure 4.** Estimated wing pitch angle

The recorded GPS data and the video based on which the wing pitch angles were estimated had to be time-synchronized. The AGL altitude increase seen at about time 7 seconds in Figure 3 was used to align the video with the GPS data. The altitude increase was due to the rotation of the airplane as it was taking off and it had to correspond to an increase in the wing pitch angle at about the same time. Figure 4 shows the estimated wing pitch angle after the video time was synchronized with the GPS time.

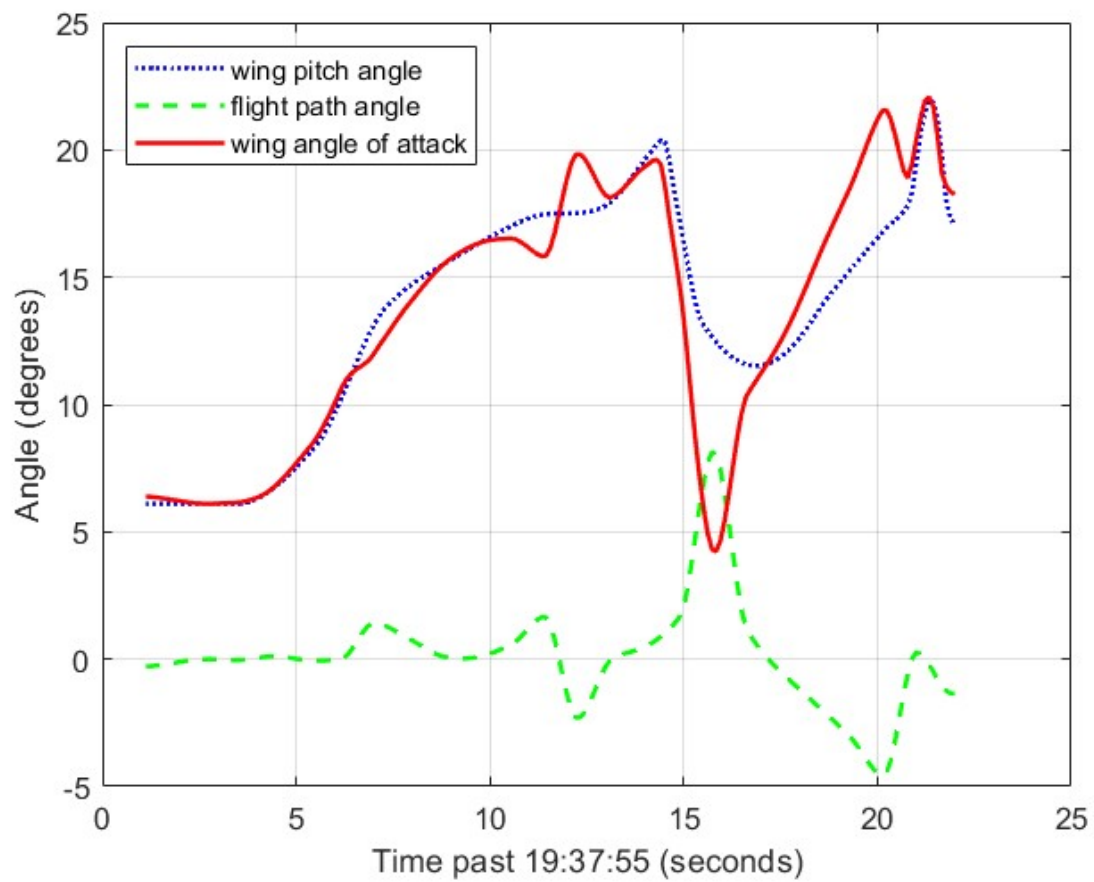
**Figure 5.** Estimation of wing angle of attack

Figure 5 shows the estimated wing pitch angle, the estimated flight path angle, and their difference, the estimated wing angle of attack. Because of the significantly barrel-distorted video frames and the inaccuracy of the recorded AGL altitude, the inaccuracy of the estimated wing angle of attack is set at  $\pm 4^\circ$ . Figure 5 shows that the estimated wing angle of attack was about  $20^\circ$  at time 12.2 seconds. Even if the inaccuracy at that time is at its negative maximum of  $-4^\circ$ , the estimated wing angle of attack at that time is still about  $16^\circ$ , a high value.

After about time 15 seconds, the wing angle of attack was quickly reduced because the wing pitch angle decreased, and the flight path angle increased. However, after about time 17 seconds, the wing angle of attack started increasing again because the wing pitch angle was increasing, and the flight path angle became negative as the airplane was losing altitude. At time 19.1 seconds, the video shows that the elevator deflection started increasing. It reached maximum deflection at time 19.4 seconds, probably in an attempt to regain altitude as the airplane was approaching trees.

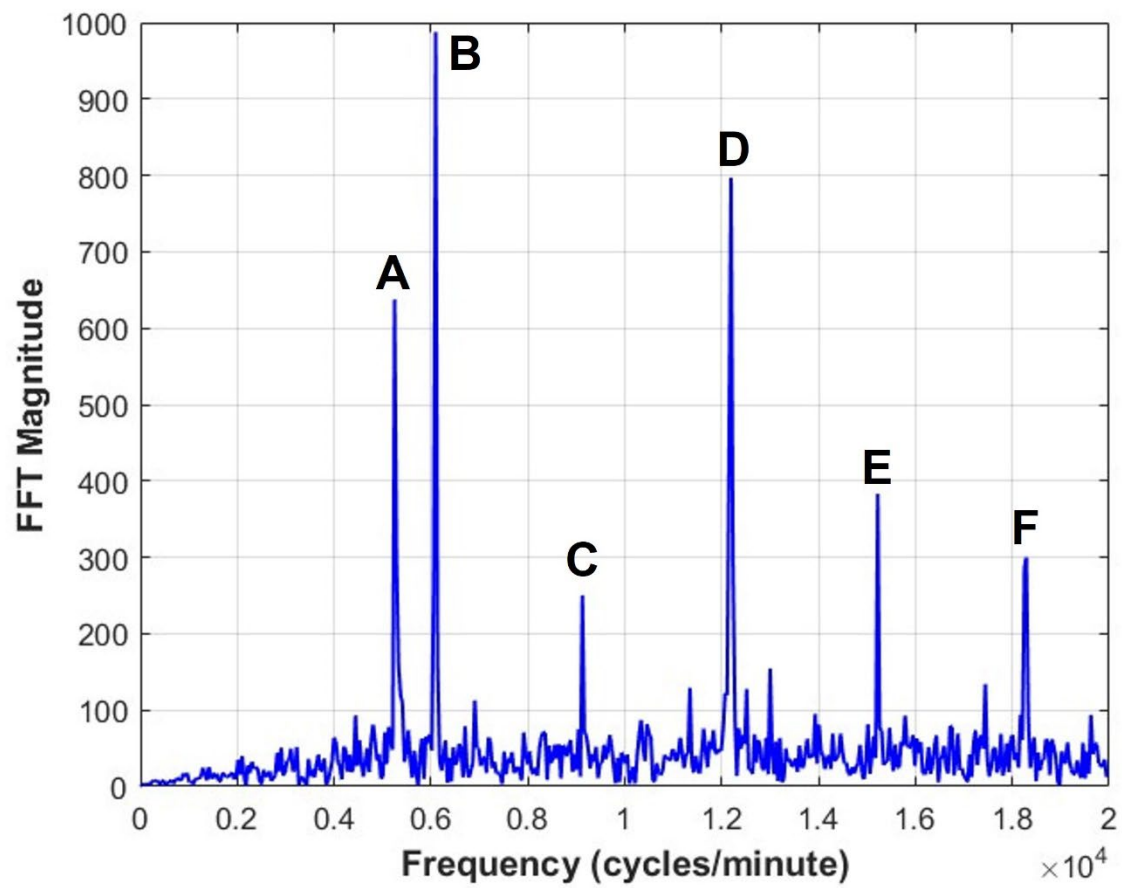
**Figure 6.** Engine sound spectrum

Table 1 lists the frequencies of the six measured spectral peaks marked in Figure 6 and the spectral peak frequencies expected based on the above analysis if it is assumed that the engine speed was 6090 rpm. Assumed engine speed of 6090 rpm results in propeller blade passage frequency (BPF) of  $6090 \times 3/3.47 = 5265$  blades per minute.

The measured spectral frequencies listed in Table 1 are as expected considering that the frequency resolution of the FFT algorithm was 40 cpm. The accurate agreement between measured and expected frequencies confirms that the engine

speed was 6090 rpm and that the gearbox operated properly. The engine speed and the proper operation of the gearbox remained constant throughout the flight.
