# National Transportation Safety Board

ERA22LA312

## **PERFORMANCE STUDY**

Location: Russell, Pennsylvania  
Date: July 14, 2022  
Time: 1940 eastern daylight time (EDT)  
Aircraft: Flightstar II-SC, N6116U

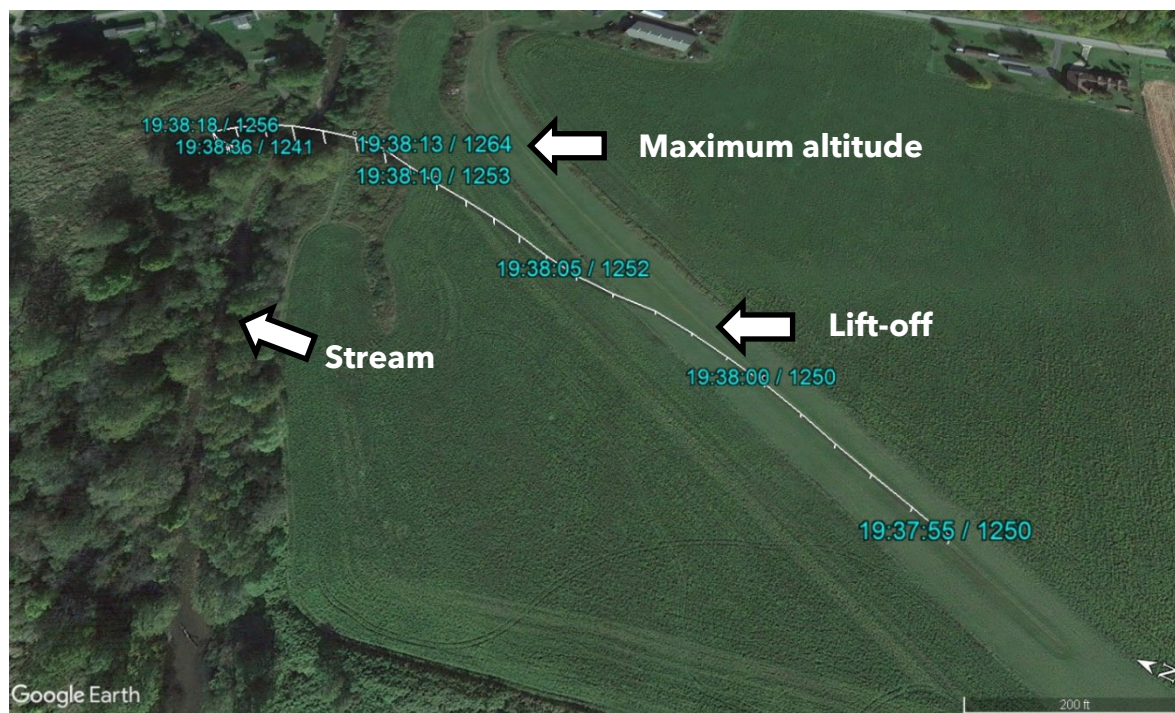
The aircraft was taking off from a grass field, seen in Figure 2. The altitude recorded by the onboard device was corrected by a constant offset to more accurately reflect the terrain elevation in the area. Figure 3 shows the estimated height above the ground of the wheels, calculated airspeed, and calculated groundspeed. The final points from 19:38:25 to 19:28:36 are not shown as the aircraft is no longer moving.

**Figure 2.** Aircraft flight path with selected times and altitudes above mean sea level (msl) annotated. Lift-off (19:38:02) and maximum altitude are noted in addition to the stream bed.

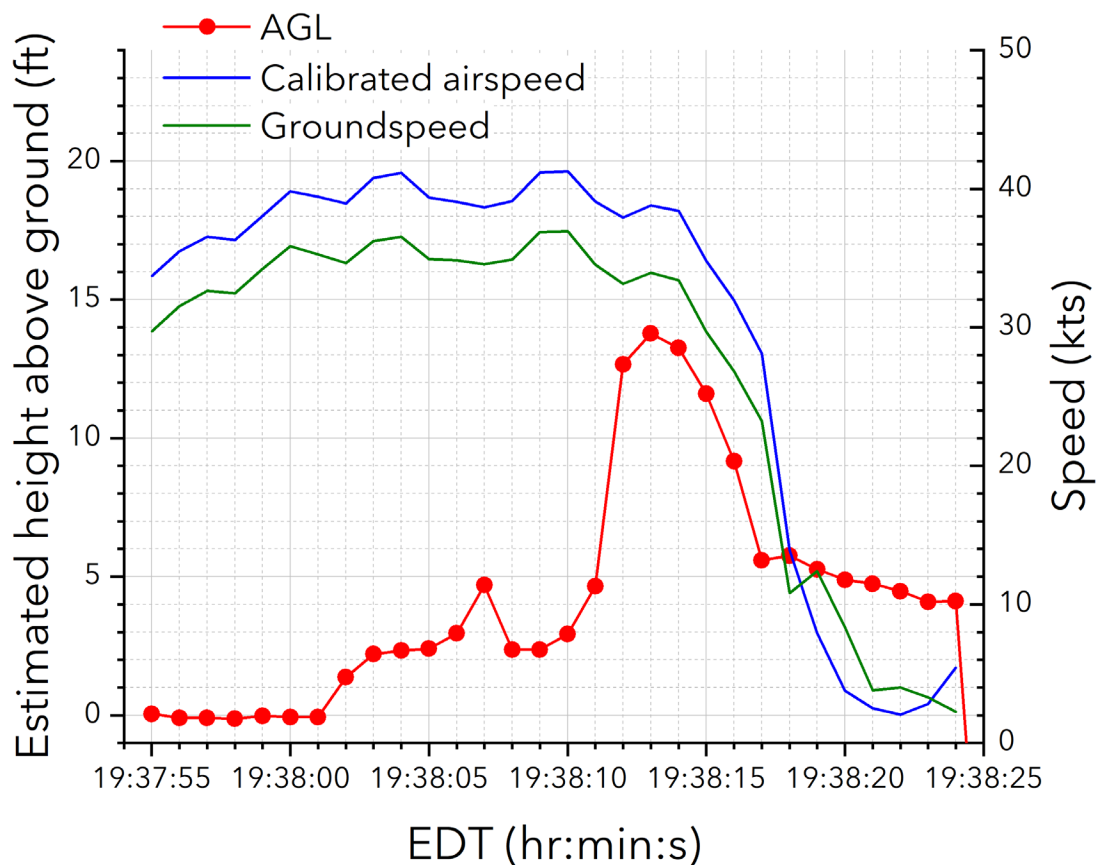
**Figure 3.** Aircraft altitude above ground level (AGL), calculated calibrated airspeed, and calculated groundspeed.

Calibrated airspeed was about 2.5 kts higher than the groundspeed, but was based on wind and atmospheric conditions recorded 20 NM away from the accident location. The aircraft accelerated down the runway along the centerline until 19:38:02 when the track began deviating to the left and the altitude increased slightly at an airspeed of about 40 kts. The aircraft tracked to the left while not gaining significant altitude and maintaining airspeed for another 5-7 seconds. The aircraft then gained 10 ft in about 3 seconds (200 ft/min climb rate).

The estimated stall speed for the aircraft is 31 kts<sup>1</sup>. The aircraft's groundspeed dropped below 30 kts at 19:38:15 and the calibrated airspeed dropped below that level at 19:38:17 as it was descending. Assuming the winds were accurate, the aircraft was at risk of aerodynamic stall after approximately 19:38:17, possibly earlier with different winds. The loss of altitude and airspeed at 19:38:14 was consistent with stall.

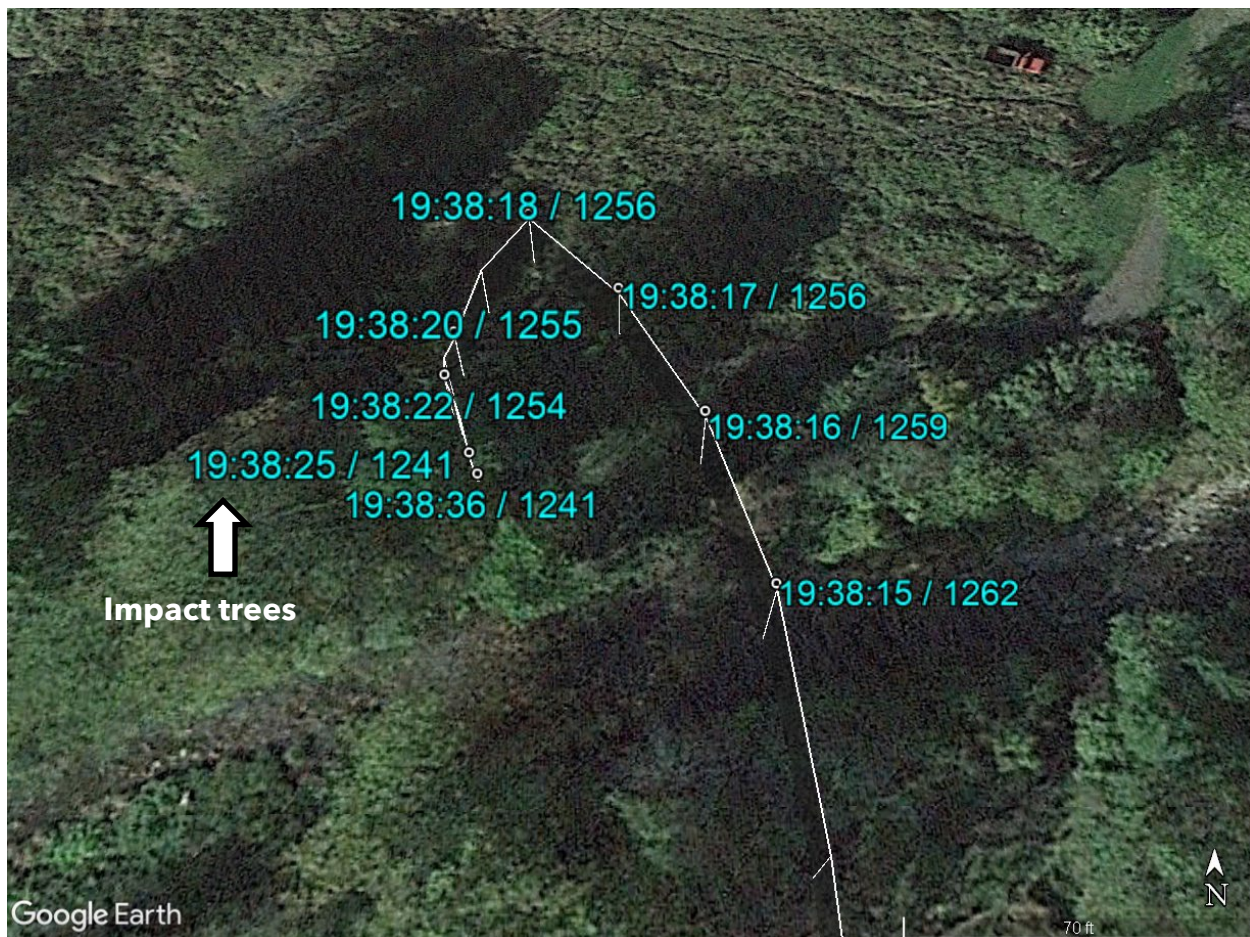
The aircraft slowed and lost altitude. It descended and continued making a gradual left turn. At 19:38:18, as speed dropped below 20 kts, the aircraft's flight track made a sharp left turn (Figure 4). This is consistent with the video ending at 19:38:17.7 with tree branches in view. The aircraft then made a 180° turn and traveled another 70 ft while slowing to near zero.

**Figure 4.** End of flight times and altitudes for selected points.
