ERA22LA312

## INVESTIGATION PHOTOGRAPHS

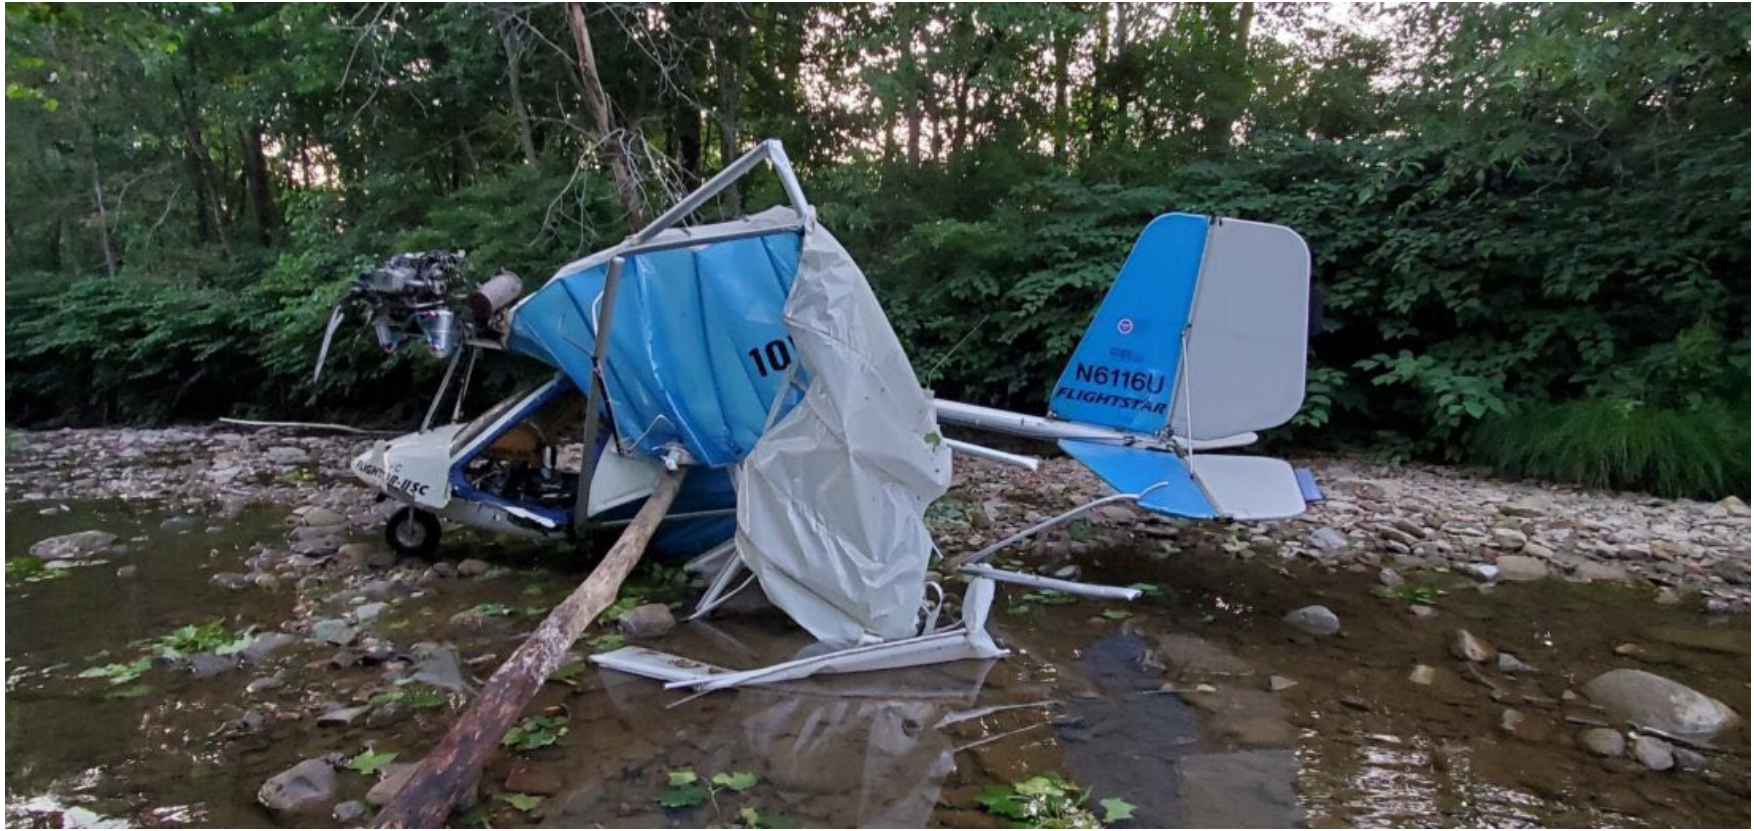
**Photograph 1 - Left side profile view of damaged airplane. (Courtesy of FAA)**

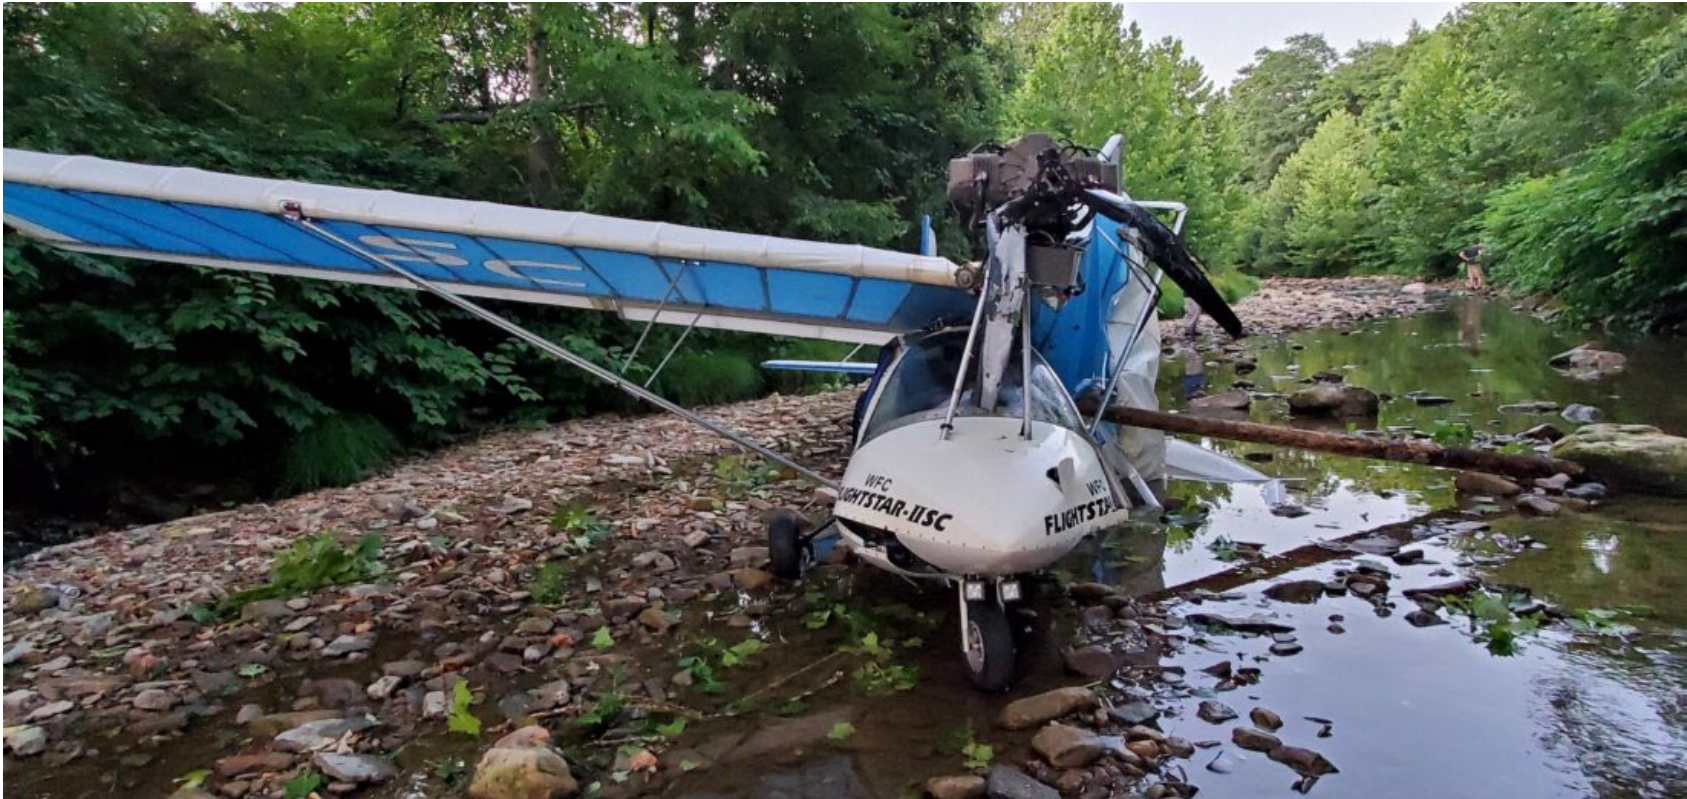
**Photograph 2 - Front view of airplane damage and fractured left wing. (Courtesy of FAA)**

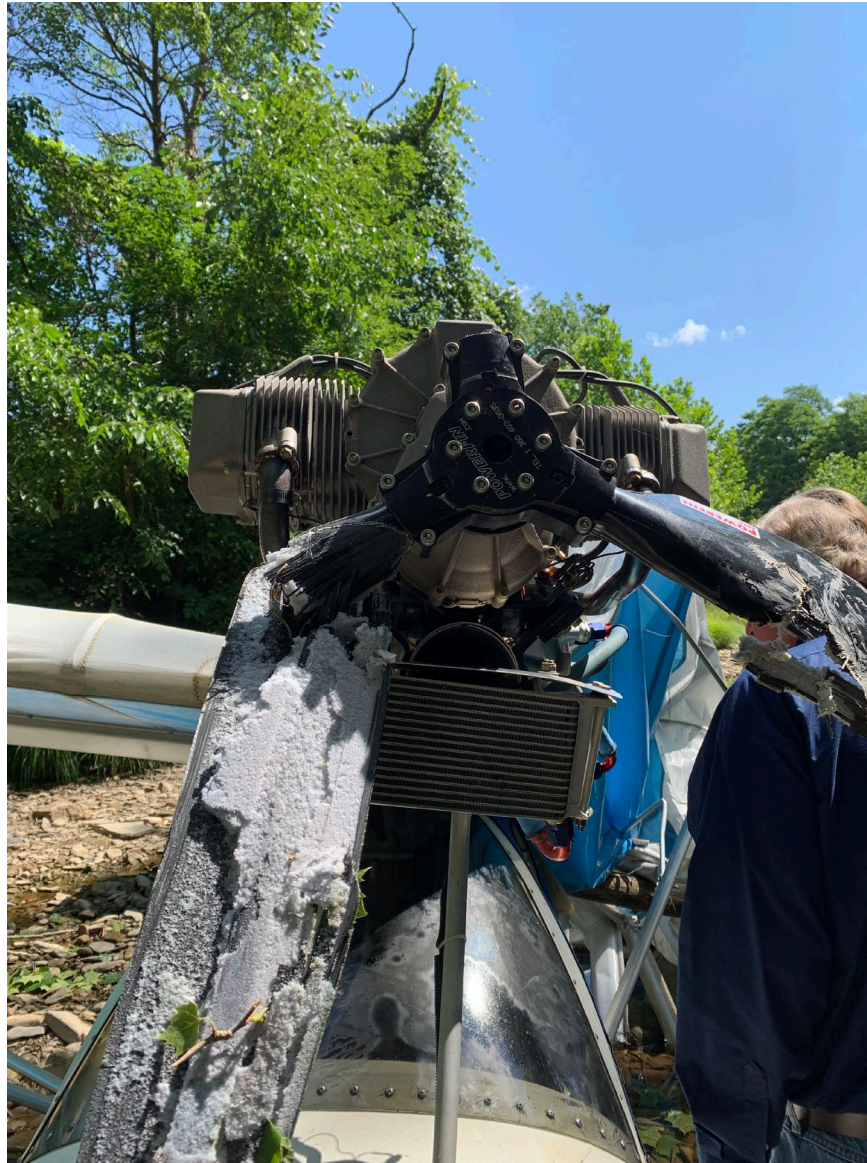
**Photograph 3 - View of damaged and shattered propeller blades. (Courtesy of FAA)**
