## RECORD OF CONVERSATION

**Date: June 13, 2022**  
**Person Contacted: Ronald Edward Awad**  
**NTSB Accident Number: ERA22LA313**

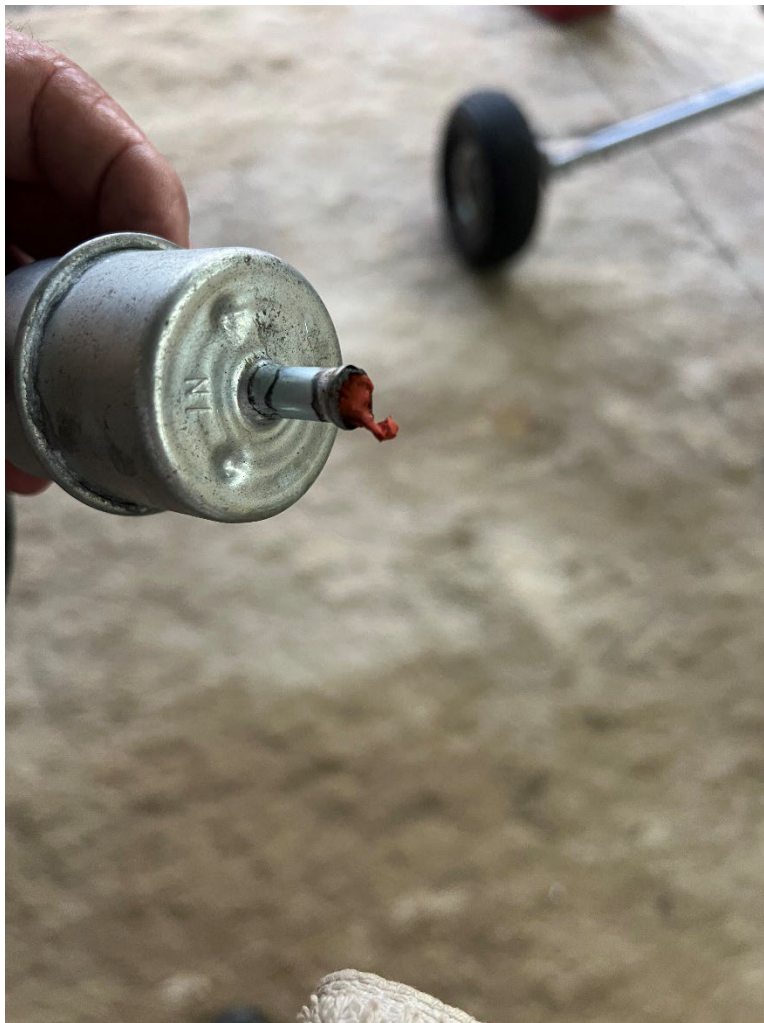
On June 14, 2022, he texted NTSB 4 photographs depicting foreign material in the inlet fitting of the fuel filter which nearly completely blocked the inlet (Figures 1 and 2). Subsequently on June 19, 2022, at 1454 EDT, he texted NTSB the following verbiage and also 4 photographs, “Went to airport today for a short visit and pulled the seat to get access to the fuel tank. Wanted to check for RTV in tank or around fuel sending unit. Sure enough there was silicone around the sending unit and a glob on the bottom of the tank under it. Probably been that way since the machine was built.” One photograph depicted the same orange sealant on the fuel tank sealing area for the fuel sending unit (Figure 3) and another photograph depicted the same orange sealant in the bottom of the fuel tank beneath the opening in the fuel tank where the fuel tank sending unit would be installed (Figure 4).

Figure 1: Digital Photograph From Pilot. View Depicting Foreign Object in Fuel Filter Inlet Fitting.

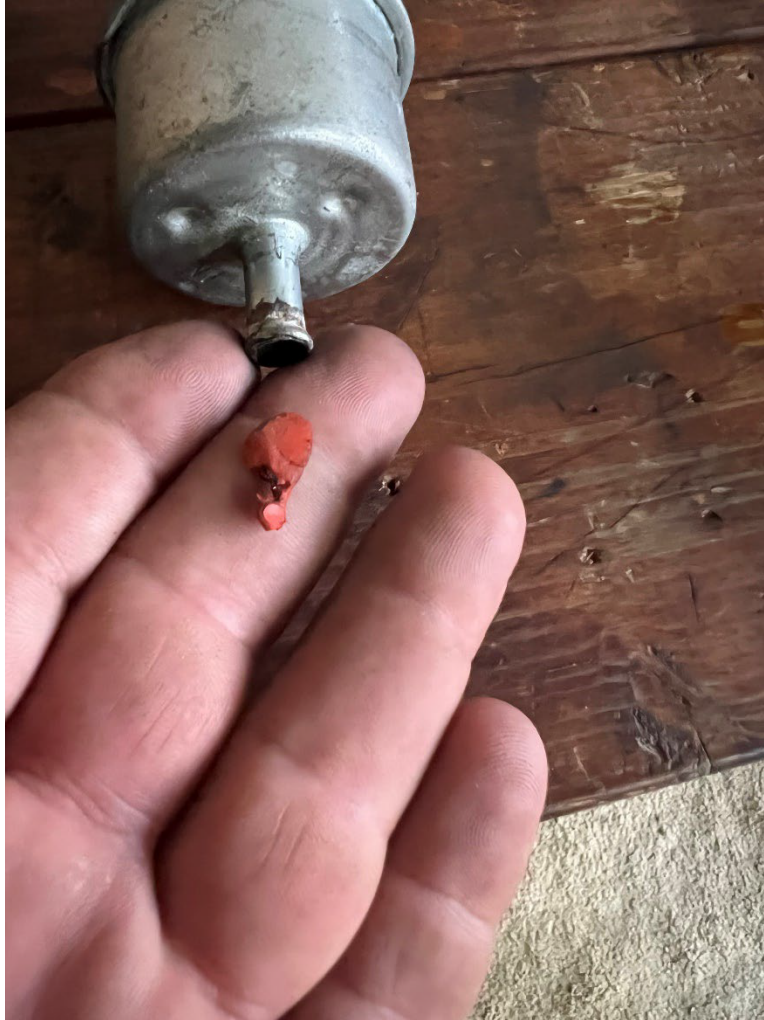
Figure 2: Digital Photograph From Pilot. View Depicting Foreign Object Removed From Fuel Filter Inlet.

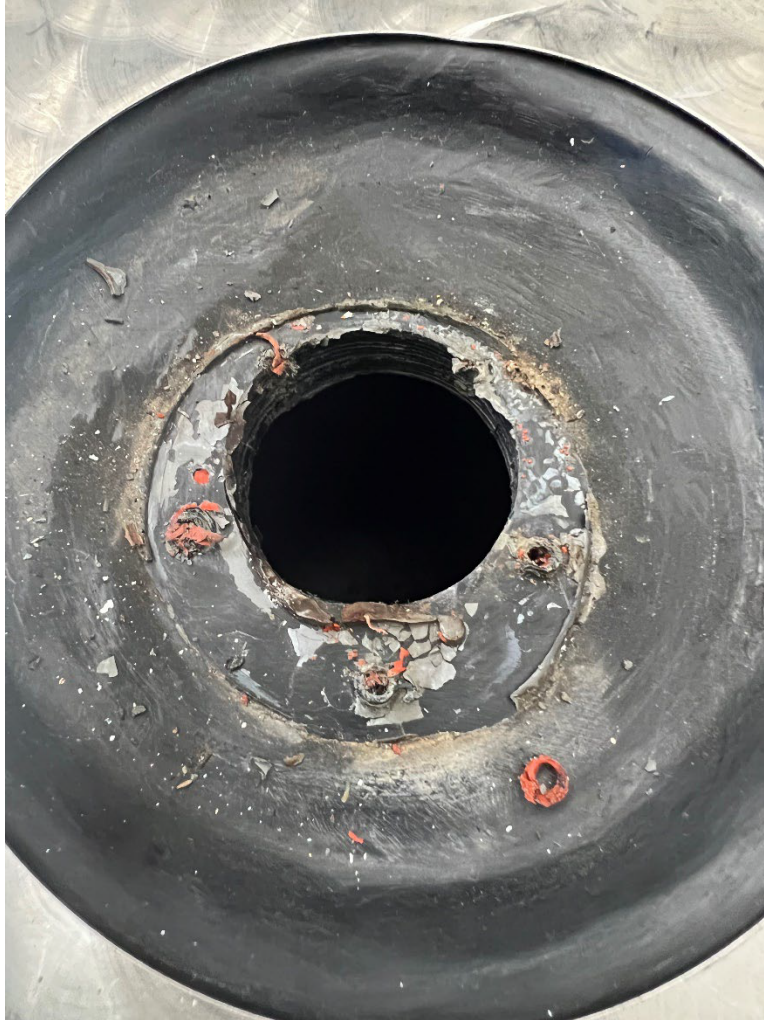
Figure 3: Digital Photograph From Pilot. View Depicting The Fuel Tank Opening Where Fuel Sending Unit is Installed. Note The Similar Colored Sealant Found in the Fuel Filter Inlet.

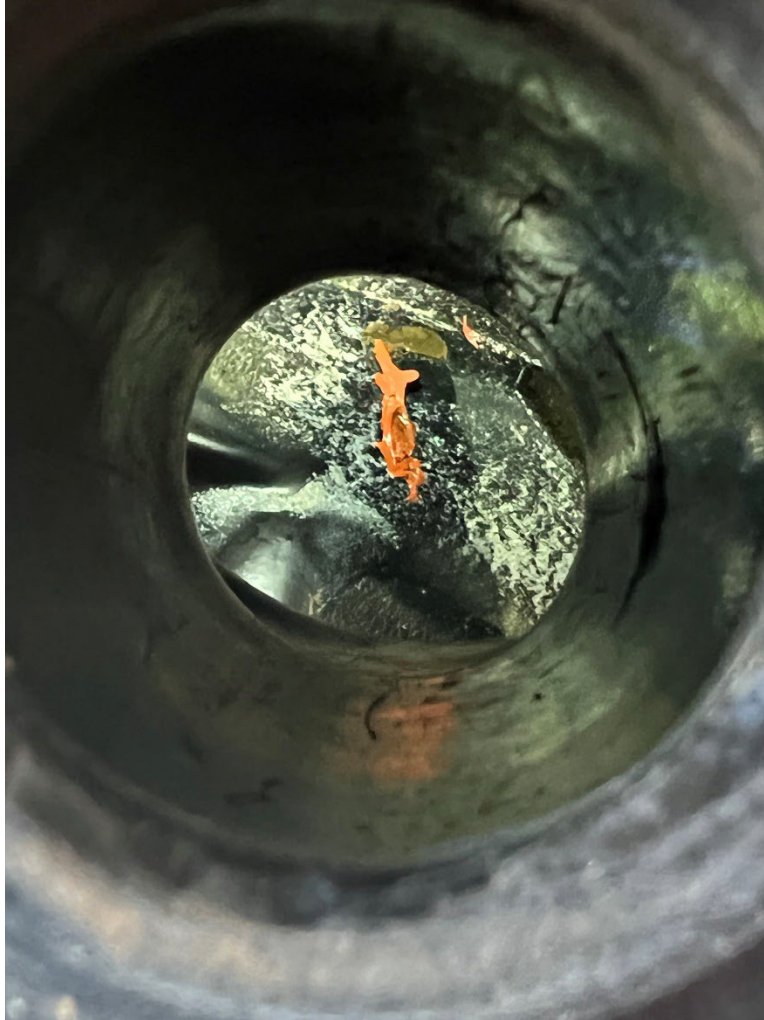
Figure 4: Digital Photograph From Pilot. View Looking Inside The Fuel Tank. Note the Same Colored Material in the Bottom Of the Fuel Tank as Was Found in the Fuel Filter Inlet.
