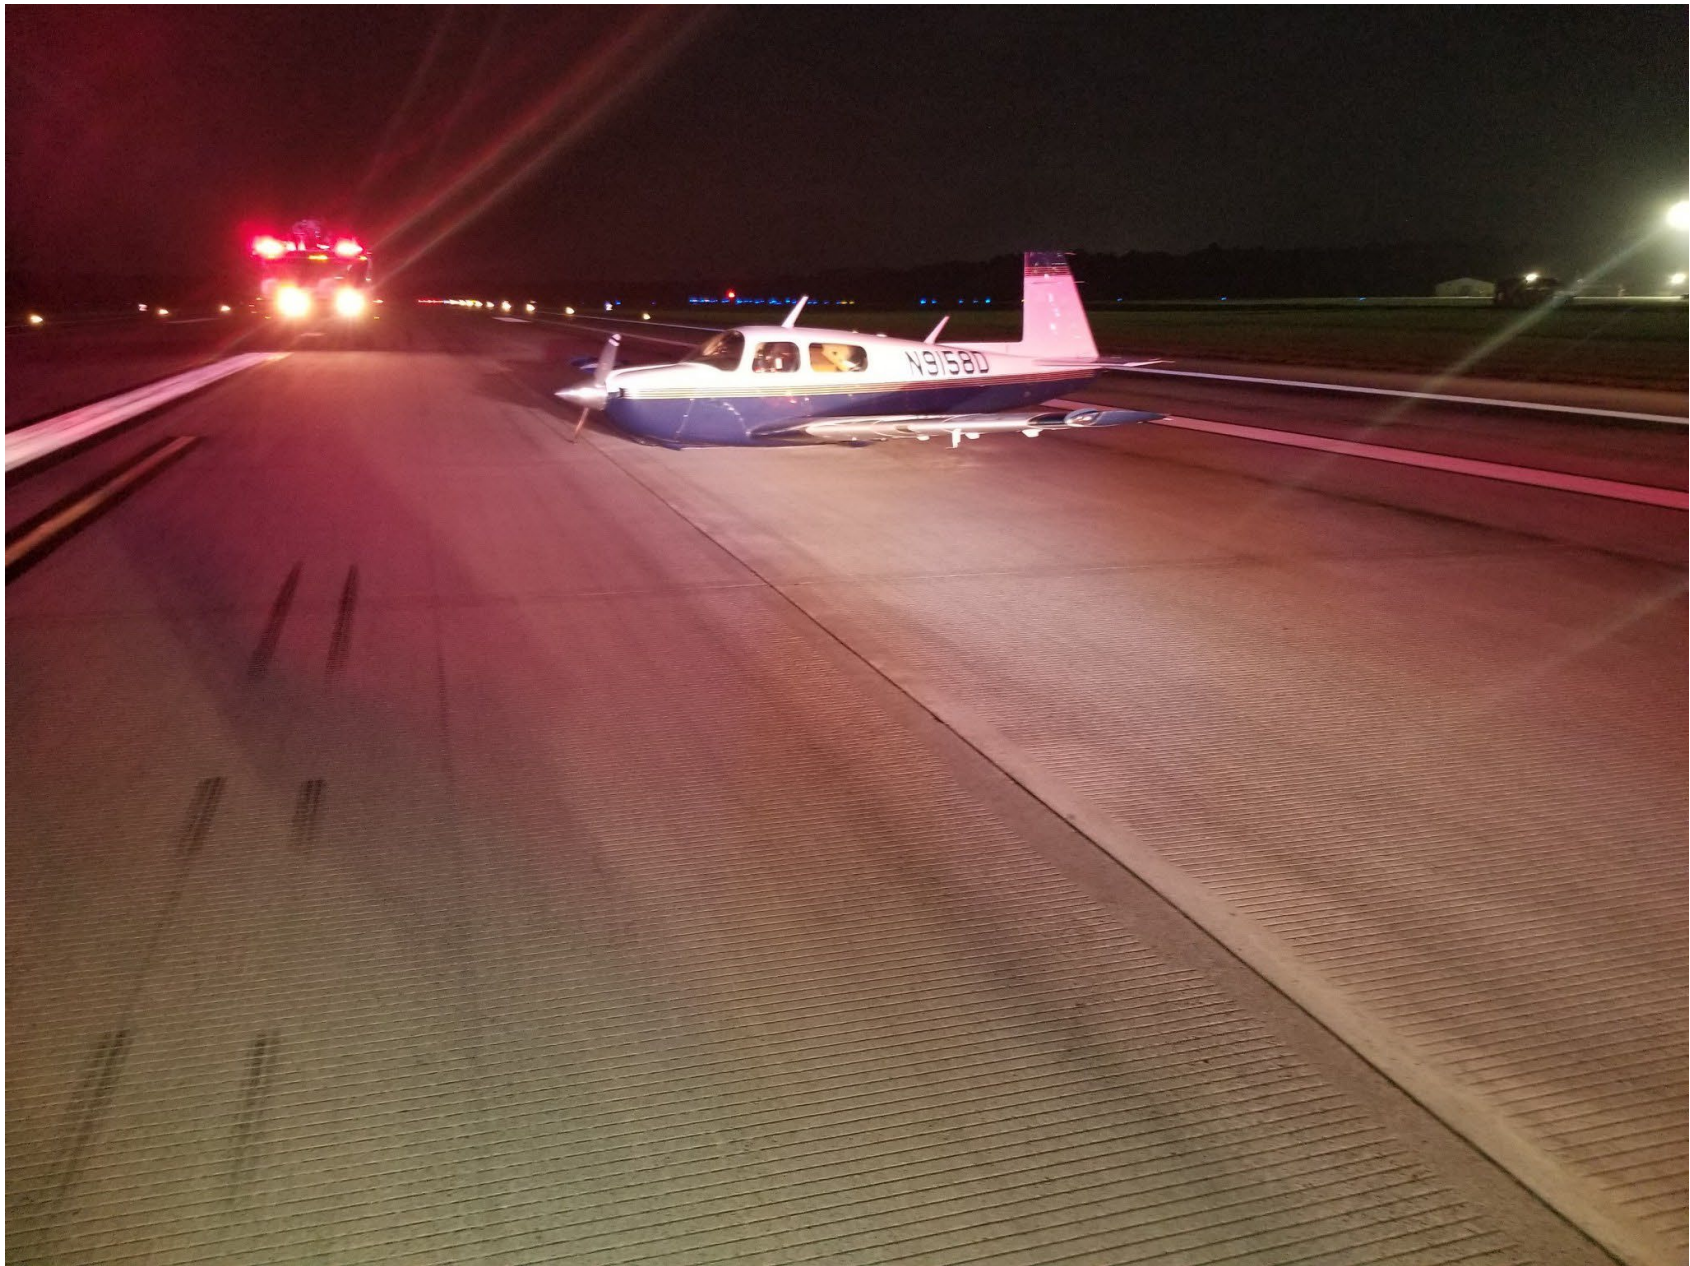
**Photo 1 – Digital Photograph From Charleston Air Force Base Airport Operations. Left Side View of the Airplane on the Runway.**

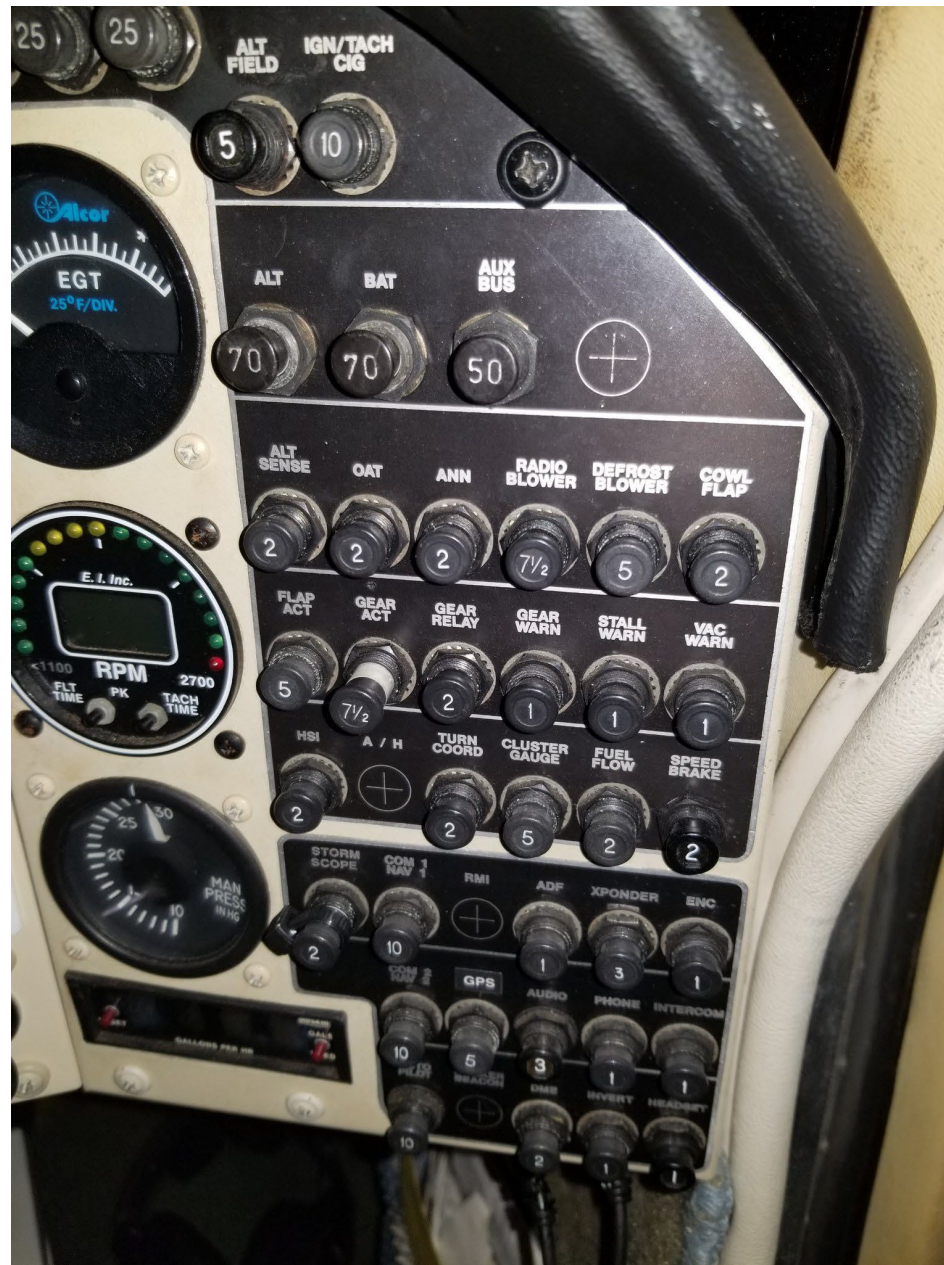
**Photo 2 - Digital Photograph From Charleston Air Force Base Airport Operations. View of the Circuit Breaker Panel Showing the Gear Actuator Circuit Breaker Tripped.**

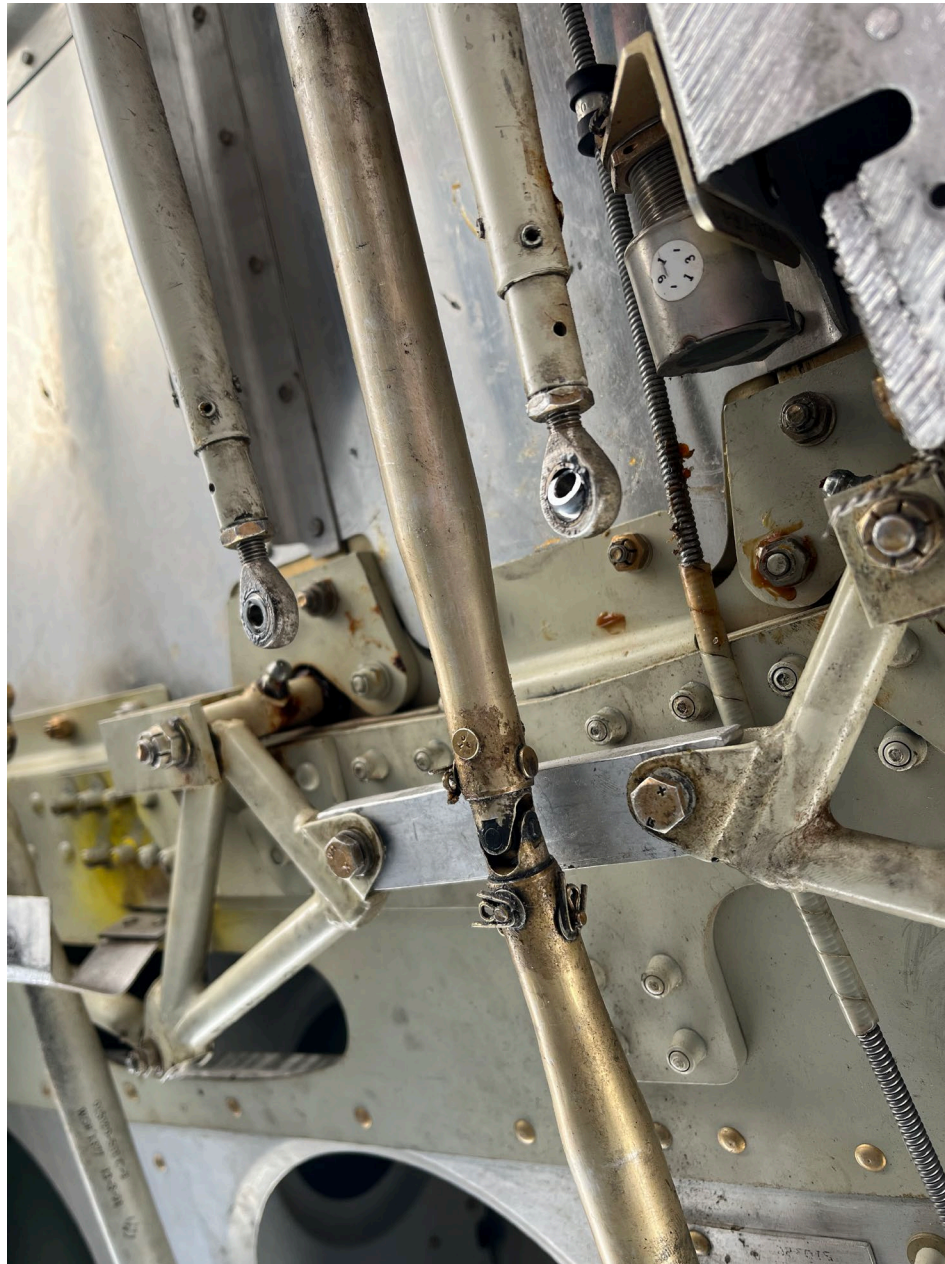
**Photo 3 – Digital Photograph From Interstate Turbine. View Depicting the Rods that were Disconnected to Allow the Landing Gear to be Lowered During Recovery of the Airplane From the Runway.**

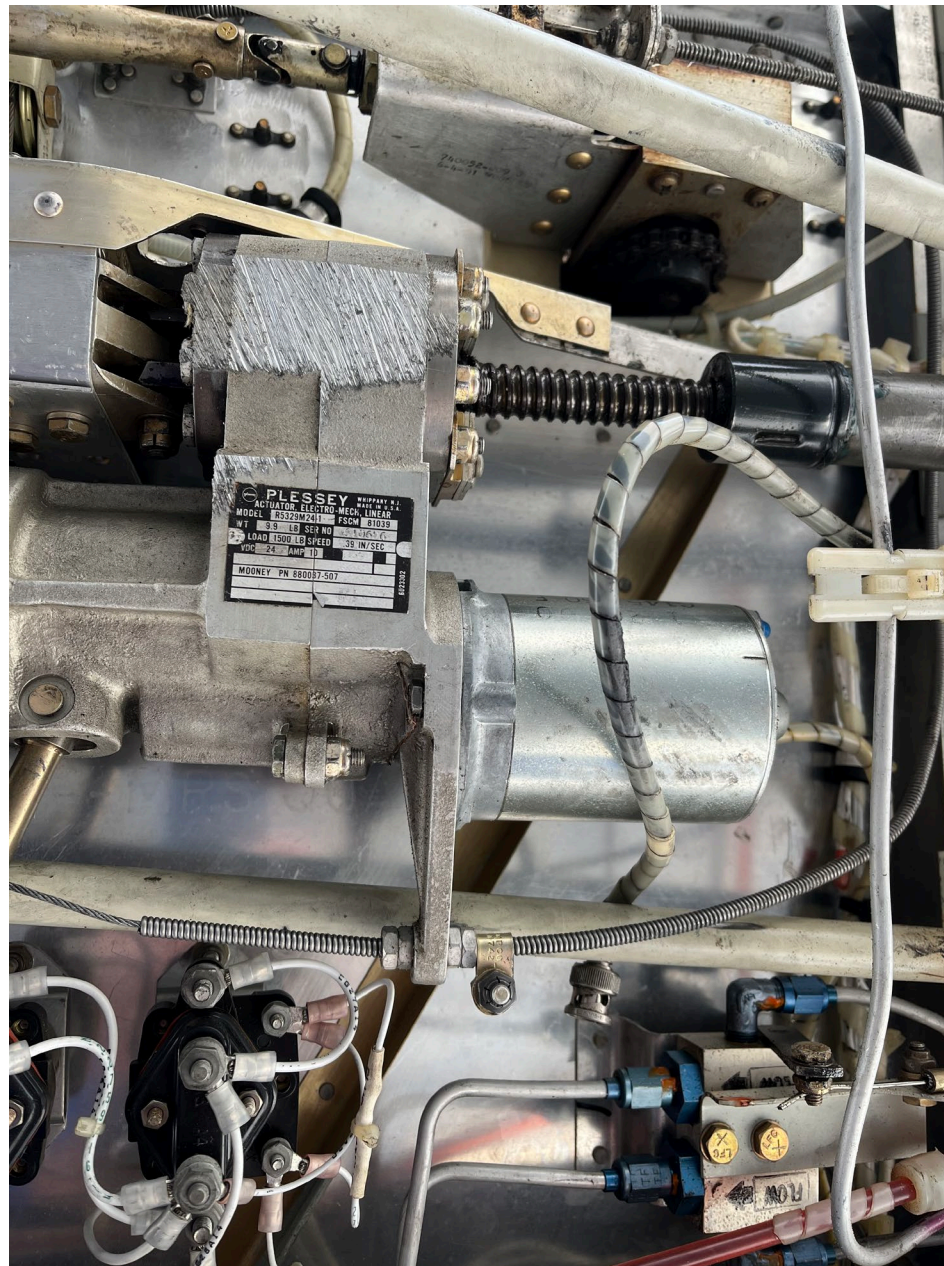
**Photo 4 - Digital Photograph From Interstate Turbine. View Depicting the Plessey Landing Gear Actuator Installed in the Airplane.**

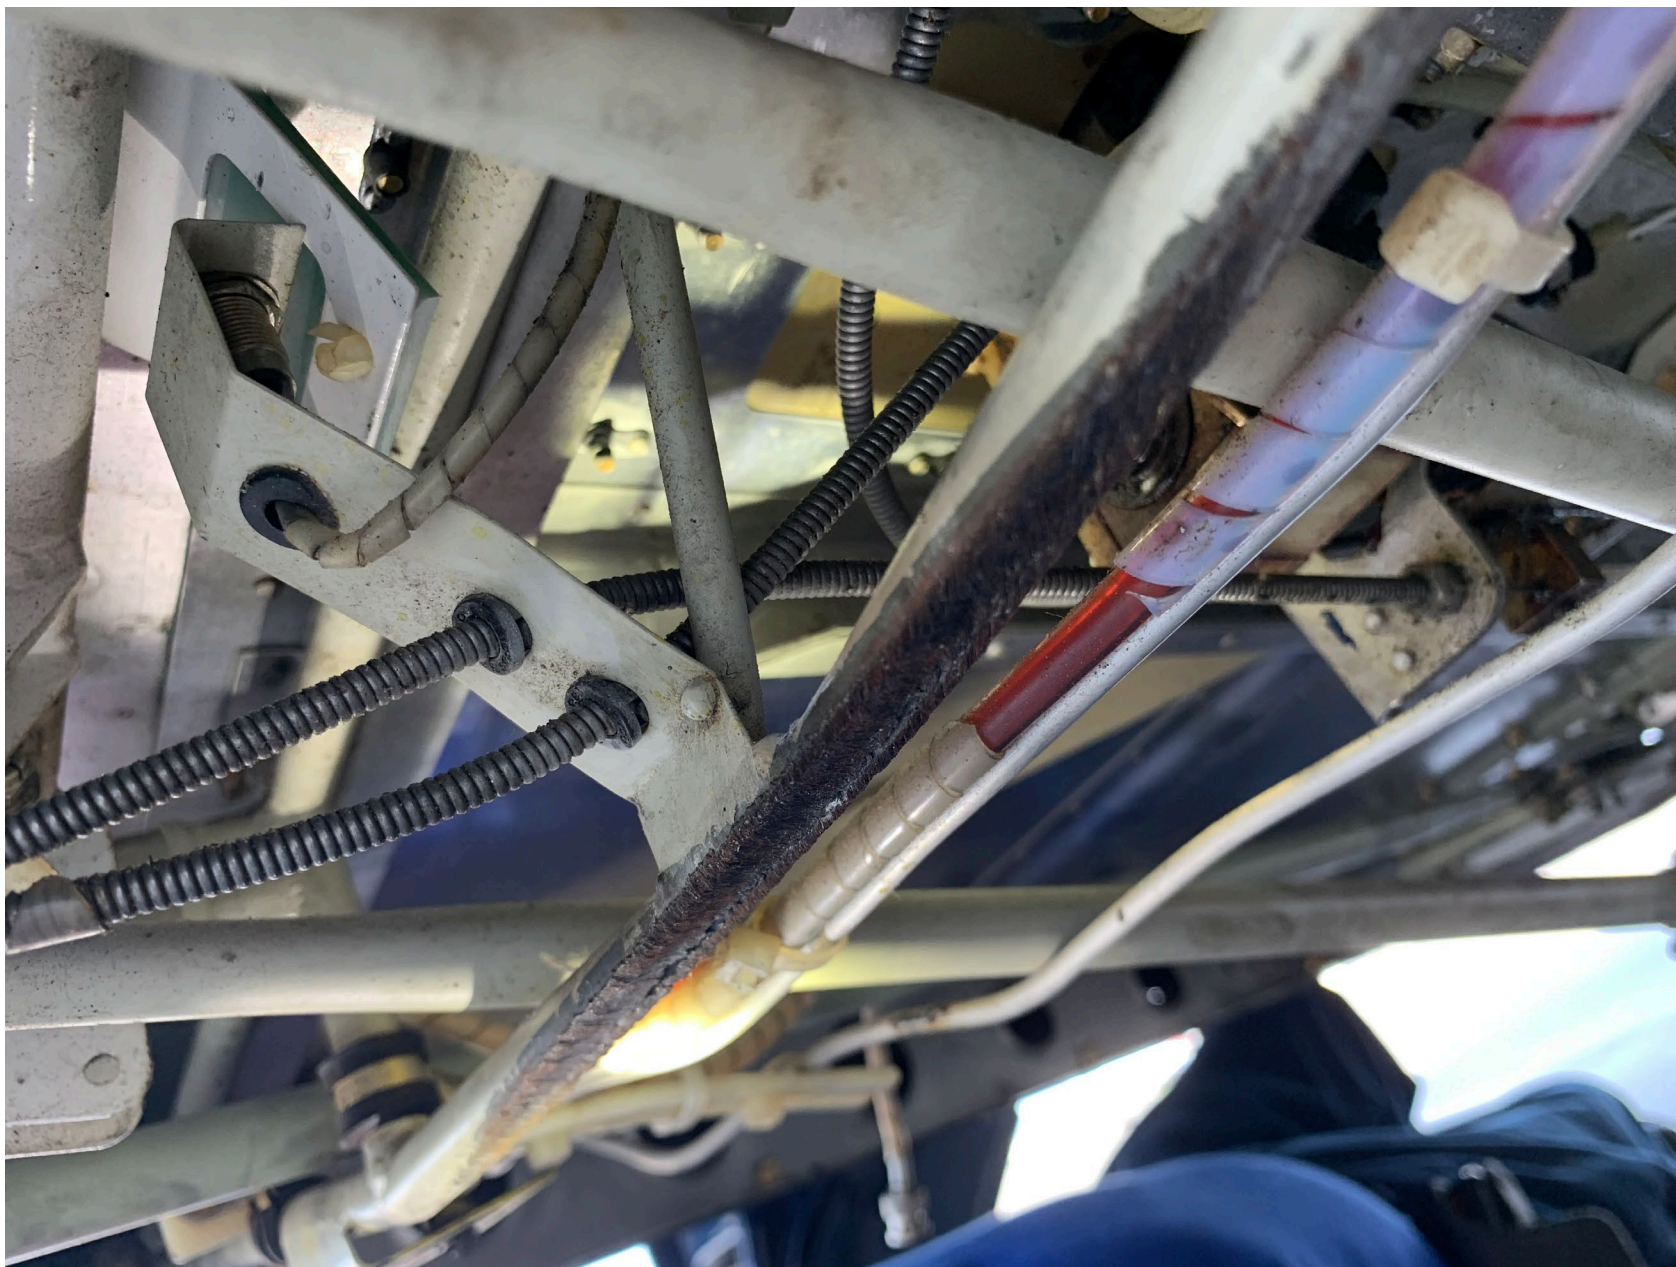
**Photo 5 – FAA Digital Photograph. View Depicting the Damage to a Tubular Steel Truss Primary Structure Which Required Major Repair and Classification as an Accident.**

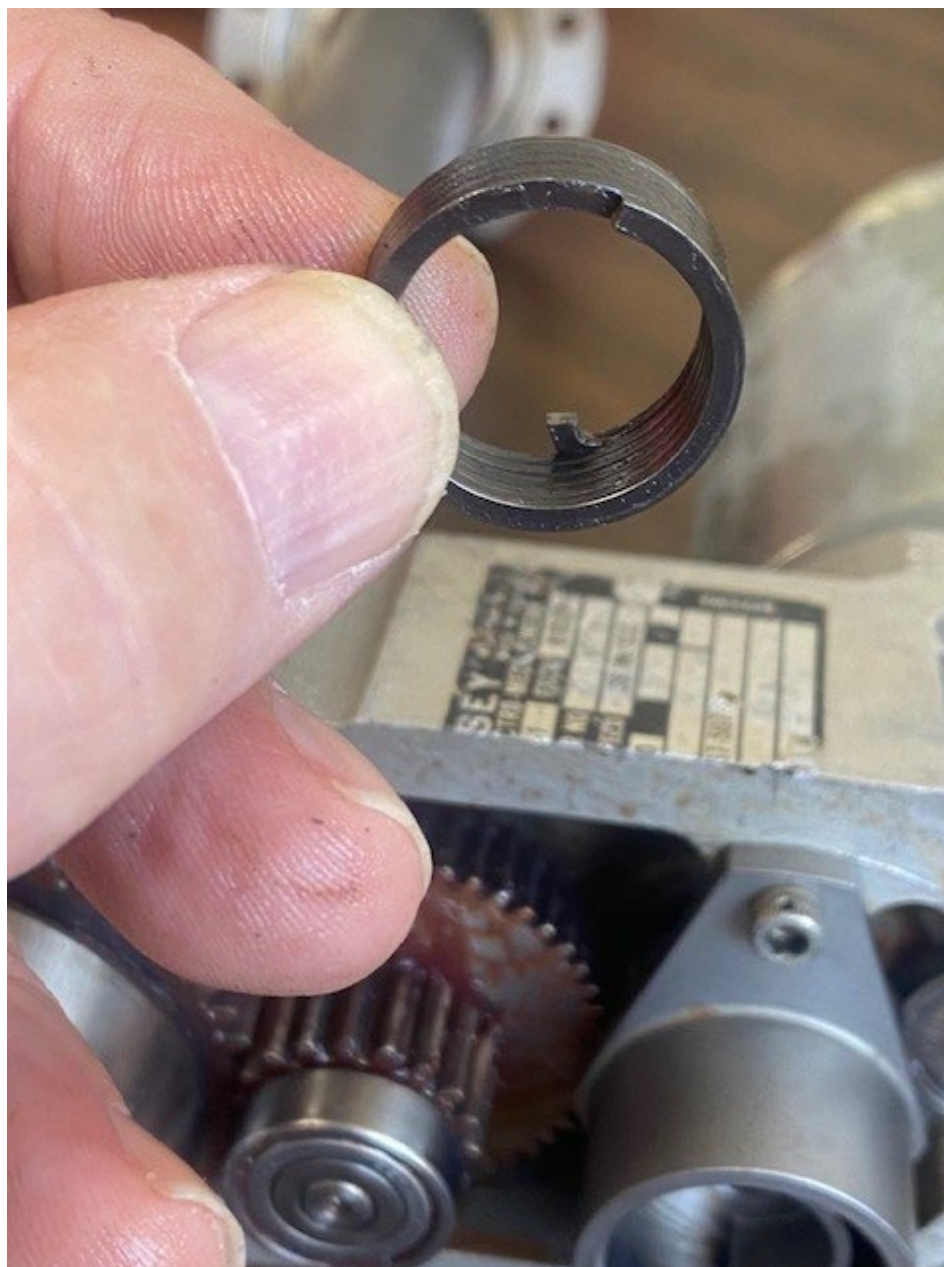
**Photo 6 – Digital Photograph From Don Maxwell Aviation. View Depicting Fractured “Tang” of Torsion Spring Inside Clutch Drive Assembly of the Plessey Landing Gear Actuator.**
