## **Accident/Incident Field notes**

Task: T-SO13-FY22-1766  
Activity: SO13202203045  
ATQA: ASO1322032  
NTSB: ERA22LA319  
Location: Charleston, SC  
Date of accident: June 12, 2022  
Time: 0150  
Operator: Private (part 91)  
Registration: N9158D  
Aircraft: Mooney M20J  
Serial: 24-3261

A teardown of the landing gear actuator was conducted to determine probable cause of landing gear extension failure. The involved part is a Plessey linear actuator, Model R5329M24-1 Mooney PN 880037-507 Serial number (could not determine). The technical data used to conduct the analysis was Mooney Service Instruction M20-02 Dated 01/15/2002.

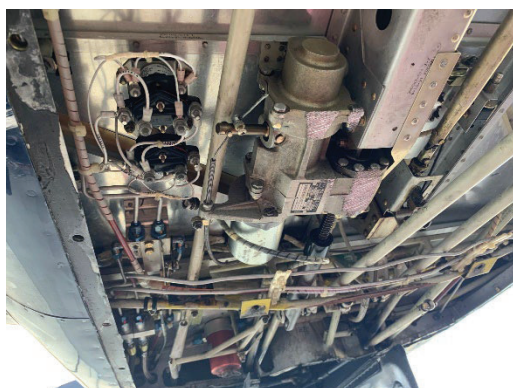
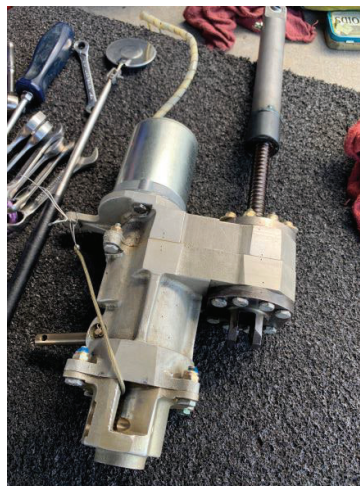
The actuator was removed from the airframe to facilitate teardown. Overall visual inspection of manual release system was conducted, cable was measured and tension noted prior to removal. No visible deficiencies with manual release system noted prior to removal. Jack screw was inspected for visible failure or issues.

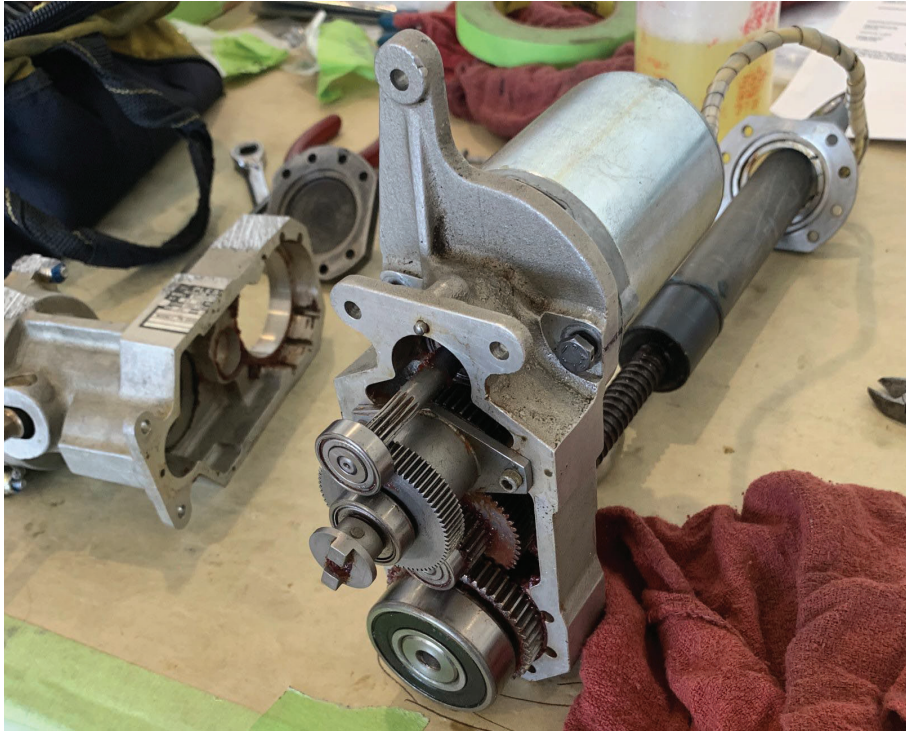
After removal of housing no visible damage noted to gears or bearings. Upon manual operation by hand the actuator would operate in one direction and not the other. The direction in which the actuator would freely turn would indicate a gear “retraction” and would not operate to “extend” the landing gear.

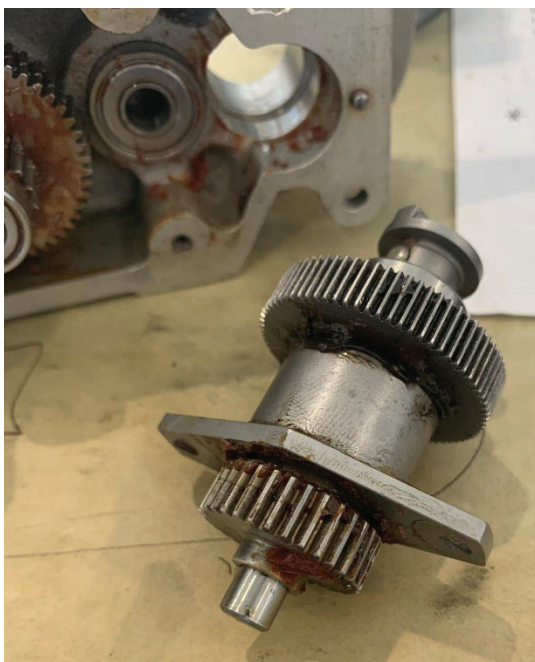
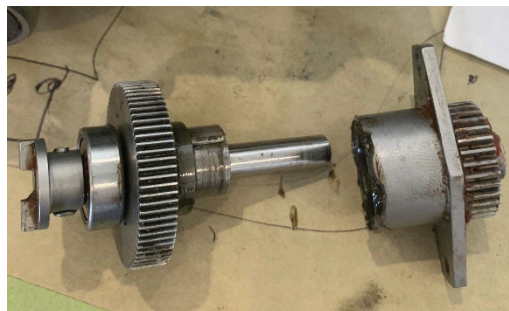
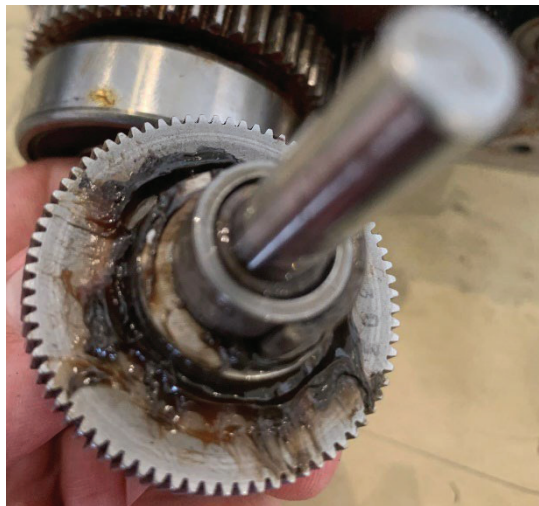
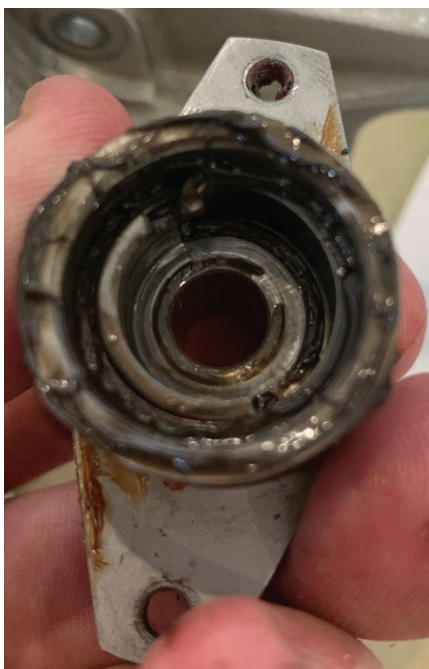
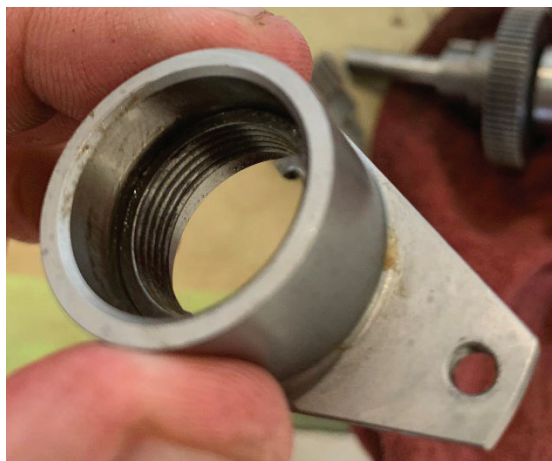
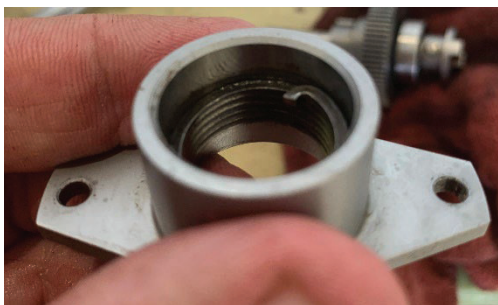
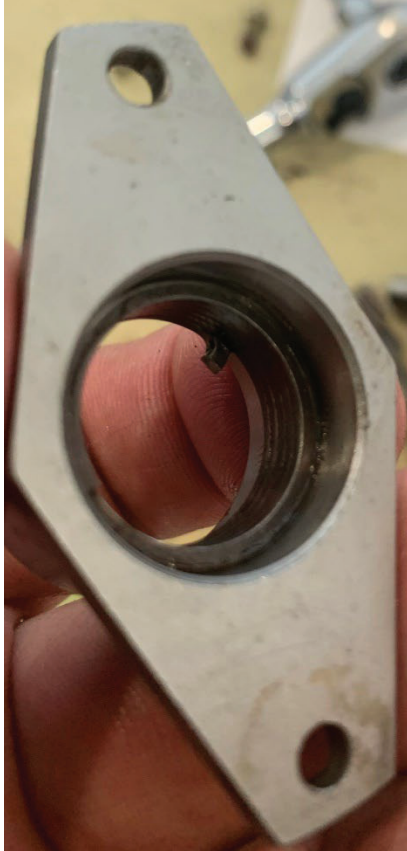
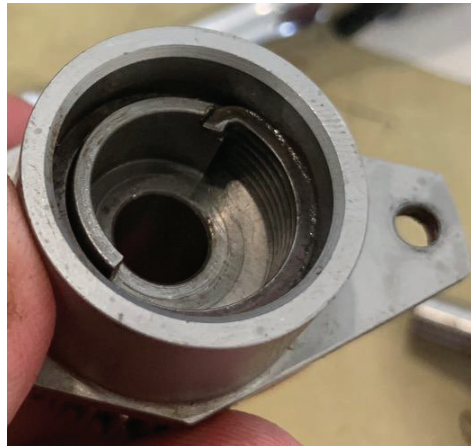
The drive clutch assembly was then removed, disassembled, cleaned and inspected for failure.

With the clutch assembly removed the actuator jack screw assembly would rotate in either direction freely without any resistance. Once clutch assembly was reinstalled the original issue reappeared, and the actuator would only operate in one direction with the clutch assembly engaged or disengaged.

The actuator was reassembled and placed in the aircraft with an identification tag notating the disassembly and data used to conduct the maintenance. No definite root cause was determined at this time. The cause of failure does appear to originate from the clutch drive assembly.
