# National Transportation Safety Board

ERA22LA333

## **MATERIALS LABORATORY**

Factual Report 23-057

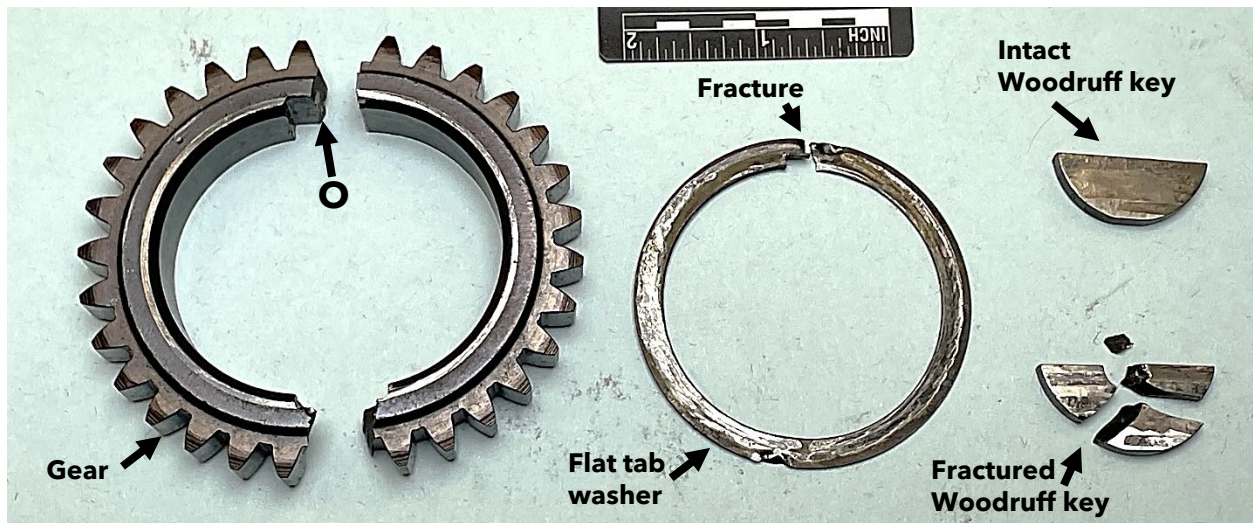
Figure 1 shows a photograph of the as-received parts. The crankshaft gear fractured into two pieces. The fractures were on diametrically opposite sides. Stereo microscope examination of the fractures revealed crack arrest marks, typical of fatigue cracking, emanating from multiple origins at the corner of the keyway, in the area indicated by arrow "O" in figure 1 and bracket "O" in figure 2. Fatigue cracking was in the general direction indicated by arrows in figure 2 and terminated in the area indicated by a dashed line in figure 2. The area located outside of the fatigue region and on the other submitted pieces exhibited coarse and irregular fracture features on slant planes typical of overstress separation.

**Figure 1.** As- received fractured crankshaft gear (2 pieces); flat tab washer; intact woodruff key; and fractured Woodruff key (4 pieces).

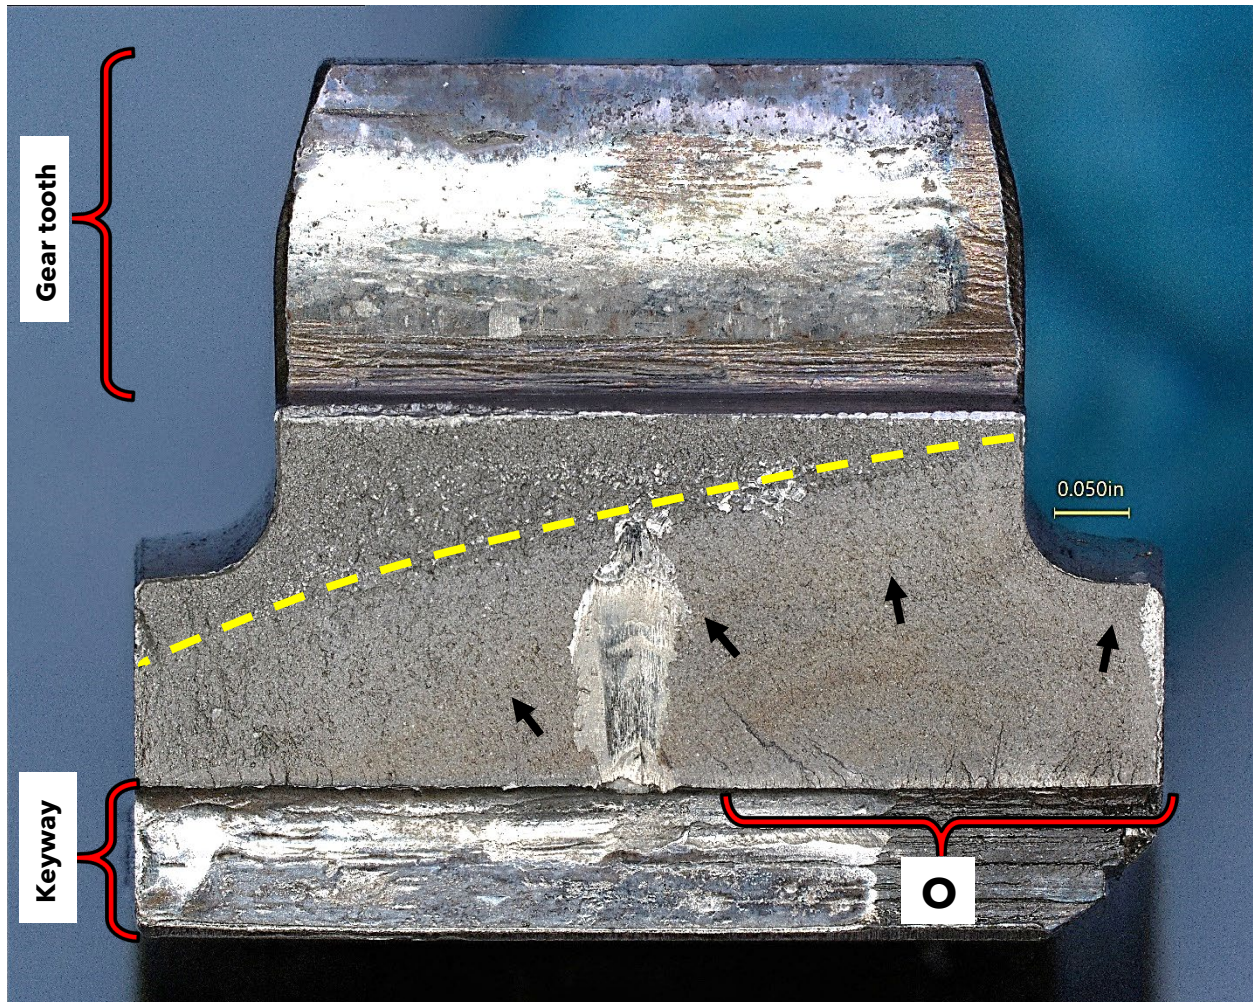
**Figure 2.** Close-up photograph of the fractured gear showing a fatigue crack that emanated from multiple origins at the corner of the keyway, in the area indicated by bracket "O".
