## Memorandum For Record

**Date: 12/13/2023**  
**NTSB Accident Number: ERA22LA333**

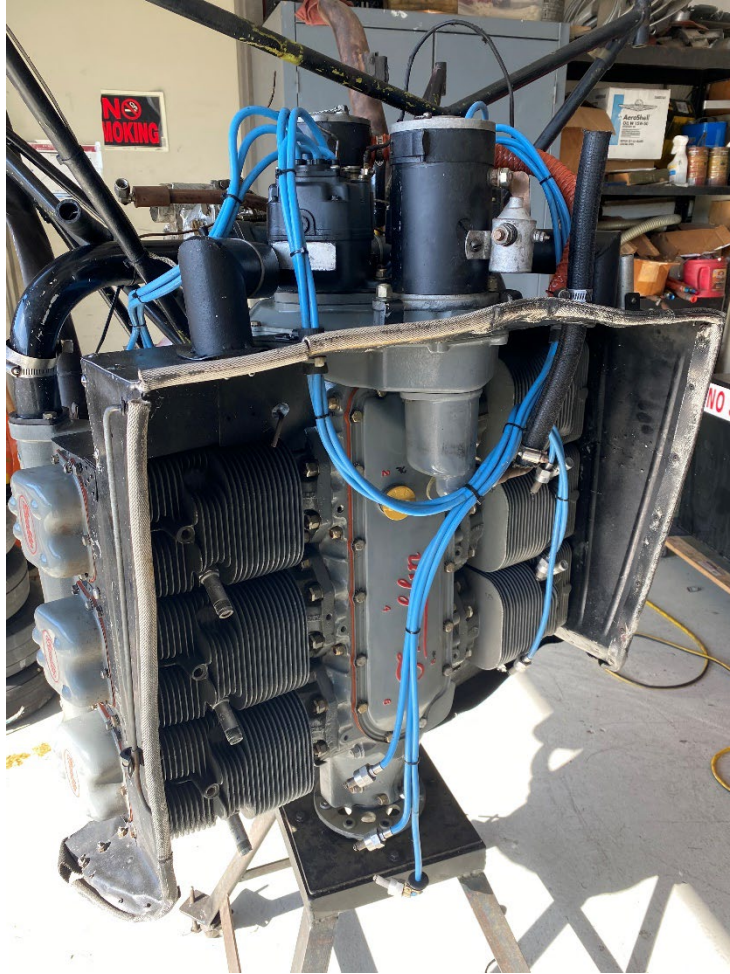
At the start of the ZOOM call, the Franklin 6A4-165-B3 engine with engine mount, serial number 31227 was bolted vertically by the crankshaft flange to a stand (Figure 1). To facilitate inspection of the crankshaft and camshaft gears, the starter and magnetos were removed from the accessory case. Following removal of the accessory case it was noted that the crankshaft gear was fractured (Figure 2). It was also noted that one "tab" of the "tab washer" was separated and the washer was fractured (Figure 3). One woodruff key which was intact was found in the core of the crankshaft, while portions of a fractured woodruff key were also found in the core of the crankshaft. Additionally, a piece of the fractured woodruff key was found in the oil sump. Inspection of the floating oil suction tube revealed the screen was clean.

Figure 1: AMF Aviation Digital Photograph. View of the Engine Before Examination.

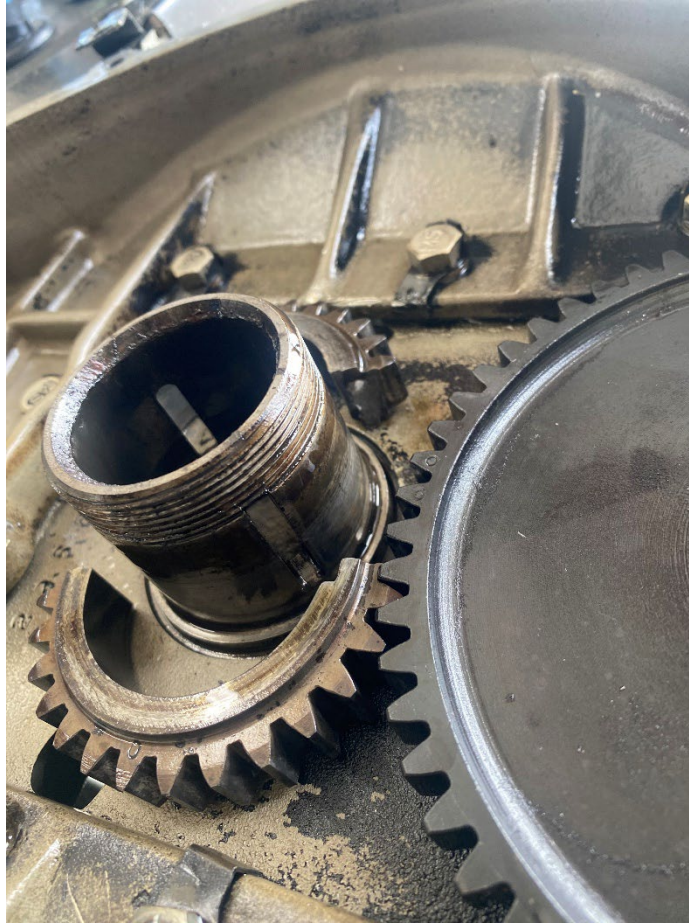
Figure 2: AMF Aviation Digital Photograph. View of the Fractured Crankshaft Gear. Adjacent large gear is Camshaft Gear.

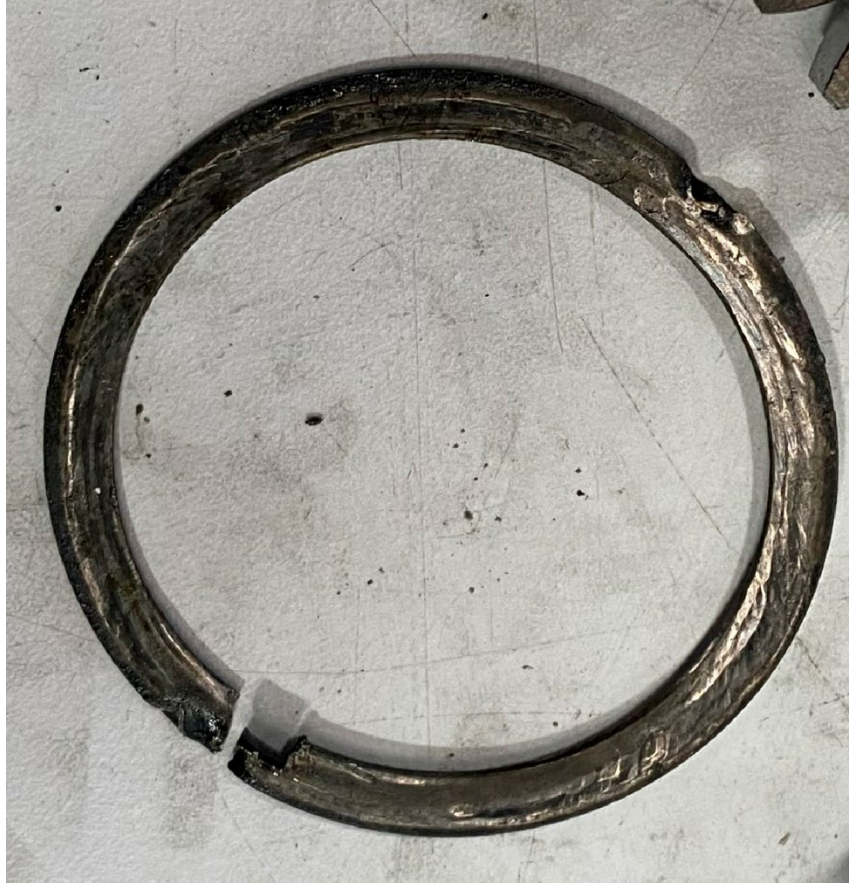
Figure 3: AMF Aviation Digital Photograph. View of the tab Washer.

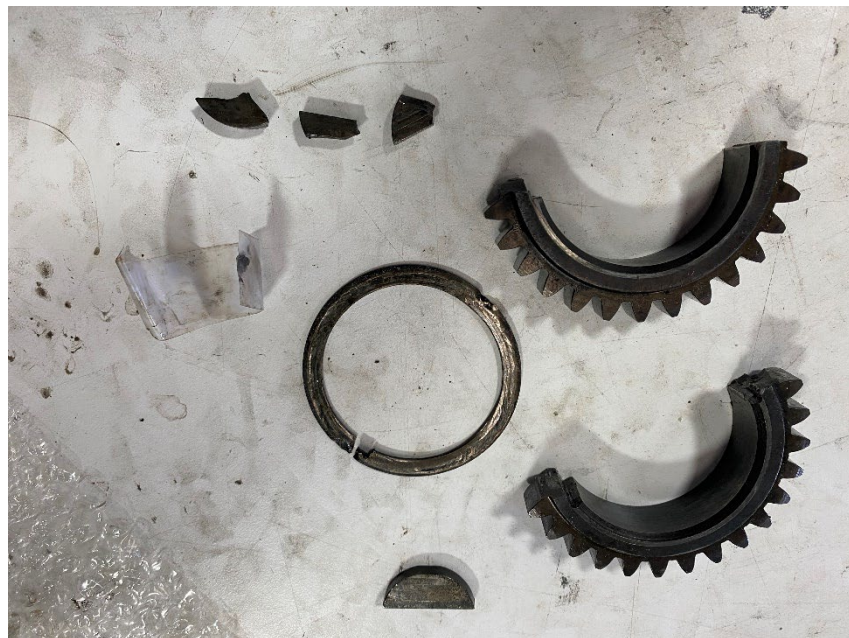
As part of the investigation, the fractured crankshaft gear, fractured flat tab washer, 1 intact woodruff key, and multiple pieces of the fractured woodruff key (Figure 4) were retained for examination by the NTSB Materials Laboratory.

Figure 4: MF Aviation Digital Photograph. View of the Parts Sent to NTSB Materials Laboratory for Examination.
