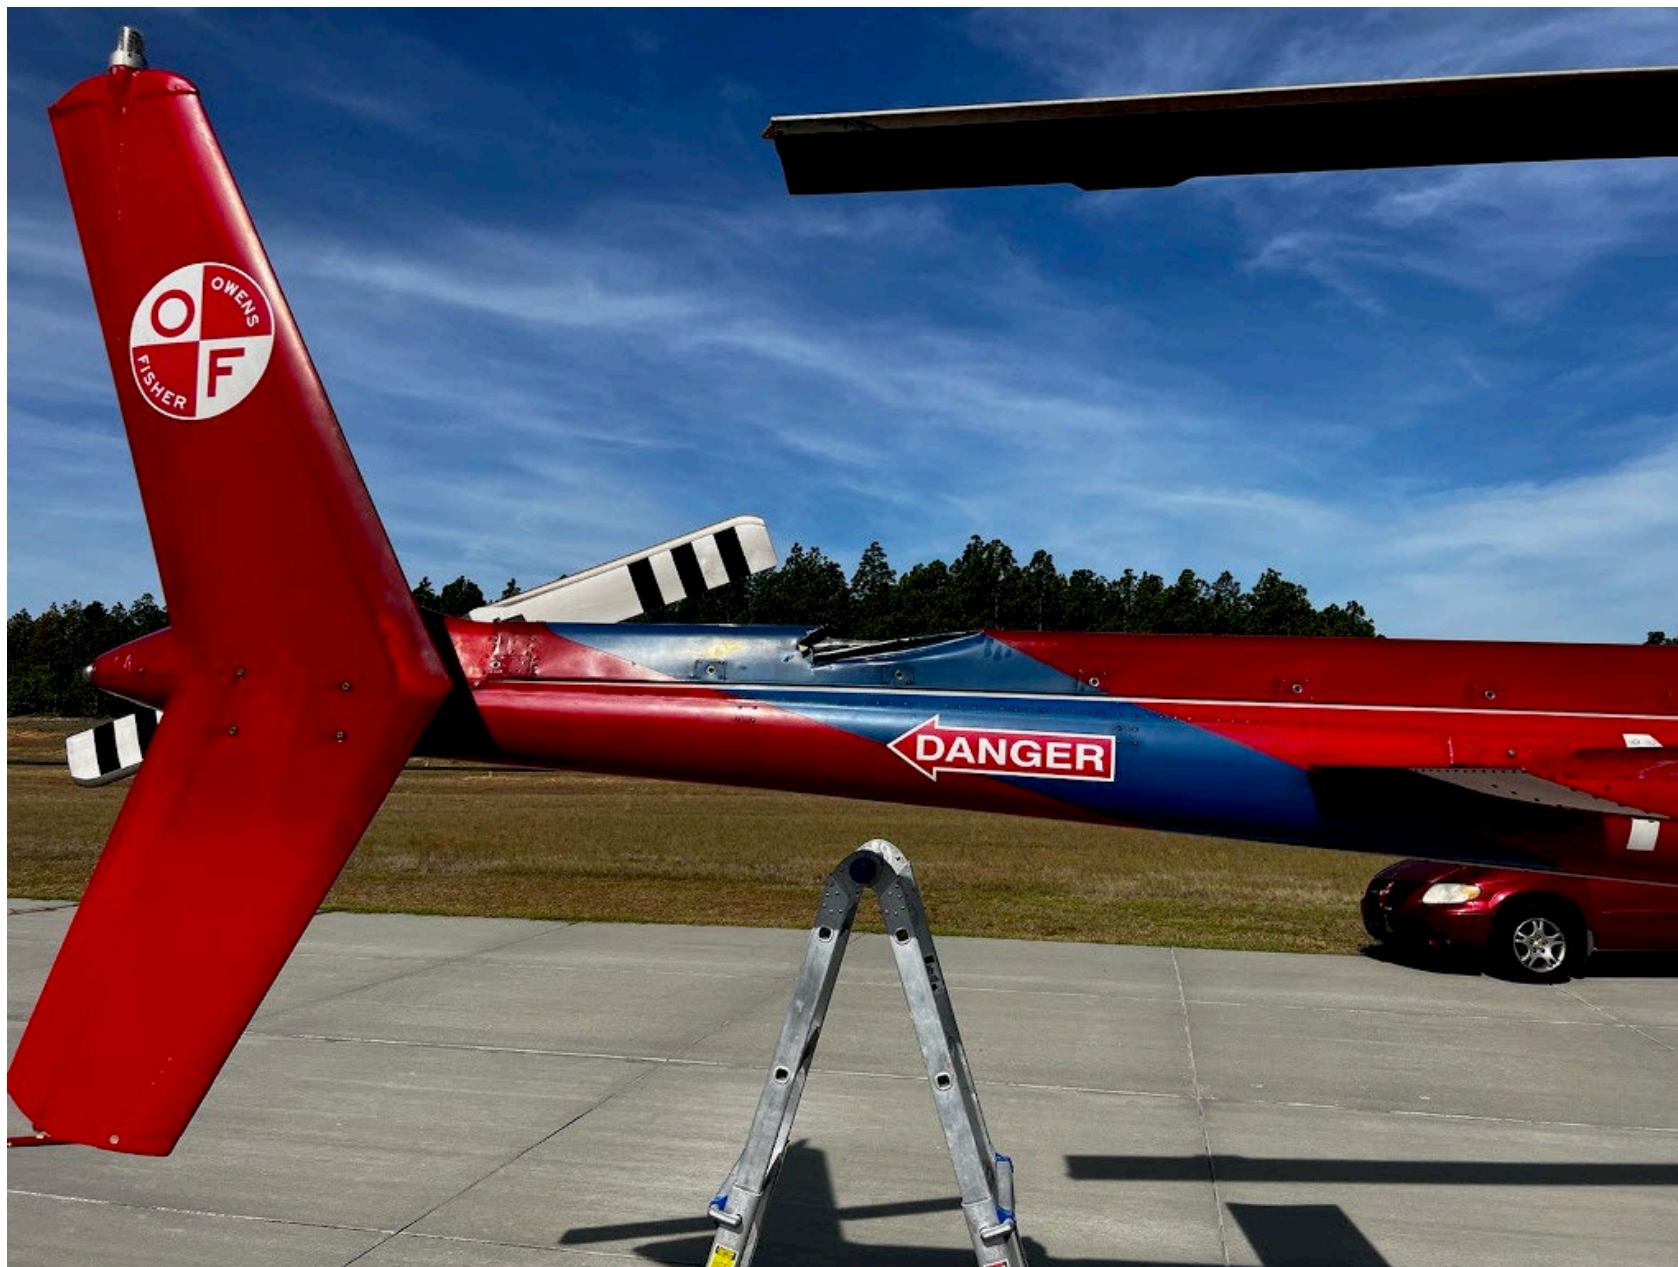
**Photo 1 – Right Side View of Damage to Tail Boom (FAA)**

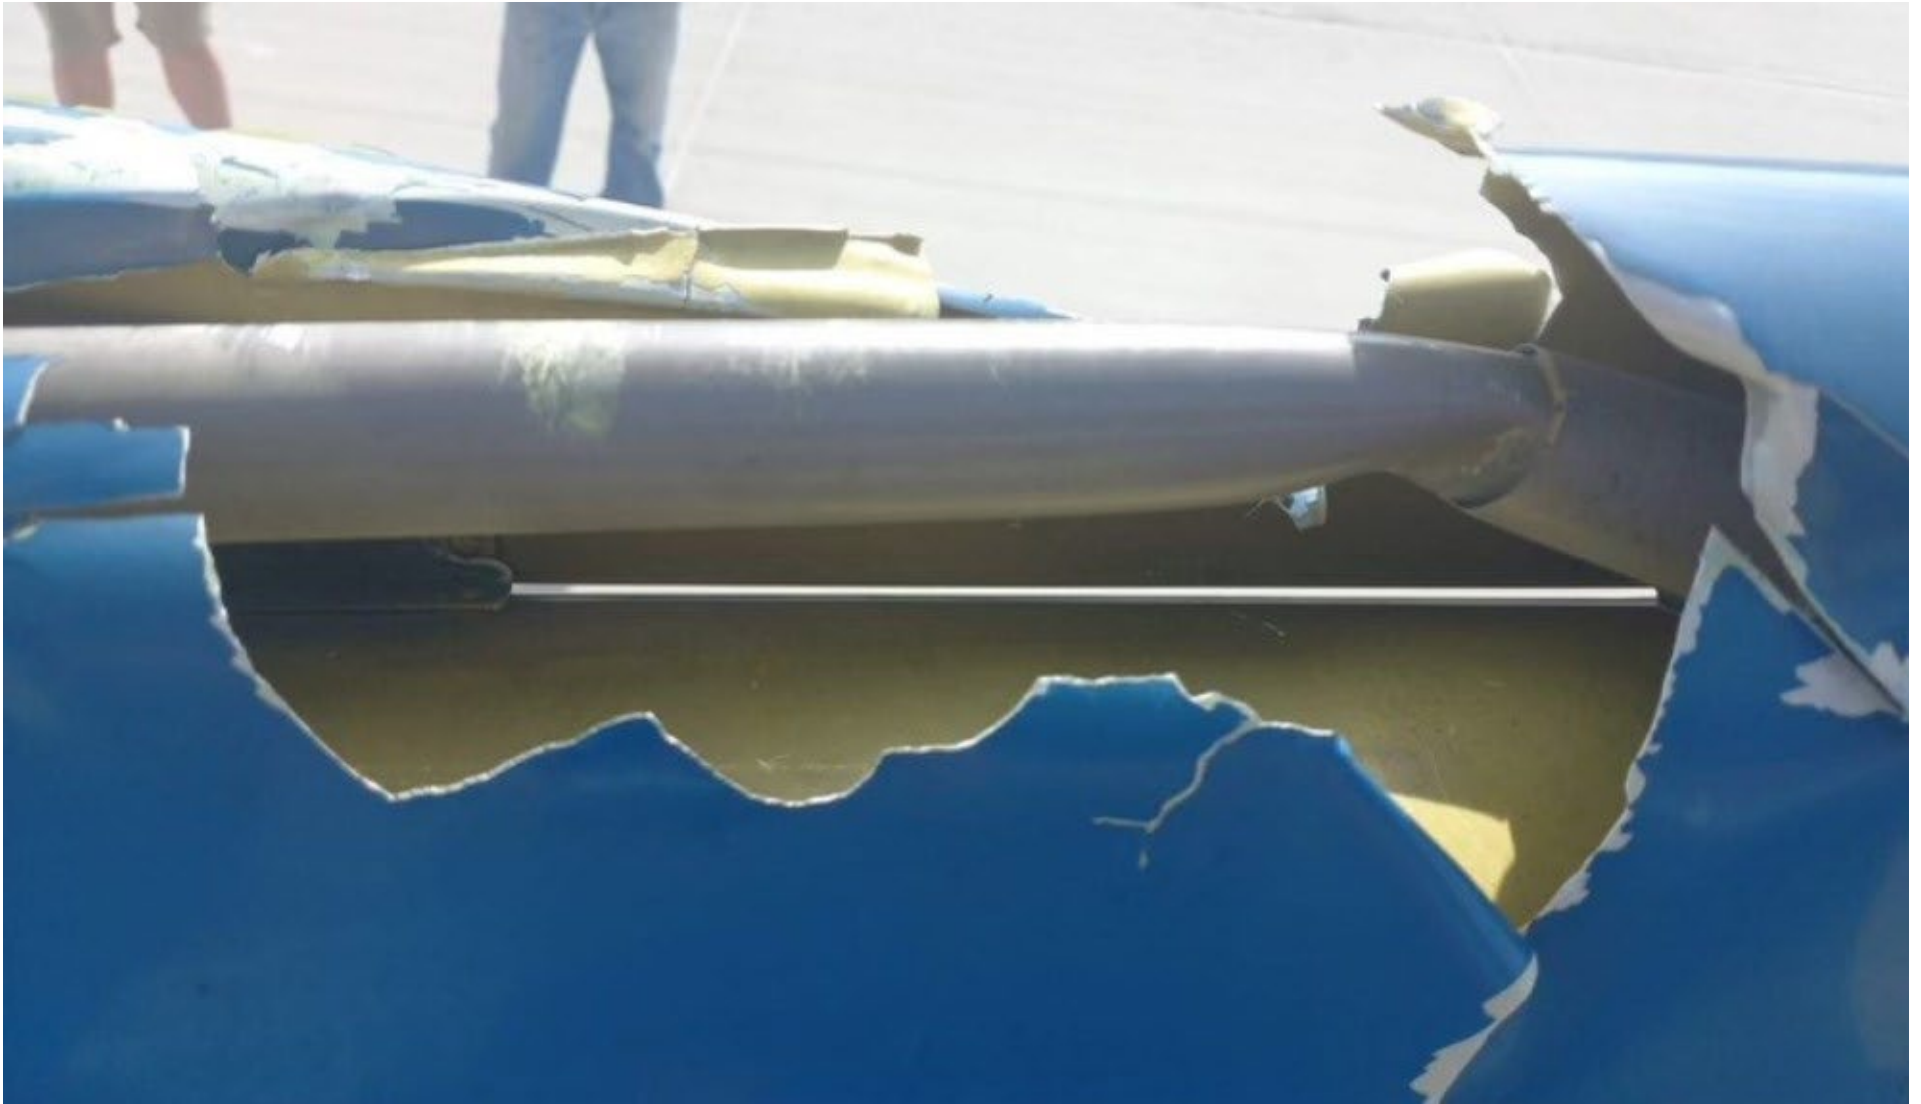
**Photo 2 – Bent Tail Rotor Drive Shaft (FAA)**
