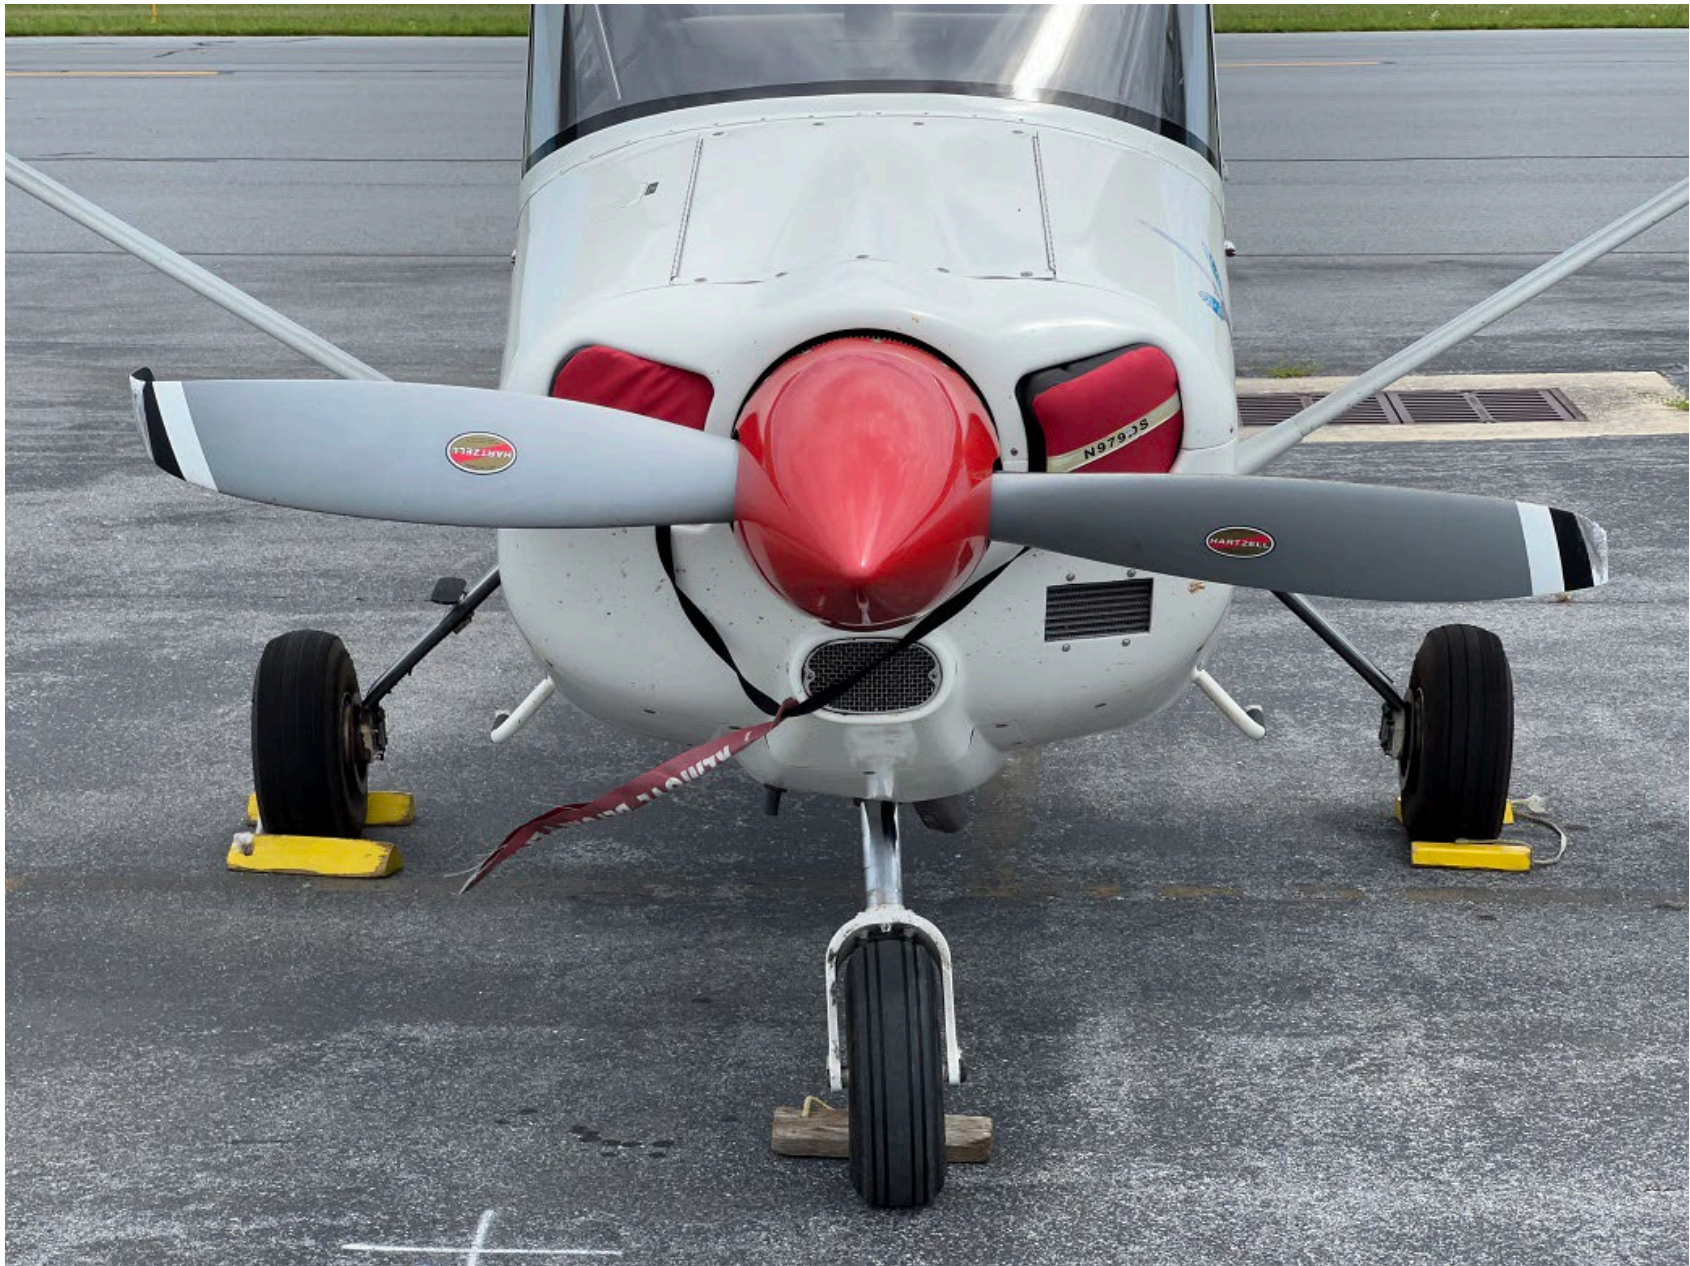
**Photo 1 – Main Wreckage (Photo Courtesy of FAA)**

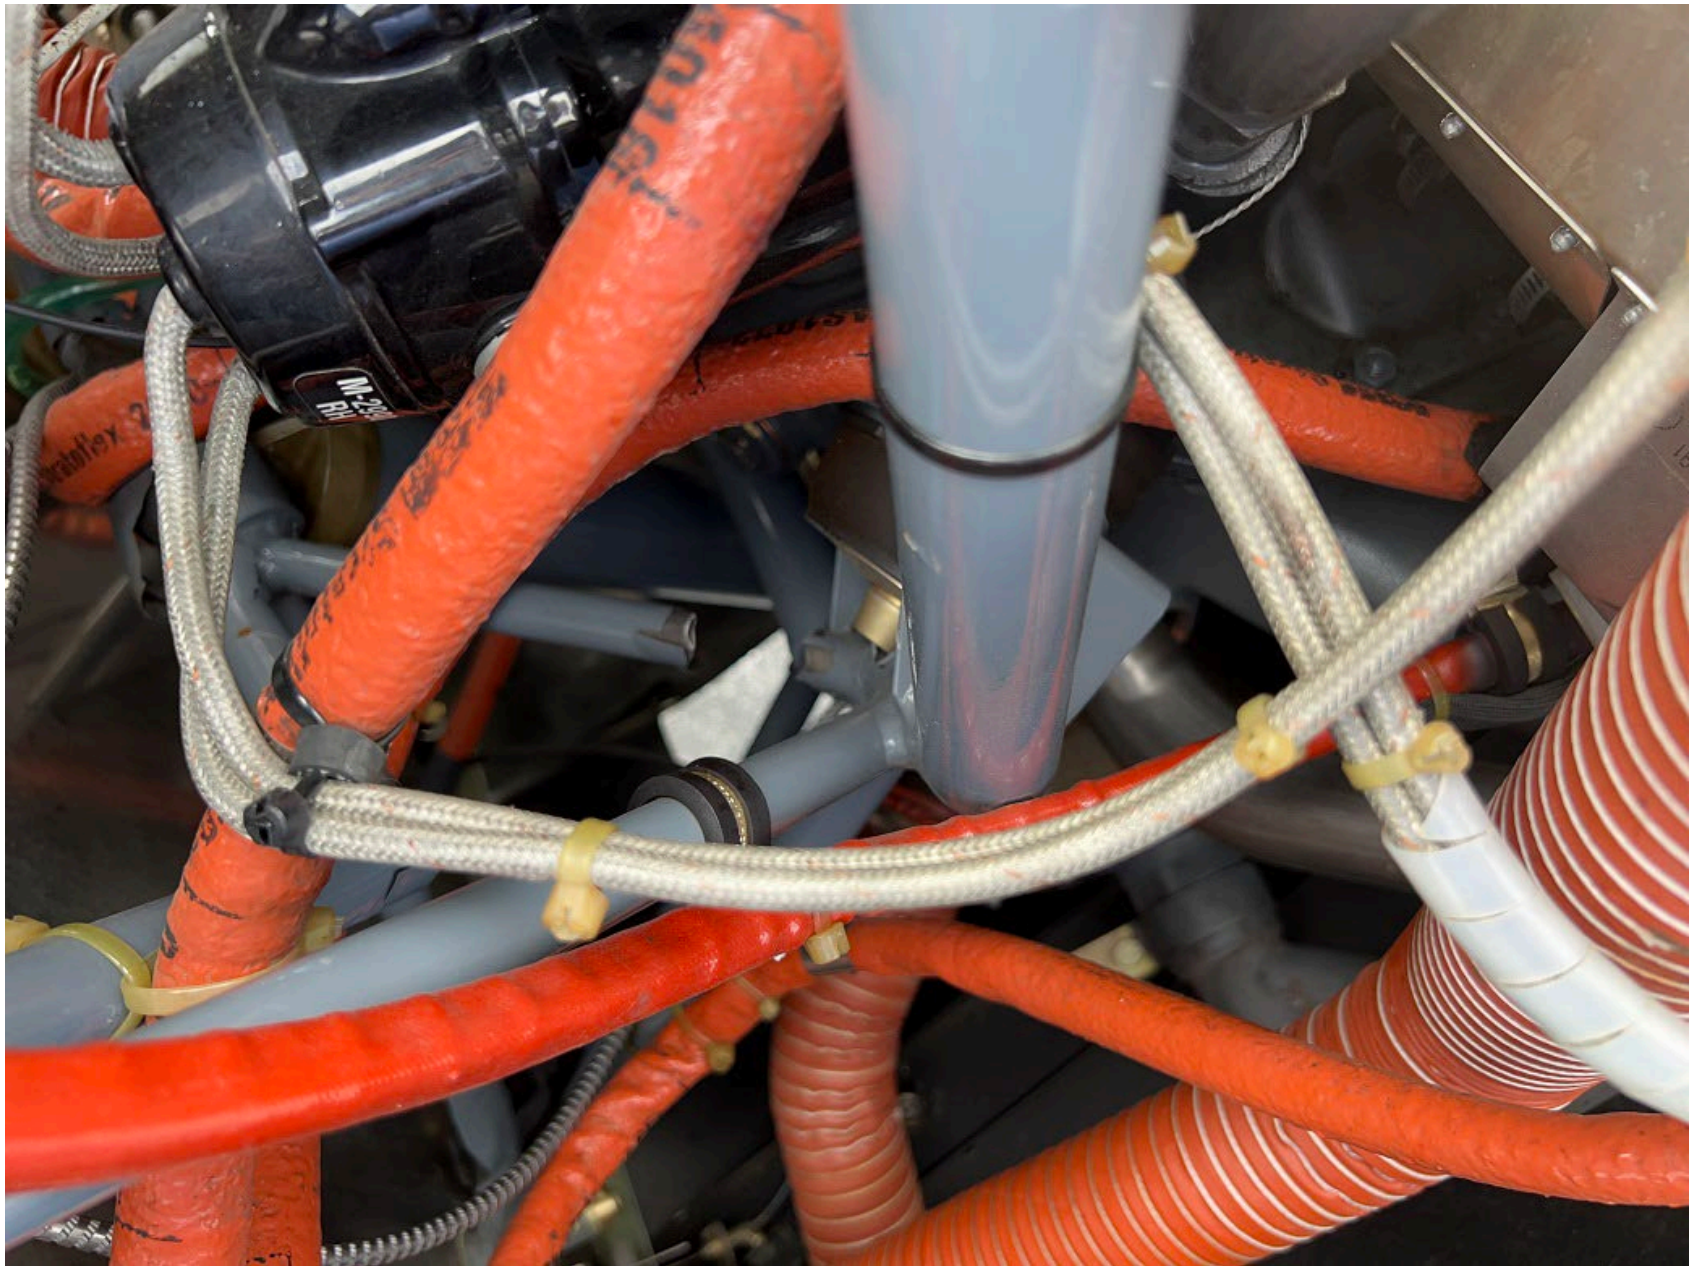
**Photo 2 – Fractured Engine Mounts (Photo Courtesy of FAA)**
