## **NATIONAL TRANSPORTATION SAFETY BOARD**

# **TAIL ROTOR BLADE EXAMINATION**

**ERA22LA340**

Location: Hollywood, Florida  
Date: July 27, 2022  
Aircraft: Robinson R22 Mariner, N42WC

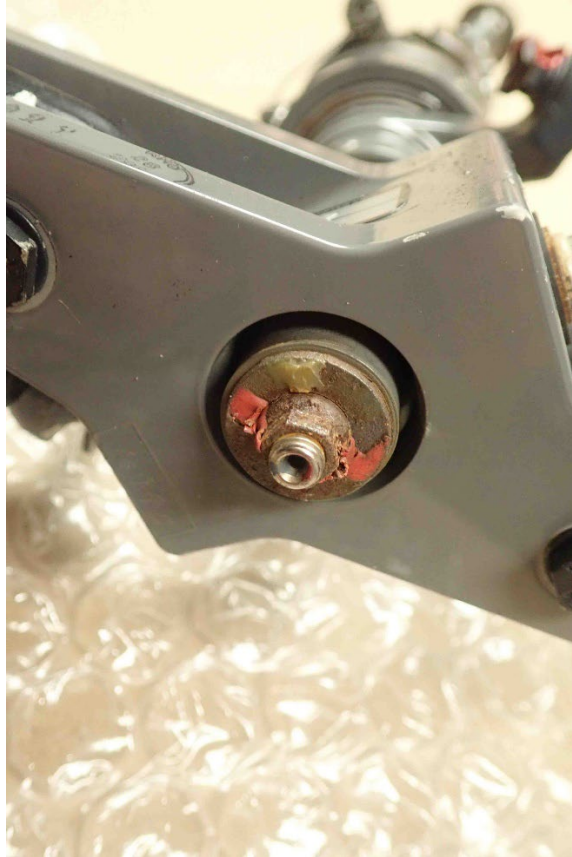
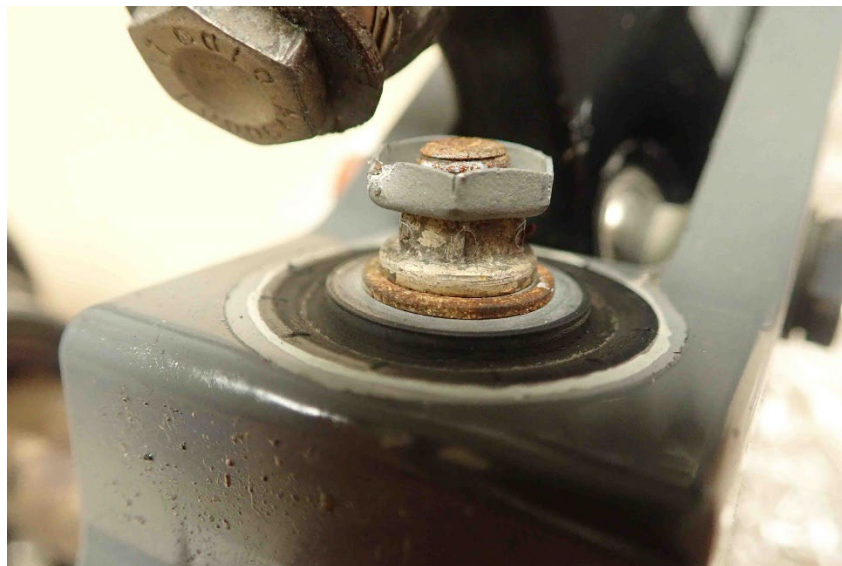
Brown corrosion was present on all exposed nut and bolt heads along with the surface of the output drive shaft (figures 1, 2, 3).

Figure 1 – Corrosion to hardware

Figure 2 – Corrosion to hardware

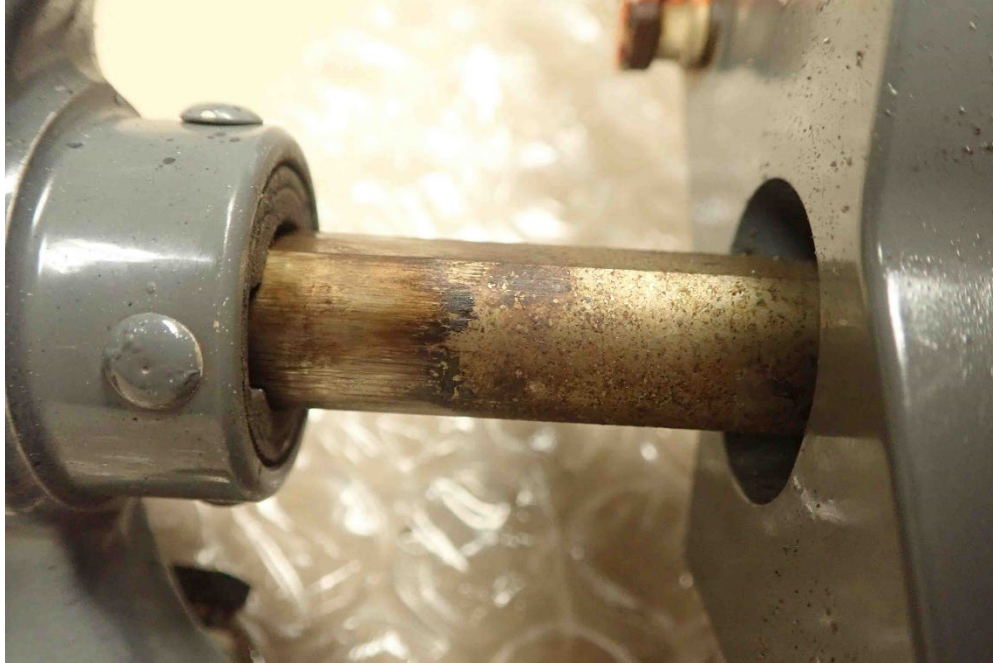
Figure 3- Corrosion to output shaft

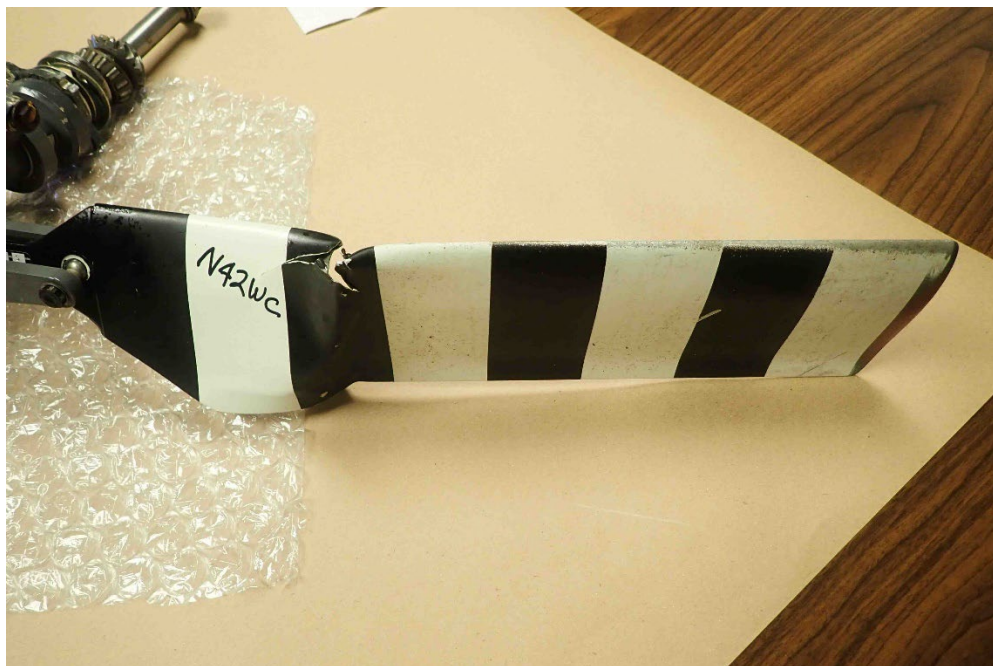
The blade was twisted about 20 degrees and torn 5 inches from the outboard tail rotor attachment bolts (figure 4).

Figure 4 – Twisted blade 7433

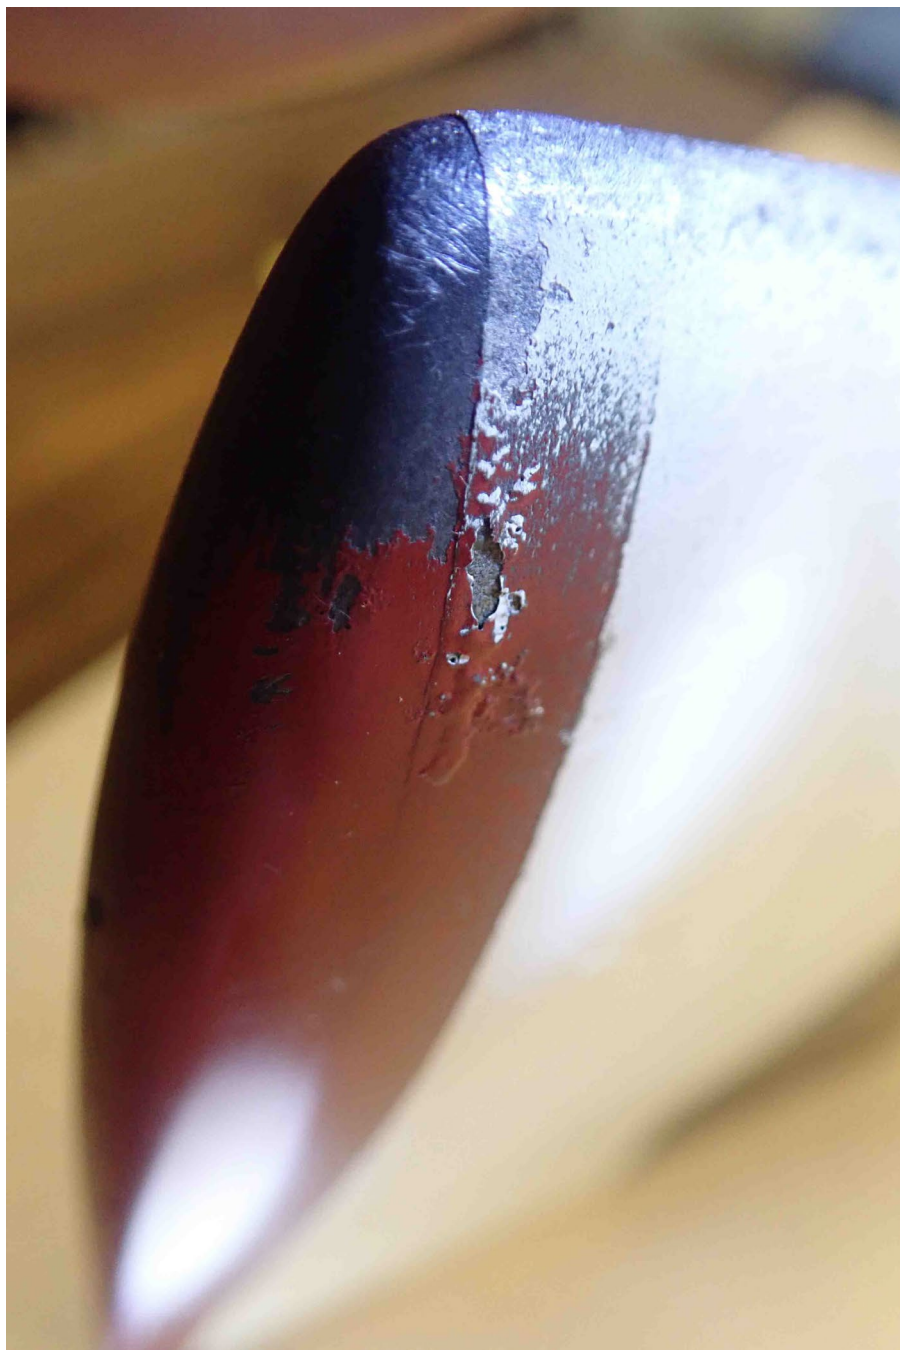
The outboard 8 inches of the leading-edge skin showed pitting and paint removal. The tip cap had been refinished with red paint, and bubbling corrosion-like formations were at the intersection of the cap with the blade skin (figure 5).

Figure 5 – Corrosion at tip cap

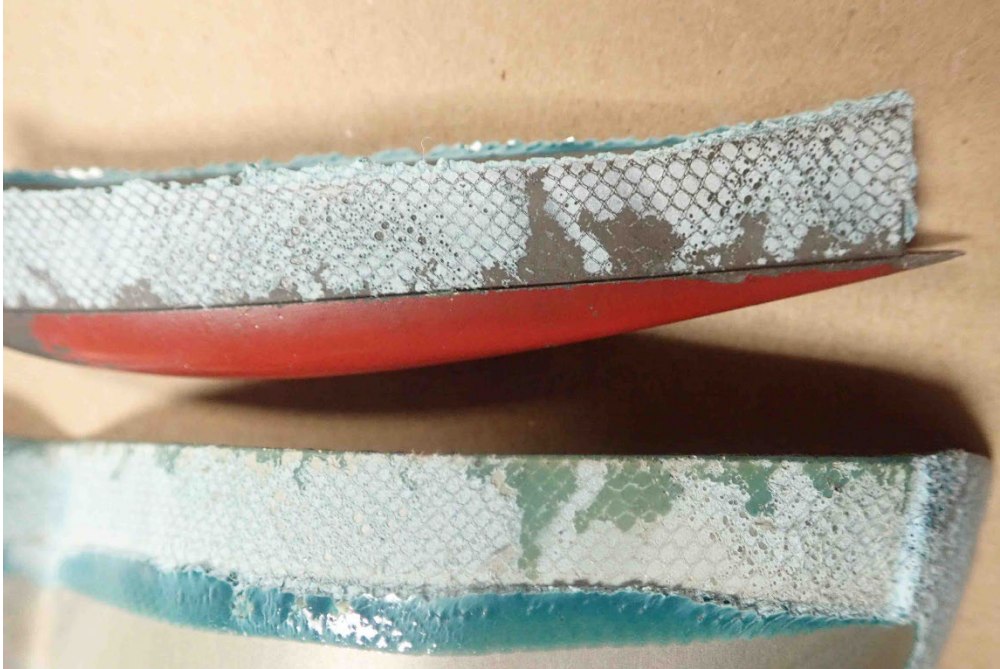
Using a chisel, the trailing edge bond joint was opened, and the skins were peeled apart. Cohesive adhesion was observed throughout the entire length, with trails of adhesive failure at the tip edge contact junction (figure 6).

Figure 6 – Tip and contacting skin

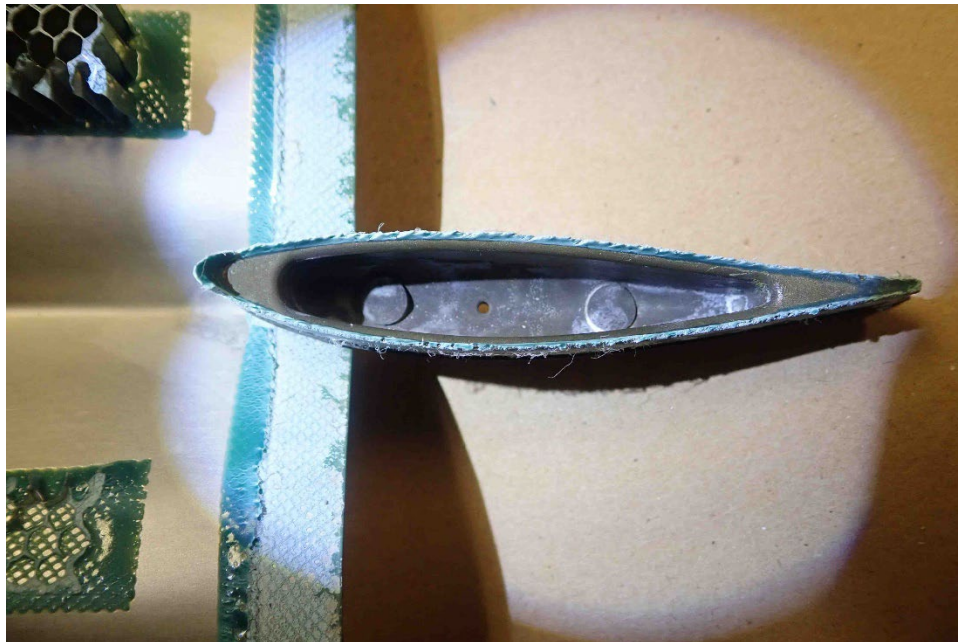
White corrosion-like deposits were observed to the inner surface of the tip cap (figure 7).

Figure 7 – Tip cap inner surface

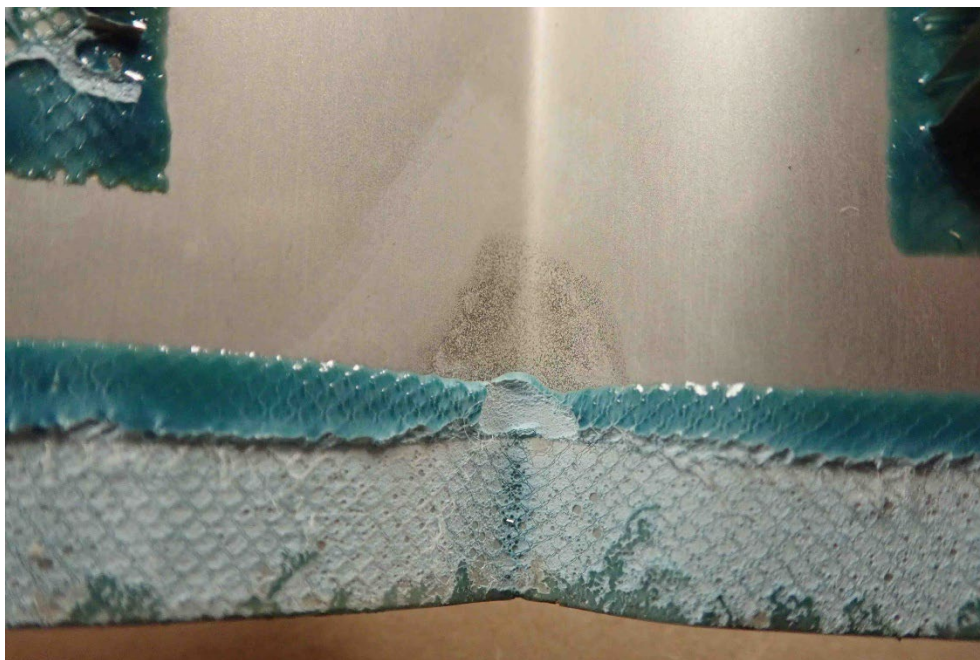
A water puddle mark was present on the inner surface of the leading-edge skin (figure 8).

Figure 8 – Water puddling marks

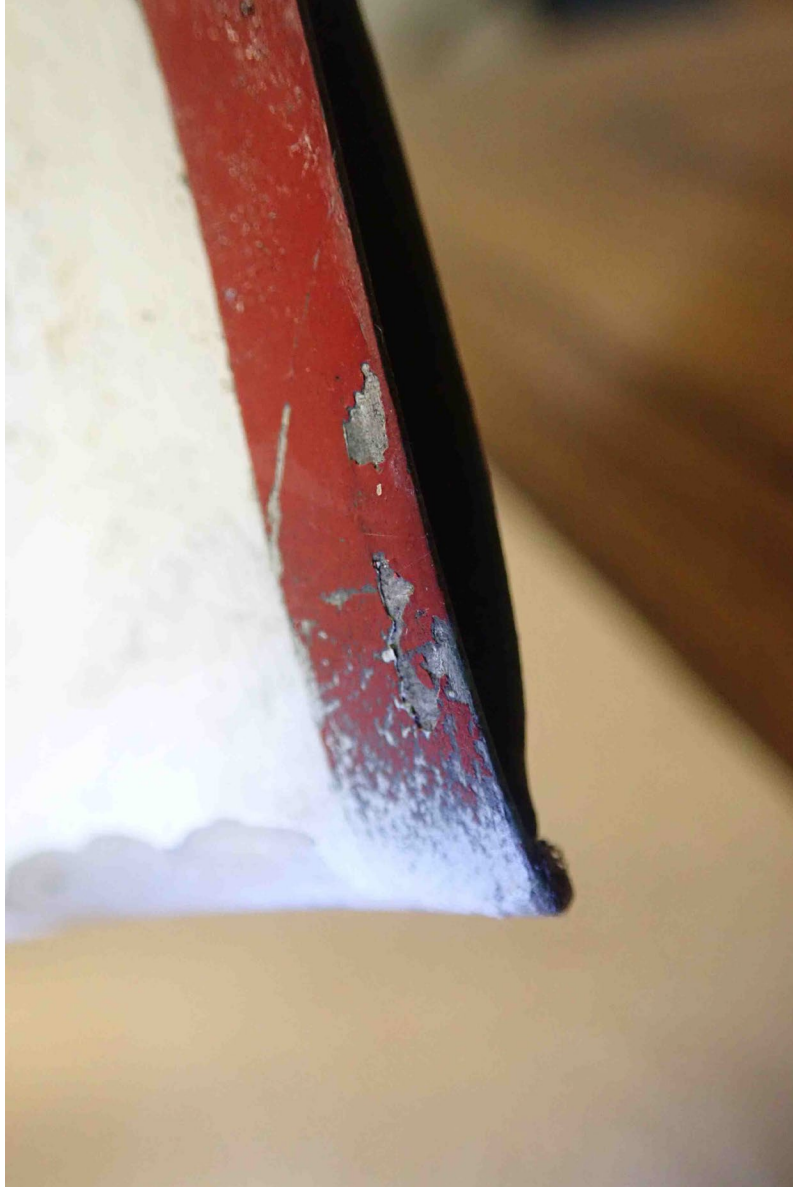
The blade exhibited a 10-degree progressive curve along its entire length (figure 15). The outboard 8 inches of the leading-edge skin exhibited paint removal and pitting. The tip cap was missing. On the inner and outer portions of inboard skin, bubbling red paint was observed at the tip edge (figure 9).

Figure 9 – Corrosion and paint bubbles

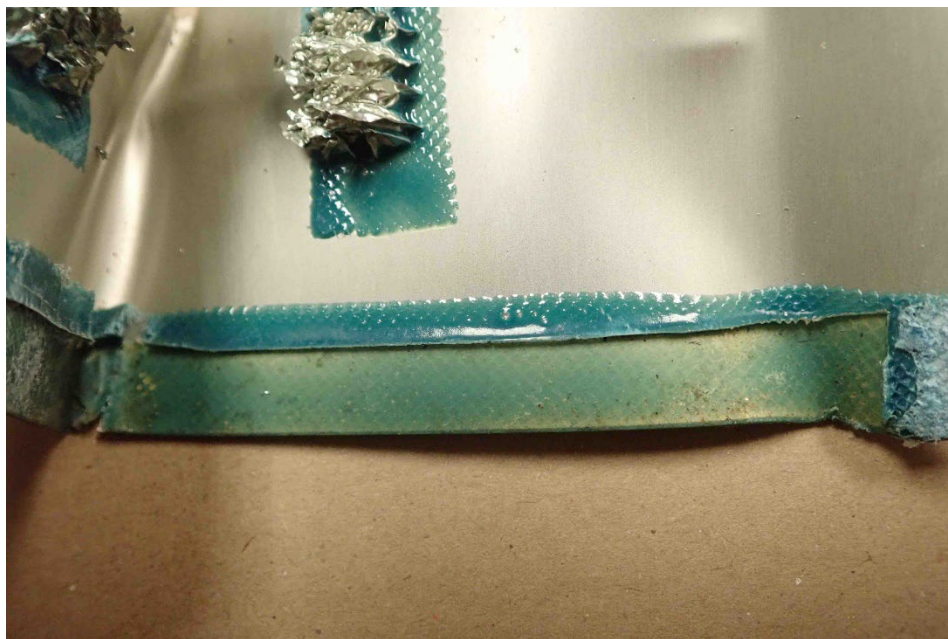
Using a chisel, the trailing edge bond joint was opened, and the skins were opened. On the inside of the outboard skin, smooth dark green adhesive was observed along its entire length, consistent with adhesive failure (figure 10).

Figure 10 - Smooth dark green adhesive

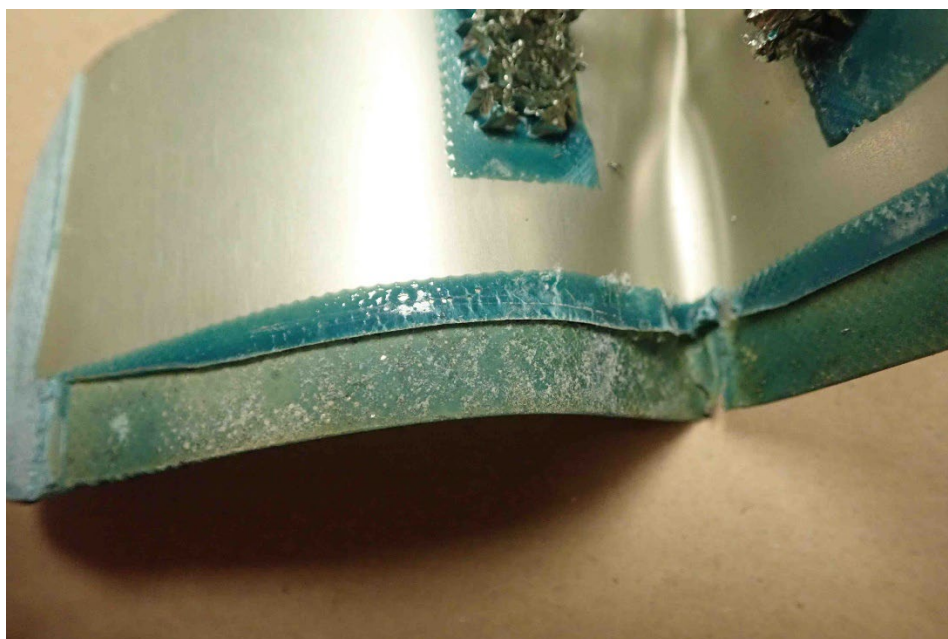
On the inside of the inboard skin, a white powdery corrosion-like substance was present to about 85% of the surface length from the leading edge aft (figure 11). The last 15% of the surface exhibited smooth dark green adhesive consistent with adhesive failure (figure 11).

Figure 11 – White corrosion deposits

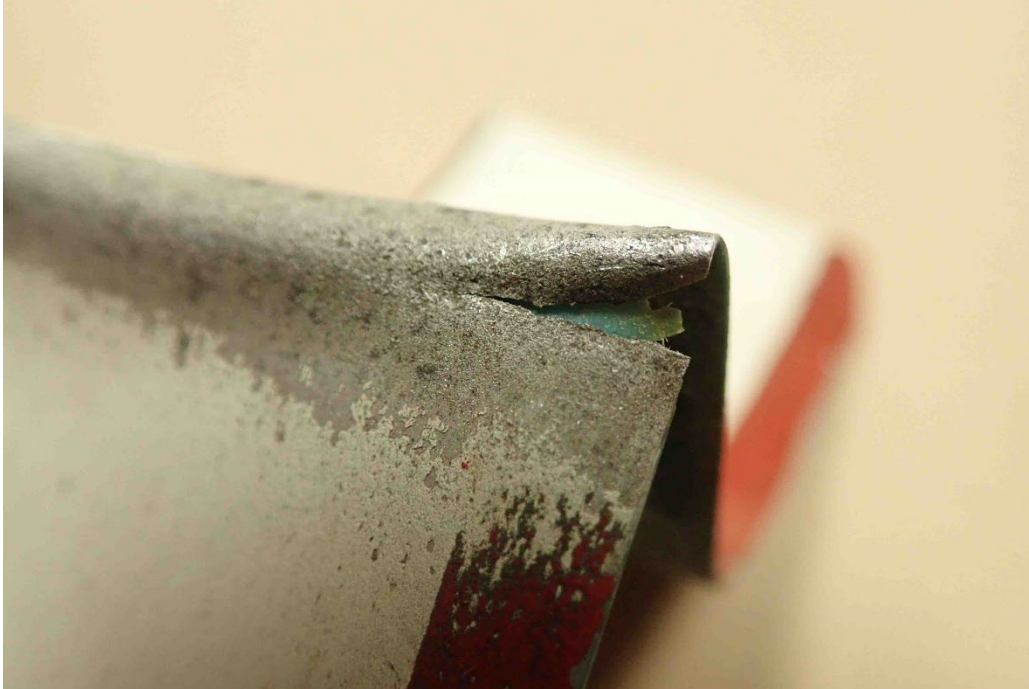
The leading-edge skin had thinned to a knife-edge (nominal thickness should have been 0.63mm) and was torn at the intersection with the tip cap (figure 12).

Figure 12 – Leading edge tip crack/tear

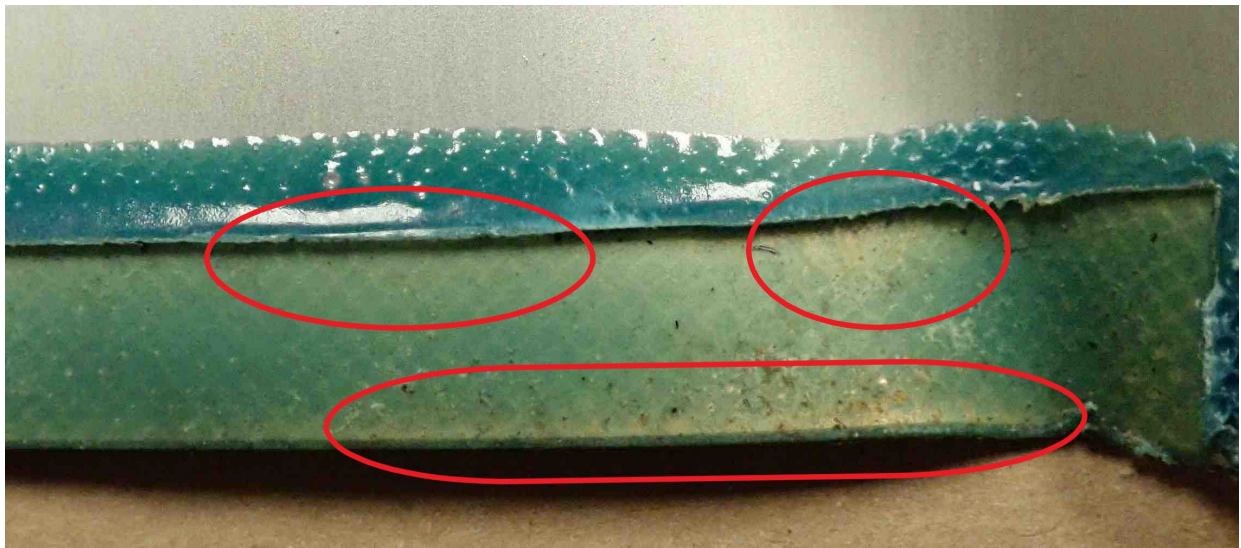
Under microscope examination, fluid oozed from yellow patches (figure 13) when pressed.

Figure 13 - Yellow patches under adhesive

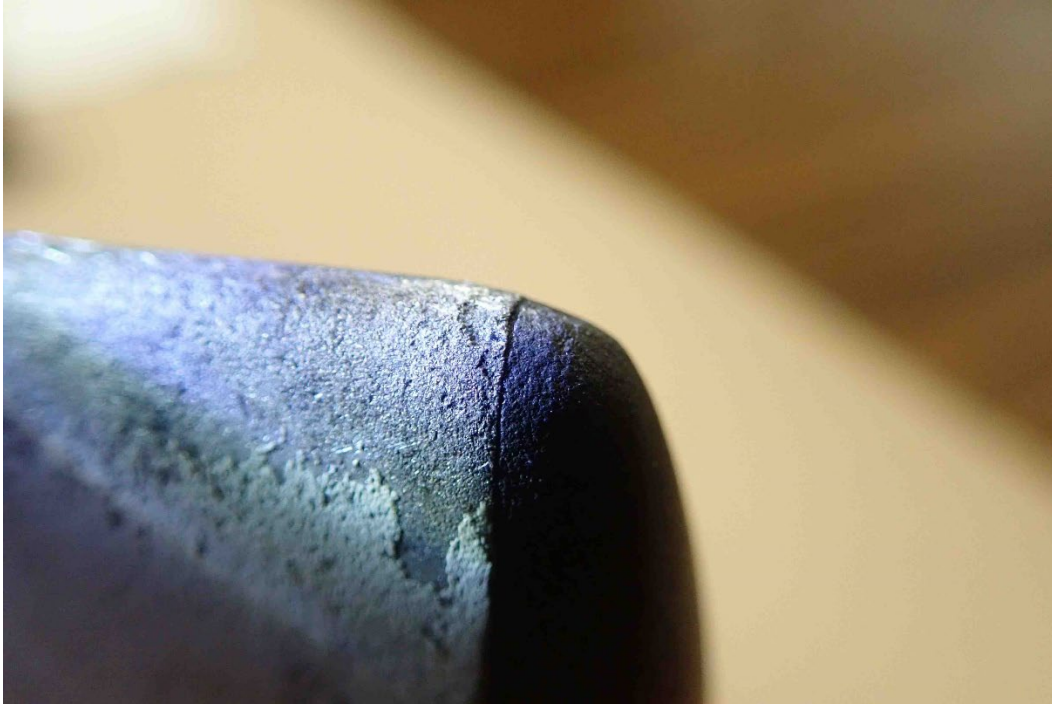
Thinning of the leading-edge skin surface was evident at the leading edge join with the tip cap (figure 14). The drain hole appeared to be free of blockage.

Figure 14 – Tip cap leading edge skin thinning

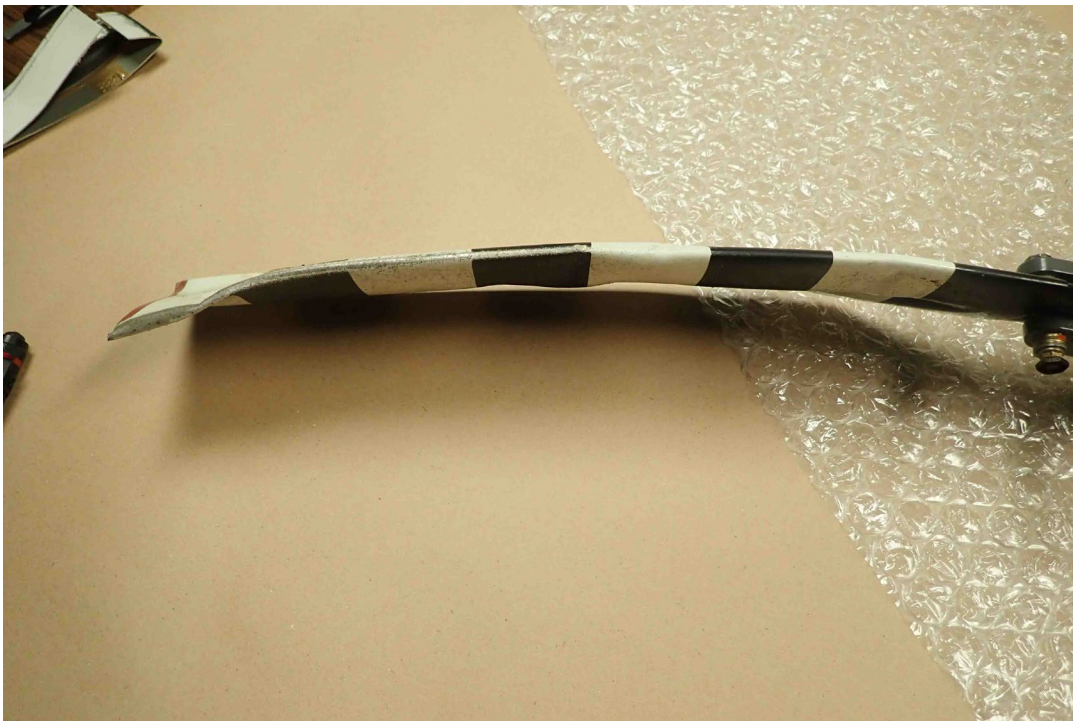
Figure 15 – Blade 7434
