Subject: Witness statement to hard landing/incident of N160TH, BO-105CBS-4  
Helicopter on June 30, 2022, 06:42 hours

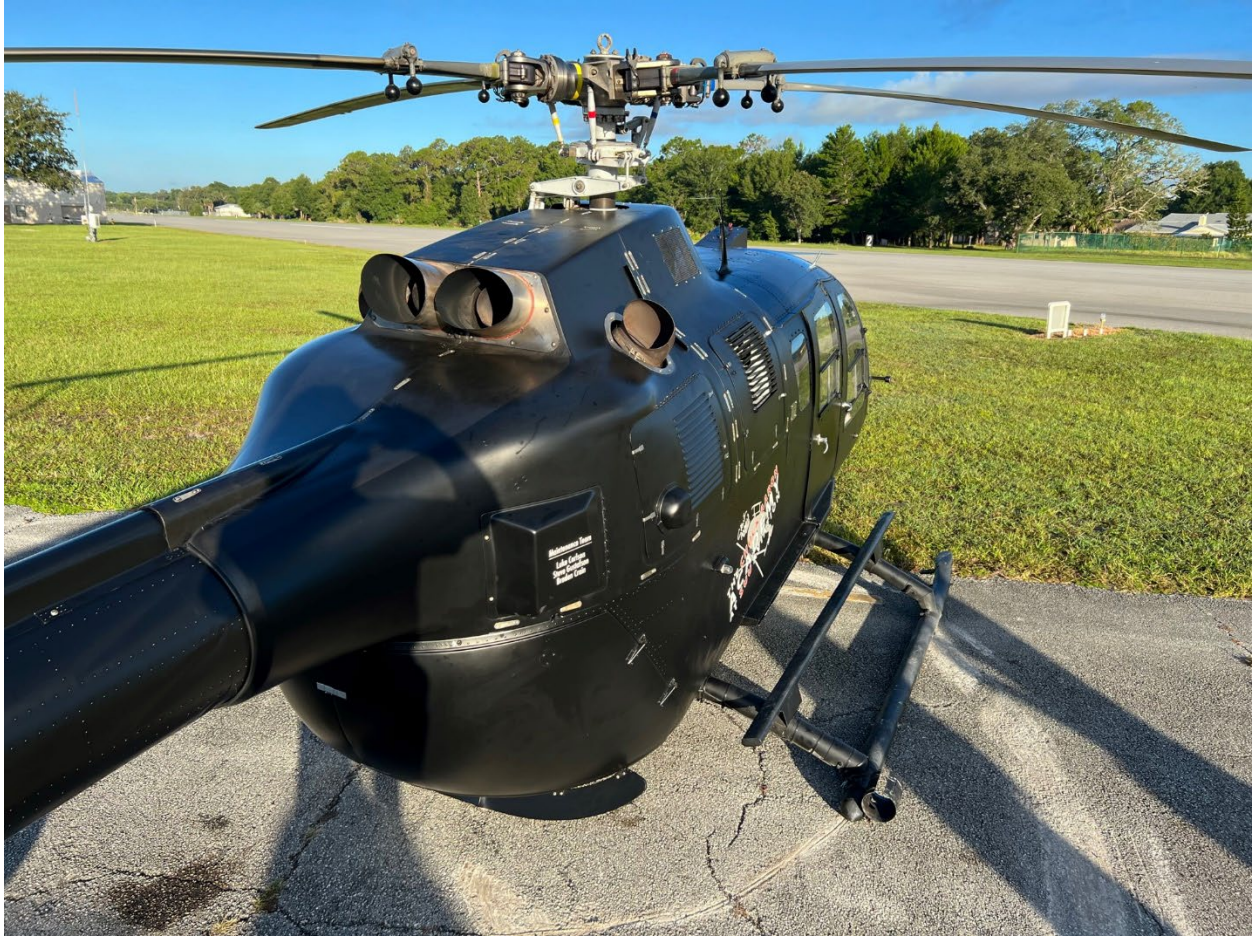
PHOTO - 1

Note the “Skid Marks” on the ground indicating counterclockwise spin from having too much left pedal control input when ground contact was made.

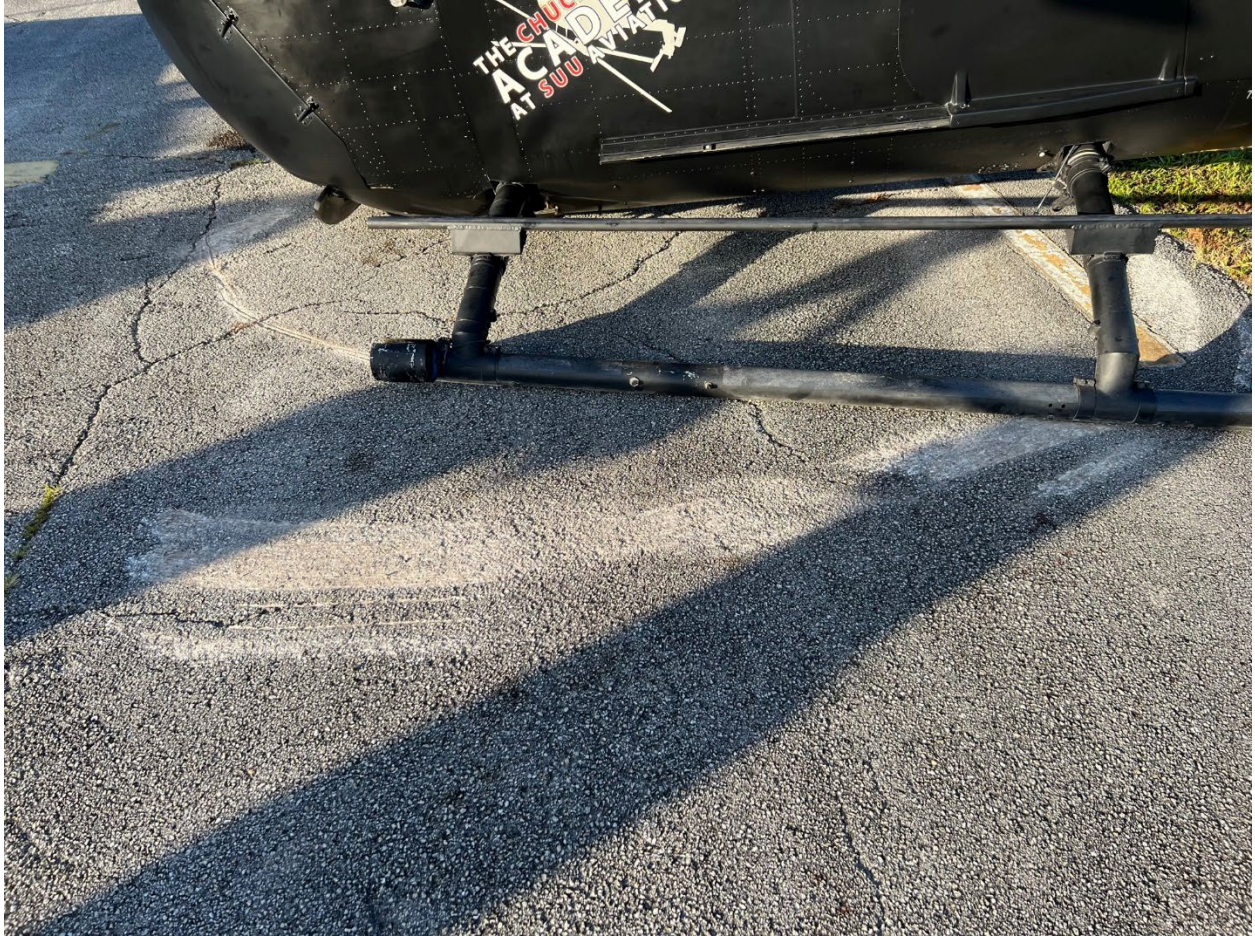
PHOTO - 2

Skid Marks showing direction of spin

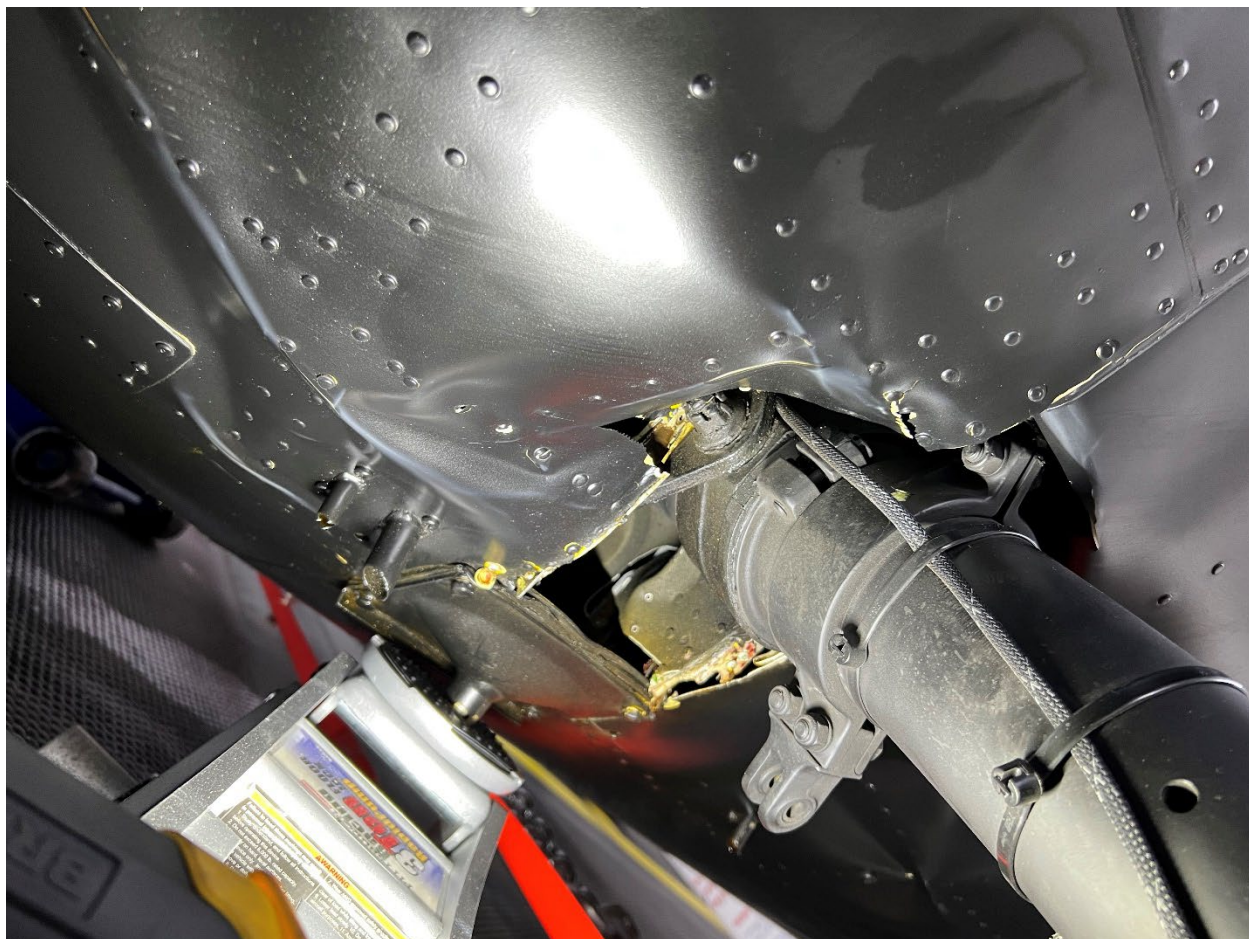
PHOTO – 3

Post hard landing inspection revealed, that the Aft Right Cross Tube had been impacted and jammed into the belly section approx.. 6 inches and bent lower vertically (see photo – 3) and had come into direct contact with Tail Rotor push pull control tube and crushed the tail rotor pitch control tube (see photo – 4), which jammed the pedals locked after the second and final hard landing.

Right Rear Aft Cross Tube damage

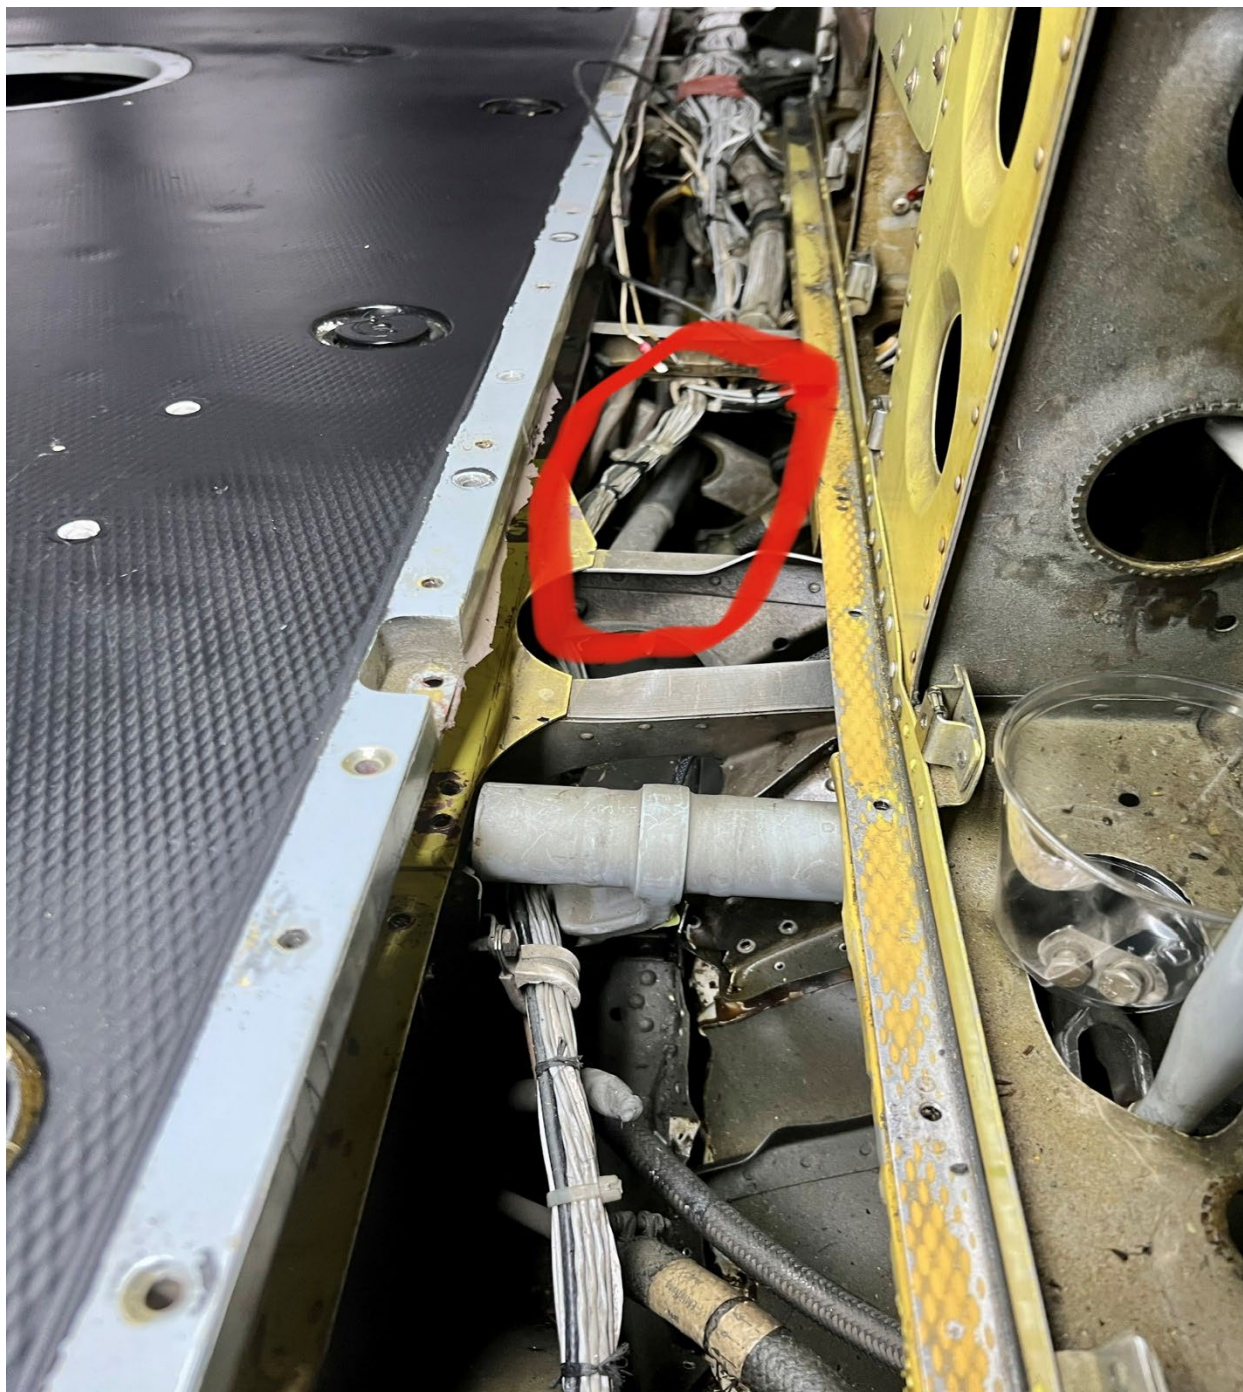
PHOTO – 4

In the Red Circle showing the Tail Rotor push pull control tube bent and jammed by the aft cross tube.

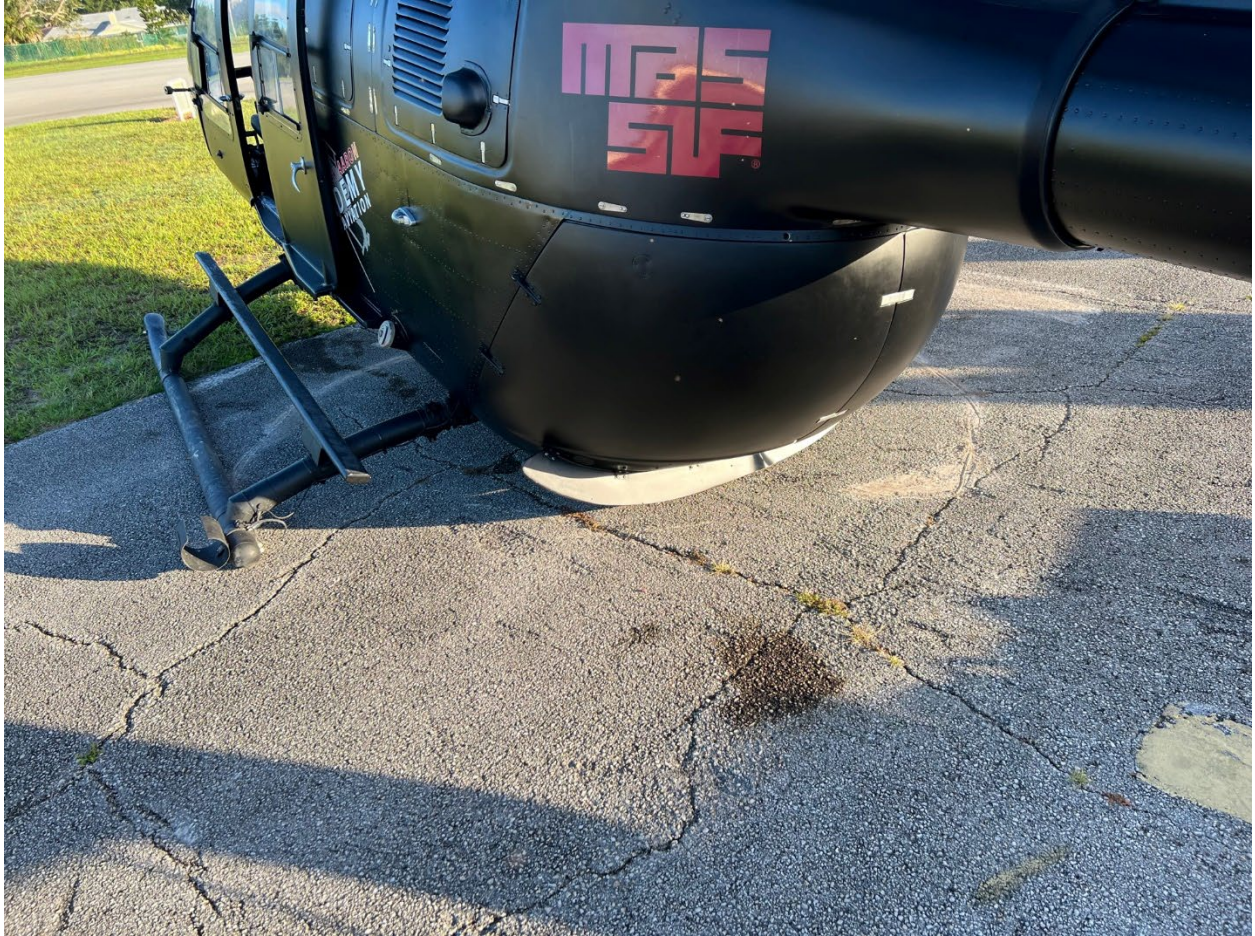
Note the ground scratching from skids, which is indication of a left pedal control input in a counterclockwise rotation/spin.
