ERA22LA345

## INVESTIGATION PHOTOGRAPHS

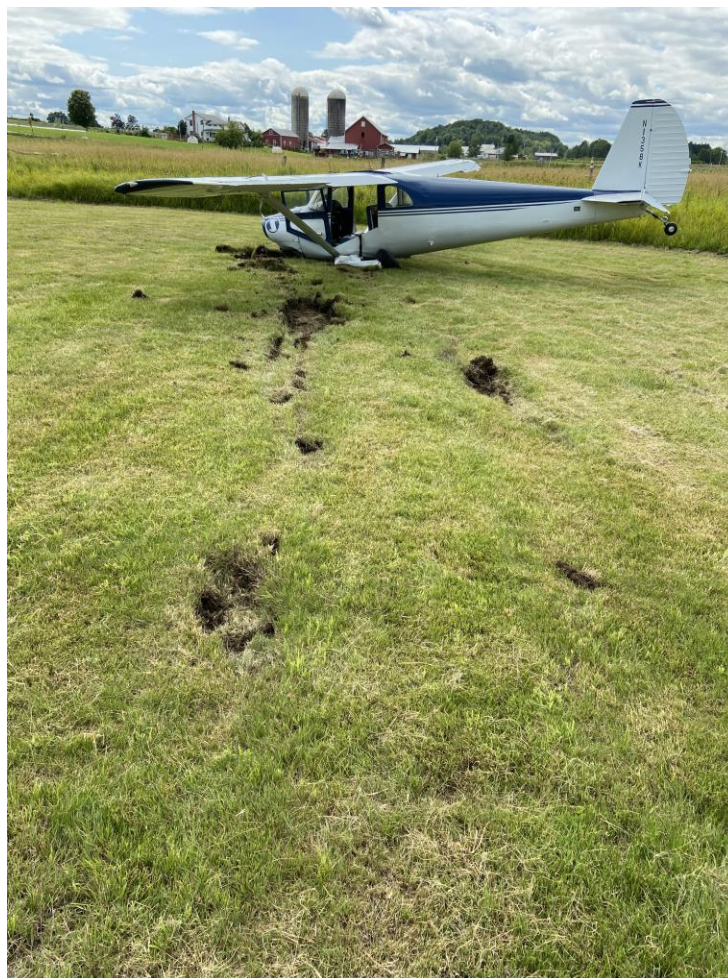
**Photograph 1 -View of ground scars and airplane. (Courtesy of FAA)**

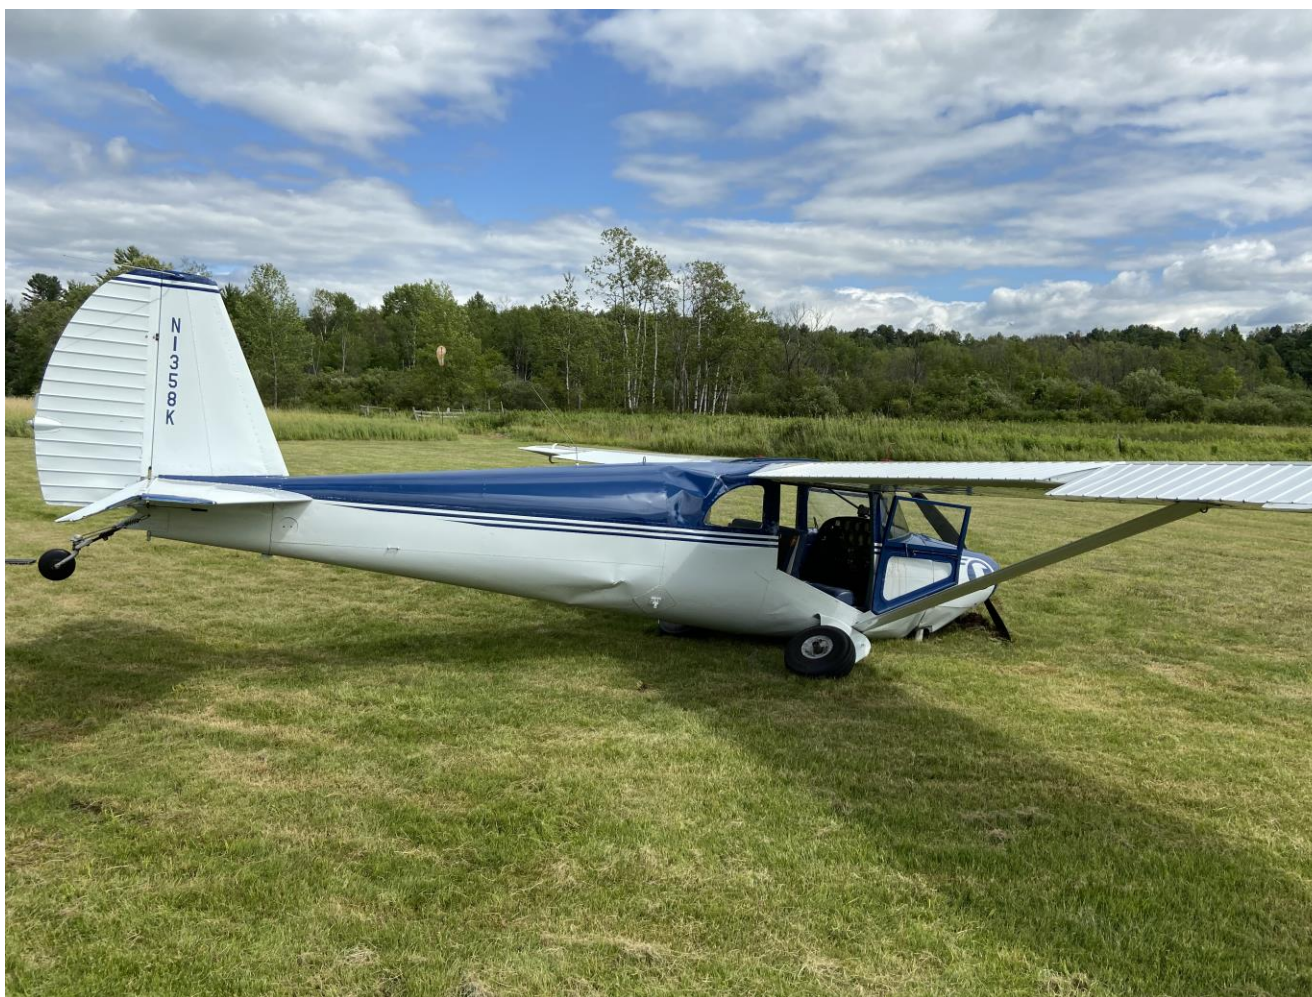
**Photograph 2 - Right profile view of airplane damage. (Courtesy of FAA)**

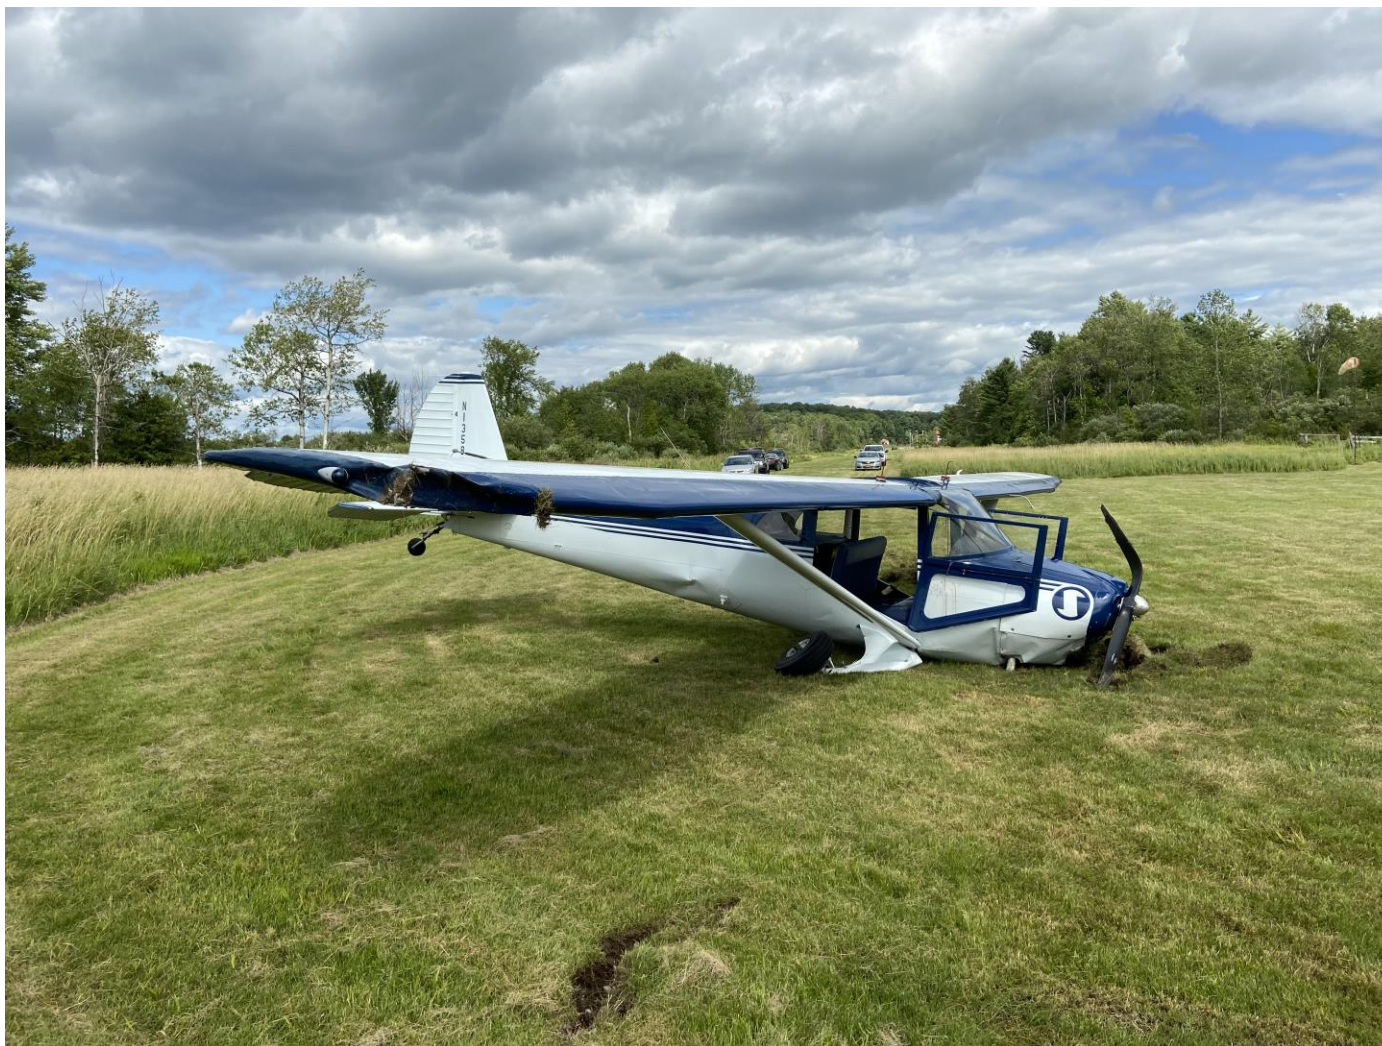
**Photograph 3 - Right front quarter view of right wing and airframe damage. (Courtesy of FAA)**
