# National Transportation Safety Board

ERA22LA348

## **MATERIALS LABORATORY**

Factual Report 22-099

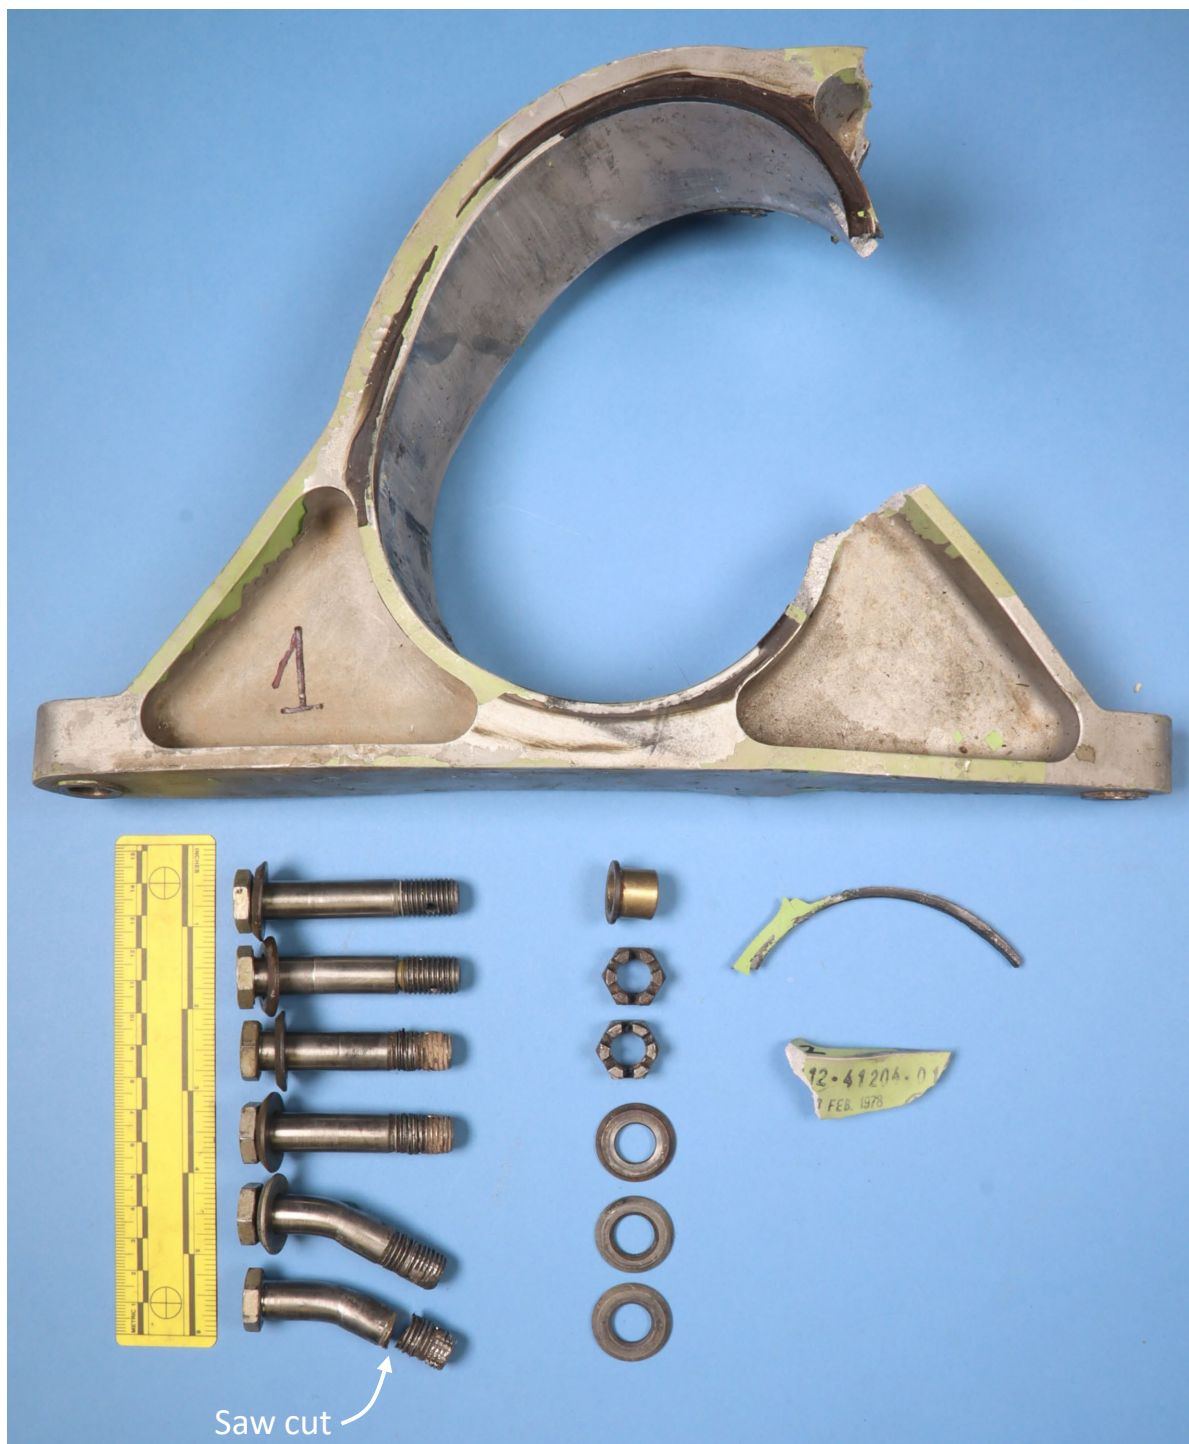
The submitted right main landing gear items are shown in in Figure 1.

**Figure 1.** Image of the submitted items.

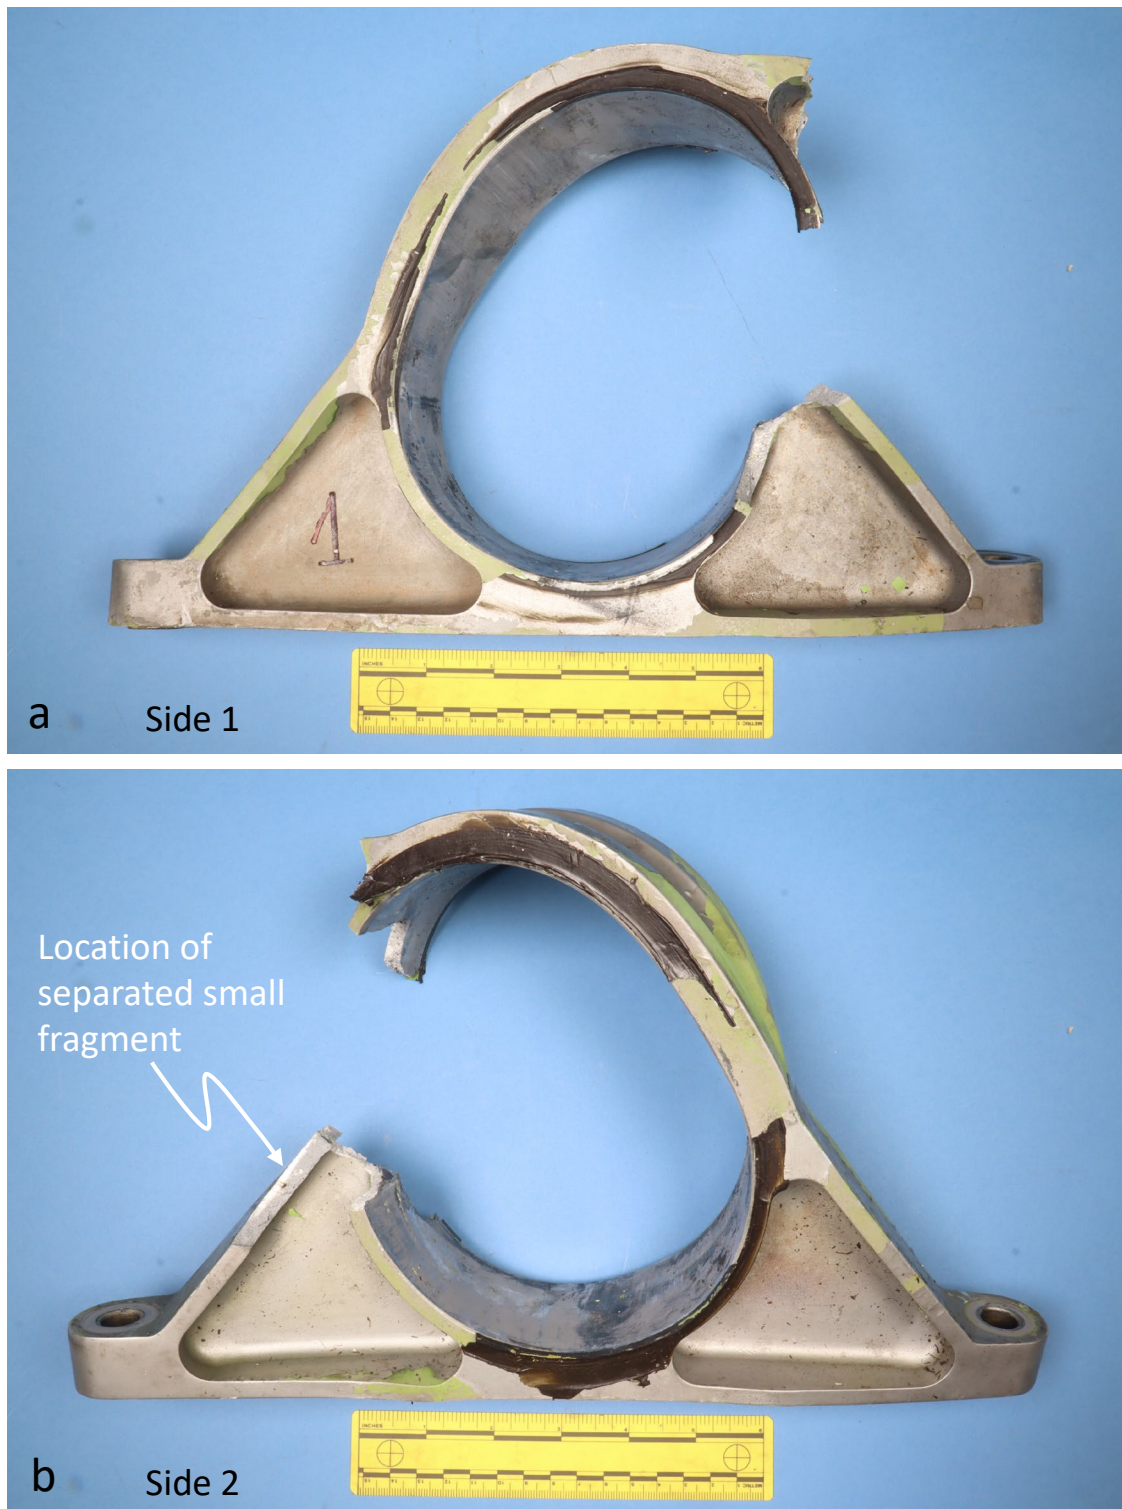
Images of the right main landing gear upper fitting are in Figures 2-4. All exposed fracture surfaces were examined using a 5X to 50X stereozoom microscope. The fracture faces exhibited features consistent with overstress separation. No progressive or pre-existing fracture features were observed. One closed secondary crack was noted as identified in Figure 3. This crack was not opened for examination.

**Figure 2.** Images showing two sides of the primary piece of the right main landing gear upper fitting.

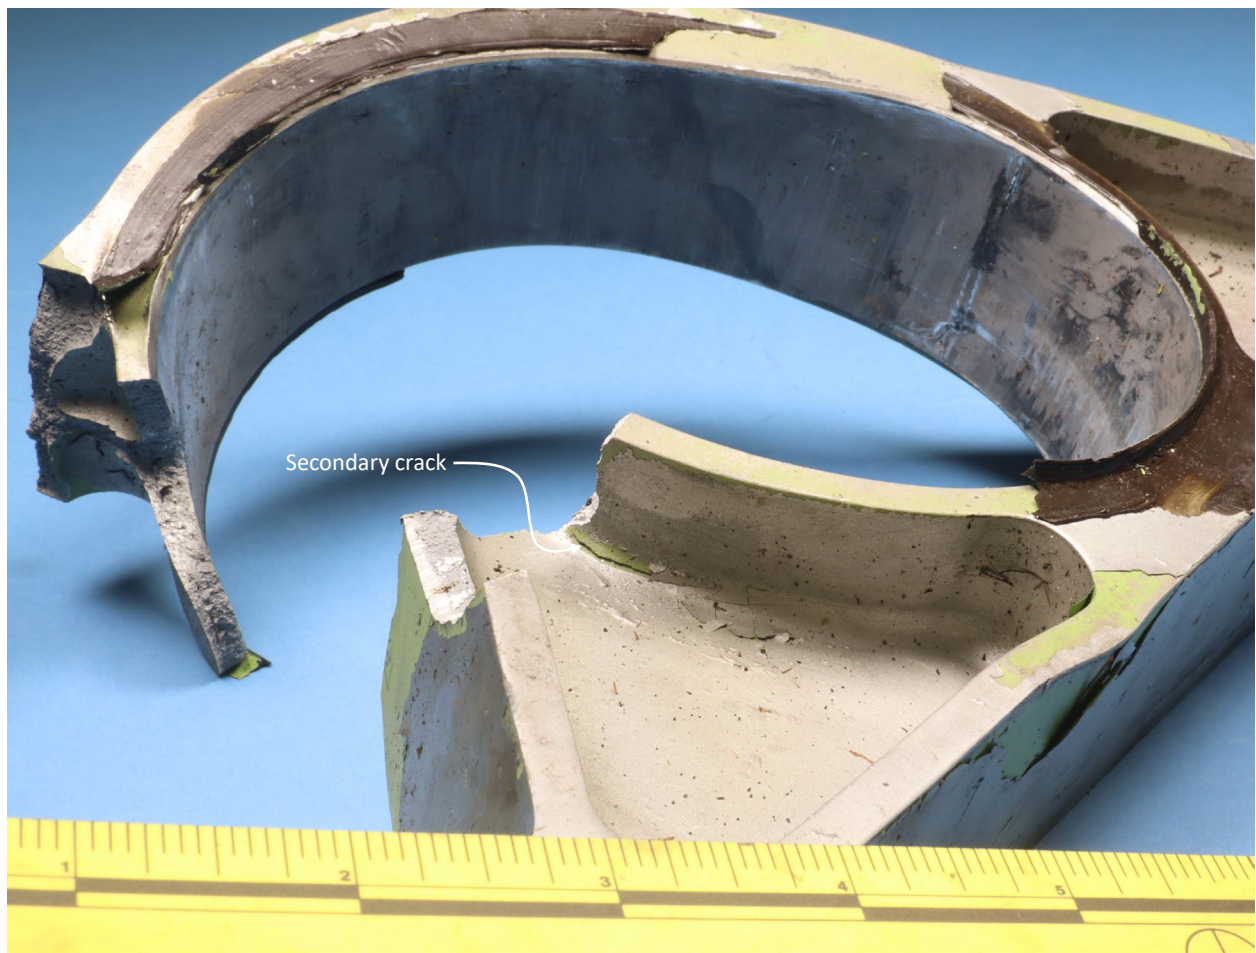
**Figure 3.** Oblique image of the primary piece of the right main landing gear upper fitting, with a secondary crack identified.

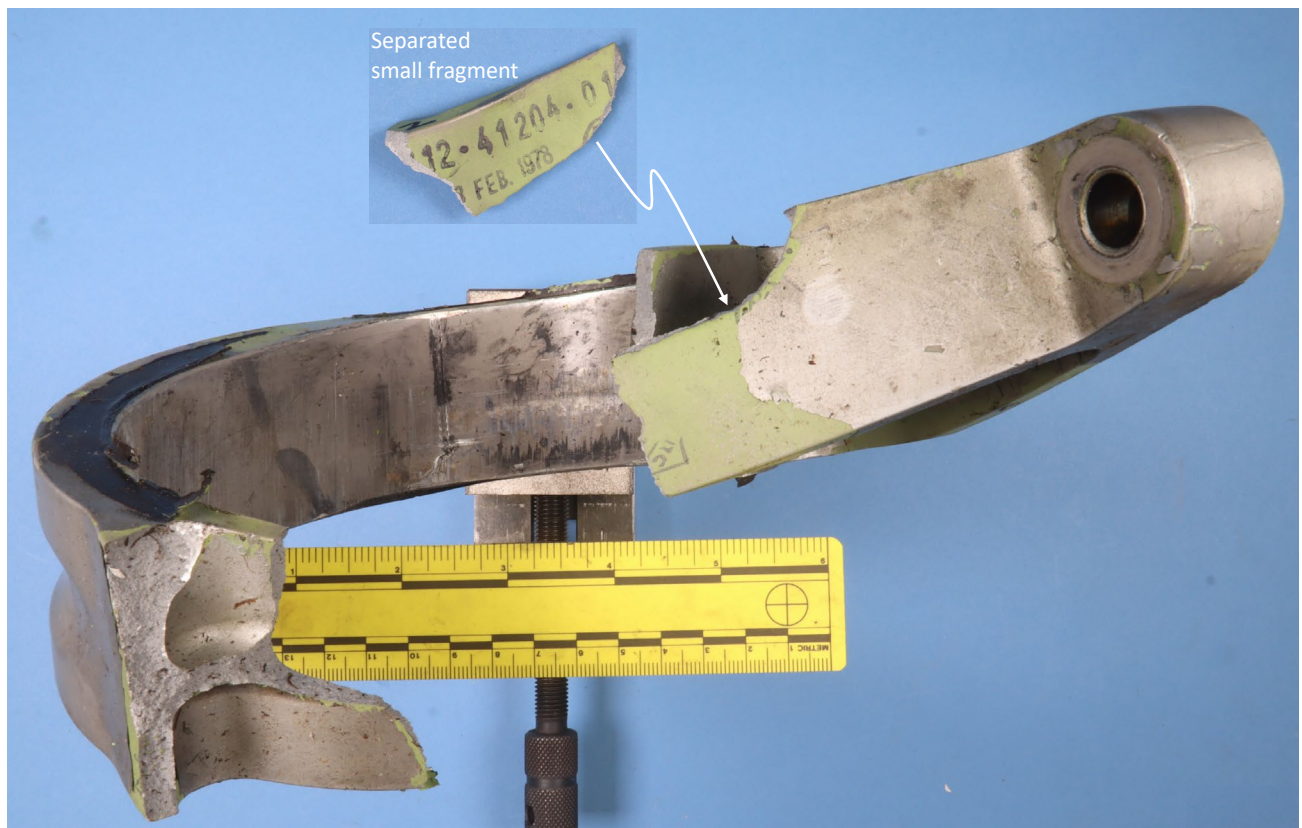
**Figure 4.** Side view of the primary piece of the right main landing gear upper fitting with an inset image of a separated fragment.
