**NATIONAL TRANSPORTATION SAFETY BOARD**

Office of Aviation Safety  
Eastern Region

**Photo Array**

**ERA22LA348**

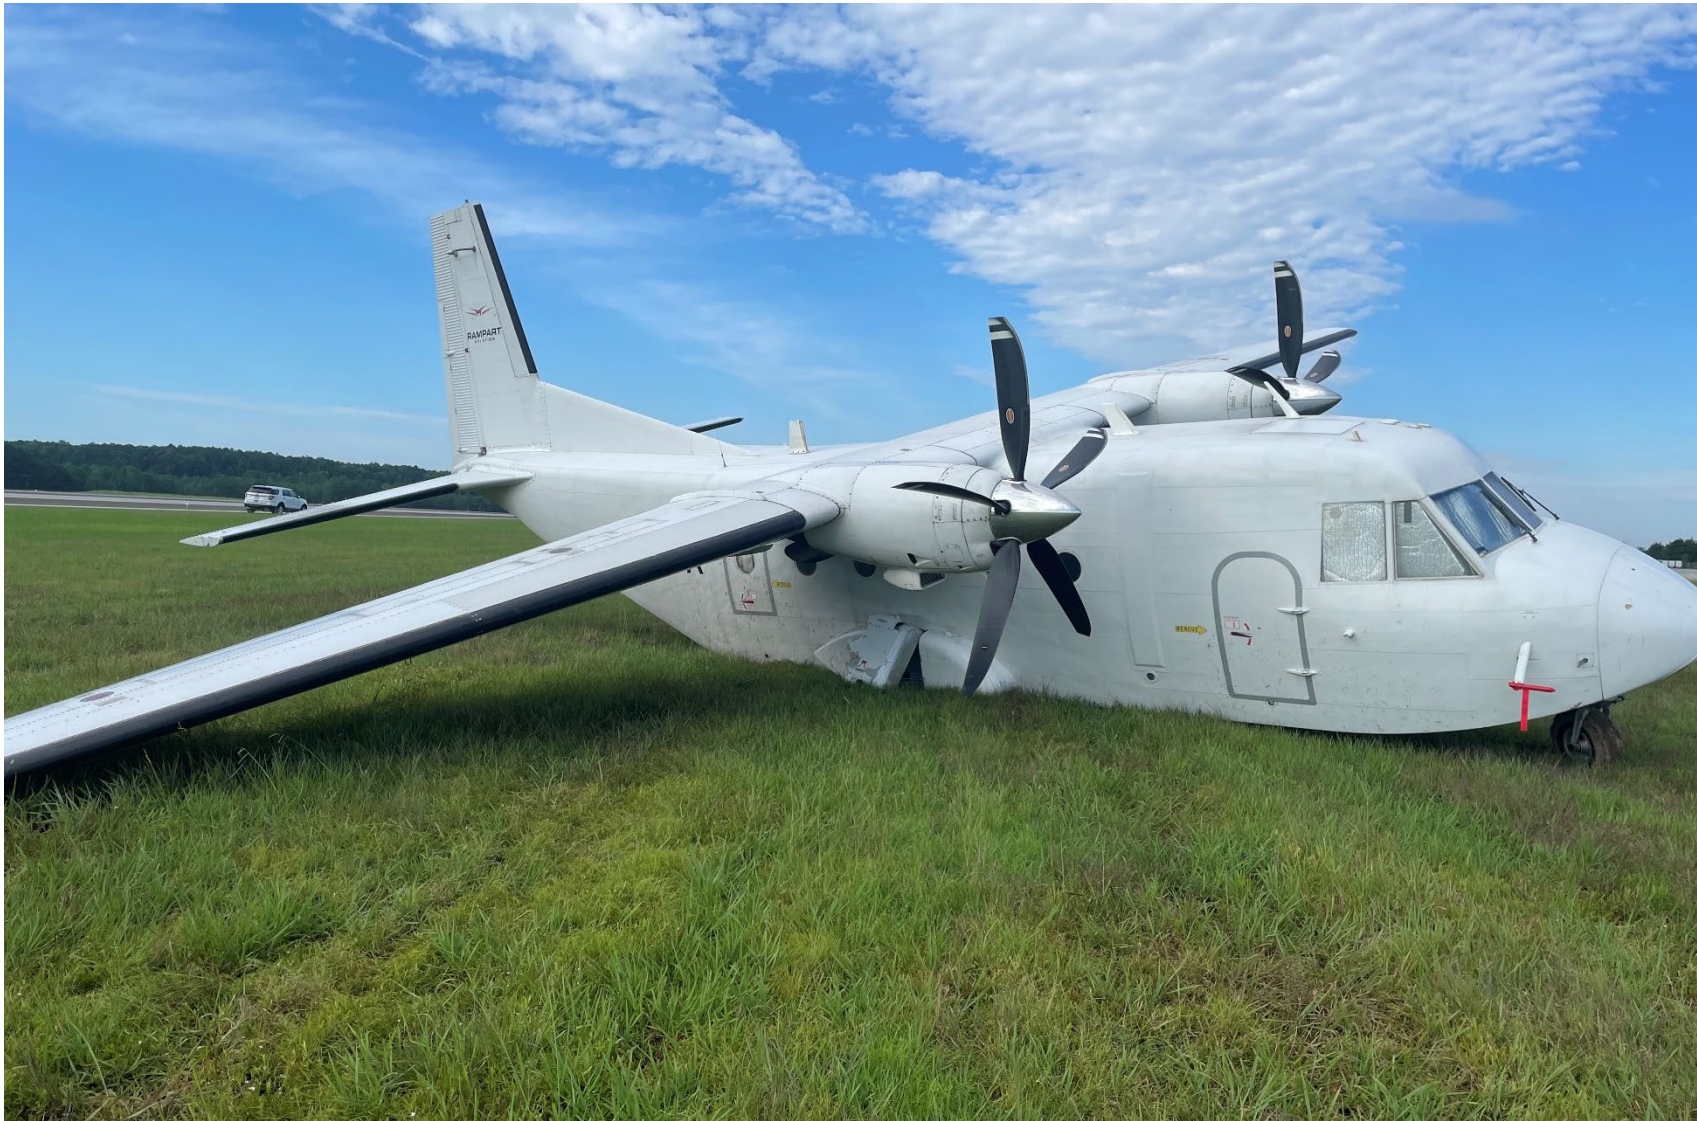
**Photo 1 – View of airplane from right front (Photo courtesy of FAA)**

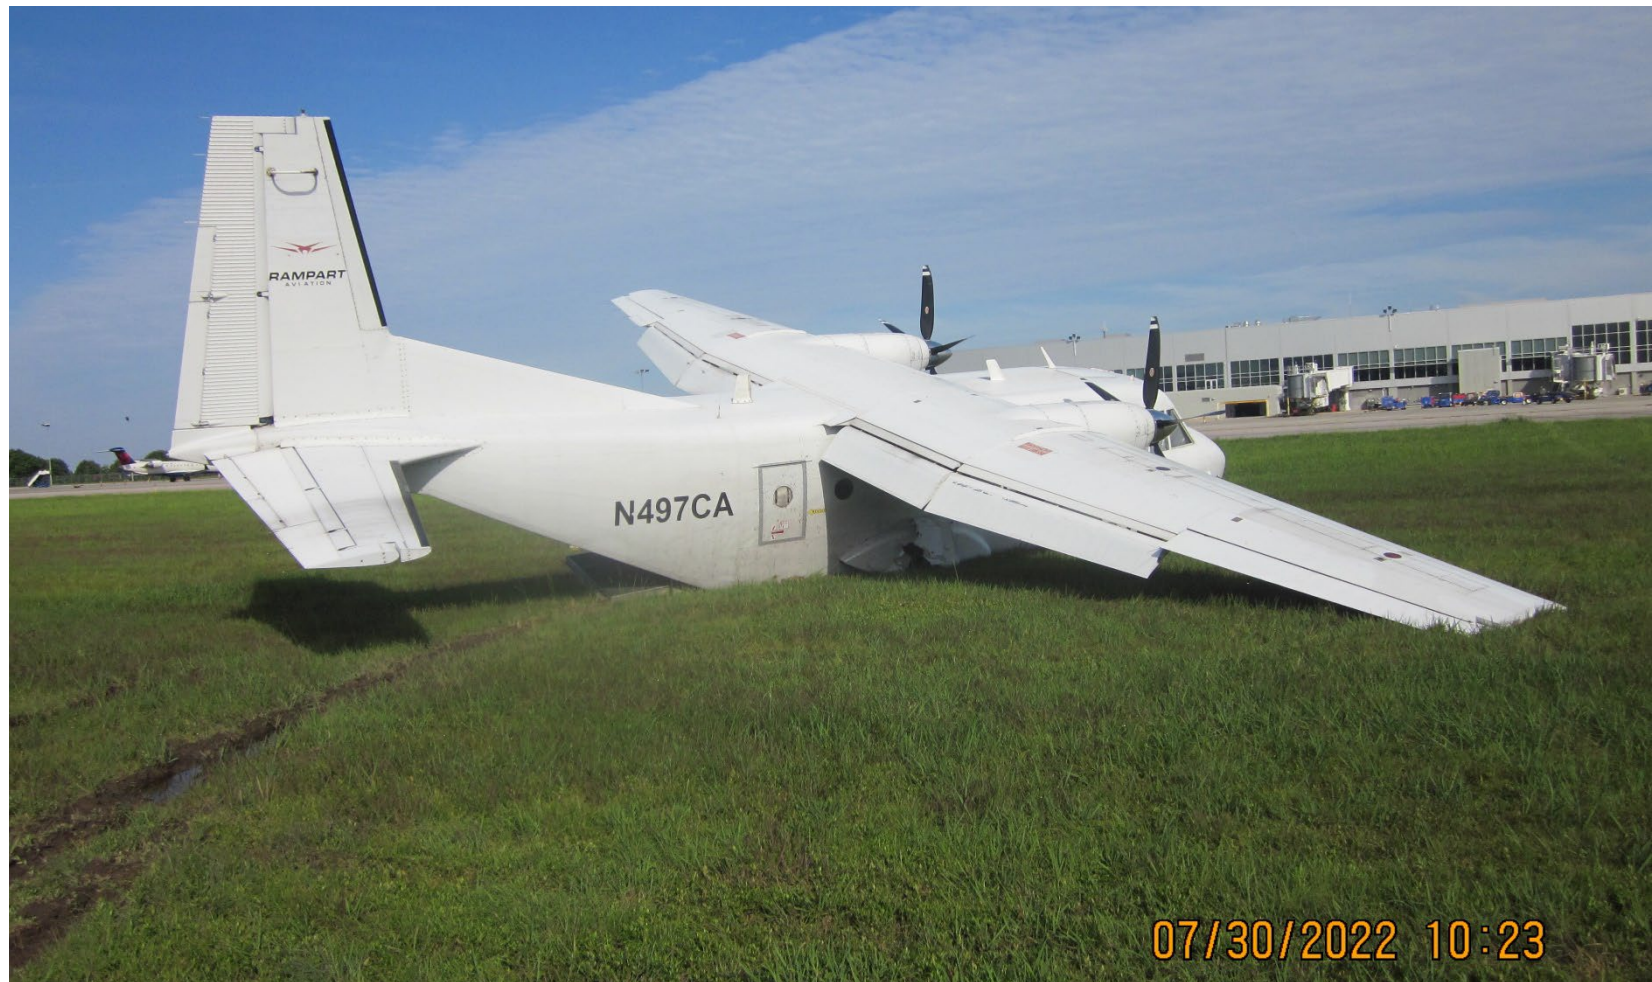
**Photo 2 – View of airplane from right rear (Photo courtesy of FAA)**

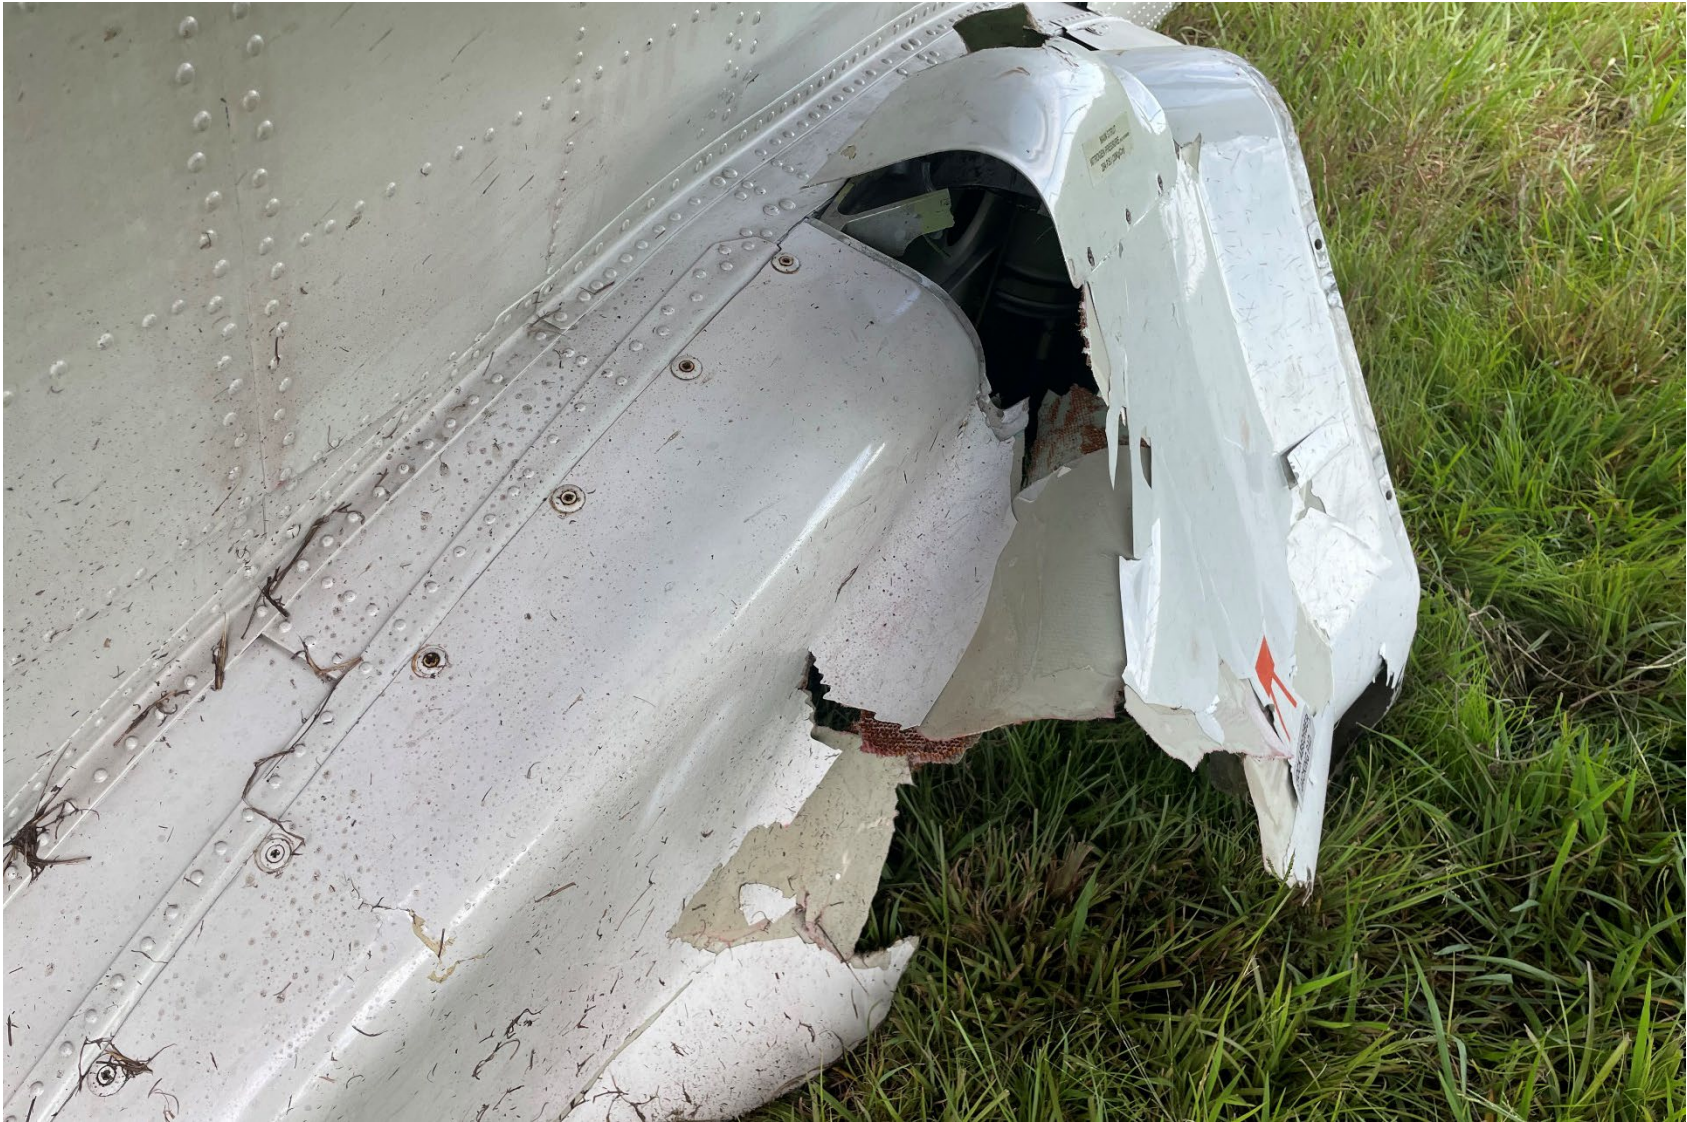
**Photo 3 – View of damage near right main landing gear (Photo courtesy of FAA)**

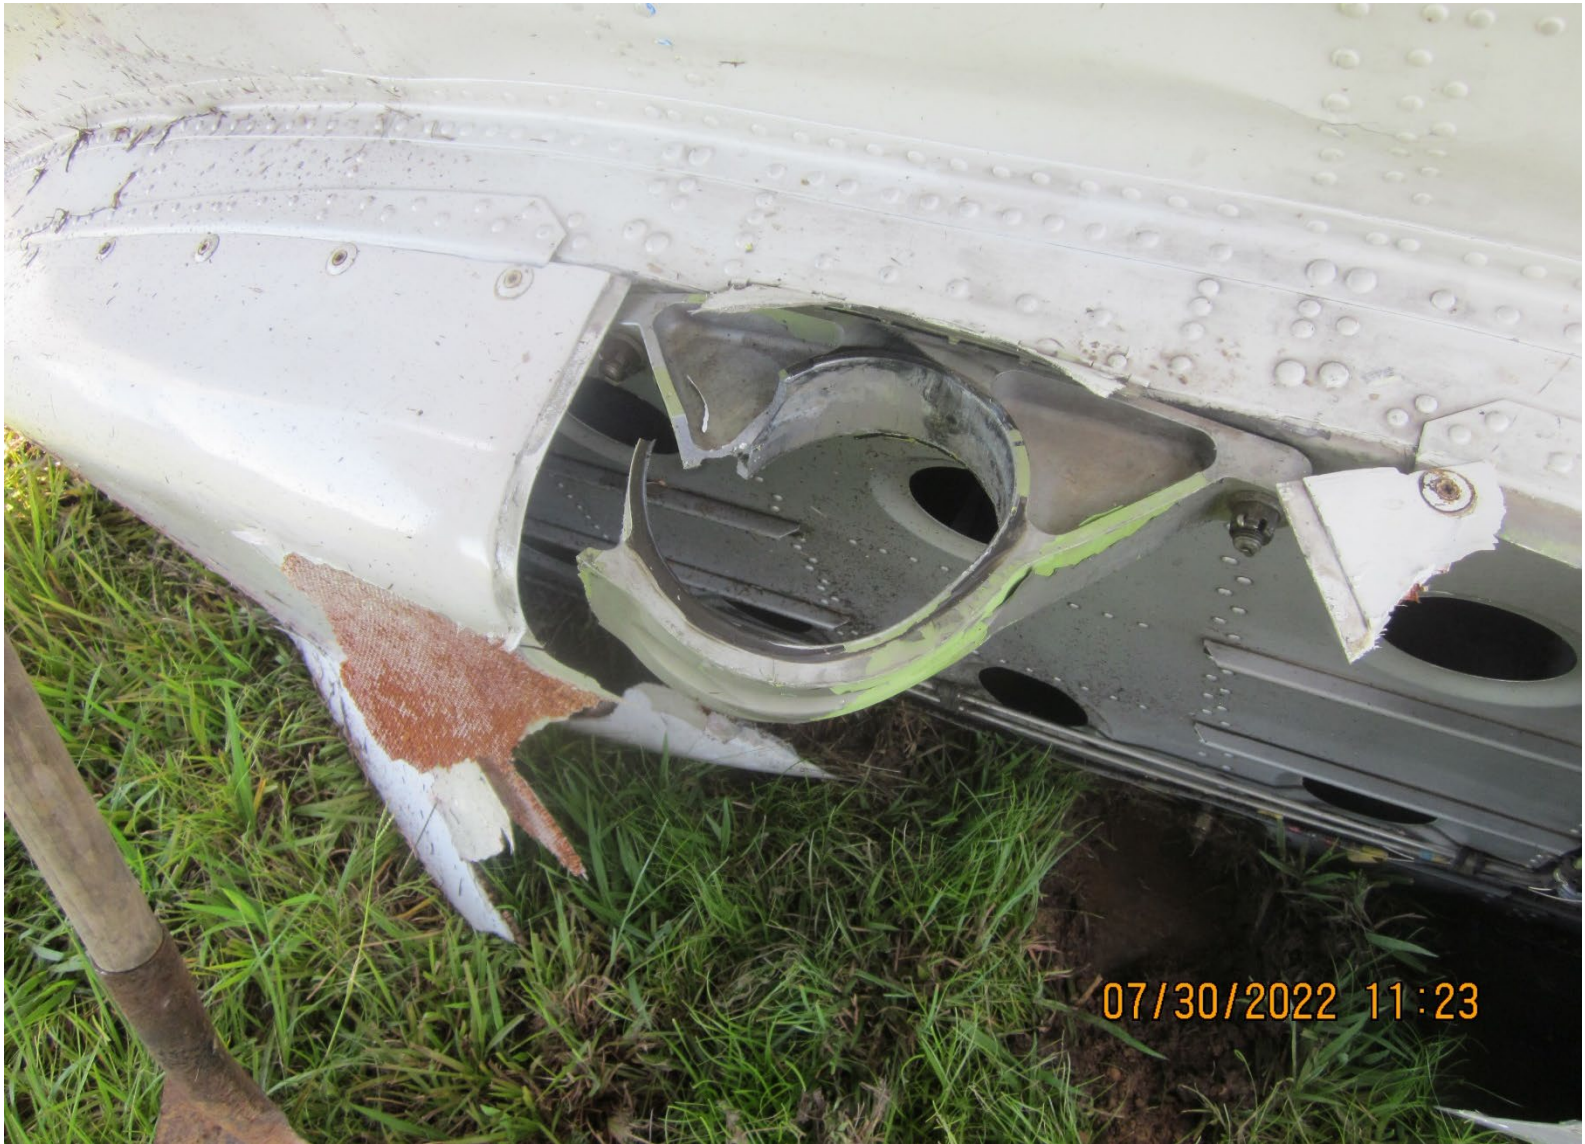
**Photo 4 – View of fractured right main landing gear upper fitting (Photo courtesy of FAA)**

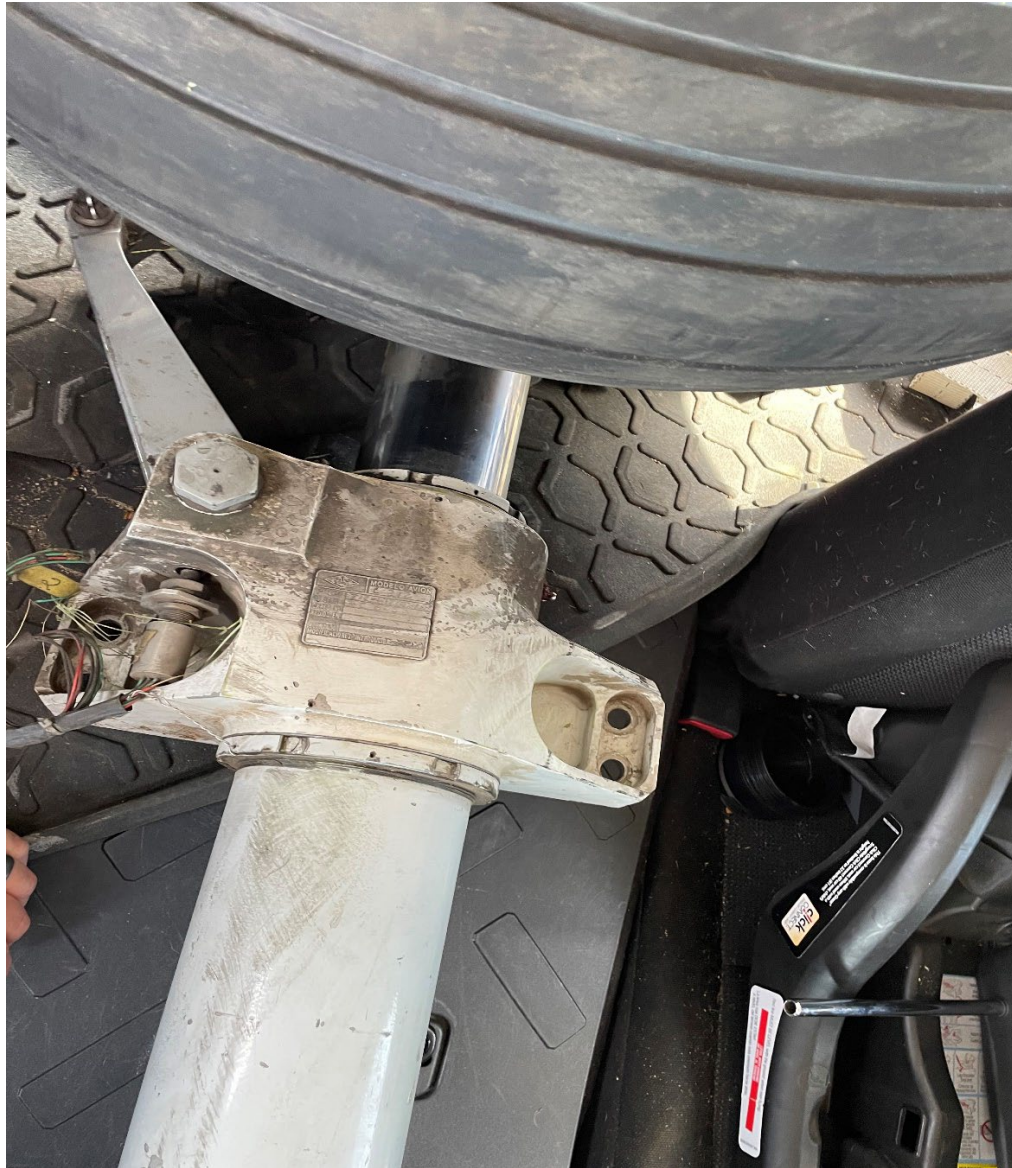
**Photo 5 – View of fractured right main landing gear lower attachment points (Photo courtesy of FAA)**

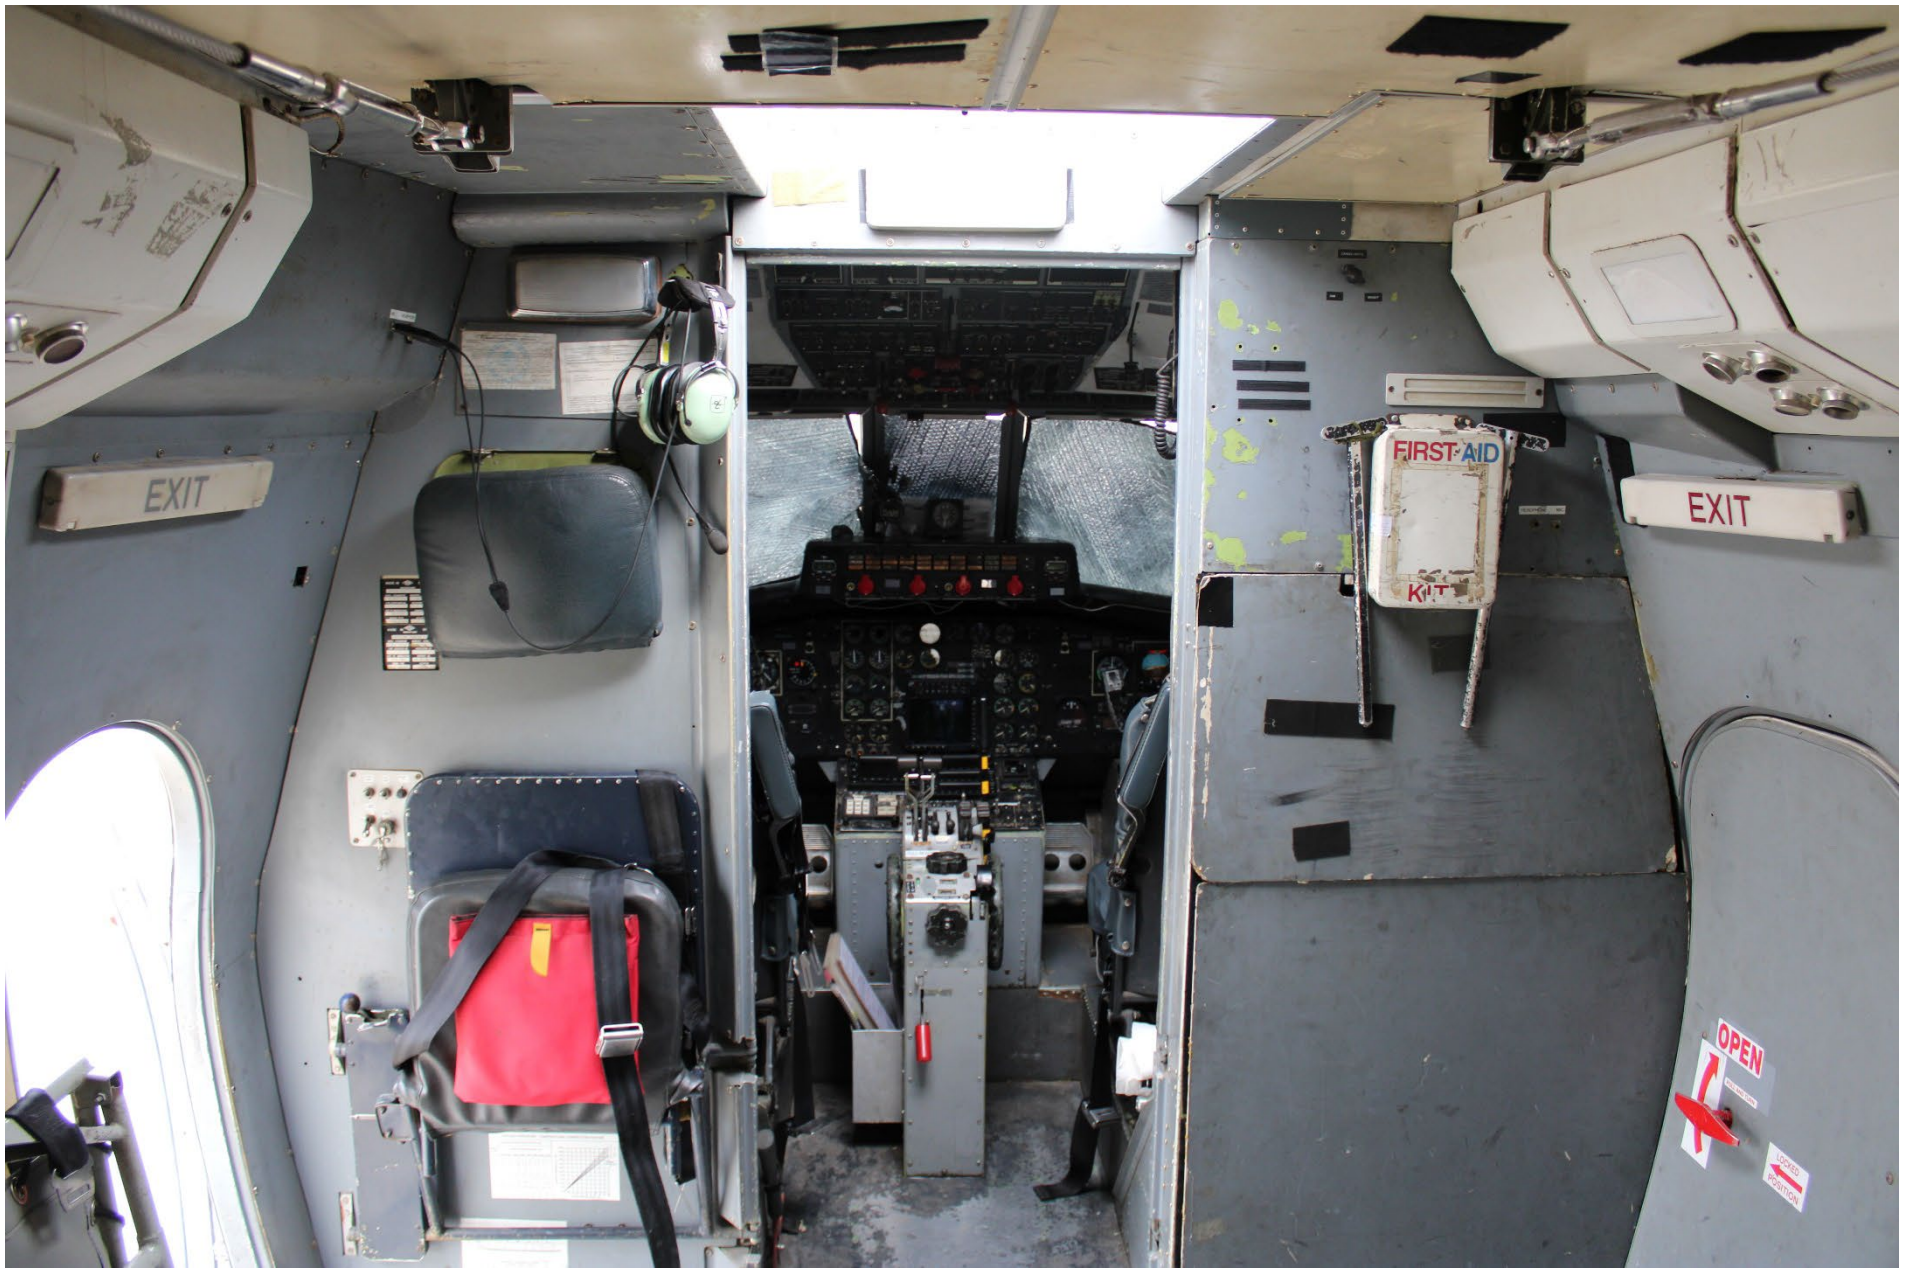
**Photo 6 – View of cockpit from cabin**

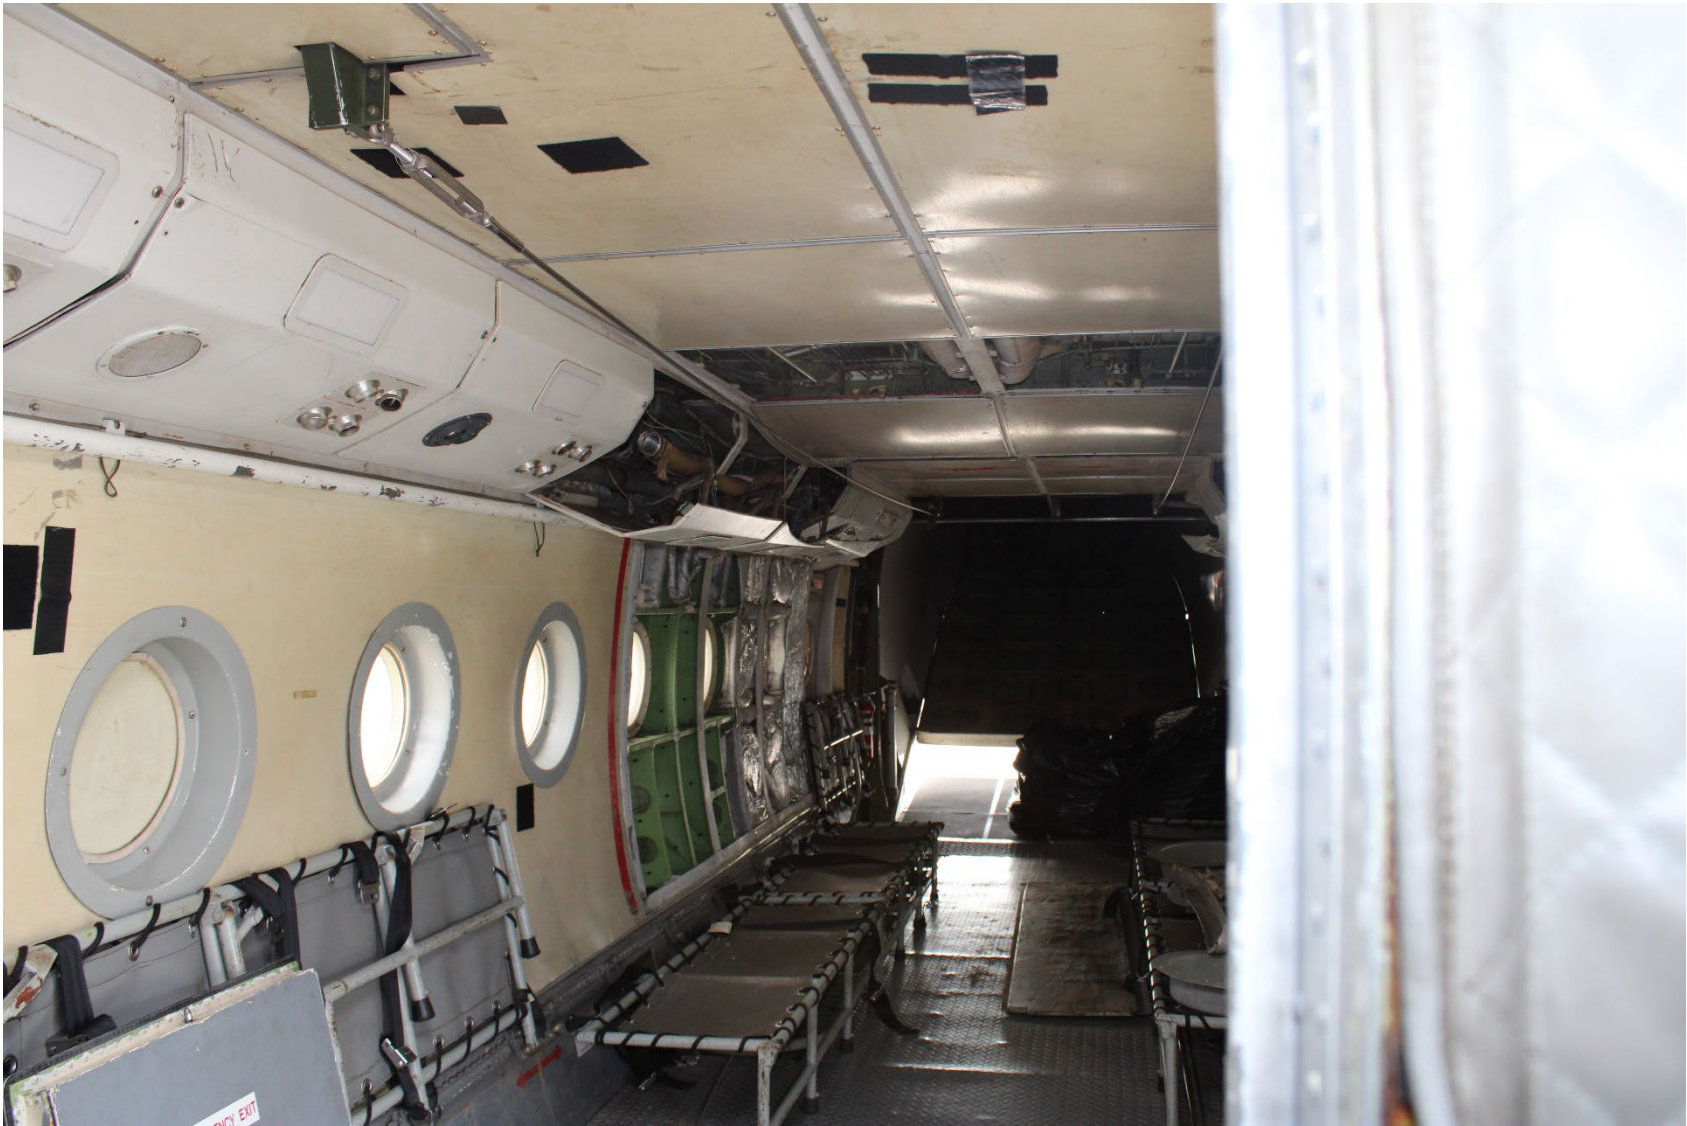
**Photo 7 – View from left pilot seat toward rear of airplane**

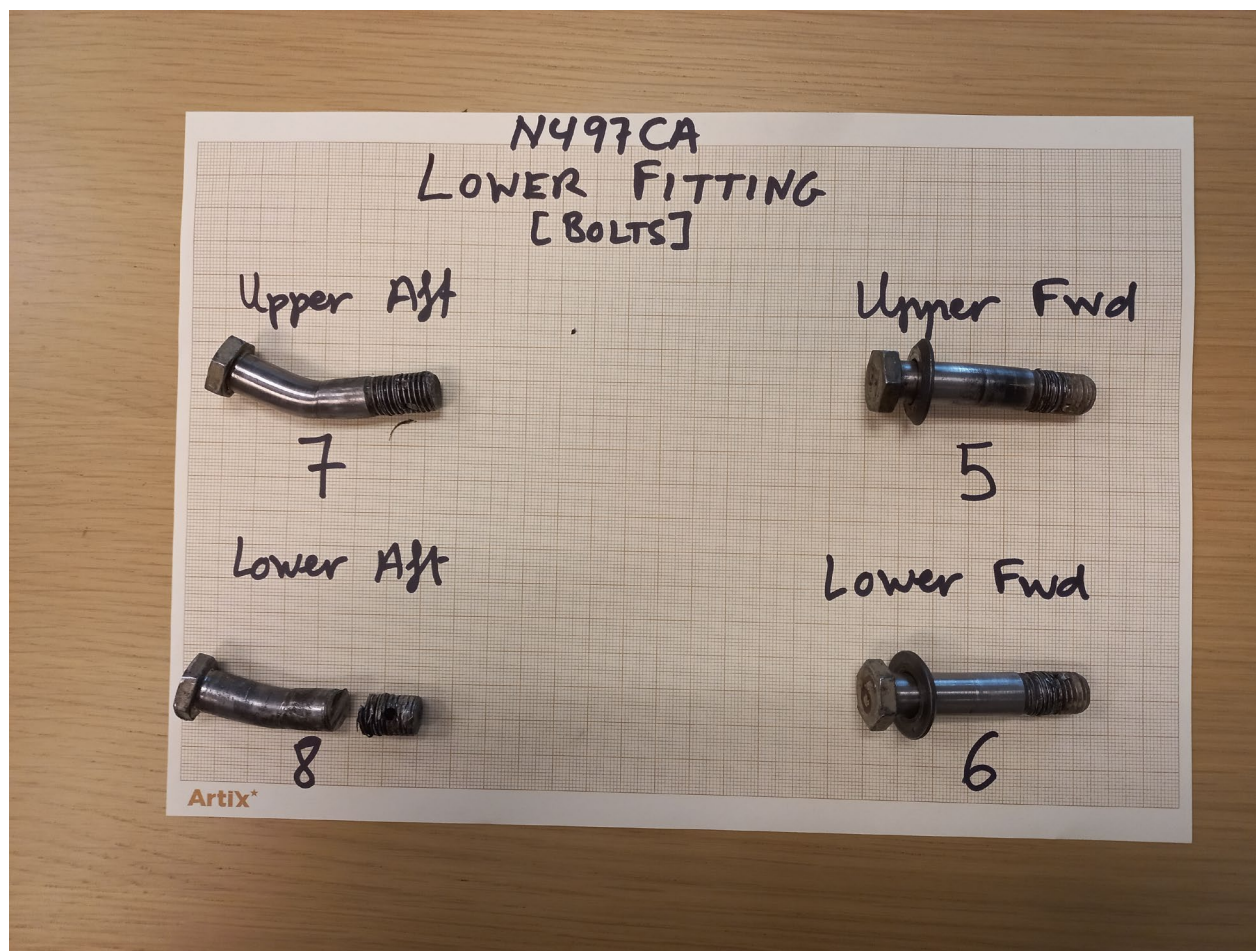
Photo 9 – View of lower fitting bolts for right main landing gear (Photo courtesy of Airbus)

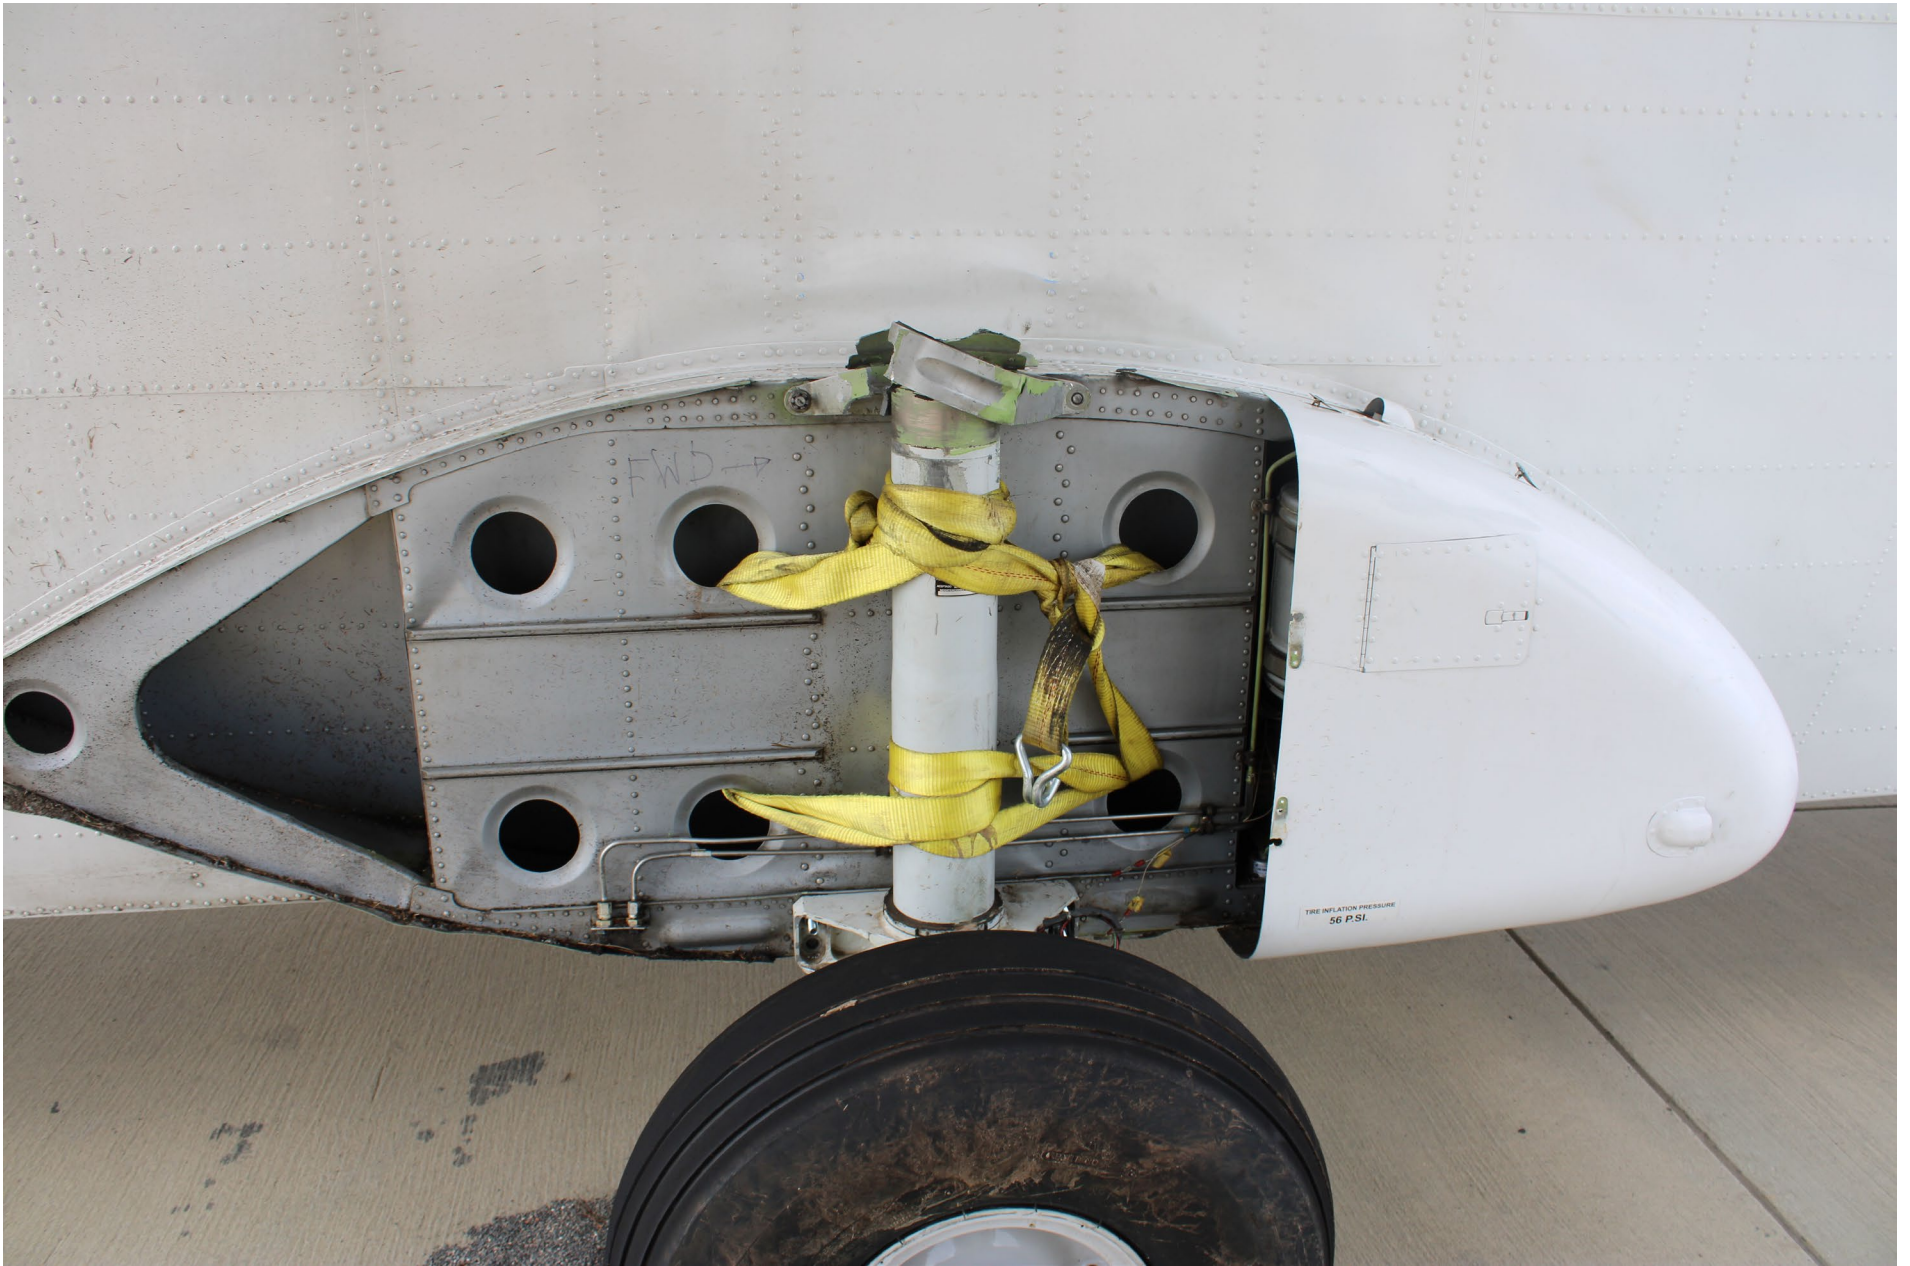
**Photo 10 – View of fractured right main landing gear as configured for recovery and ferry**
