# National Transportation Safety Board

ERA22LA358

## **MATERIALS LABORATORY**

Factual Report 22-097

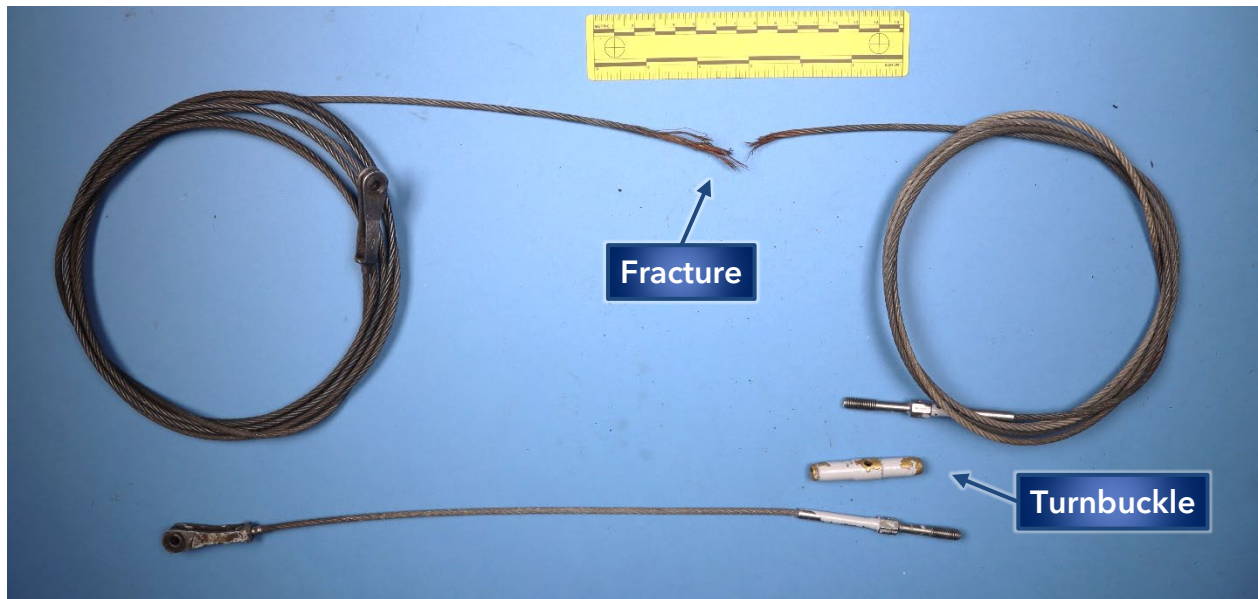
Overall views of the submitted rudder control cable assembly and pulleys are shown in figures 1 and 2. The rudder cable was fractured at a location approximately 94 inches from the turnbuckle terminal end and 152 inches from the center of the attachment holes in the clevis at the other end of the fractured cable.

**Figure 1.** Overall view of the submitted control cable assembly.

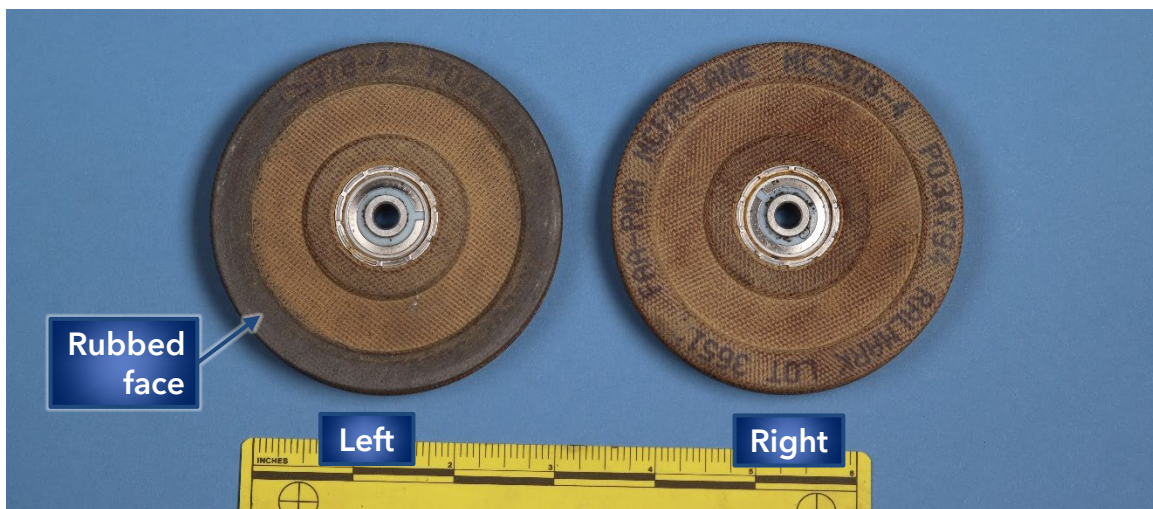
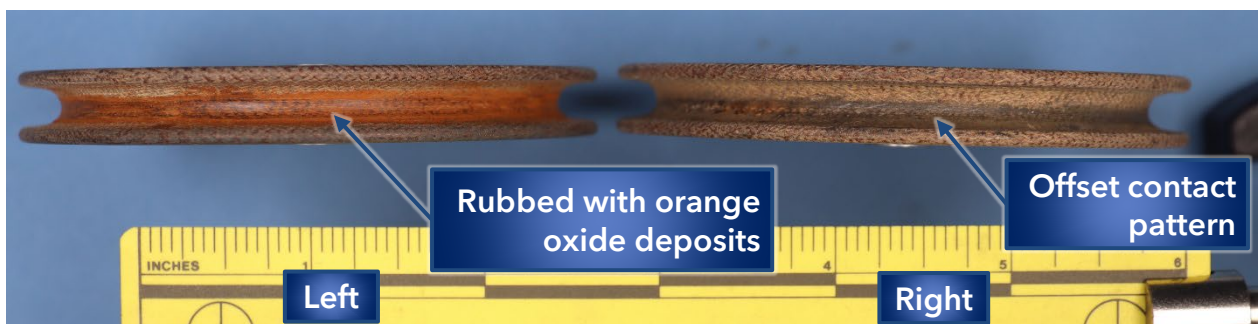
The bearings at the centers of the pulleys moved freely in both submitted pulleys. However, the outer rim of the left pulley was rubbed as indicated in figure 2, obscuring most of the part marking information. A view of the cable grooves for the two pulleys are also shown in figure 2. The groove for the left pulley was mostly covered with orange deposits, and the groove contact surface was rubbed around much of the circumference. No oxide deposits were observed on the right pulley, but the contact pattern in the pulley was offset from the groove centerline as indicated in the lower image in figure 2.

**Figure 2.** Left and right pulleys from the rudder control system showing the faces with identification markings (upper image) and the cable grooves (lower image).

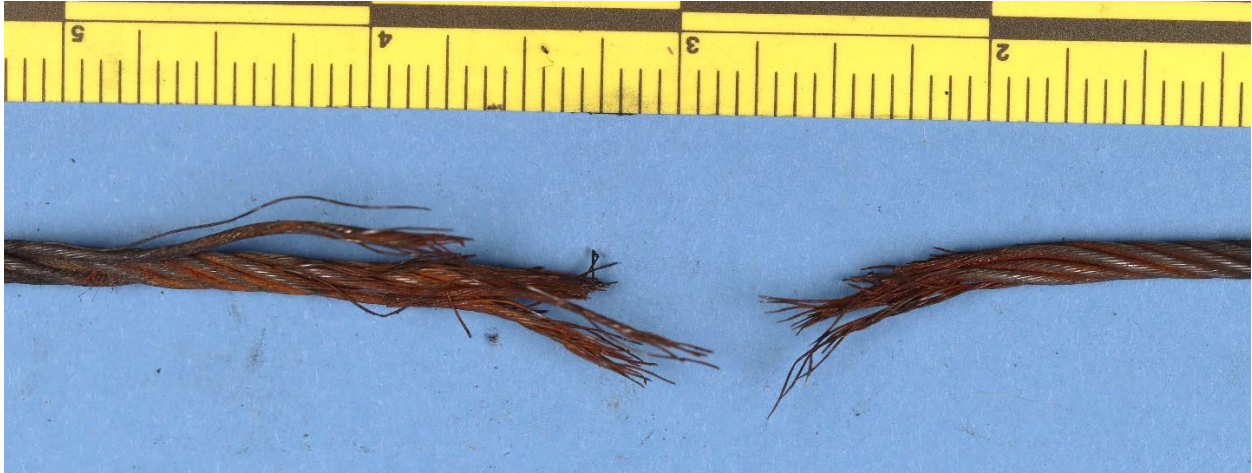
A closer view of the cable fracture is shown in figure 3. The fractured ends showed limited splaying of the strands adjacent to the fracture. Orange oxides were present on the cable locally near the fractured ends as shown in figure 3. The fracture on the left side of the image in figure 3 was selected for closer examination and imaging, and the remaining images in this report were all obtained using a Keyence VHX 7000 microscope operated in depth mode.

**Figure 3.** Closer view of the cable fracture indicated in figure 1.

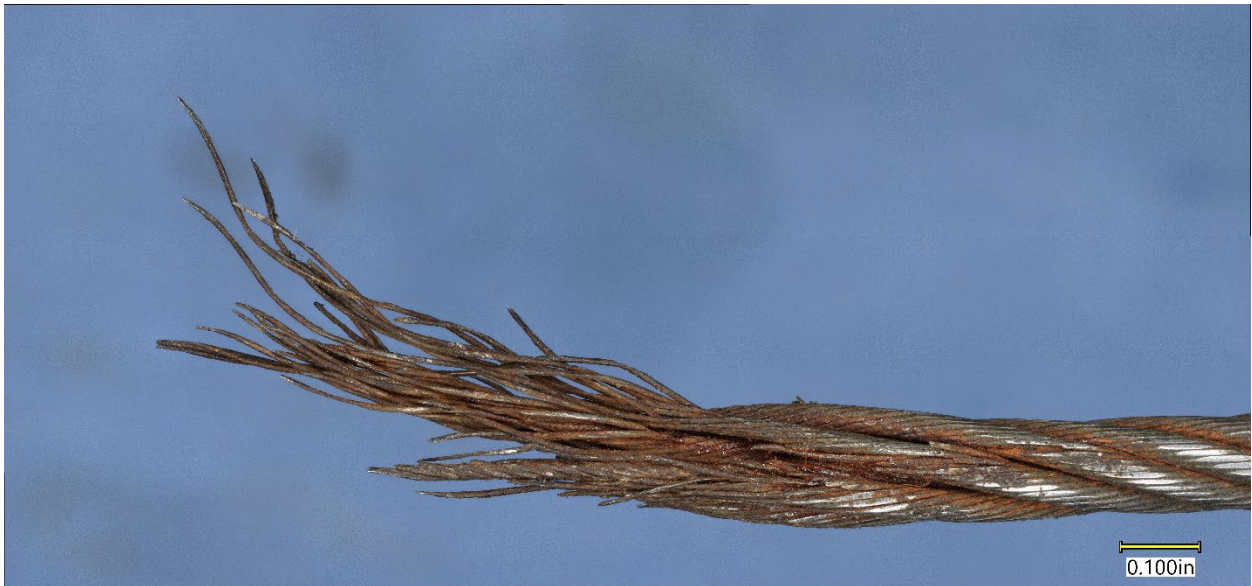
A magnified view of the selected side of the fracture is shown in figure 4. The surfaces of the cable near the fracture oxidized and worn. Individual wires were mostly worn to a tapered end with no discernable fracture features. To facilitate a closer examination of wires on each strand, the strands were separated by unraveling the strands from around the core. The six outer strands were then sequentially

**Figure 4.** Magnified view of the fracture side shown on the left side of the image in the previous figure.

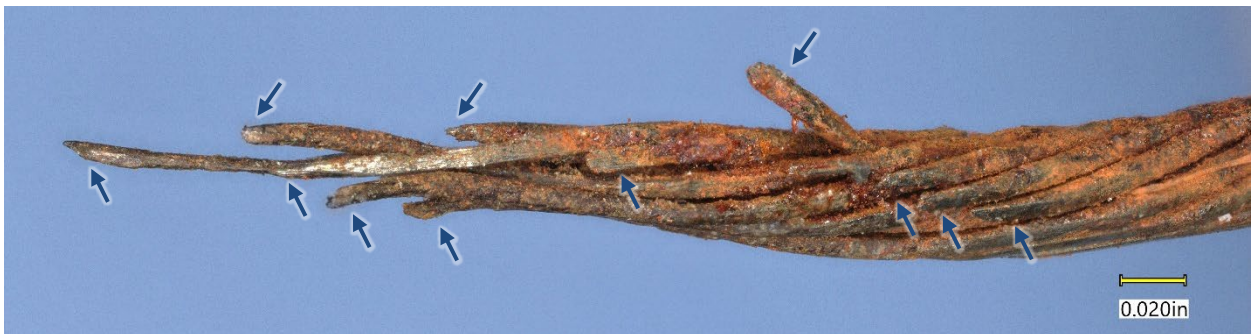
numbered within one lay starting with the strand that was unraveled furthest from the fracture. Each of the six wrapping strands and the core strand were then imaged as shown in figures 5 through 7. In each image, unlabeled arrows point to fractured wires visible in each image with substantial wear though most or all of the wire cross-section, leaving ends tapered to a chisel-like point in most cases. Approximately 6 wires in the core strand showed limited wear as indicated in figure 7 and had necking deformation consistent with ductile overstress fracture.

**Figure 5.** Fractured end of strand 1. Unlabeled arrows indicate worn and fractured wires visible in this view.

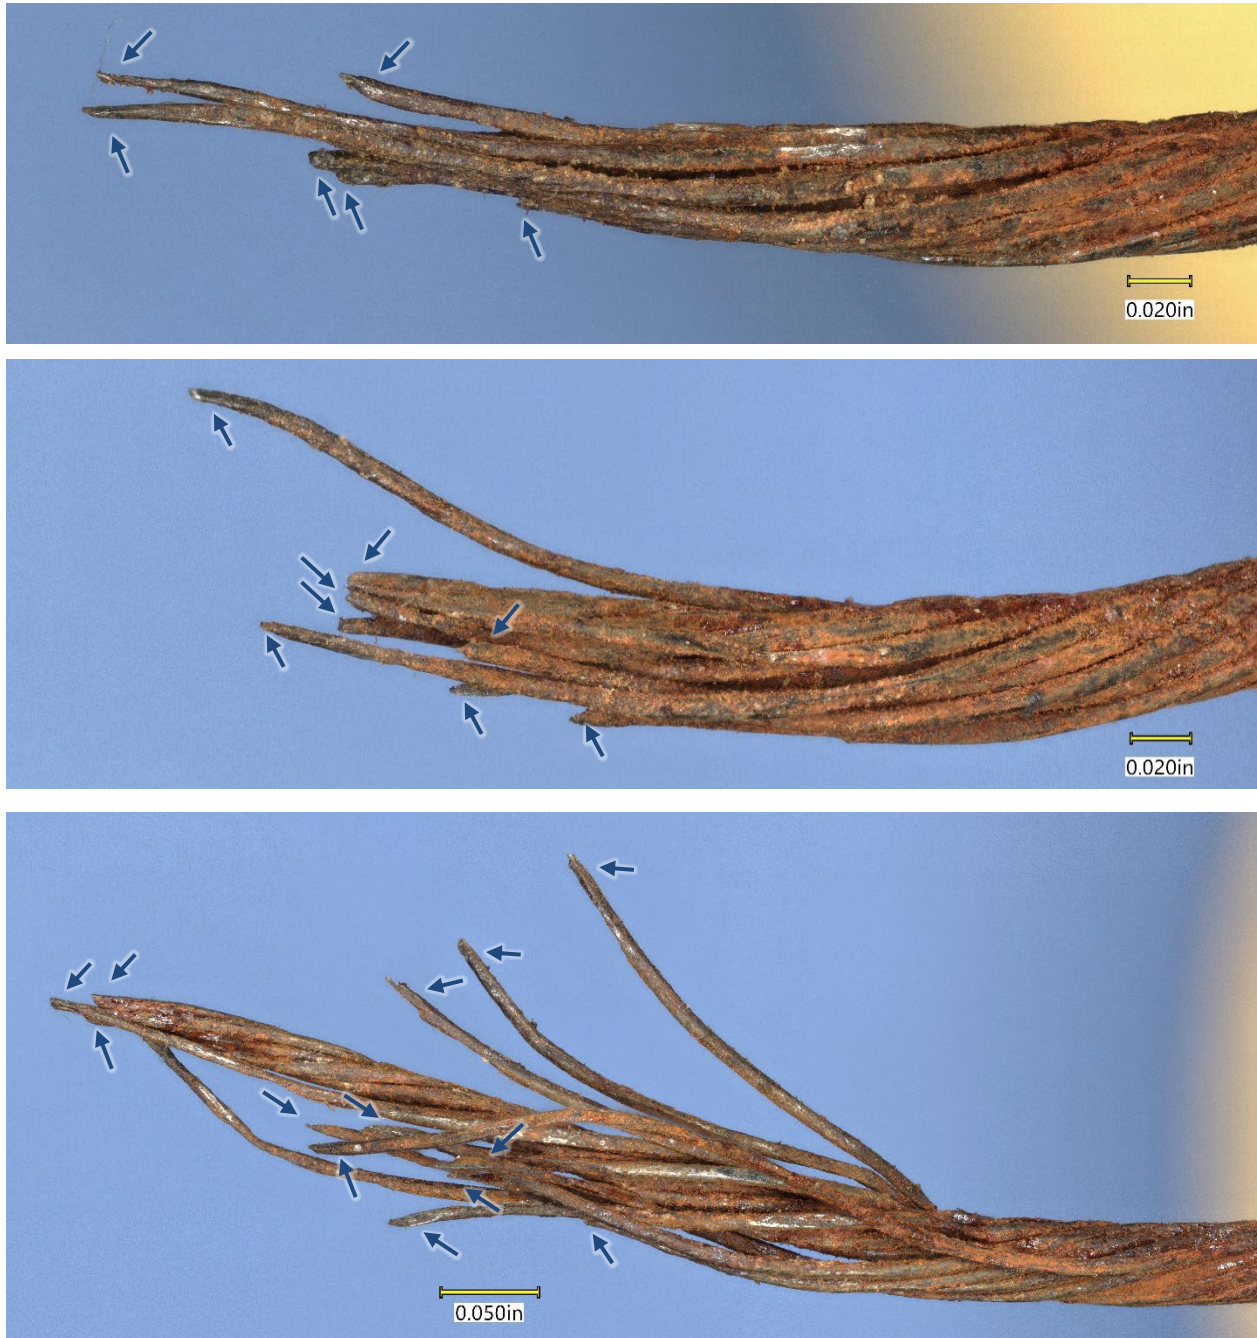
**Figure 6.** Fractured ends of strands 2 (upper image), 3 (middle image), and 4 (lower image). Unlabeled arrows indicate worn and fractured wires visible in these views.

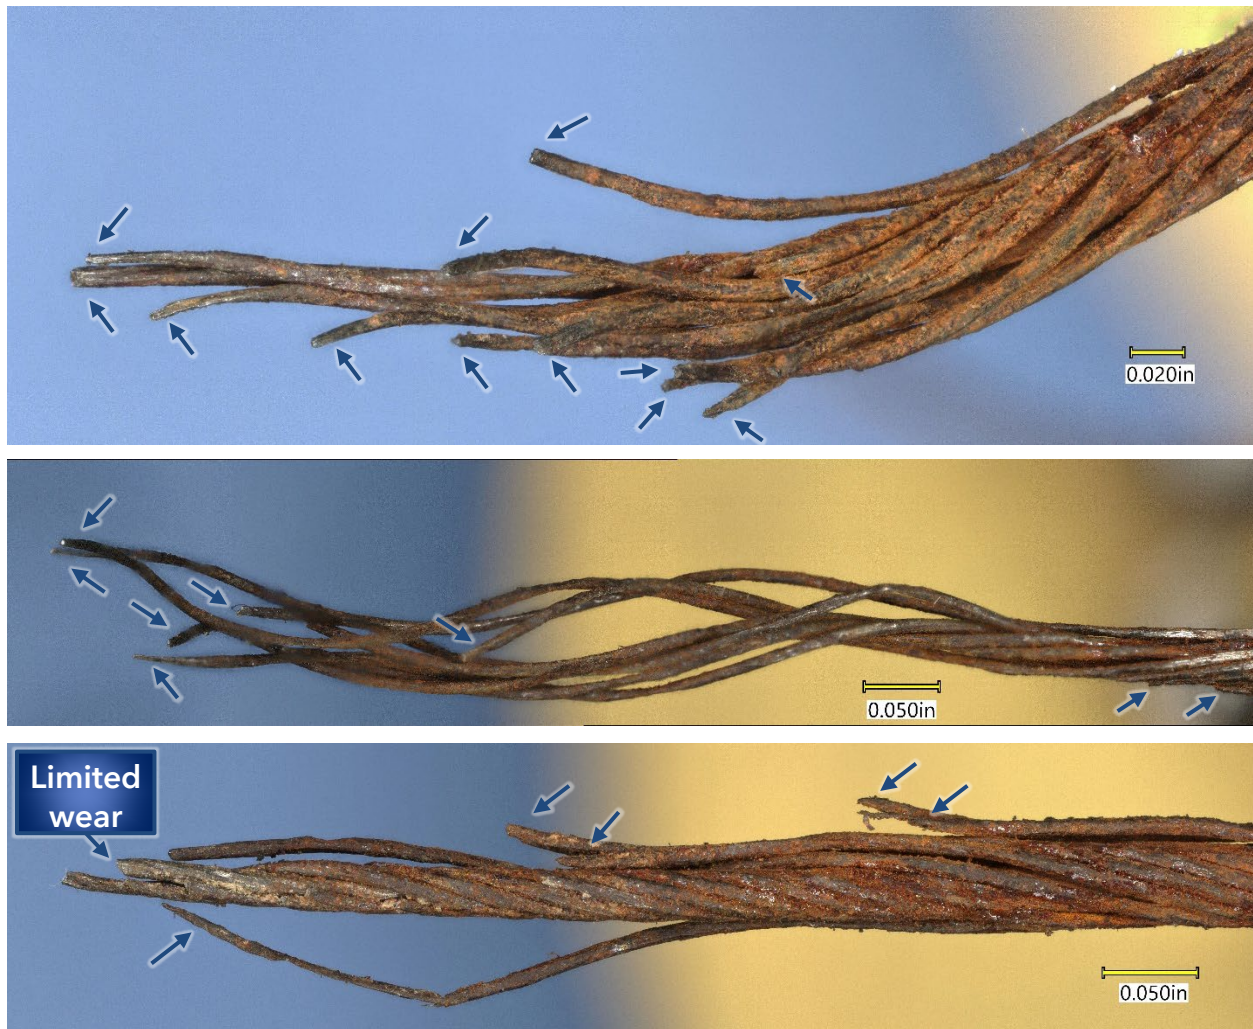
**Figure 7.** Fractured ends of strands 5 (upper image) and 6 (middle image) and the core strand (lower image). Unlabeled arrows indicate worn and fractured wires visible in these views.
