## **NATIONAL TRANSPORTATION SAFETY BOARD**

**Photo Array**

**ERA22LA358**

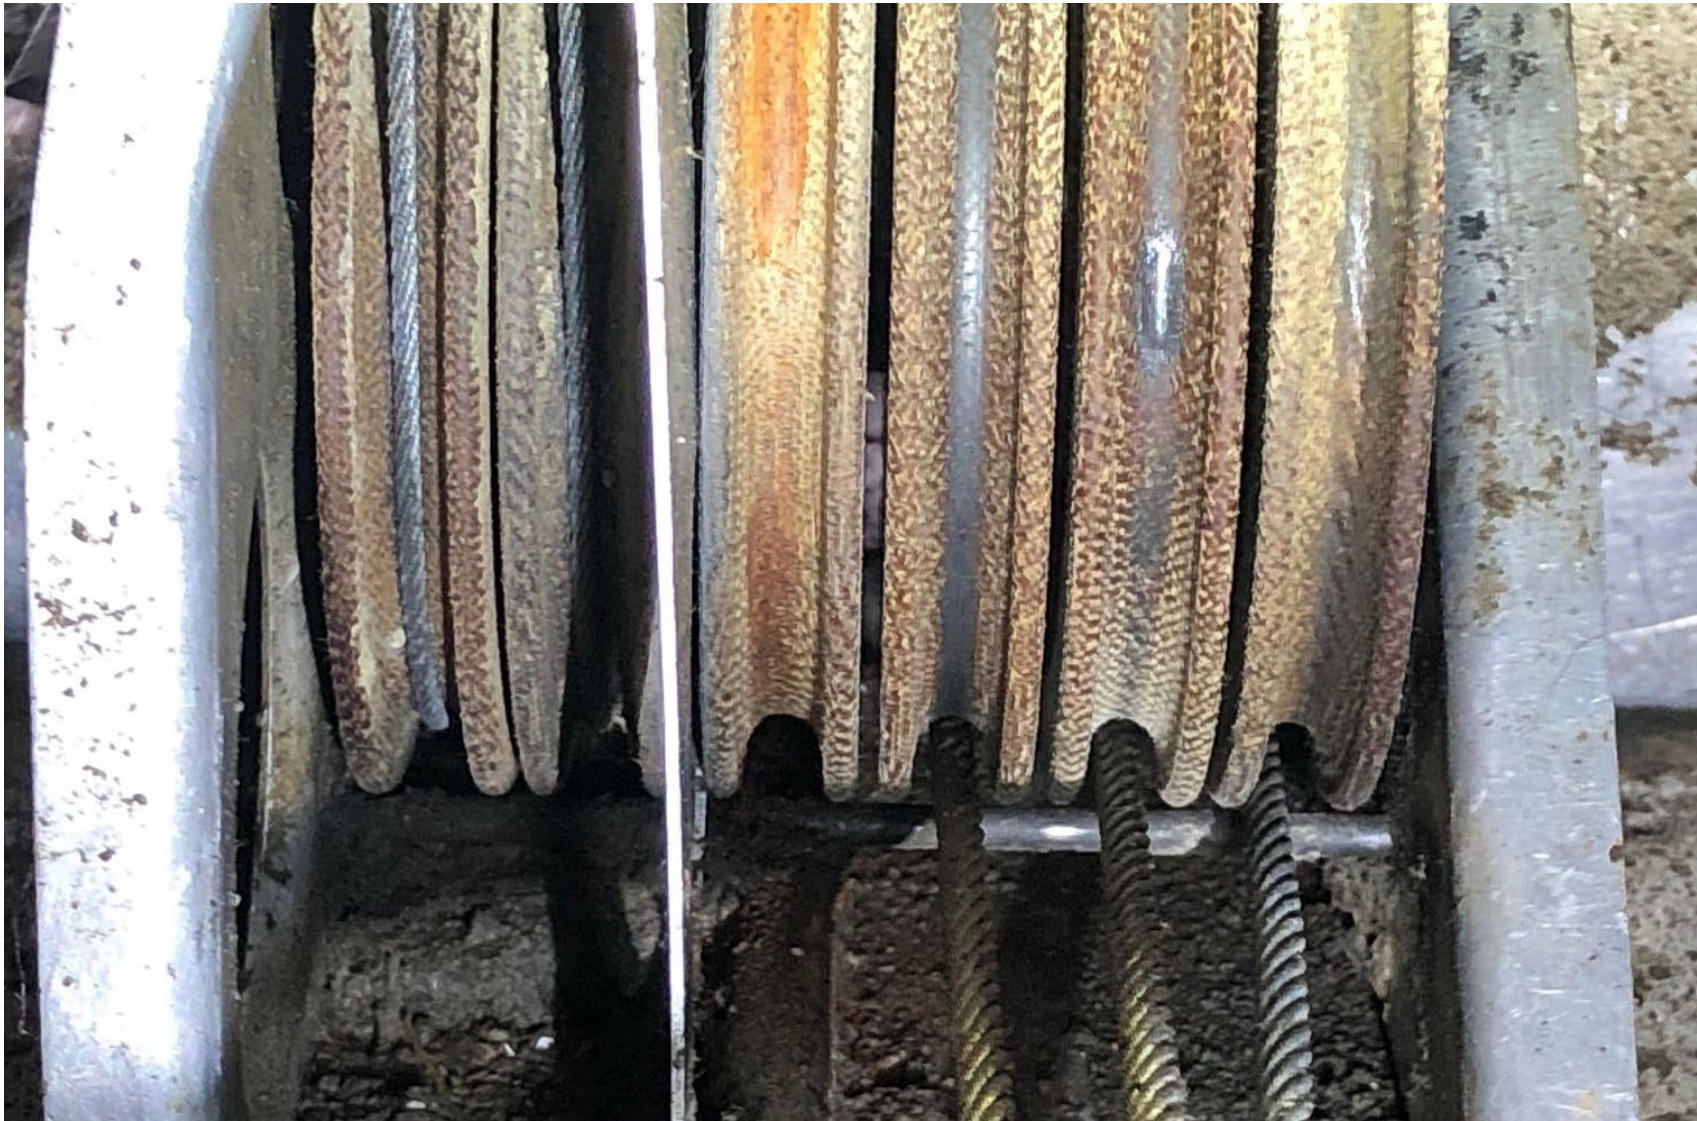
**Photo 1 – View of rudder cable pulley with orange deposits (Photo Courtesy of FAA)**

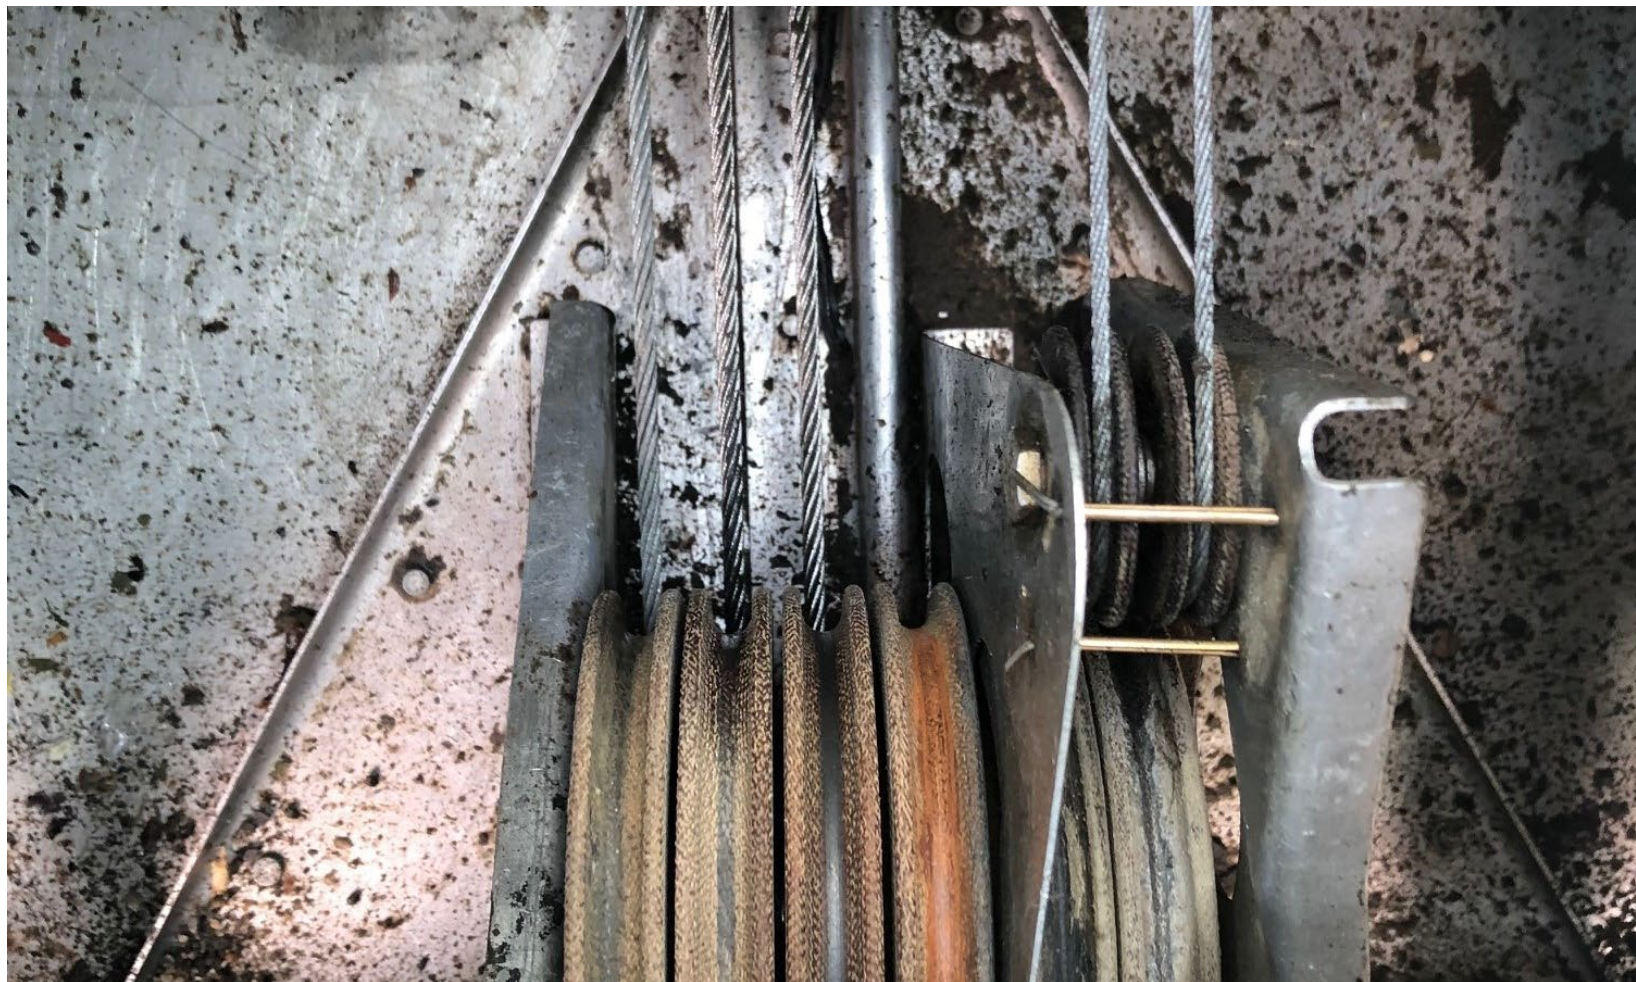
**Photo 2 – View of rudder cable pulley with orange deposits as seen from above. (Photo Courtesy of FAA)**

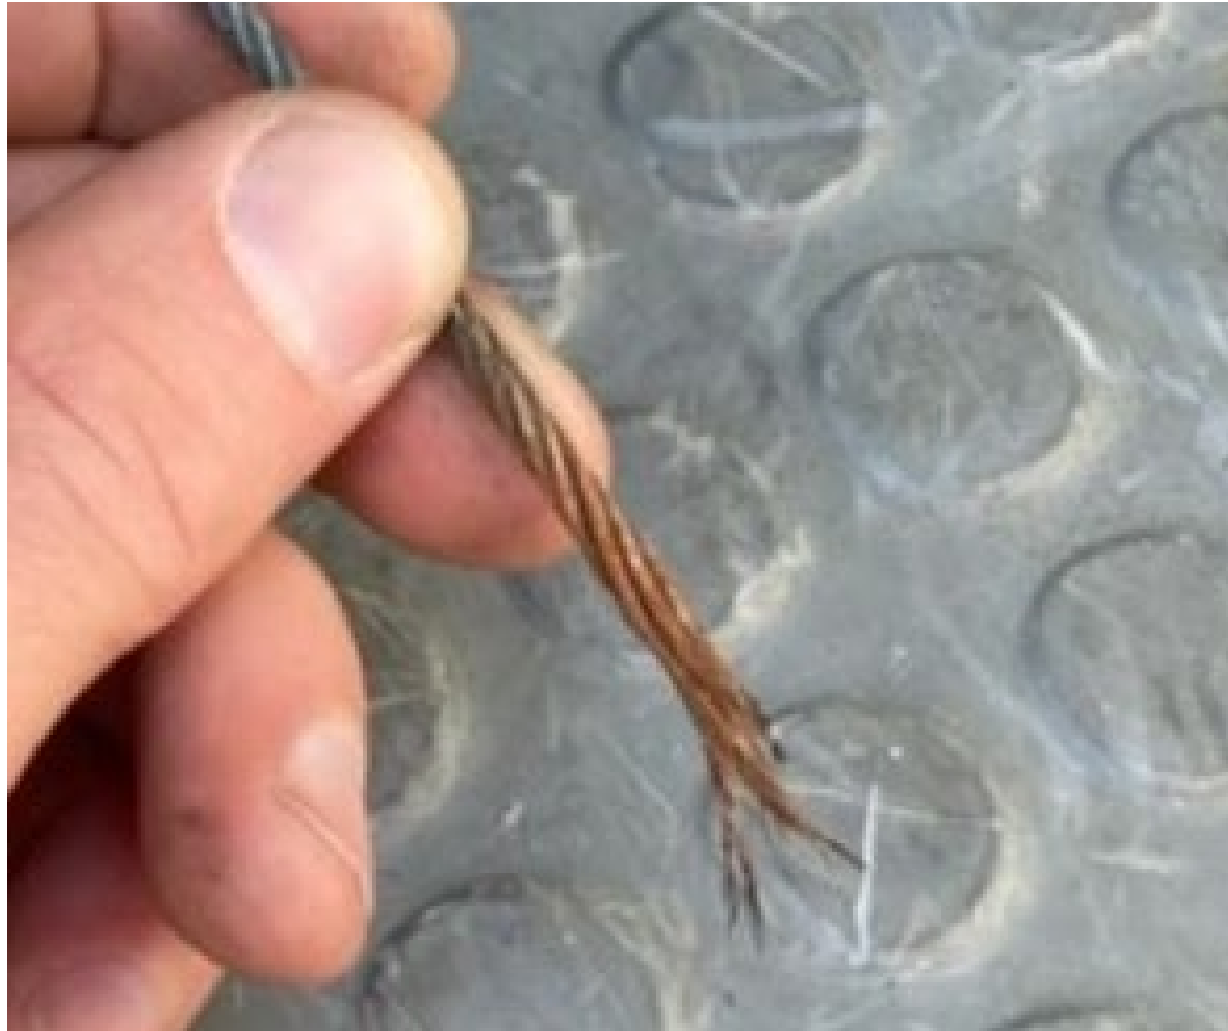
**Photo 3 – View of fractured left rudder cable (Photo Courtesy of FAA)**
