# National Transportation Safety Board

ERA22LA363

## **ENGINE EXAMINATION SUMMARY**

Location: Ellenville, New York  
Date: August 7, 2022  
Time: 0935 EDT  
1335 UTC  
Airplane: N50439, Cessna 150H

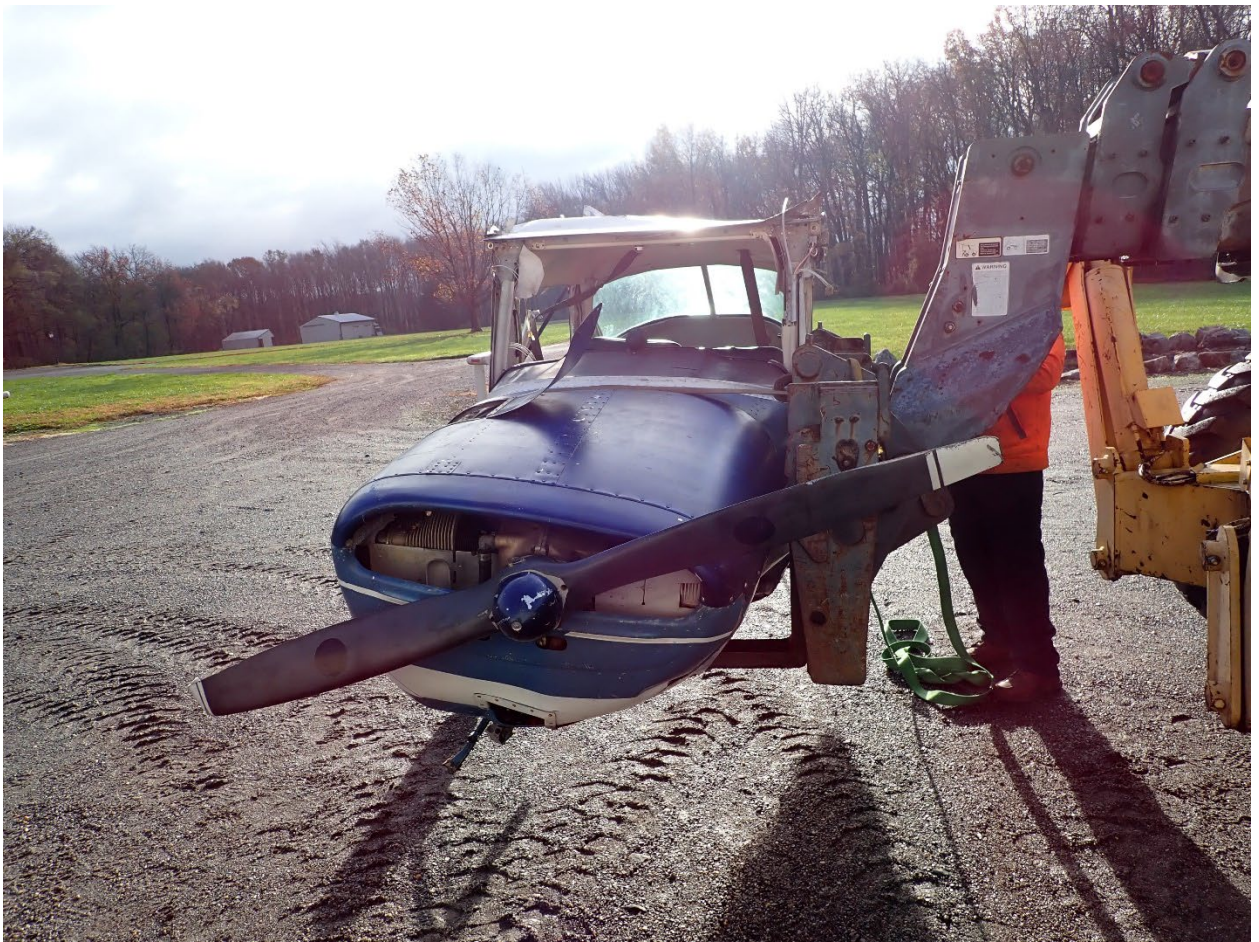
**Figure 1: Front view of airplane on telehandler**

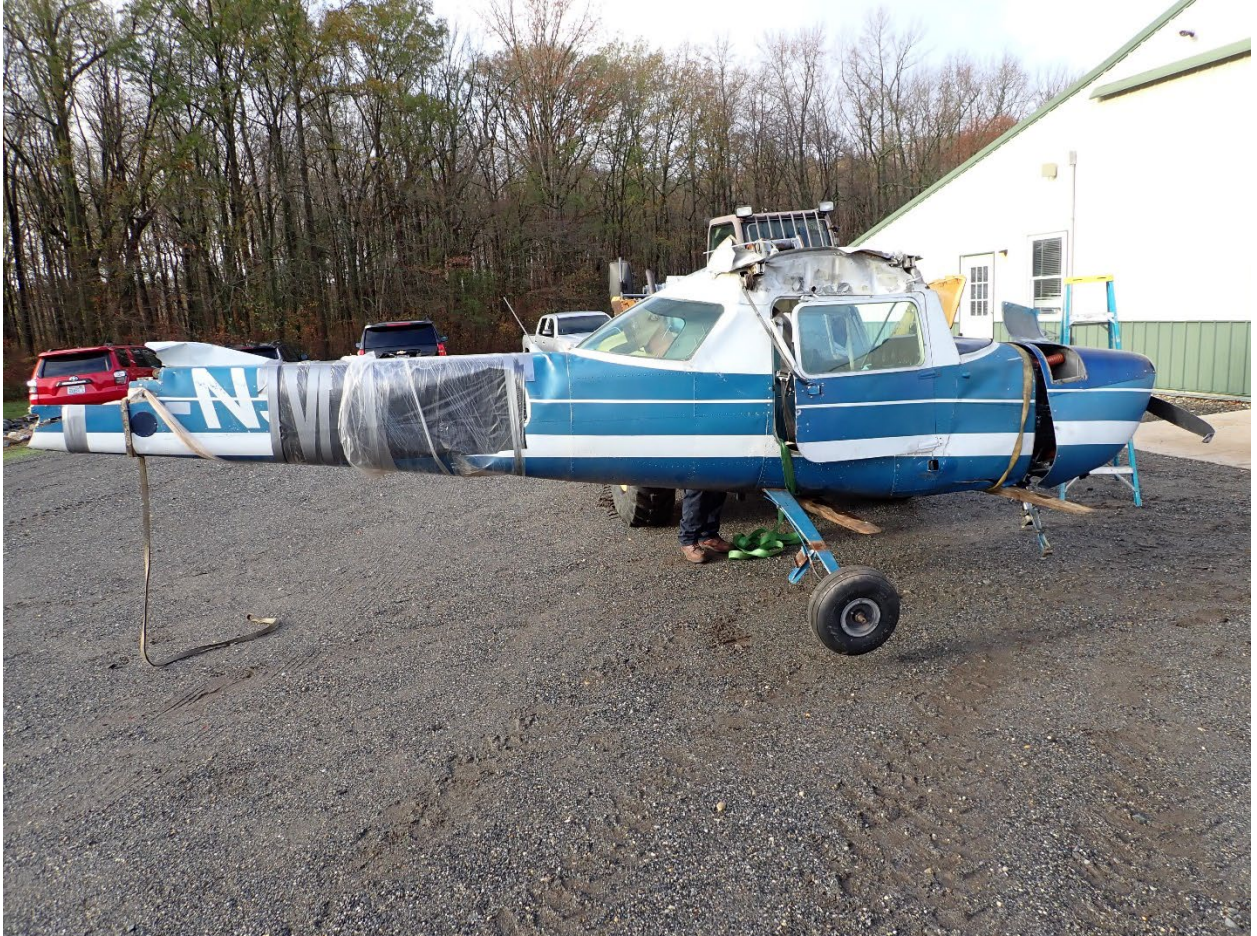
**Figure 2: View of right side of airplane on telehandler**

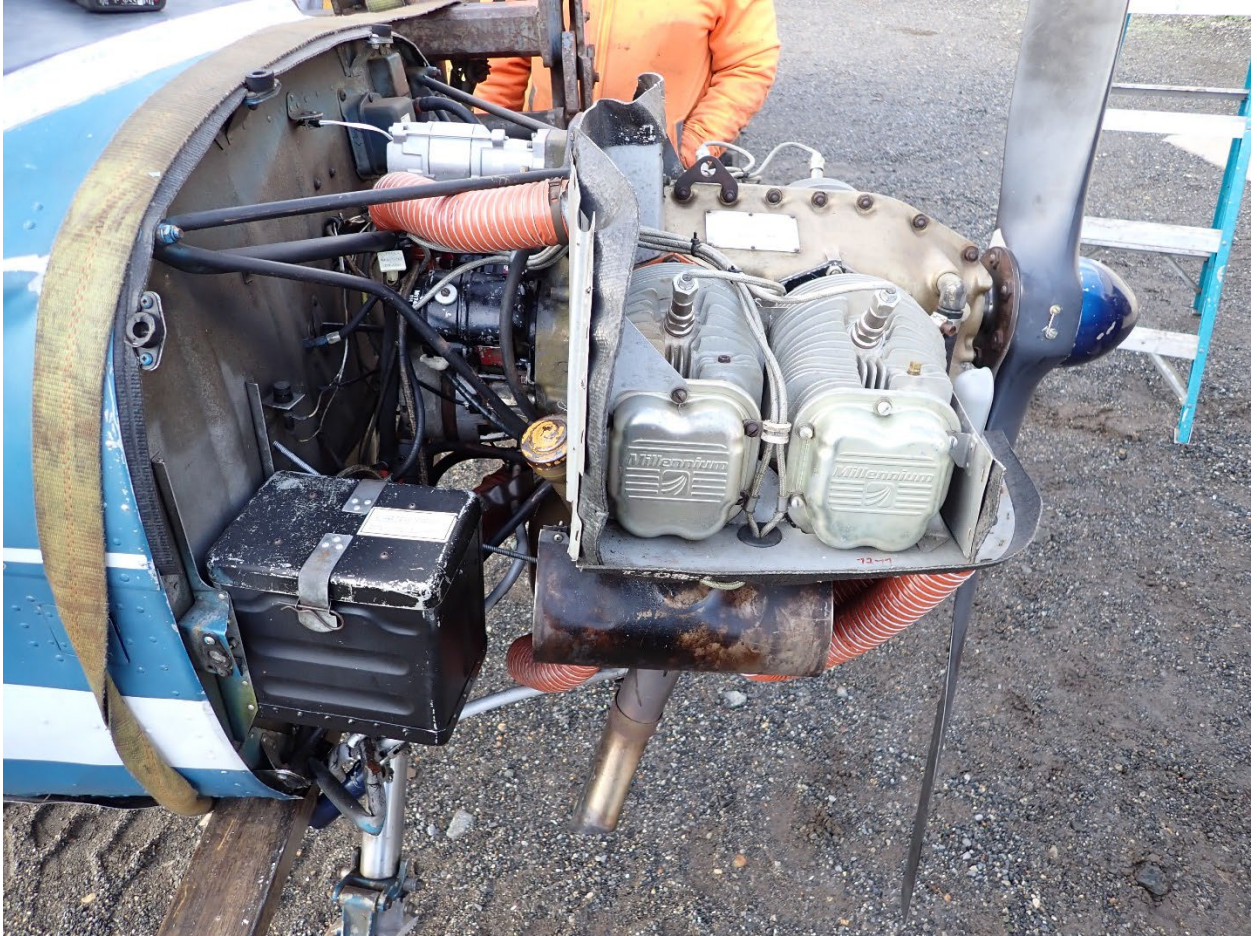
The engine remained attached to the airframe and was elevated by a telehandler to facilitate examination. The engine battery was charged with an external battery charger and an external fuel tank was plumbed into the left-wing fuel system at the wing root. The grounding leads from the magnetos were removed and the airplane was started. It ran smoothly with no pops or crackles from idle to about 2300 RPM. With the engine warm compression and suction were observed on all cylinders through 4 - 720° rotations.

**Figure 3: View of engine from right side**

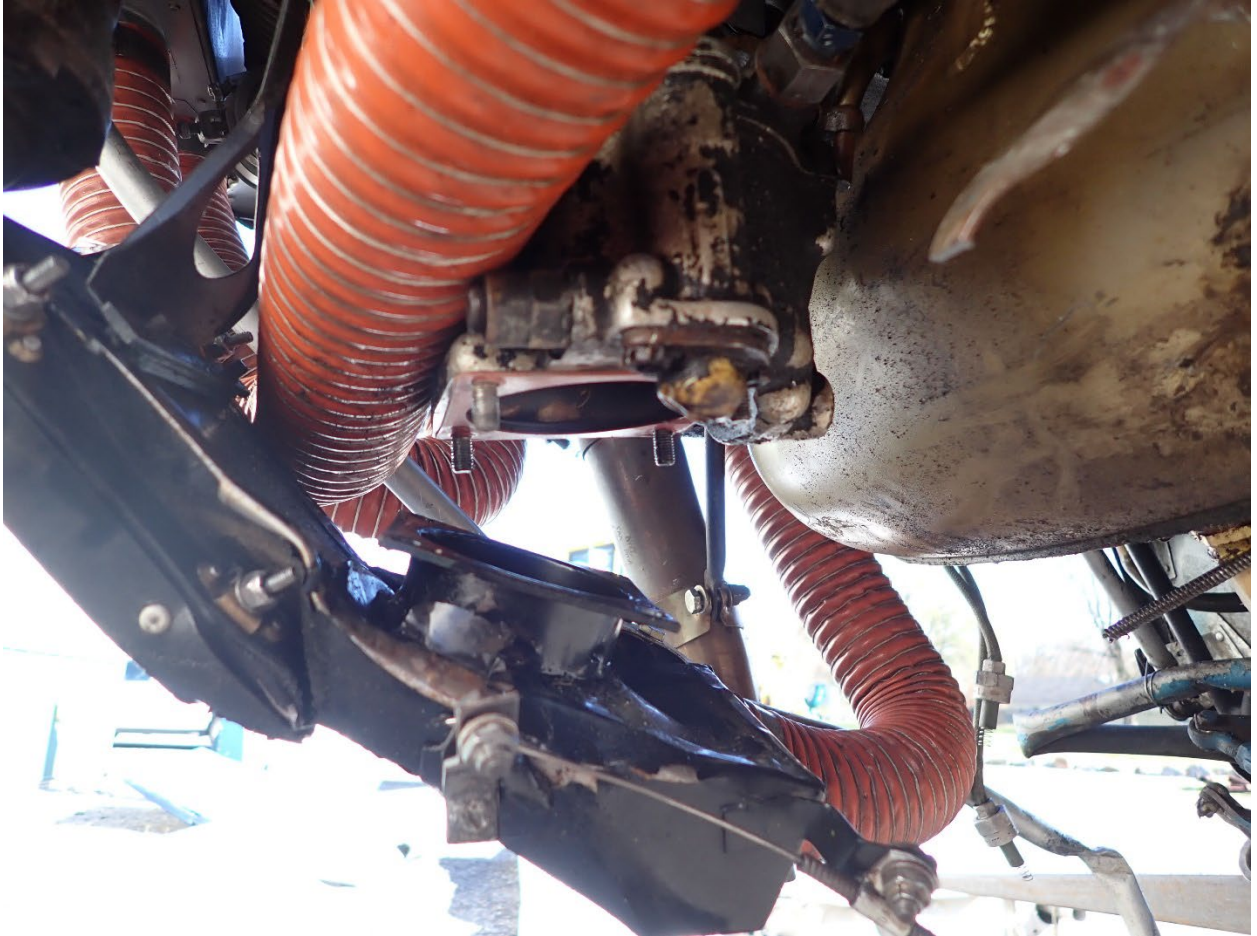
The induction air and carb heat box were impact damaged and removed to facilitate the engine run. The left side exhaust pipe was also impact damaged and removed to facilitate the engine run. The exhaust system was impact damaged and pushed on the mixture control cable.

**Figure 4: Induction air and carb heat box removed**

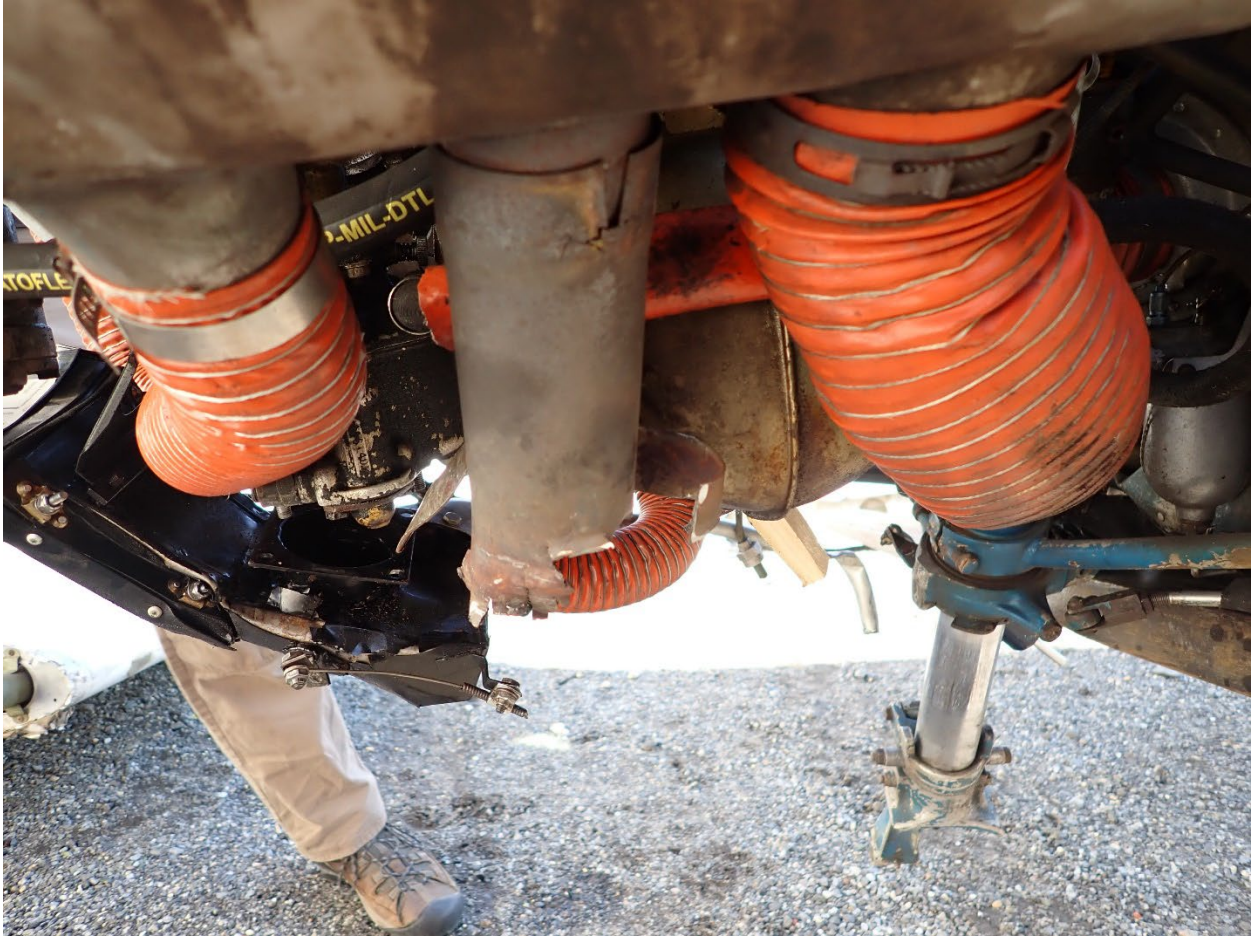
**Figure 5: Removed left side exhaust pipe**

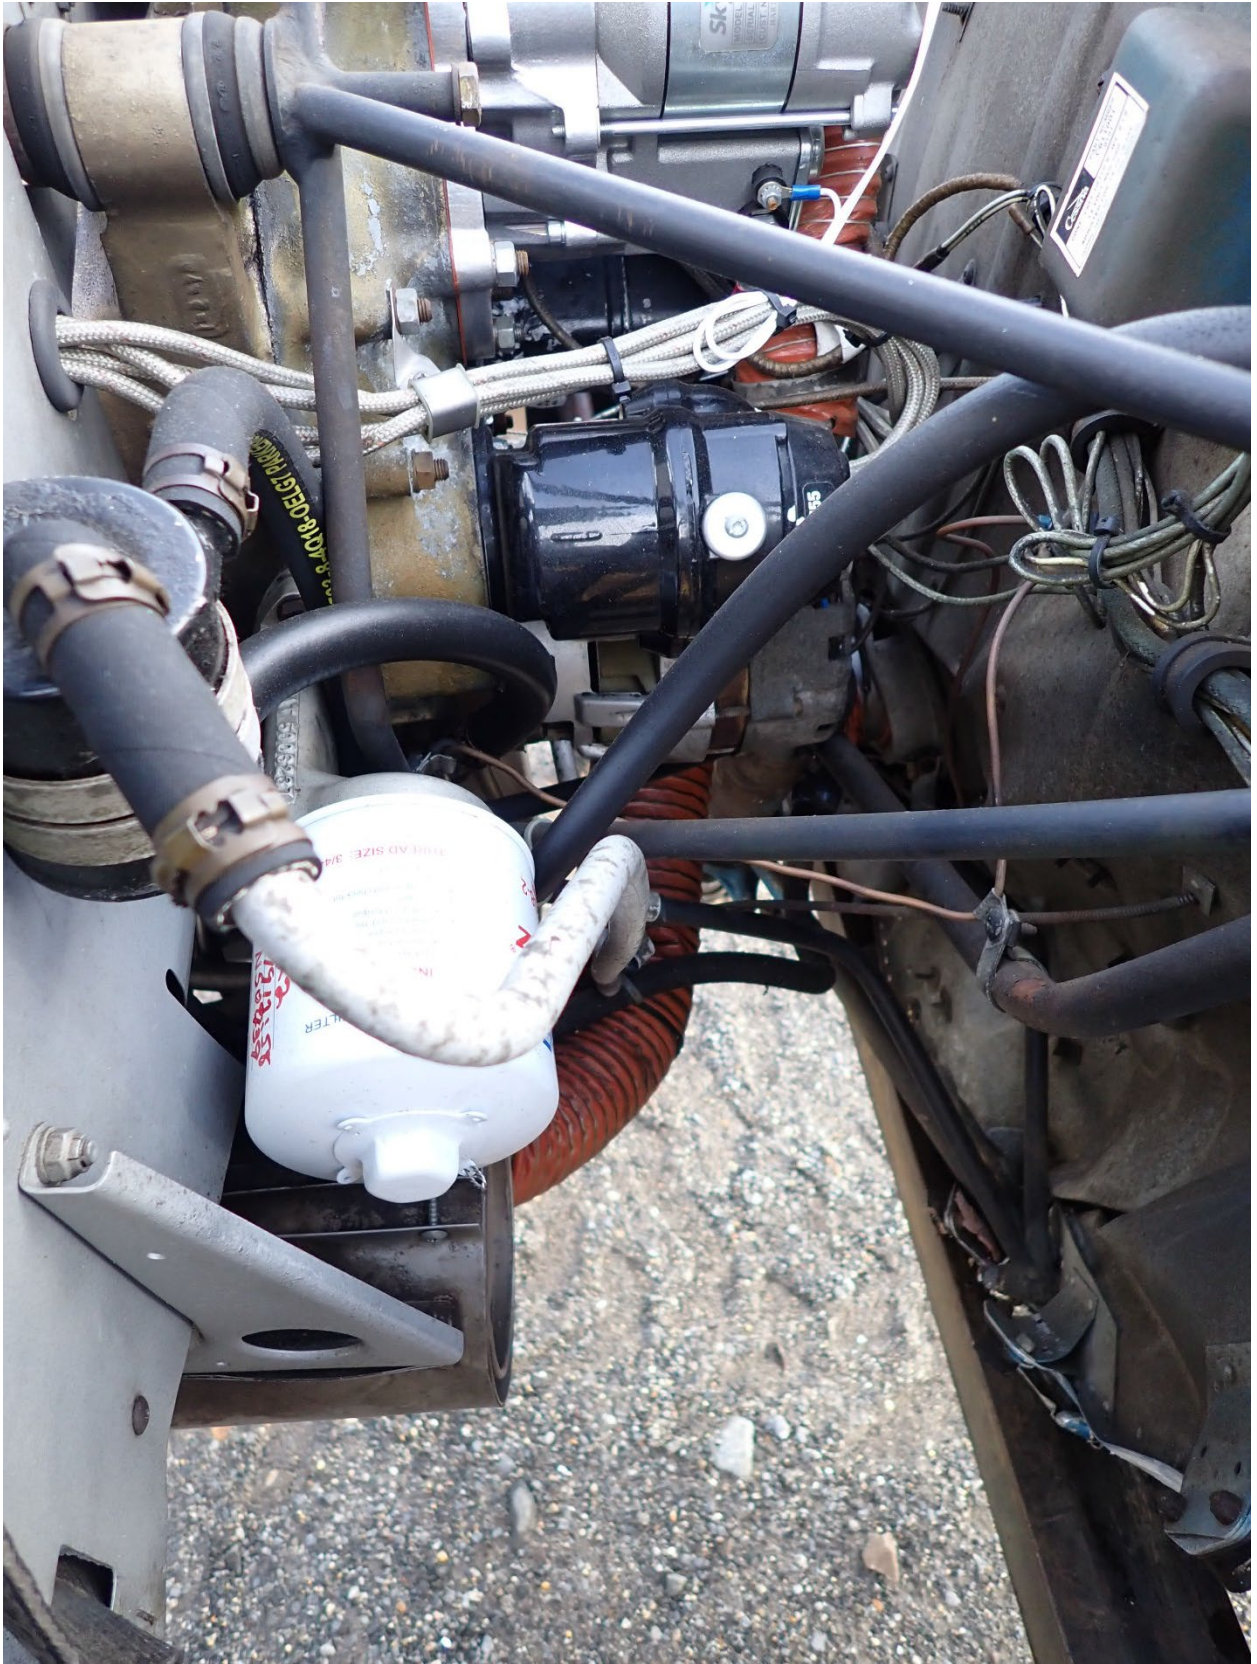
Both magnetos remained attached to the engine accessory case and operated normally. Two of the right magneto leads were impact damaged near the distributor cap. The cap and leads were replaced with a compatible unit to facilitate an engine run.

**Figure 6: Left magneto attached to accessory case**

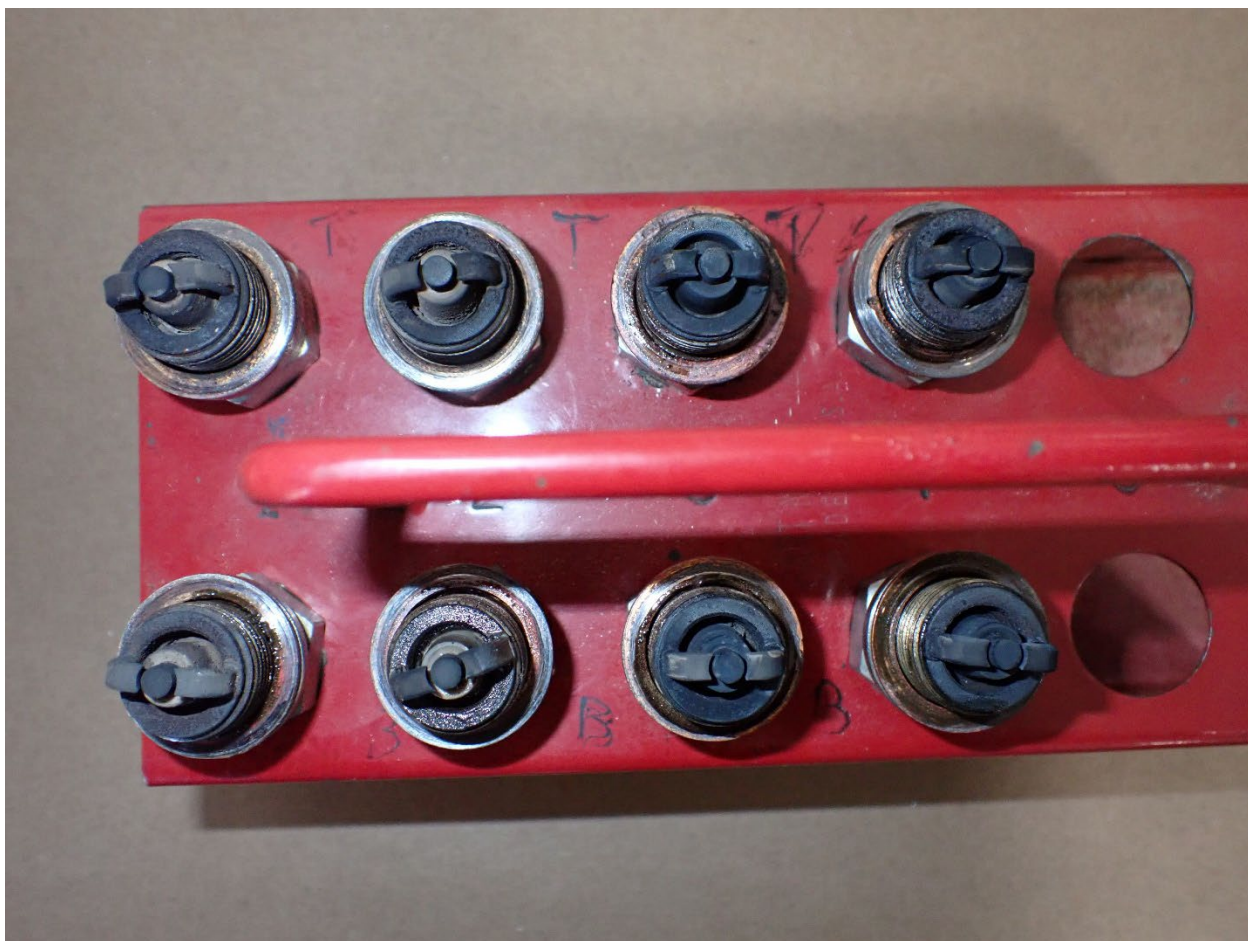
The starter motor remained attached to the accessory case and operated normally. The ignition could not be located to activate the aircraft ignition system so the P leads were removed from the magnetos. The top and bottom spark plugs were removed and showed normal wear when compared to Champion Aviation Check-a-plug. There was slight carbon fouling on the 4T and 3B plugs.

**Figure 7: Top and bottom spark plugs**

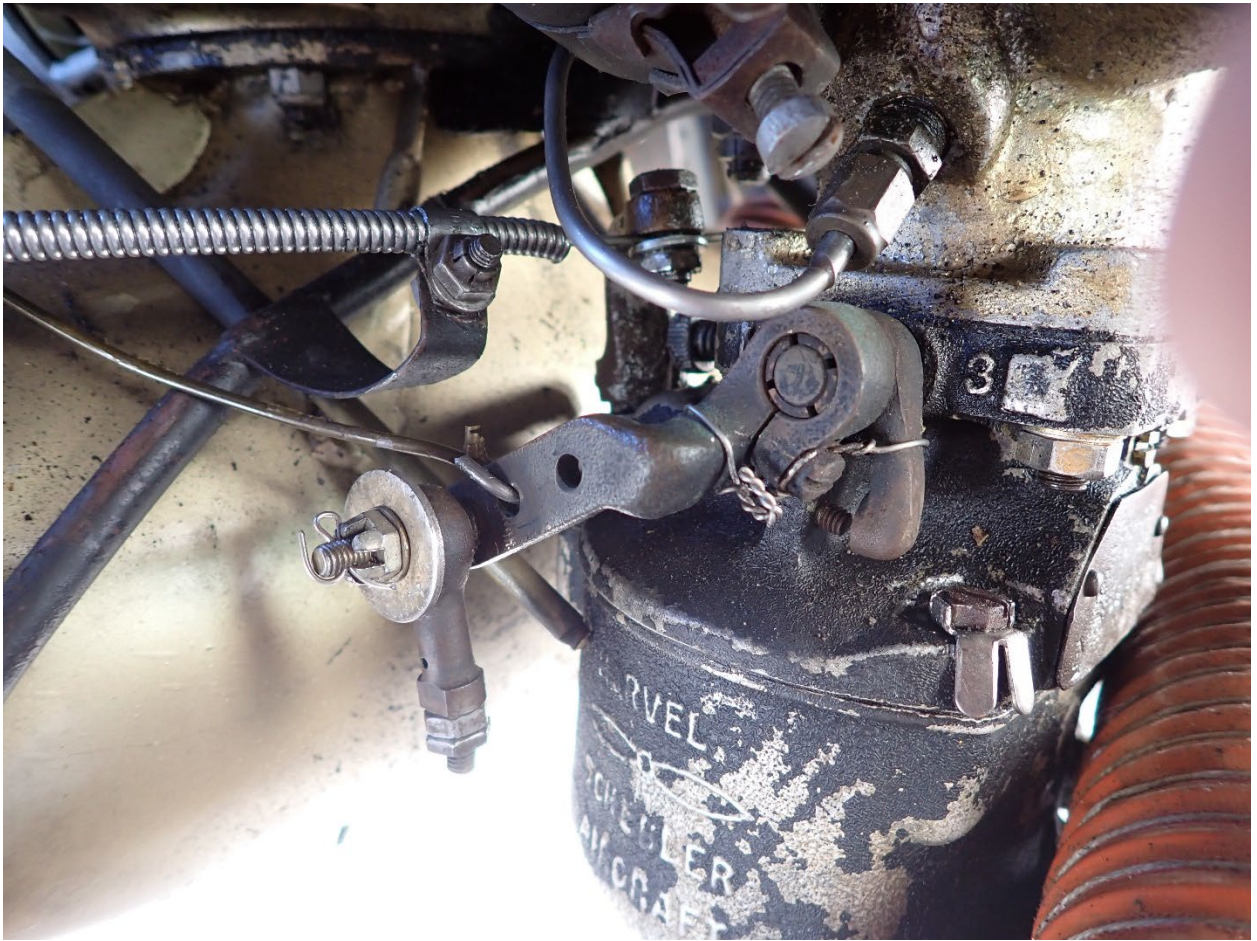
The throttle cable was broken through overstress and a cable was attached to facilitate engine run. The mixture cable was adjusted to compensate for the exhaust system damage to allow full travel of the mixture. A portable fuel container was fixed to the support equipment and plumbed into the left-wing tank fuel line and 100LL aviation fuel was added to the container. Fuel flowed through the fuel system to the right wing, which was capped. The fuel selector valve was selected to OFF, no fuel was present at the carburetor. With the fuel selector valve selected to ON, fuel was present at the carburetor.

**Figure 8: Broken throttle cable and replacement fashioned to facilitate engine run**

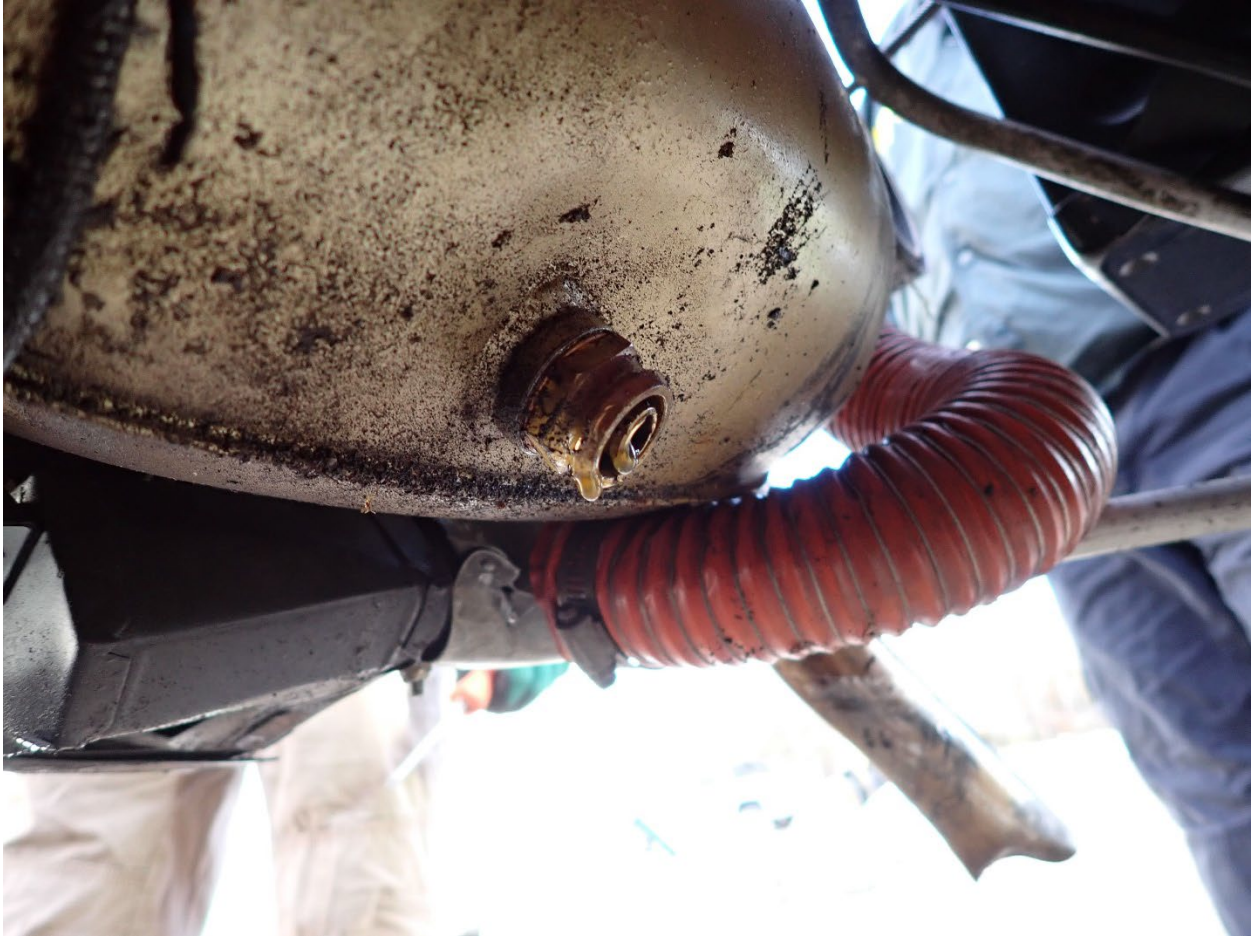
The quick oil drain was impact separated and the engine contained no visible oil on the dip stick. The oil sump drain plug was impact separated. A wooden plug was inserted into the drain to prevent leakage and 4 quarts of oil was added for the test run. The oil pressure line from the accessory housing was fractured. A cap was used to prevent leakage. 4 quarts of 20w-50 aviation oil was added to the system.

**Figure 9: Broken oil quick drain**

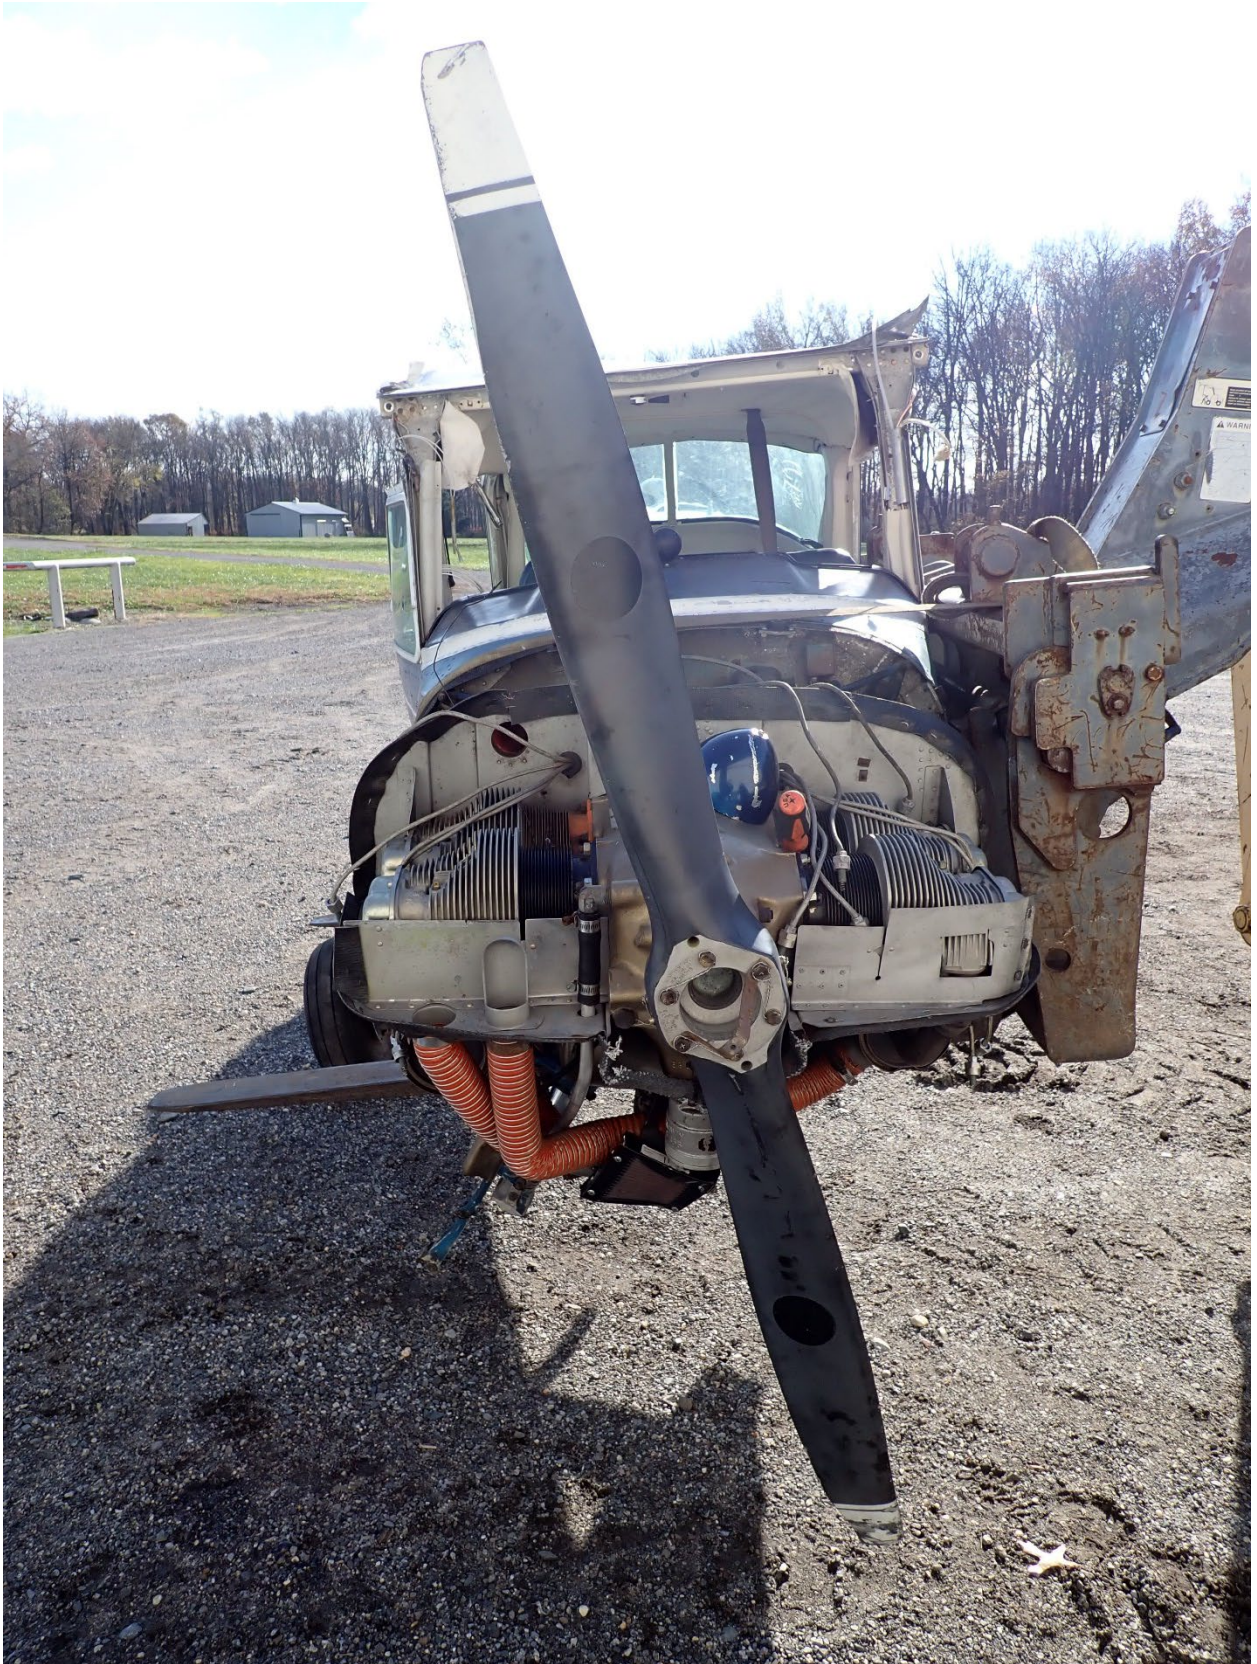
McCauley 69 inch fixed pitch propeller remained attached to the engine at the hub with 1 tip bent aft. The propeller had a measured pitch of 16°. One of the propeller blades was bent aft approximately 45 degrees near the tip. The blade was straightened to within about 10 degrees of straight.

**Figure 10: Propeller**

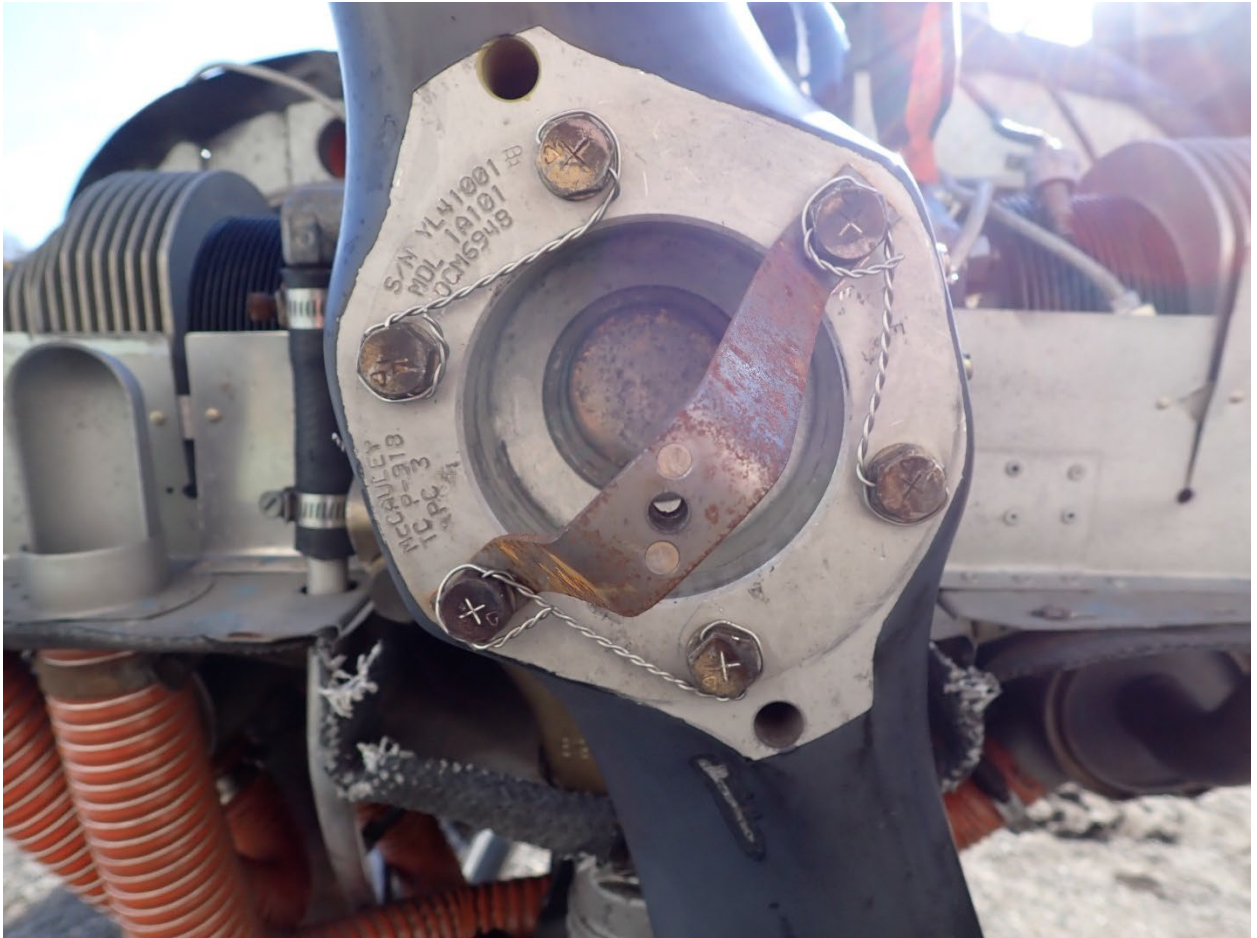
**Figure 11: Propeller hub**
