**NATIONAL TRANSPORTATION SAFETY BOARD**  
Office of Aviation Safety

**Engine Examination**

**A. ACCIDENT      ERA22LA366**

Location:            Carolina Bch, NC  
Date:                June 29, 2022  
Aircraft:            Piper Pa-32RT-300  
Engine:             Lycoming IO-540-K1G5D sn L-19009-48A  
Registration:       N4321M

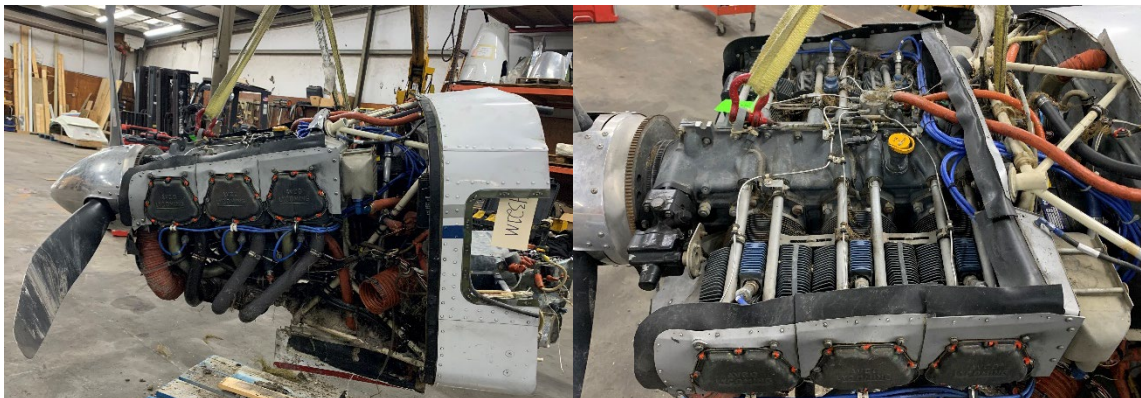
The engine was submerged and had not been preserved during the 3 ½ months between the date of the accident and the date of the engine exam. Water drained from the engine crankcase when the oil sump oil suction screen was removed. As first viewed, the fuselage had been cut and the propeller, engine, engine mount, and firewall were laying on a pallet at the facilities of Atlanta Air Recovery (AAR), in Griffin, GA. The engine was suspended from a lift, removed from the nose of the aircraft with the engine firewall and partially disassembled to facilitate the examination.

**Photograph 1 – Accident engine pre-examination.**

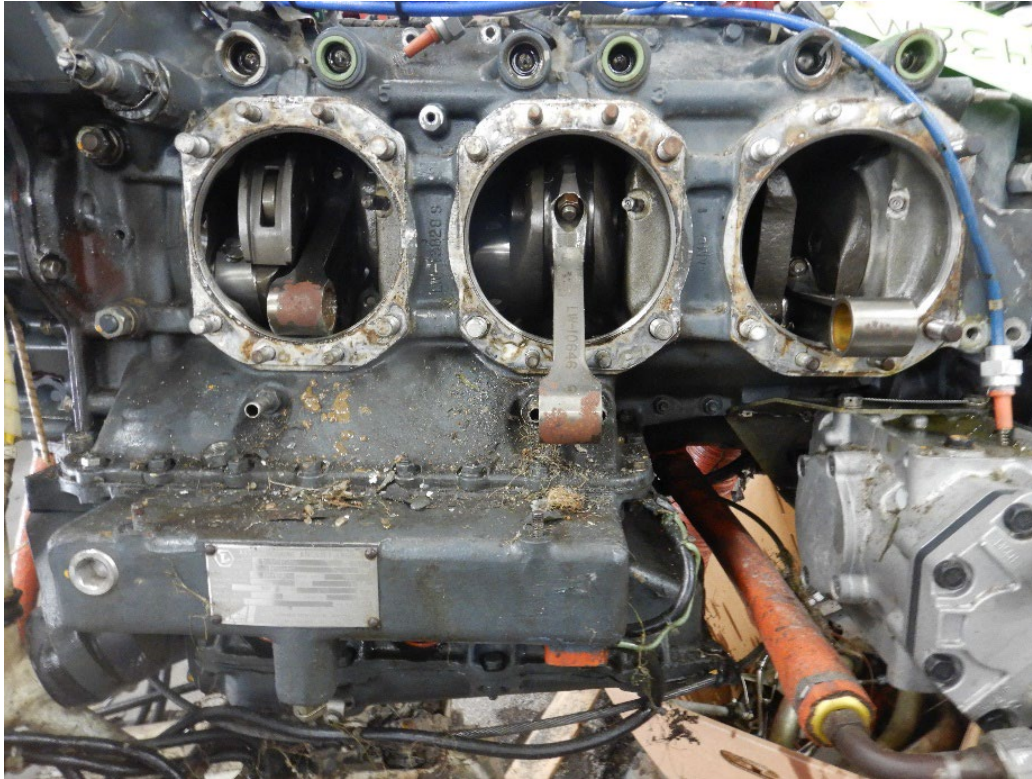
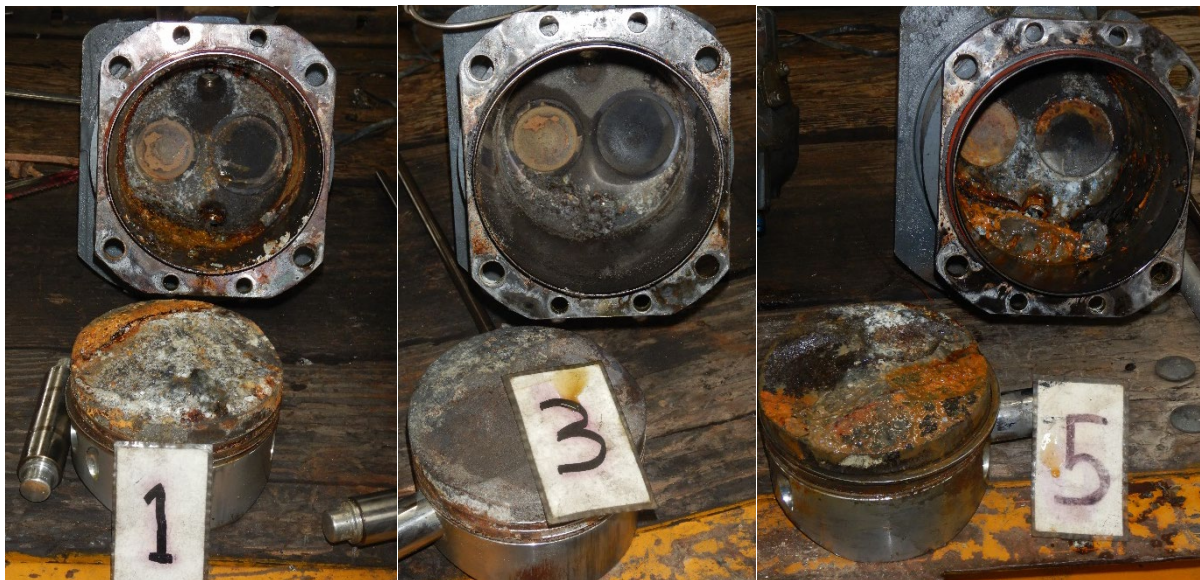
An attempt to rotate the crankshaft by turning the propeller was unsuccessful. The interiors of the cylinders were viewed using a lighted borescope. Water and corrosion debris were observed in the cylinders. The cylinder barrel walls exhibited heavy corrosion.

**Photograph 2 – Cylinder 1-3-5**

**Photograph 3 – Cylinder 1-3-5**

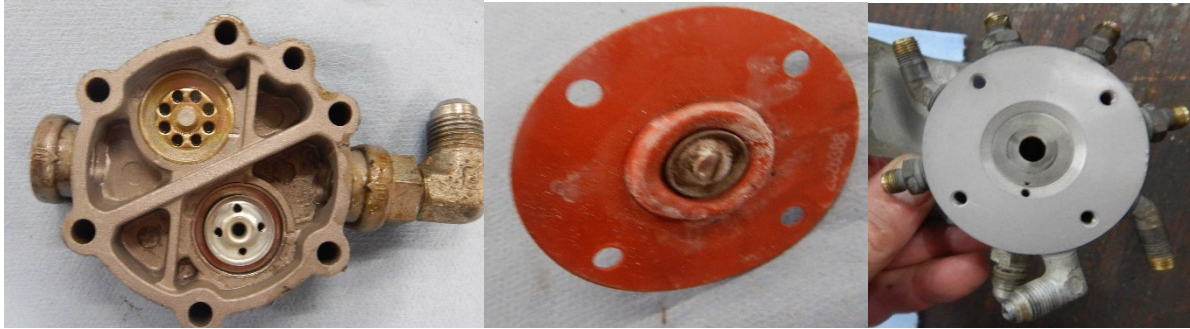
**Photograph 4 – Fuel system components.**

The fuel injector servo remained attached to the engine and no damage was noted. The throttle and mixture cables remained attached to the throttle and mixture control arms. Liquid with an odor consistent with aviation gasoline drained from the servo when it was tilted and from the fuel hoses from the engine driven fuel pump to the servo and from the servo to the flow divider. The servo fuel regulator section was partially disassembled, and no damage noted to the rubber diaphragms or other internal components. The servo fuel inlet screen was absent of debris. The fuel flow divider remained attached to the engine and no damage was noted. The metal fuel injector lines were secure. The flow divider was partially disassembled. A few drops of water drained from the flow divider. No damage to the rubber diaphragm or other internal components was noted. The fuel injector nozzles were secure and unobstructed.

The engine driven fuel pump remained attached to the engine and no damage was noted. Liquid with an odor consistent with aviation gasoline drained from the pump when it was removed and tilted. The pump produced air at the outlet port when it was operated by hand. The pump was partially disassembled and no damage to the rubber diaphragms or internal check valves observed.

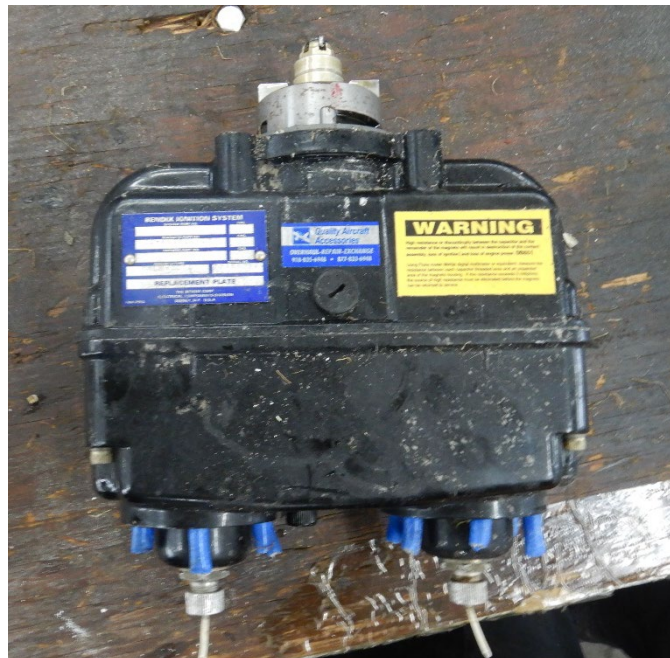
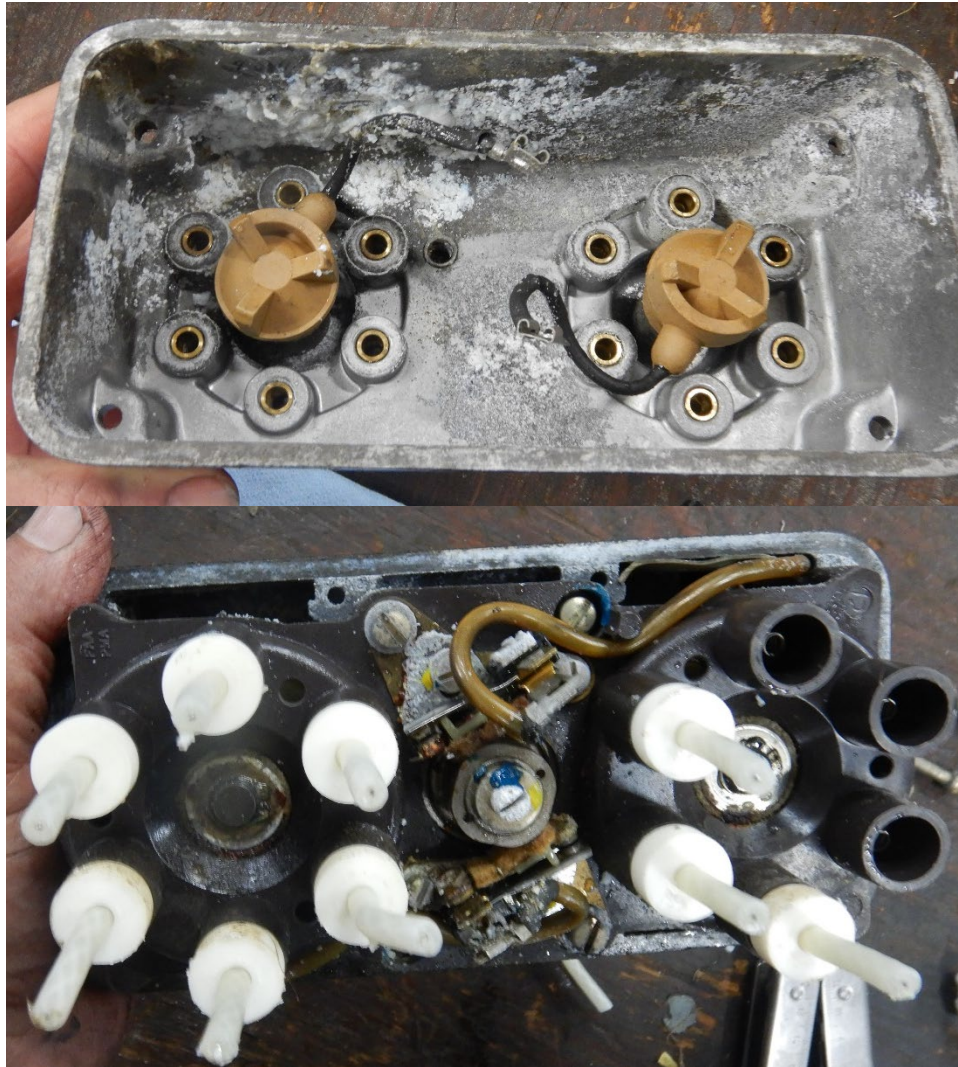
**Photograph 5 – Magneto.**

**Photograph 6 – Magneto - internal view.**

The magneto remained securely attached to the engine and no external damage was noted. The magneto was removed and rotated using an electric drill/driver. Spark was produced from all of the left magneto ignition towers but none of the right towers. The magneto was partially disassembled, and water and corrosion products observed on the internal components, including the contact points.

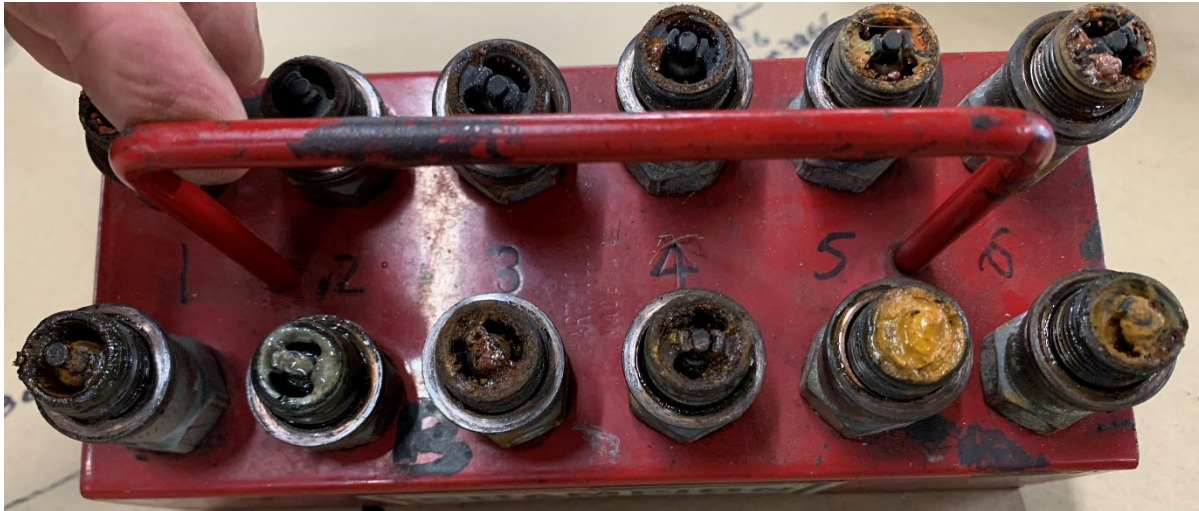
**Photograph 7 – Accident engine spark plugs.**

The spark plugs were a mixture of Autolite UREM38E and Champion REM38E manufacture. The spark plug electrodes exhibited dark gray coloration and worn normal condition. Water and corrosion were observed in the spark plug electrode wells. No damage to the ignition harness was noted. It was not tested.

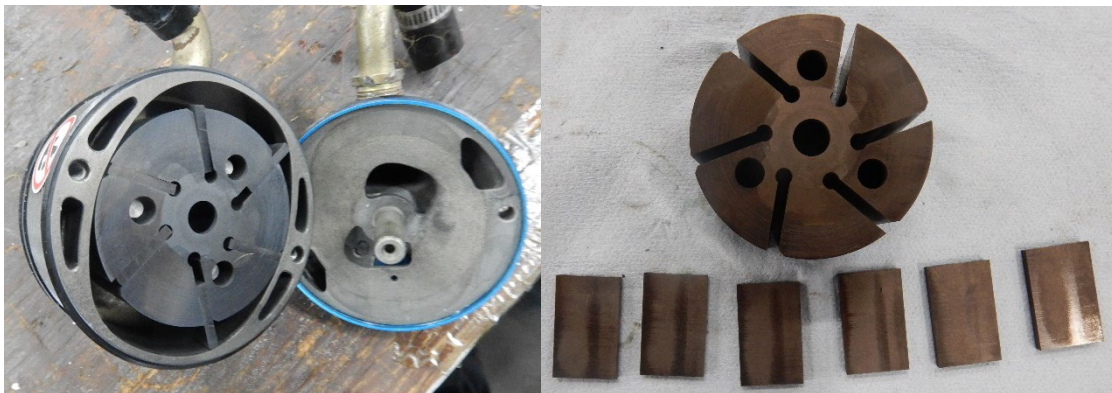
**Photograph 8 – Vacuum pump internal components.**

The vacuum pump remained attached to the engine and no damage was noted. It was removed and produced air at the outlet port when rotated by hand. The pump was partially disassembled. The composite drive assembly, carbon vanes and carbon rotor were intact.

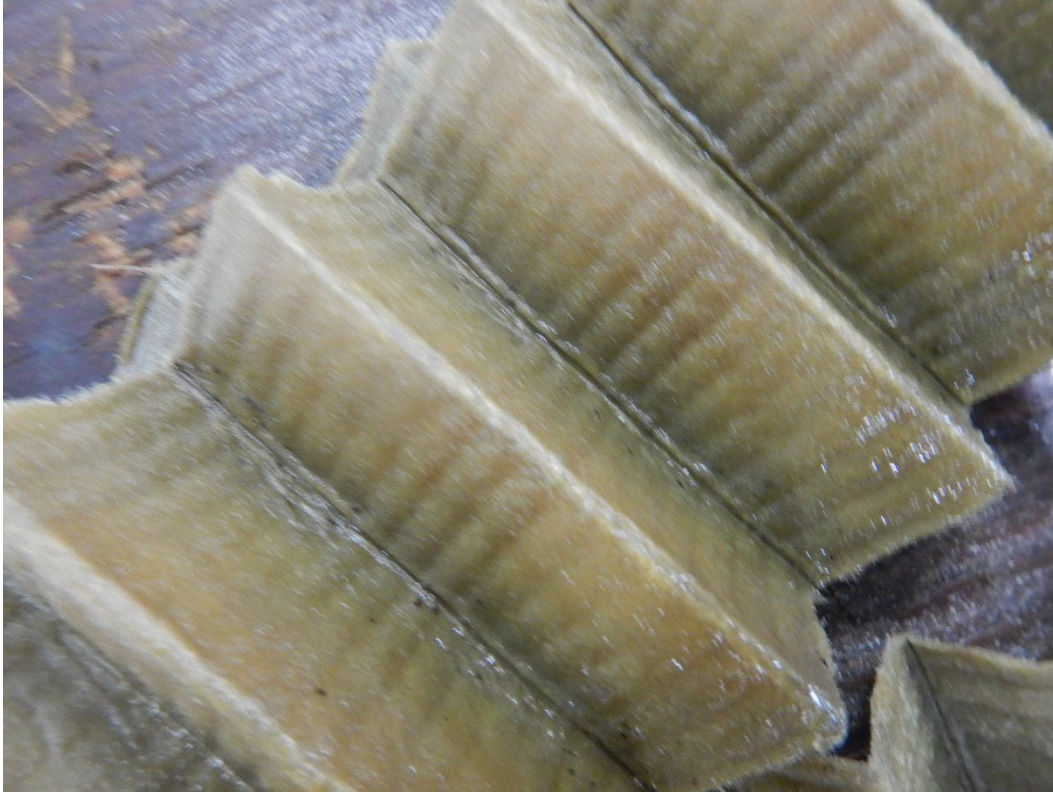
**Photograph 8 – Oil filter.**

Water and oil drained from the engine crankcase when the oil suction screen was removed. The oil suction screen exhibited wet, white corrosion products but no metallic debris. The oil filter media was absent of debris.
