U.S. Department  
of Transportation  
**Federal Aviation  
Administration**

Accident: NTSB ID ERA22LA369

Subject: After Action Brief, Teardown and Inspection Observation for CESSNA N4751F

**NTSB Accident Number: ERA22LA369**  
**Subject: Loose magneto cap reference in examination summary**  
**Date: 10/25/2022**

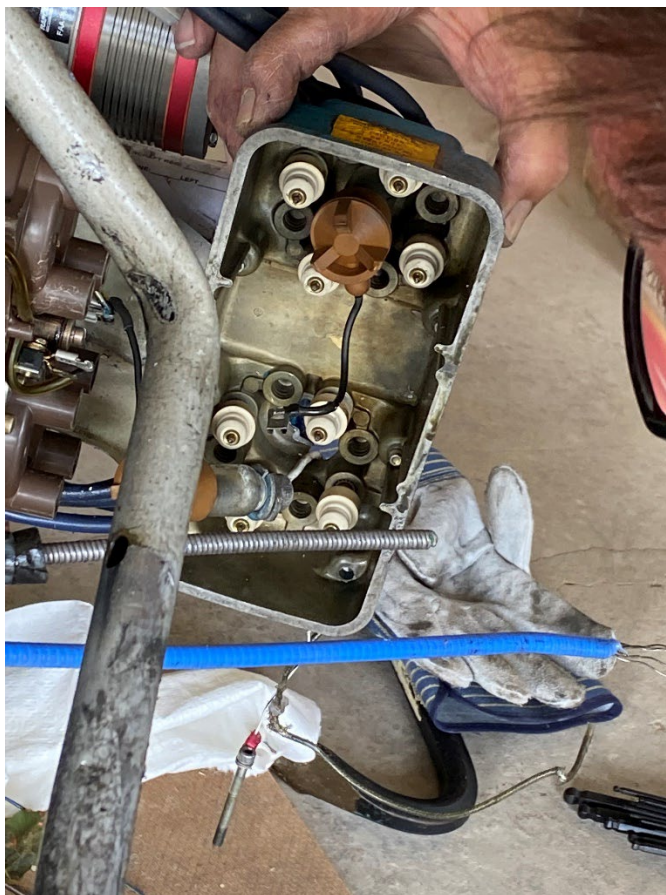
were observed when the MAG drive shaft was manually rotated. An attempt was made to time the MAG utilizing a buzz box/timing light. The R MAG had heavy damage and was unable to time, the L MAG appeared to have limited damage and an attempt was made to time but timing failed. The engine was rotated several times to establish Top Dead Center (TDC) when performing this check. To rotate the engine, the technician applied a spinning force with a hand tool to the engine crankshaft output flange. After the check, removed MAG from engine and observed the case cover/cap of MAG was loose. Further inspection revealed the (4) each fasteners holding the MAG cover/CAP were found to be loose.

Photo IMG\_0365.jpg, taken by the FAA on August 15, 2022, before wreckage recovery, showed the magneto cap off with someone holding it. This is relevant to the examination findings that describe the loose cap at the post-recovery examination.

*Photo 1 - Magneto with cap removed (Photo Courtesy of FAA)*
