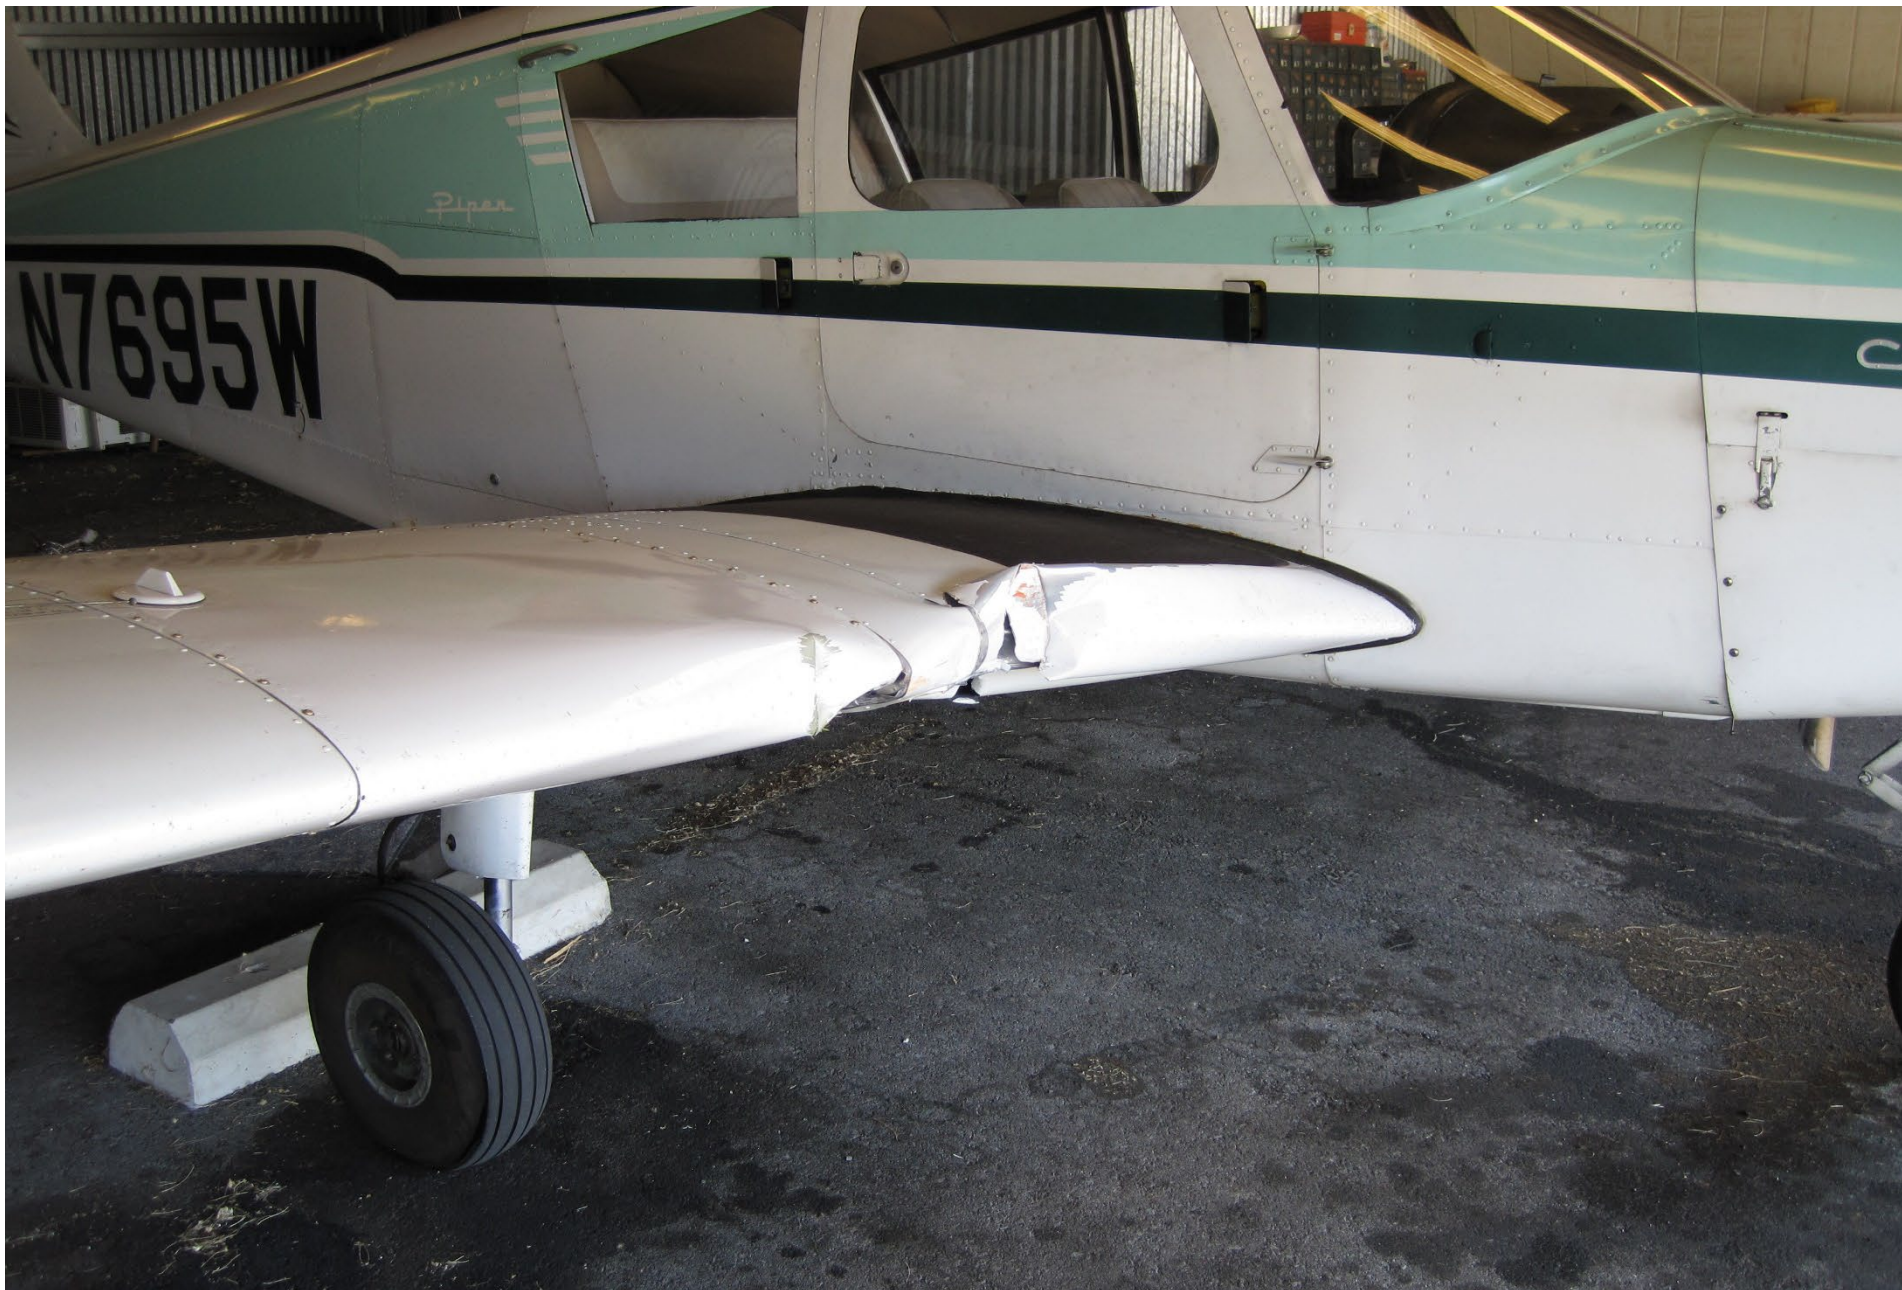
**Photo 1 – Right wing leading edge damaged, (FAA)**

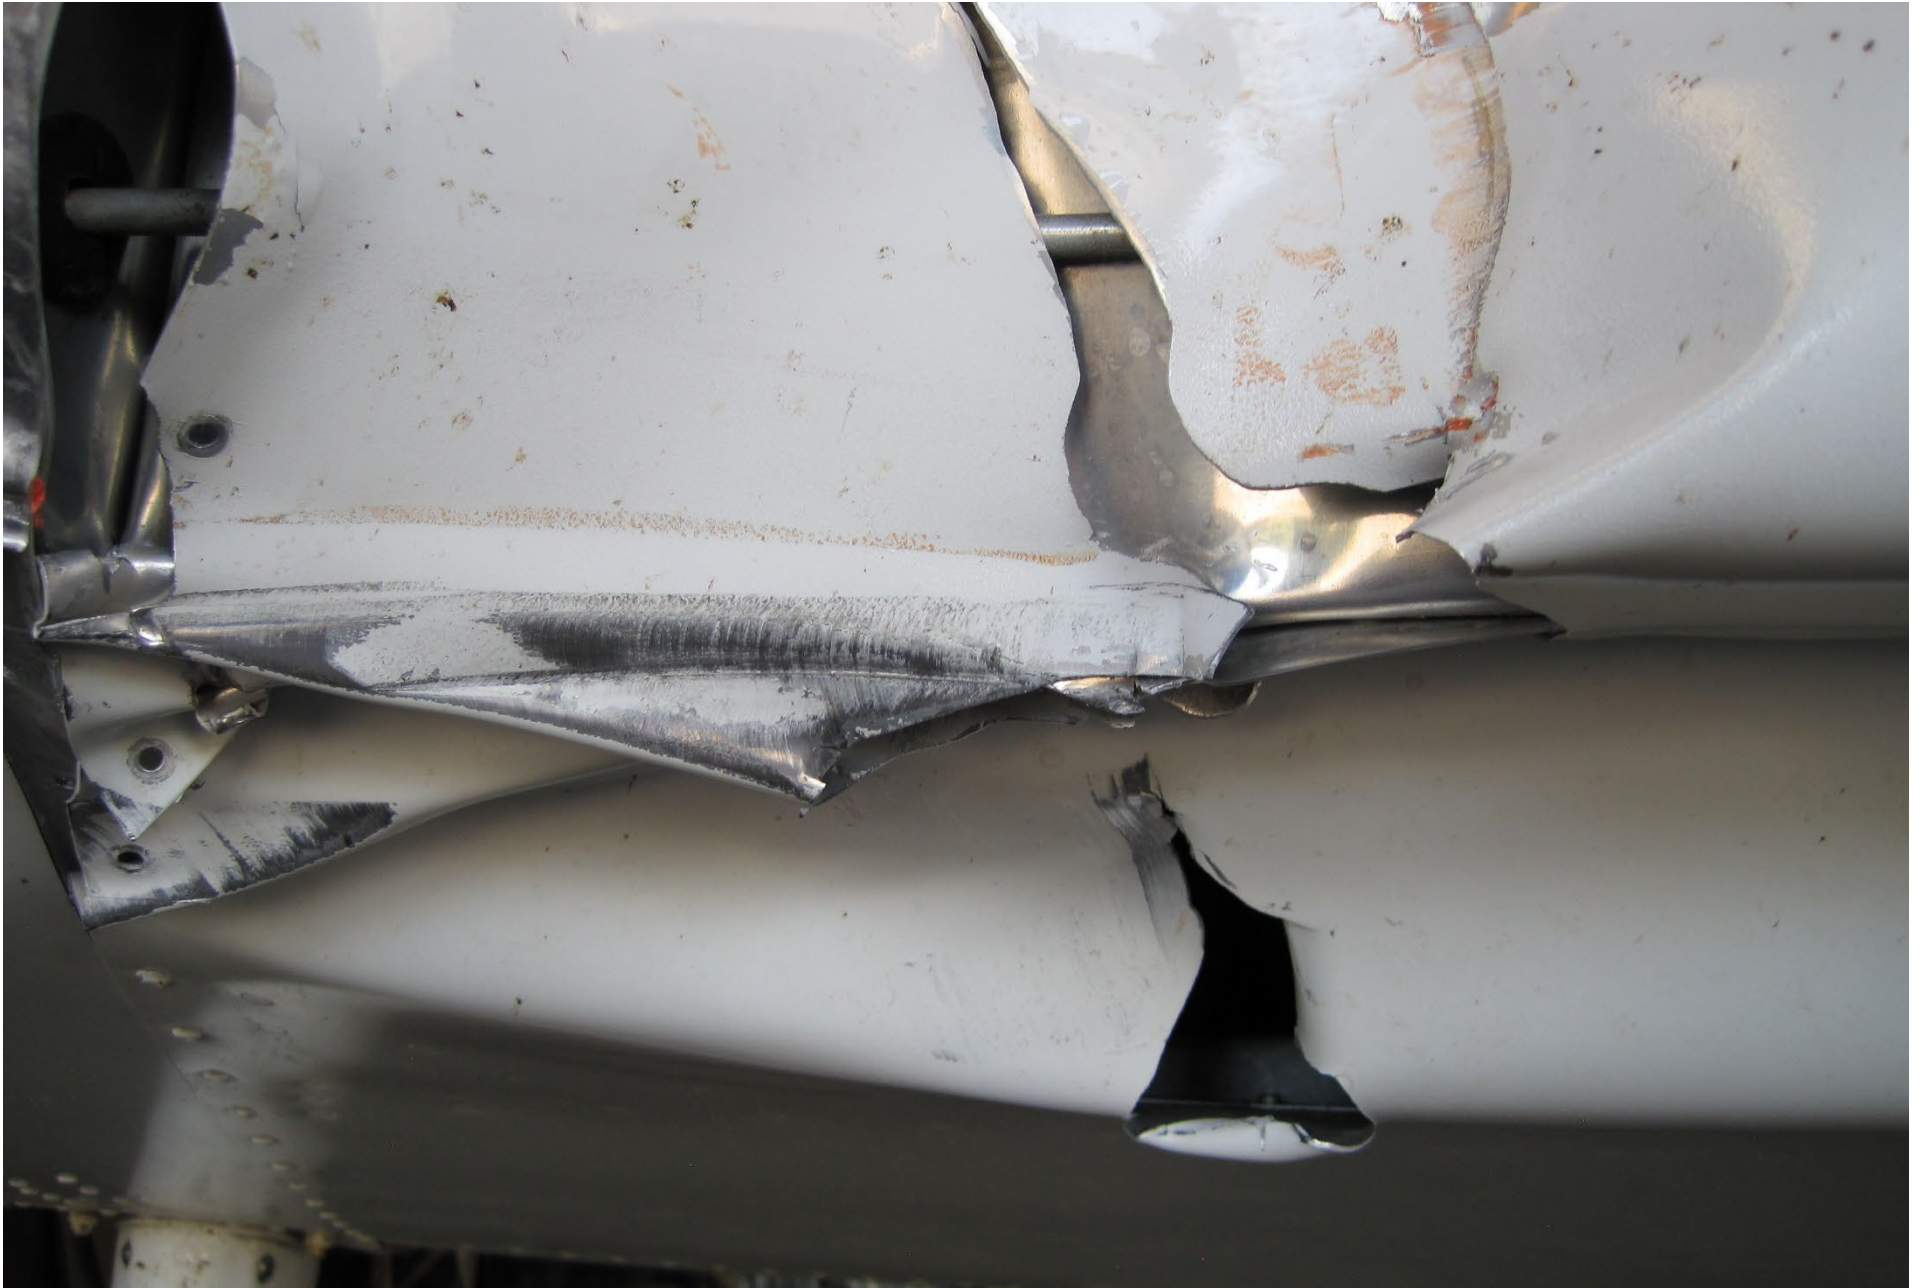
**Photo 2 – Bent spar (FAA)**
