ERA22LA378

## INVESTIGATION PHOTOGRAPHS

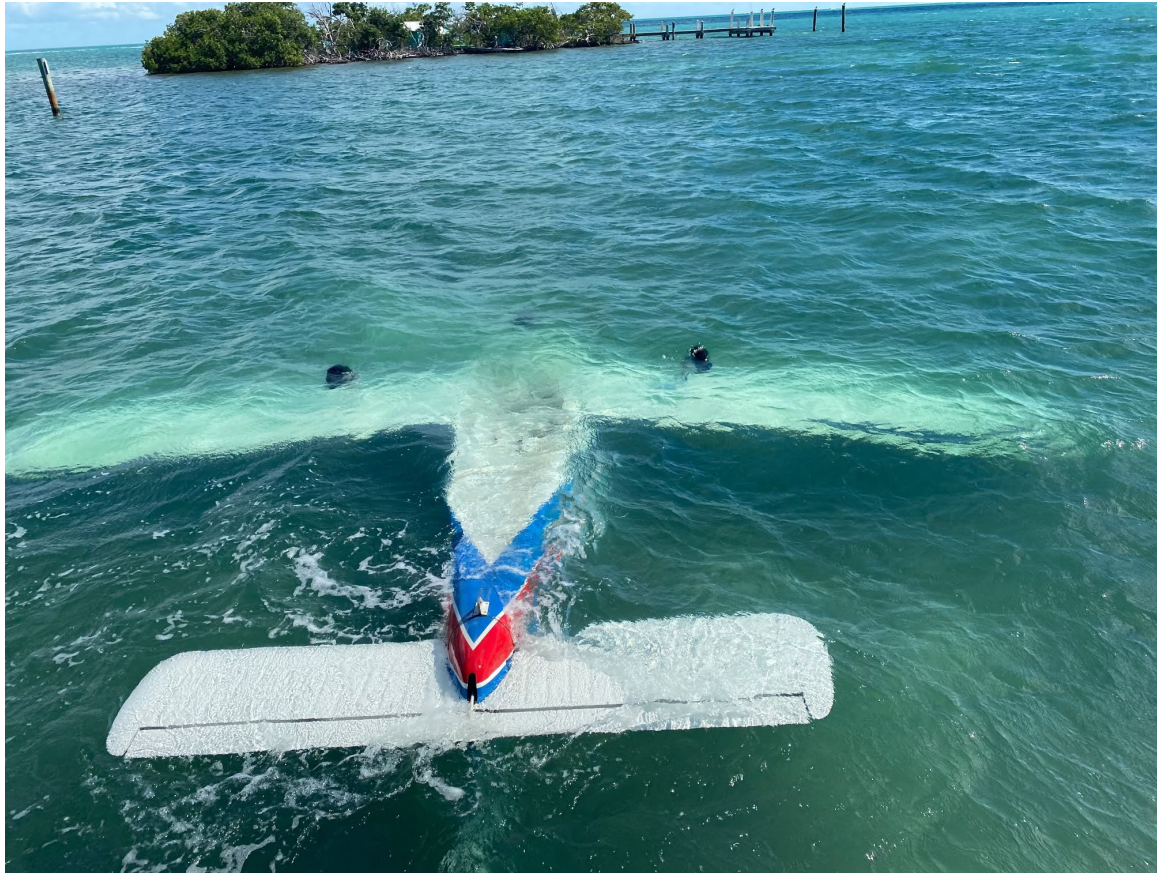
**Photograph 1 - View of airplane submerged in saltwater (Courtesy of FAA)**

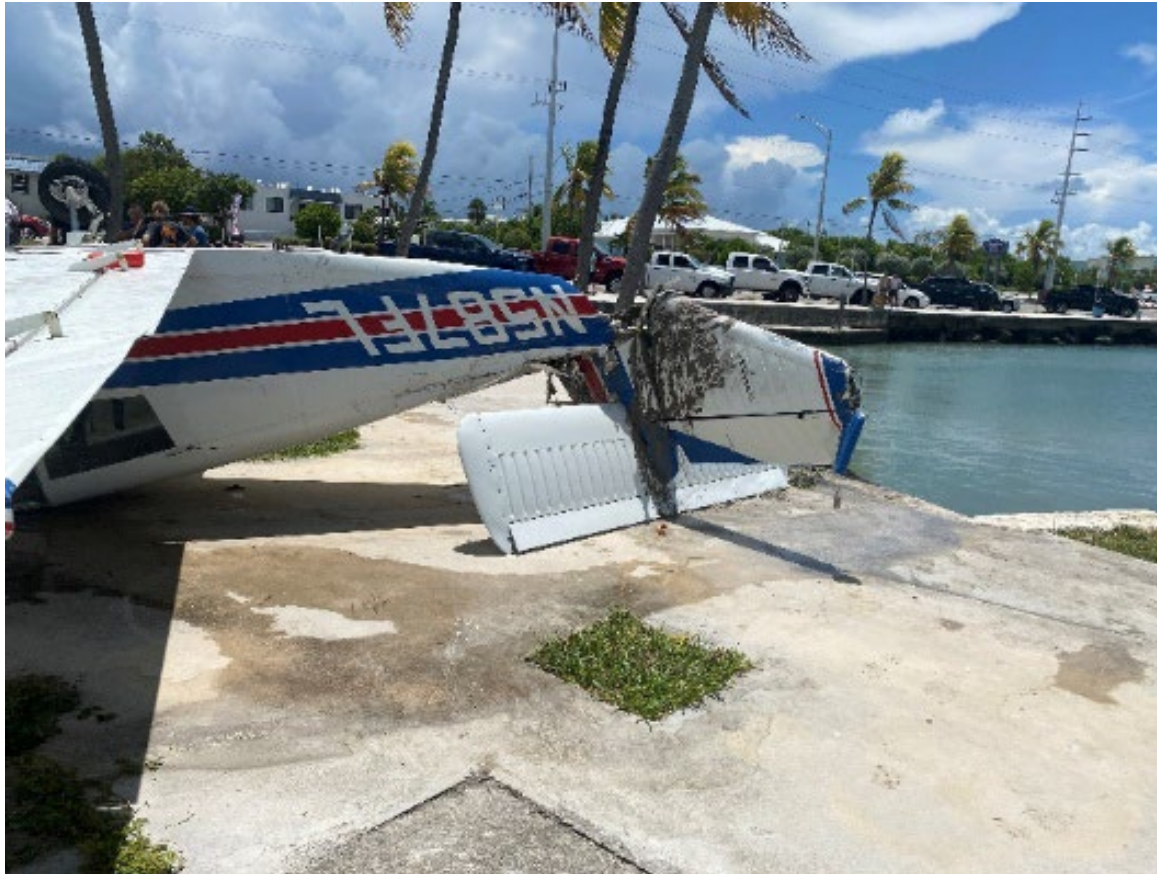
**Photograph 2 - View of airplane after recovery (Courtesy of FAA)**

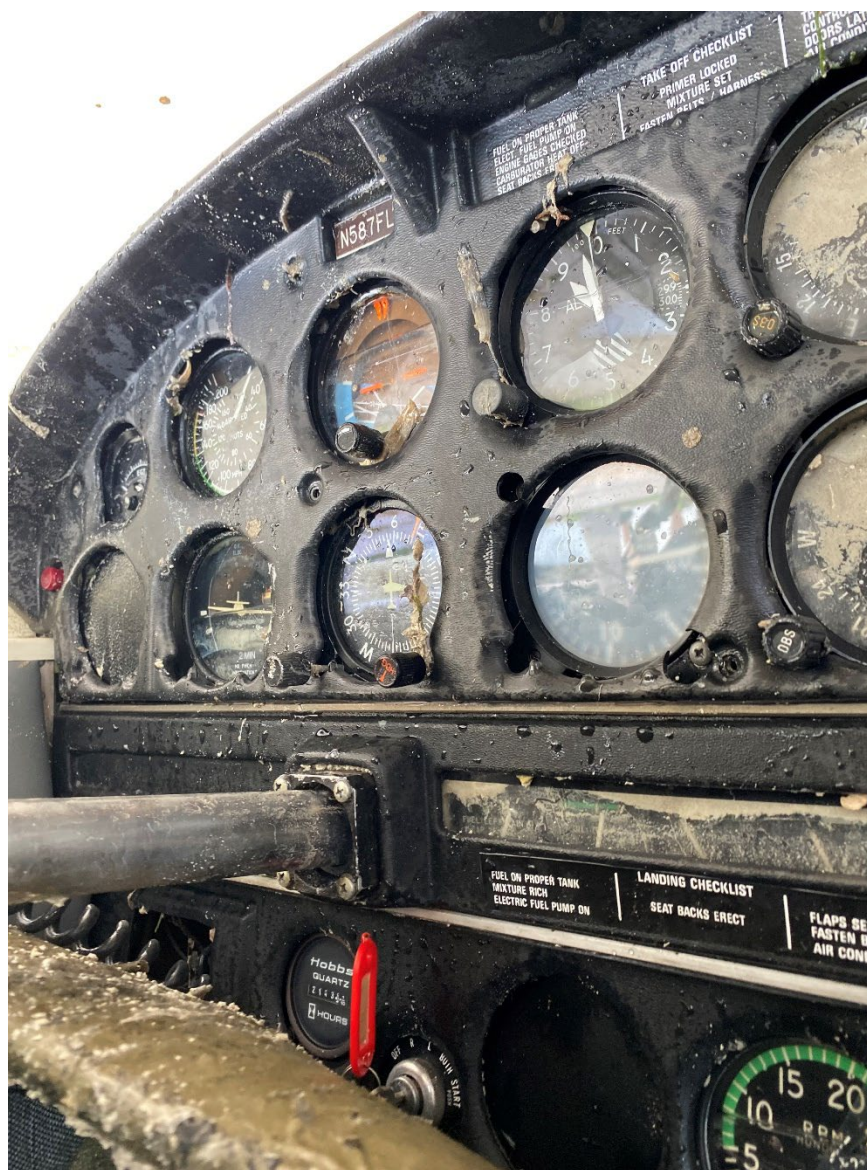
**Photograph 3 - View of instrument panel (Courtesy of FAA)**

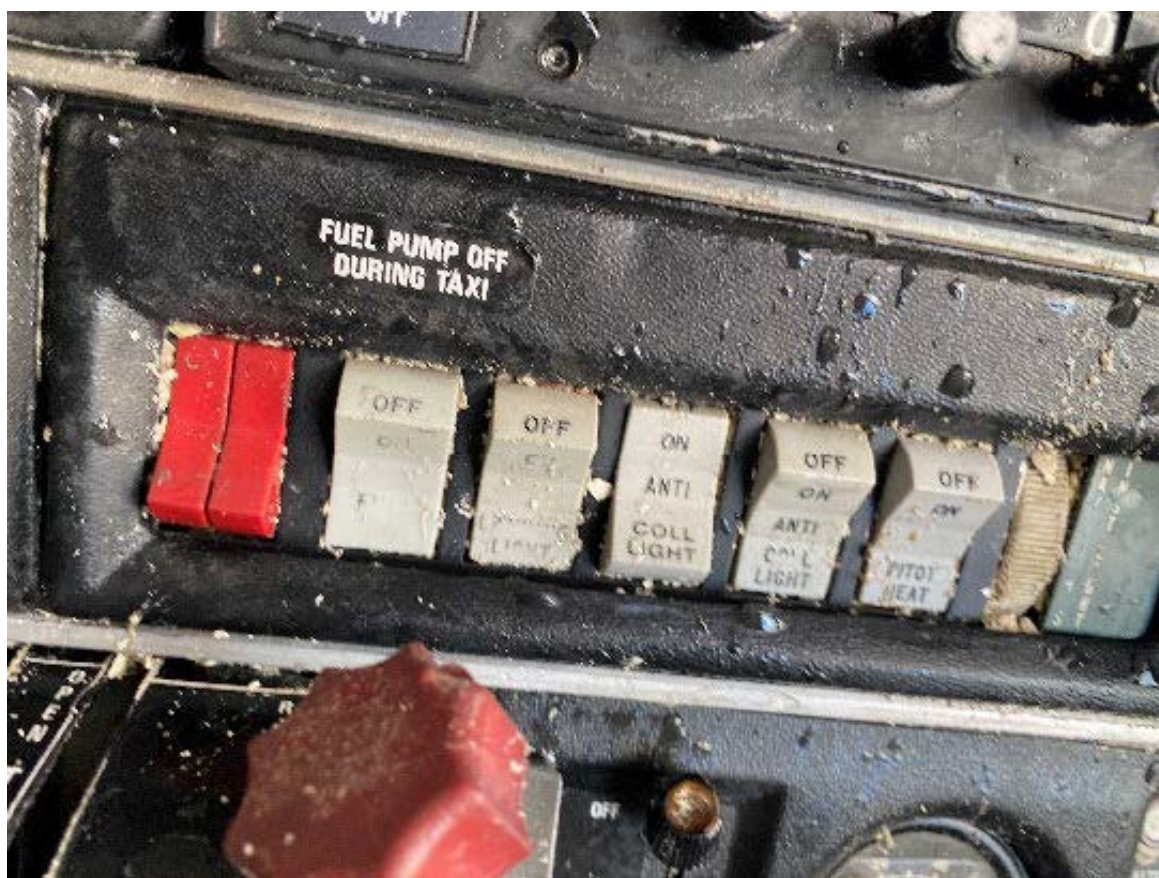
**Photograph 4 - View of cockpit switches (Courtesy of FAA)**

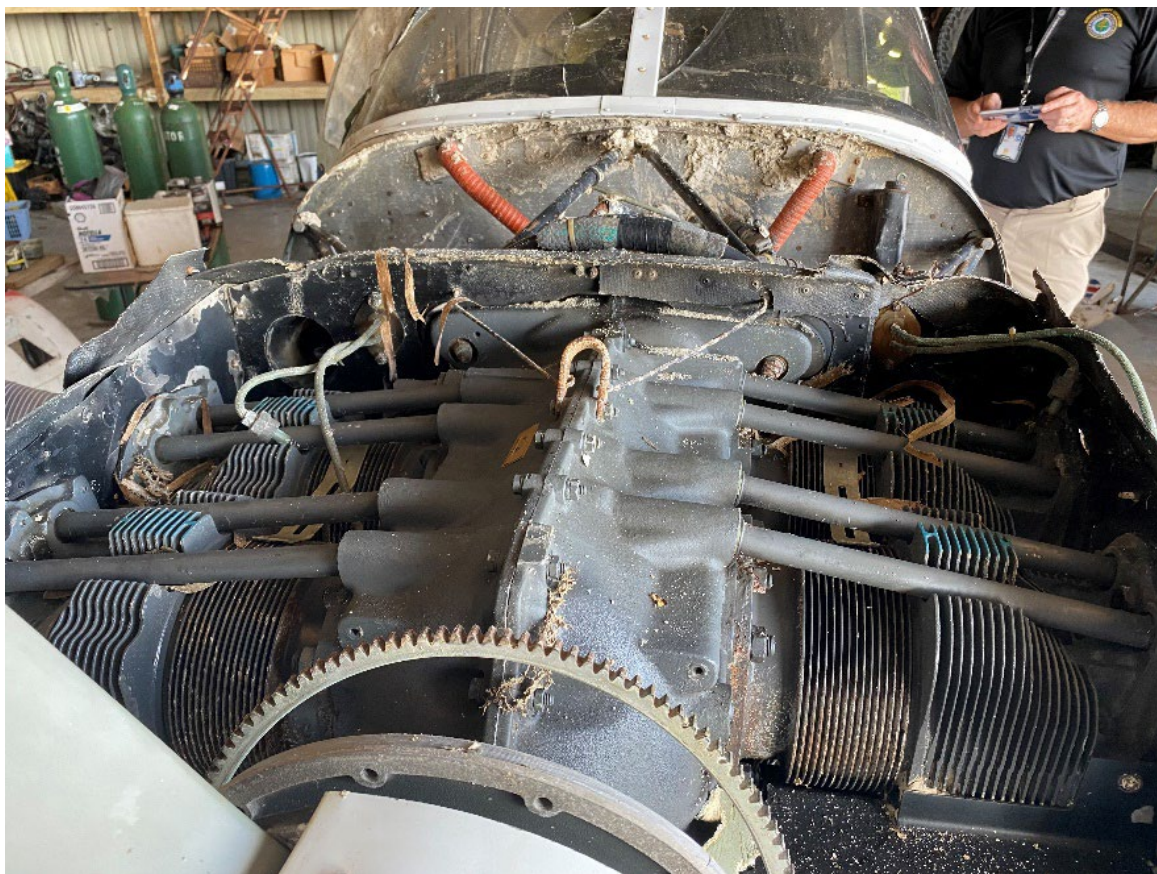
**Photograph 5 - View of engine with cowling removed (Courtesy of FAA)**
