U.S. Department  
of Transportation  
**Federal Aviation  
Administration**

### Inspectors Statement – Accident Investigation

| Personal | Records | Aircraft |
|---|---|---|
| FAA: ASI Amanda Quevedo<br>FAA: ASI Ricardo Queiroz<br>FAA: ASI Donald Casto<br>NTSB: Millicent Hill<br>A&P/IA: Patrick Kuhn | NTSB # ERA22LA378<br>ATQA No.: A-SO-19-22-065<br>SAS Activity ID: SO19202214337 | Registration: N587FL<br>Serial Number: 28-7125446<br>Model: PA-28-140<br>Make: 1971 PIPER |

N587LF - ERA22LA378 – ATQA: A-SO-19-22-065

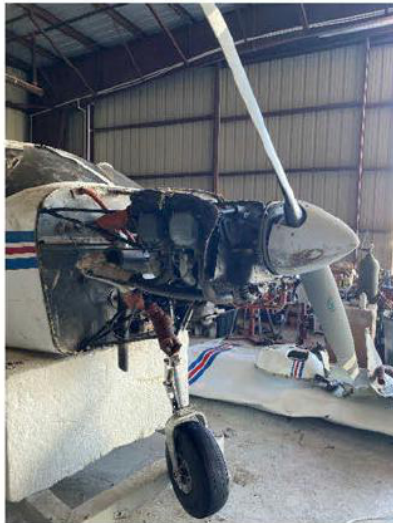
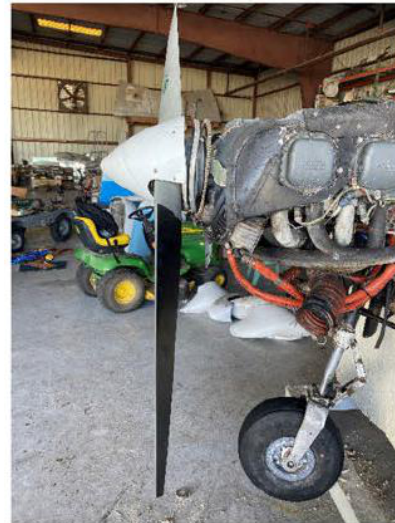
**Overall Engine Damage (cylinder damage, crankcase damage, pre-impact fire, etc.)**

- Cylinder Damage- None.
- Crank Case Damage- None.
- No obvious damage noted.

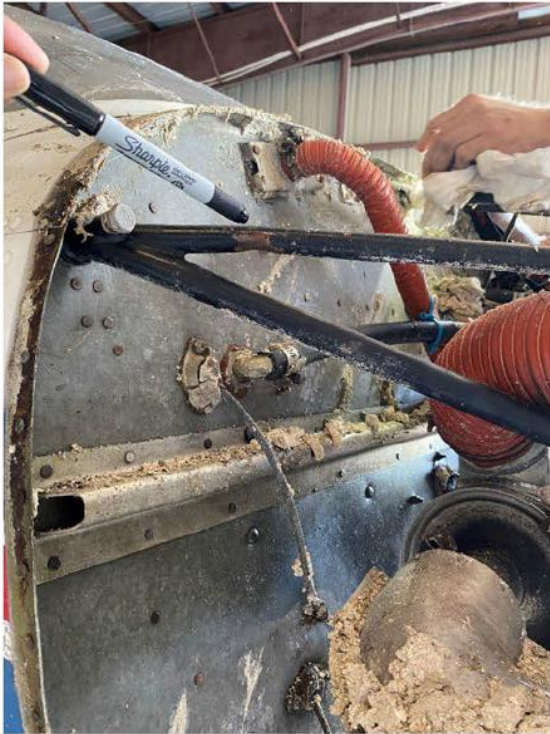
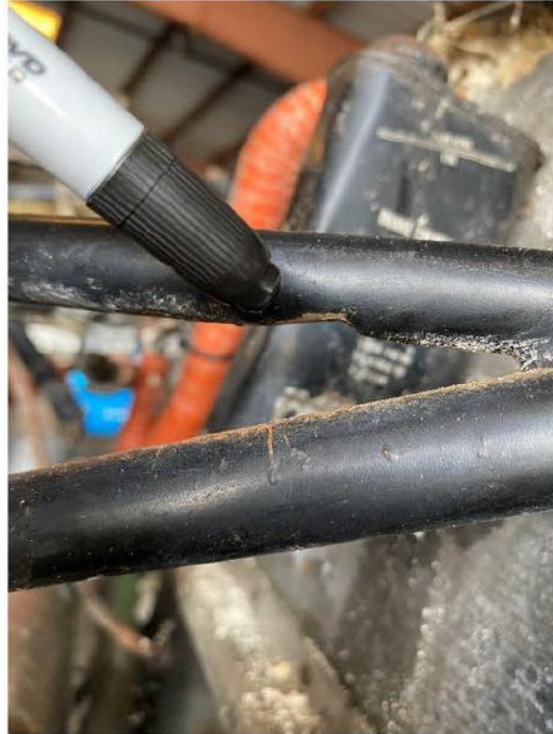
### ***Engine Mount(s) Condition***

- Engine mount top bracket slightly bent on both left and right side. Overall condition appears to be intact and secure.

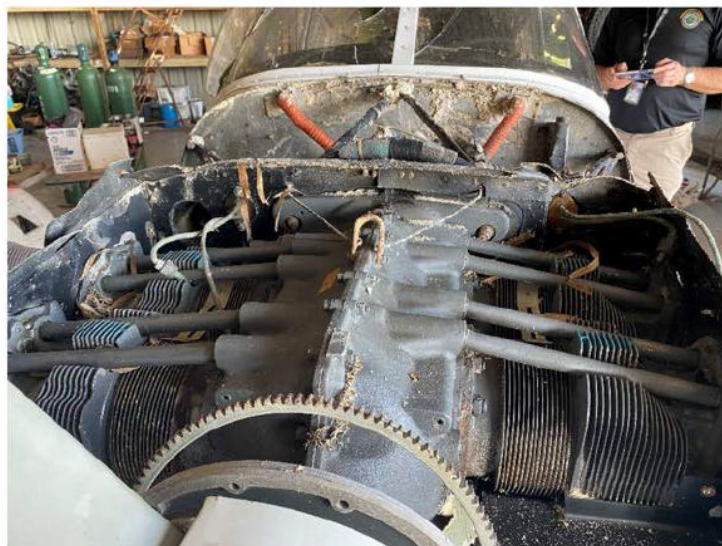
### ***Engine Accessories (what is separated, what is still attached, and are they 100% secure to their mount?)***

- Engine accessories appear to be attached and secure to their mount.

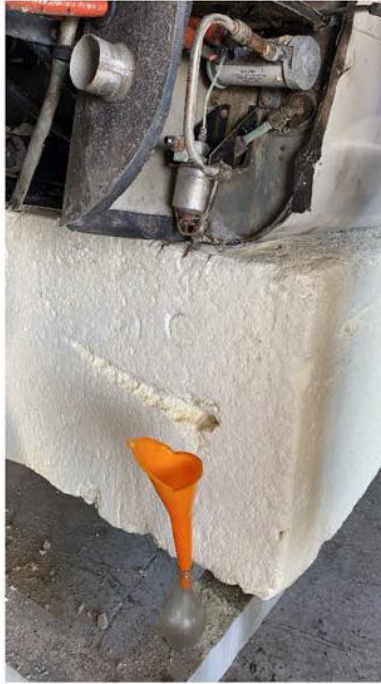
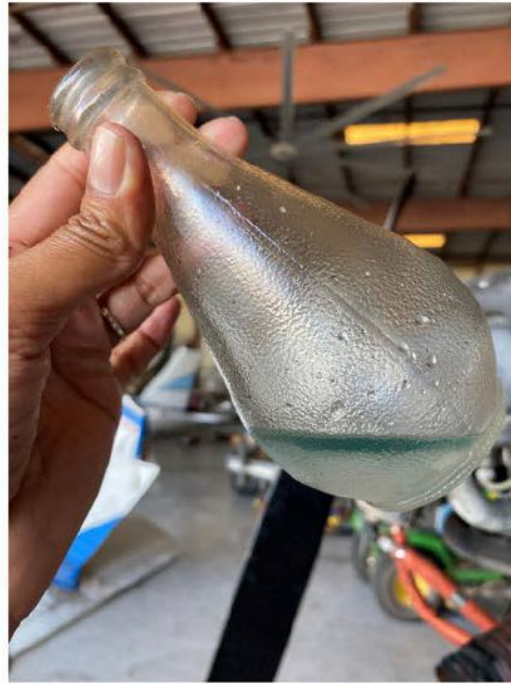
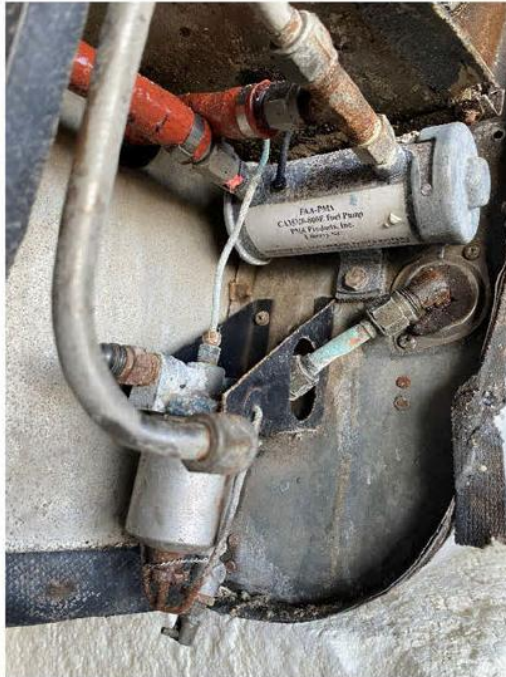
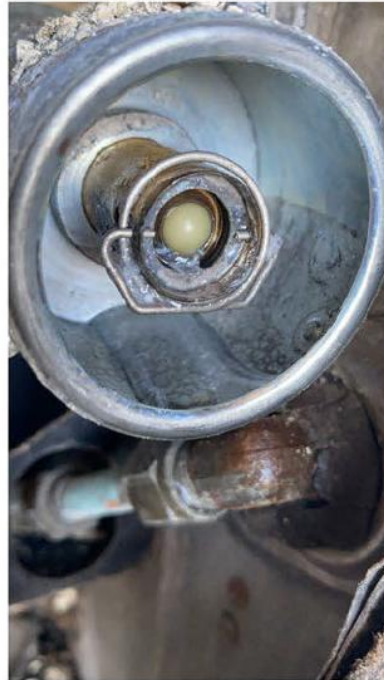
***Verify all fuel/oil lines are secure***

- Fuel & oil lines were secured, and no obvious damage was observed.
- A fuel sample was retrieved from gascolator bowl and was displaced from its receptacle. Its filter was clear of debris, and the bowl contained sediment consistent with beach sand. The electric fuel pumps filter was clear of debris, and liquid consistent in odor to aviation-type gasoline was observed within the fuel pump.

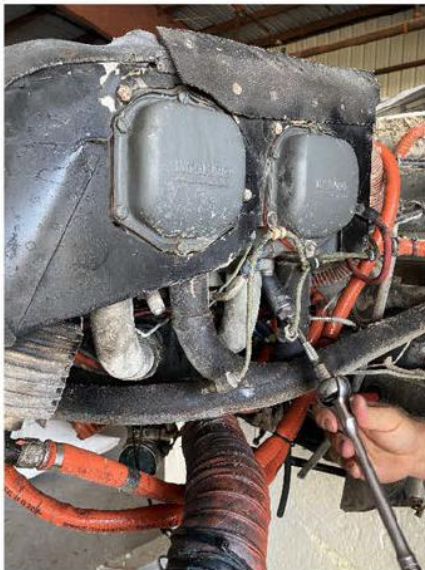
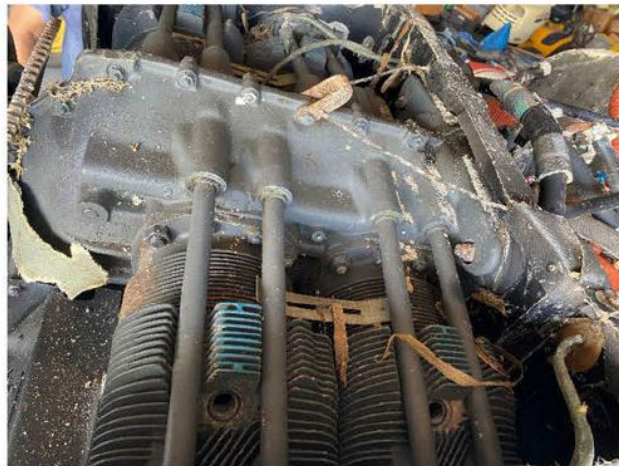
***Disconnect all spark plug wire ignition leads (top and bottom)***

- Spark plug wire ignition leads top and bottom removed. No apparent damage was observed. Removed, inspected, and tagged. No obvious damage was observed.

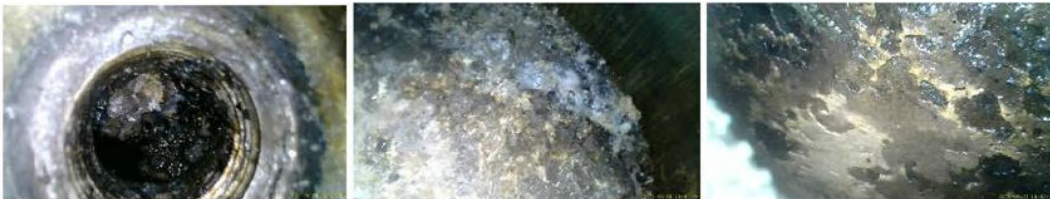
***Examine all cylinders with a borescope (if able). Look for...***

- Borescope used; however, the date and time of the photographs downloaded from the photographs are incorrectly dated 5/24/2021 due to the setting on the borescope. Borescope inspection identified corrosion which appeared to be caused by the salt water.

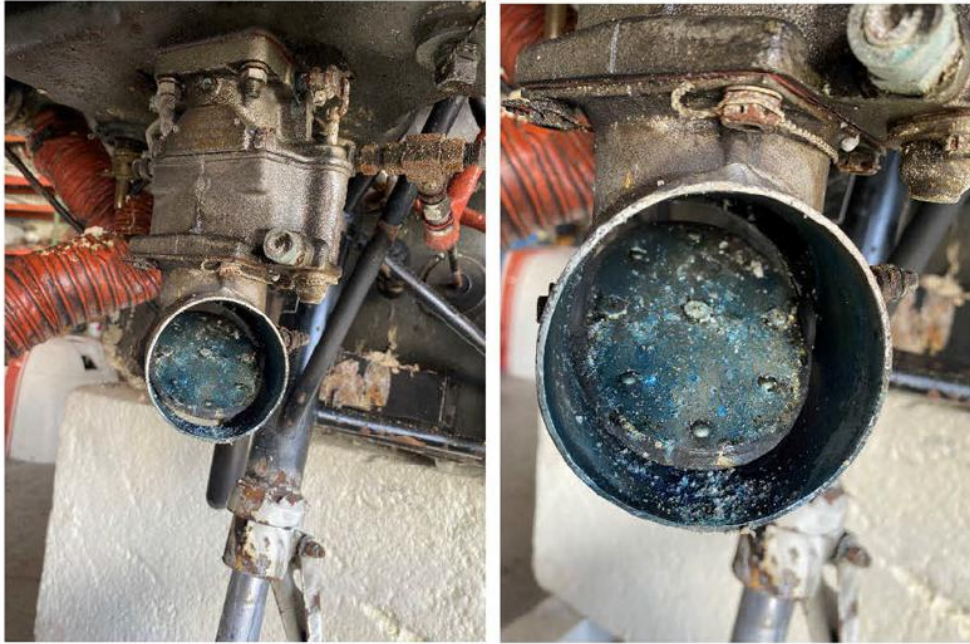
- The carburetor was not removed from the engine.

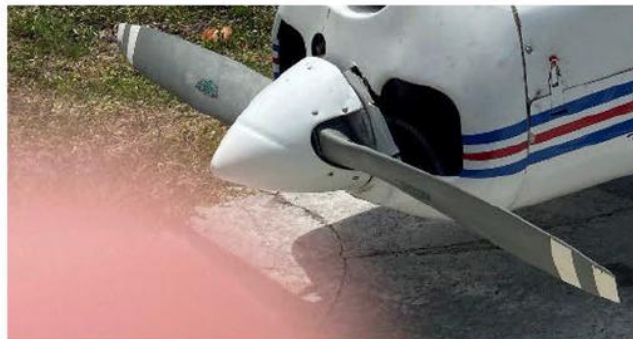
- The propeller system was not a factor in this accident. However, there was minimum or no damage to the propeller.

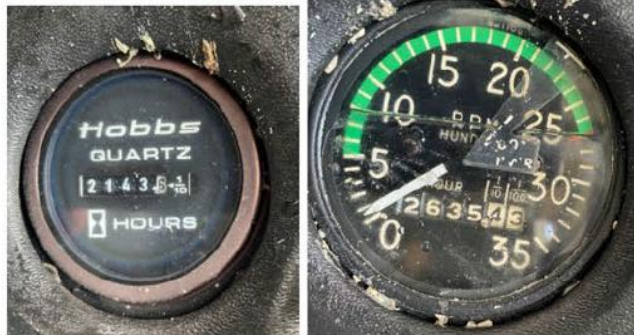
- Airframe Total Time 5662.29 as per logbook entry dated 08/15/2022
- Engine Total Time 2781.85 as per logbook entry dated 08/15/2022
  - Since major overhaul 862.55 as per logbook entry dated 08/15/2022

- Current Hobbs 2143.6 and Tach 2635.43 (On the date of accident)
