## MEMORANDUM FOR RECORD

**Date:** 10/19/2023  
**Subject:** ERA22LA380, Cessna 150F, N8797G, FAA Engine Examination  
**Contact:** Juan Garcia - FAA Aviation Safety Inspector  
Philip Grice – Manager, Field Product Performance, Continental  
Aerospace Technologies

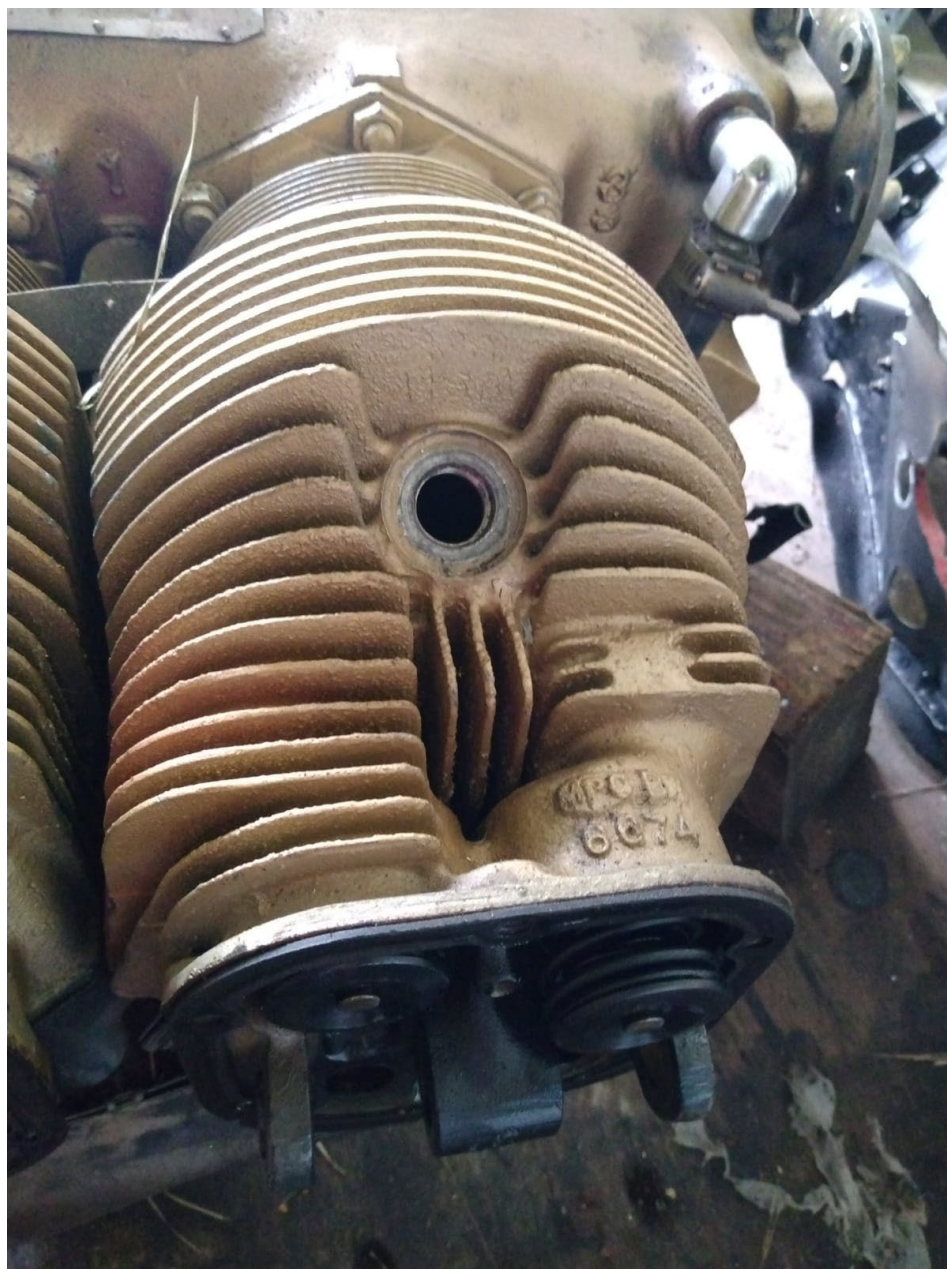
The enclosed was examined by the manager of product field performance for the engine manufacturer who stated the exhaust valve in the Number 3 cylinder was stuck in the open position. With the rockers removed, both valves should be pressed closed by valve spring tension. The exhaust valve stuck in the open position would result in a substantial power loss.

**Photo 1 – View of Number 3 Cylinder, Engine Case, and Propeller Flange (FAA)**

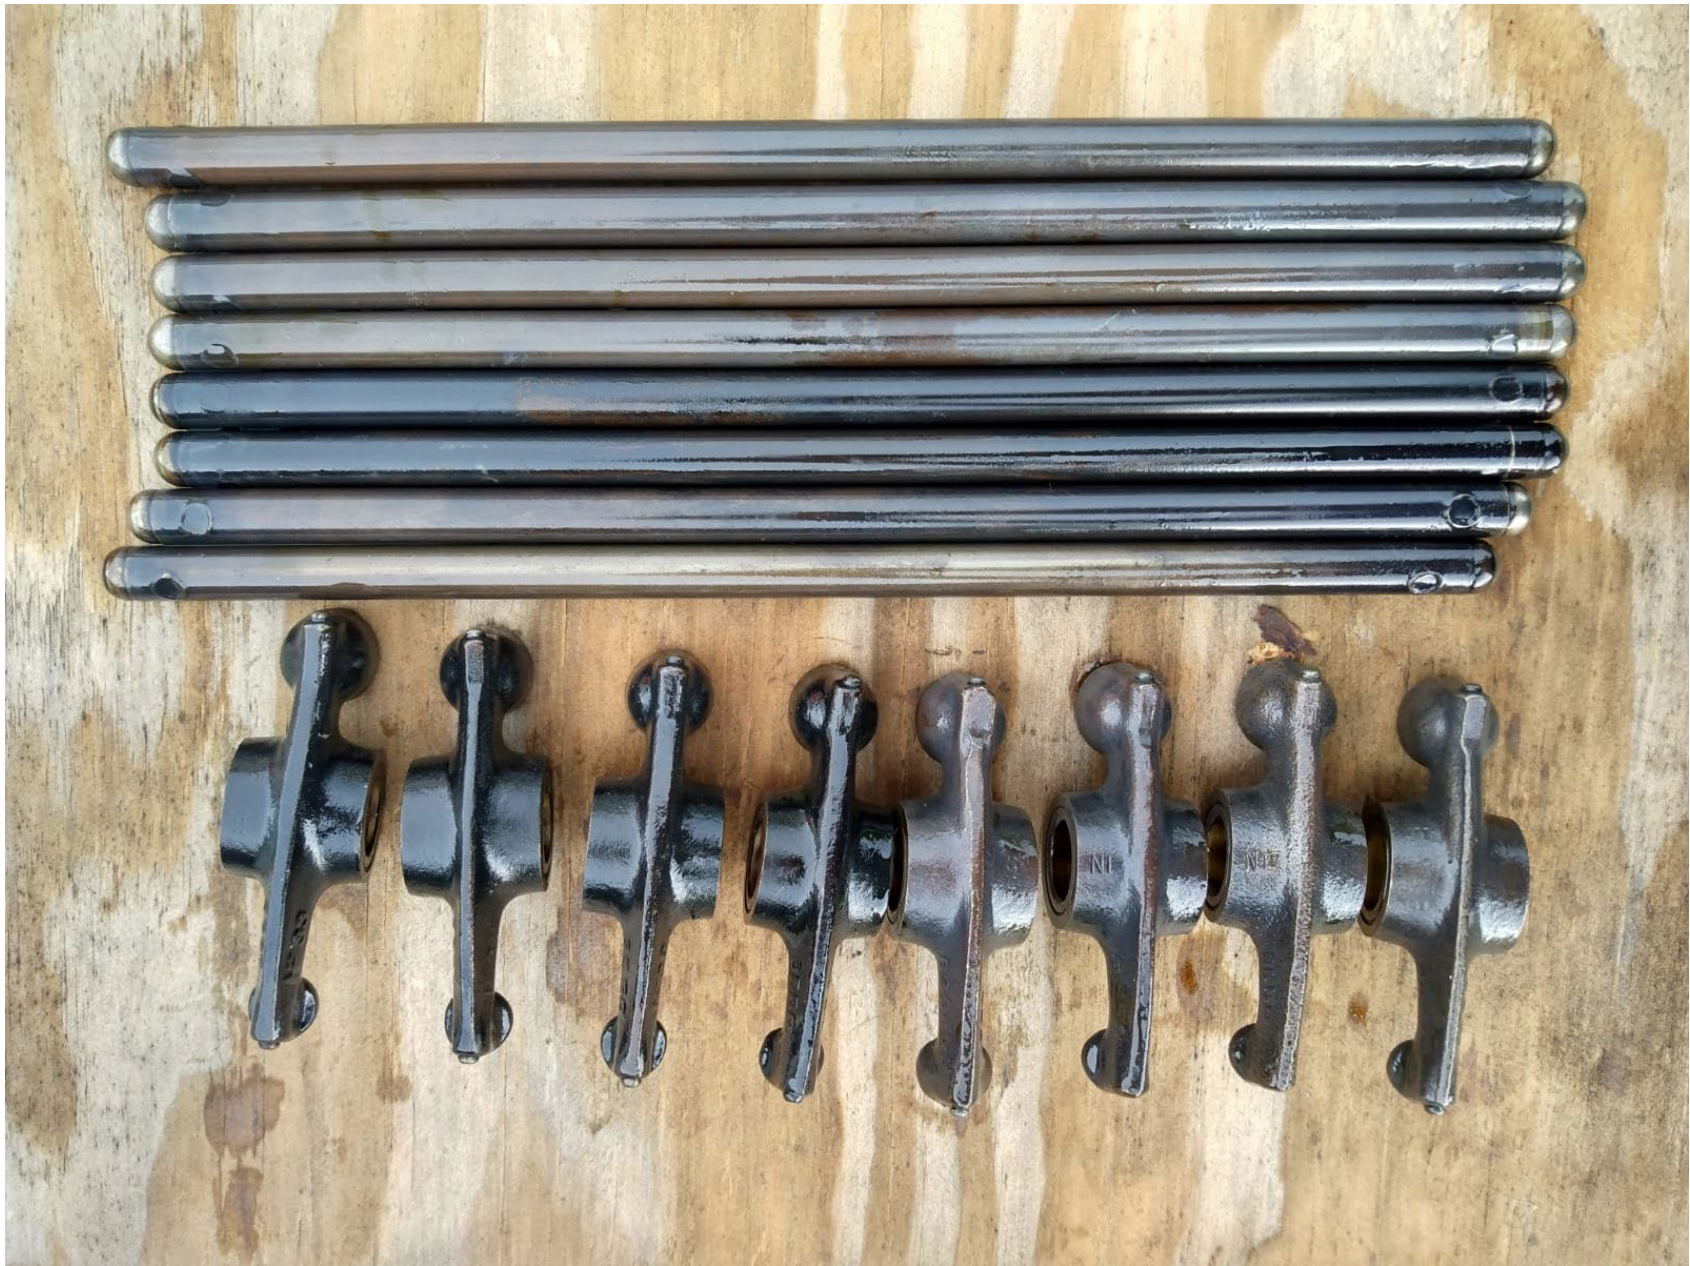
**Photo 2 – View of Rocker Arms and Pushrods as Found (FAA)**

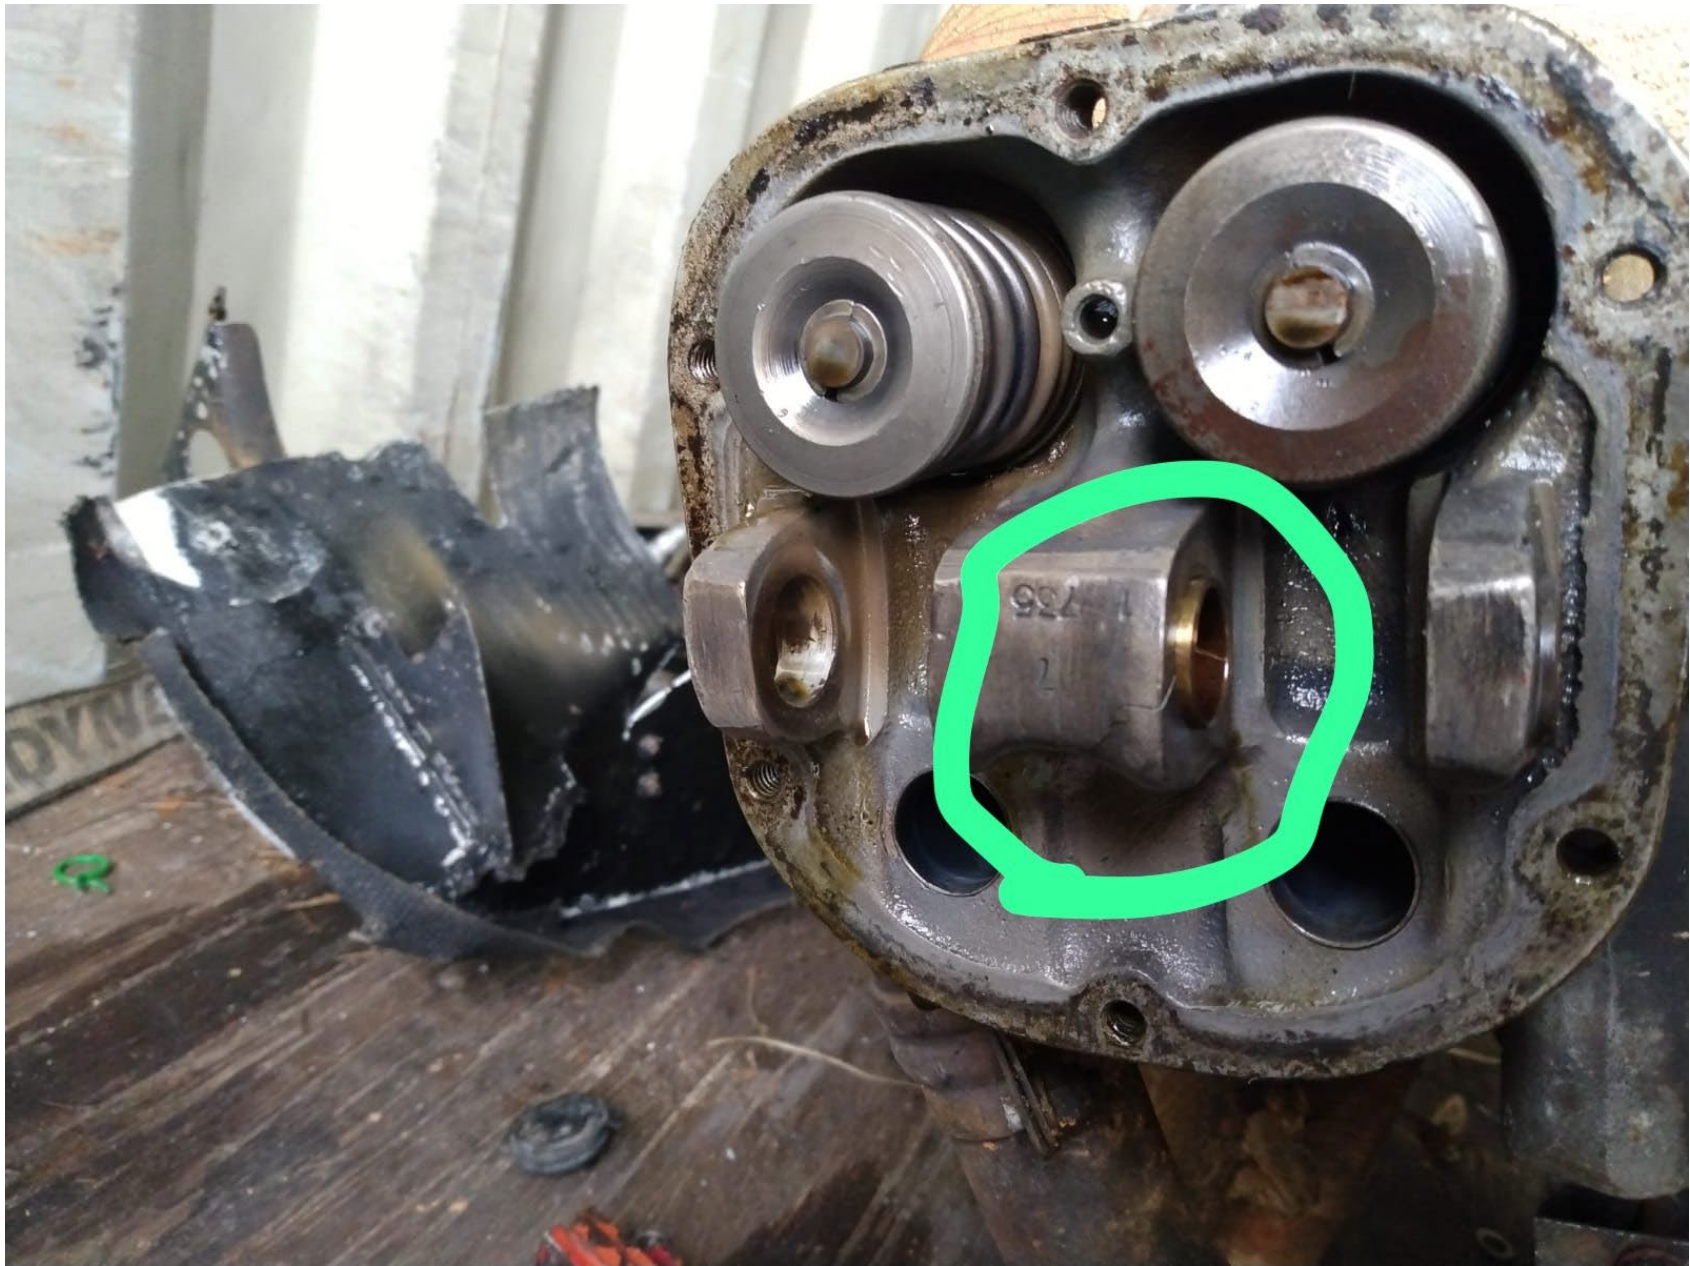
Further, he stated that bushings were not installed in the rocker boxes of the cylinders at the factory. The bushings pictured in the Number One cylinder rocker box reflect a repair had been performed on the cylinder at some time in its service life. According to the manager, the loose bushing would adversely affect the dry lifter clearance and adversely affect valve performance.

**Photo 3 – View of Number One Cylinder with Highlighted (Cracked) Rocker Box (FAA)**
