# National Transportation Safety Board

ERA22LA404

## **METEOROLOGY**

Specialist's Factual Report

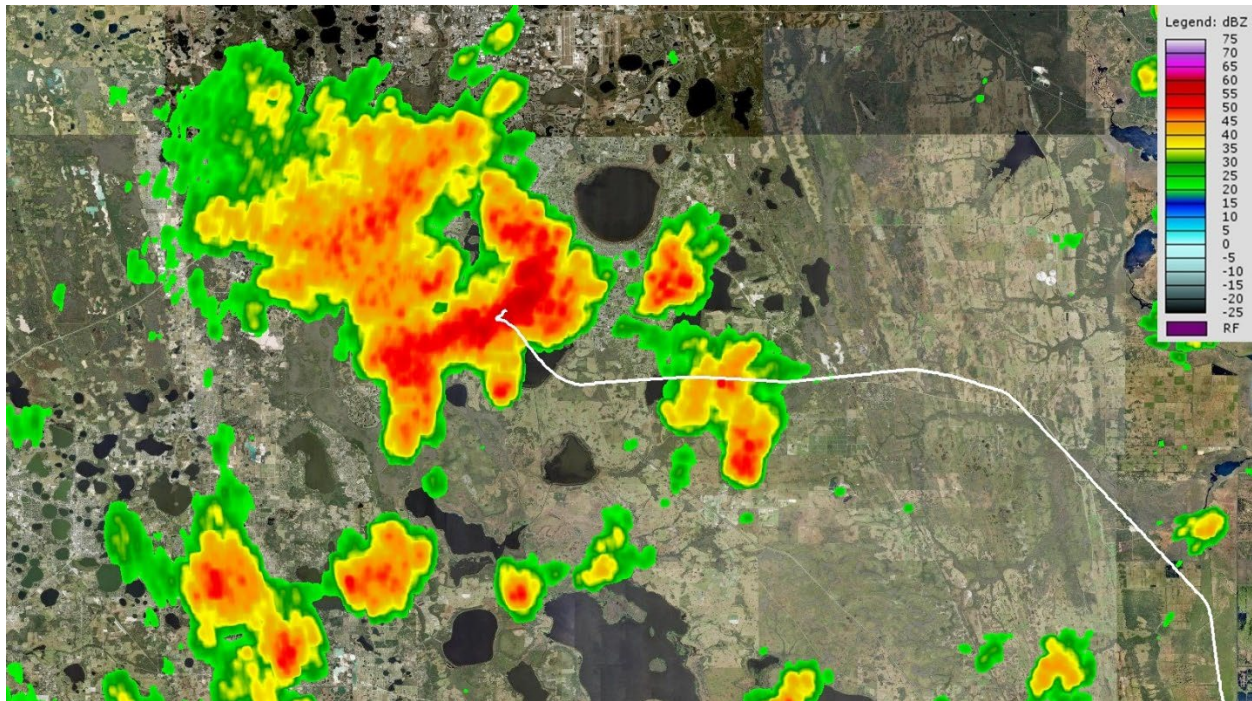
refraction and considering the  $0.95^\circ$  beam width<sup>6</sup> for the WSR-88D radar beam, the KMLB  $0.483^\circ$  tilt would have “seen” altitudes above the accident location of between about 1,100 and 5,000 feet. Figure 1 indicates that the accident aircraft’s flight path terminated amidst extreme<sup>7</sup> values of precipitation.

**Figure 1** - KMLB  $0.483^\circ$  Level-II base reflectivity product from a sweep initiated at 1502:09. Final portion of the accident aircraft’s flight path, which terminates at 1502:05, is depicted by the white line. Reflectivity has been “smoothed” and dBZ values less than 20 have been masked out.

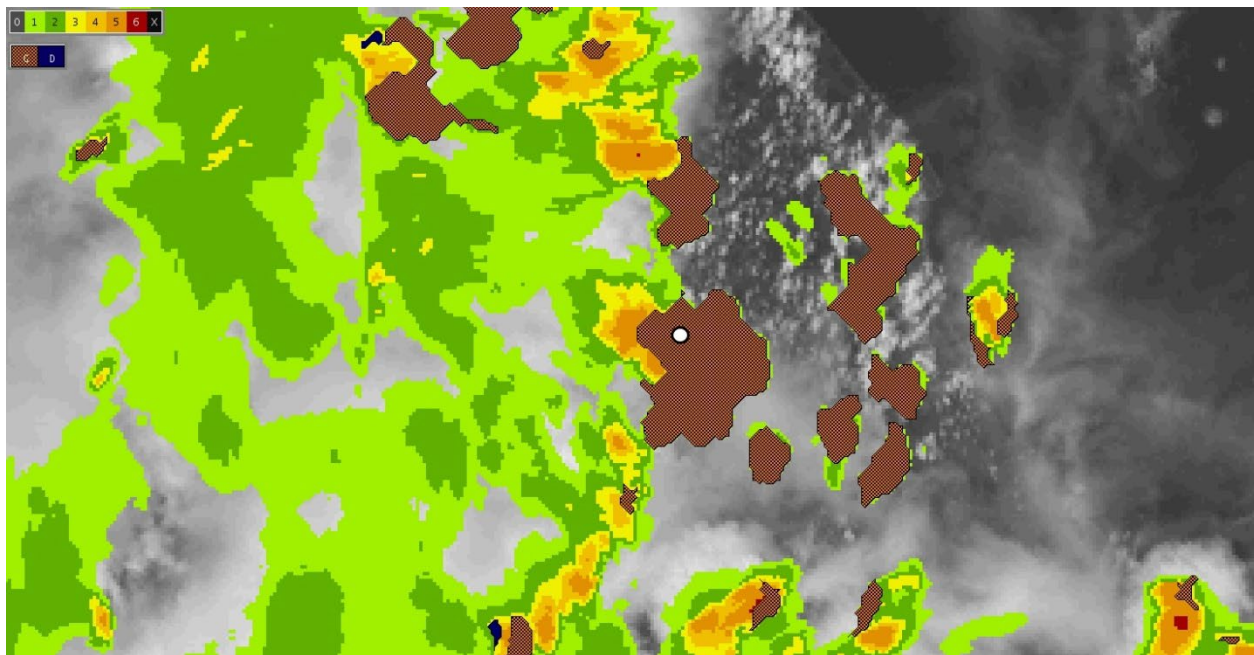
Archive data from the Federal Aviation Administration's Corridor Integrated Weather System (CIWS) for the accident region at 1500 are presented in Figure 2. This image presents precipitation and convective growth and decay (brown and blue hatched areas, respectively). Figure 2 indicates the accident location was under an area of convective growth at about the time of the accident. There are no areas of decay near the accident location.

**Figure 2** – Archive CIWS display from 1500. Areas of convective growth are identified by the brown hatched areas. Accident location is denoted by the white dot.

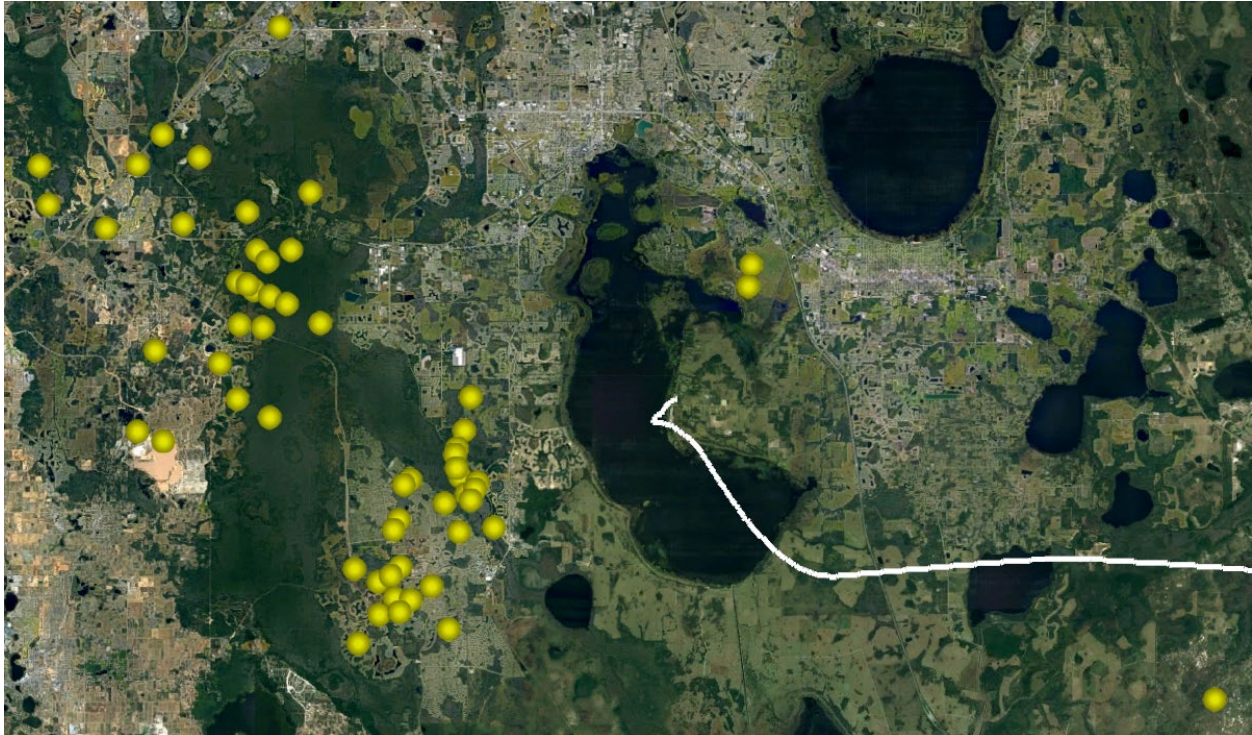
A review of the Earth Networks Total Lightning Network (ENTLN) lightning database revealed the flash total lightning activity near the accident location between 1455 and 1505 (Figure 3).<sup>8</sup>

**Figure 3** - ENTNLN total flash lightning activity between 1455 and 1505 (yellow circles). Final portion of the accident aircraft's flight path is depicted by the white line.

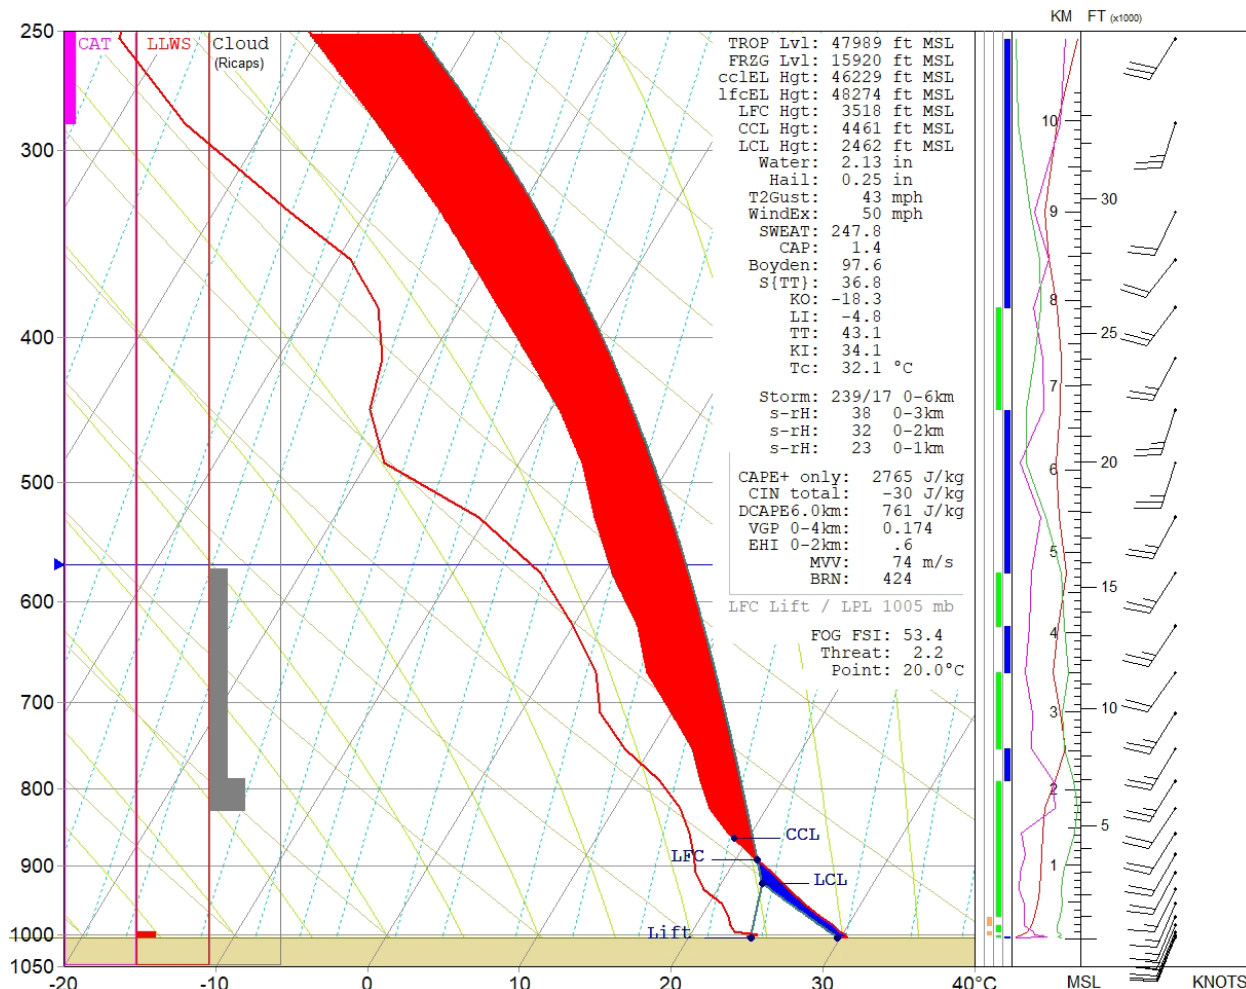
A High-Resolution Rapid Refresh (HRRR) model<sup>9</sup> sounding (Figure 4) for near the accident site<sup>10</sup> at 1500 using an elevation of about 50 feet was retrieved from the National Oceanic and Atmospheric Administration's Air Resources Laboratory and analyzed by the RAwinsonde OBservation (RAOB) program. The freezing level was noted at about 16,000 feet. The wind below 2,000 feet was from the south-southwest at magnitudes of between 10 and 20 knots. The most-unstable Convective Available Potential Energy (CAPE) parameter was 3,270 Joules/kilogram (from 1001 hectopascals [hPa]). The Lifting Condensation Level (LCL) was at 2,462 feet and the Level of Free Convection (LFC) was at 3,518 feet. Downdraft CAPE (DCAPE; 6 kilometers above ground level; coldest wetbulb temperature method) was measured at 761 Joules/kilogram. The T2Gust ("Severe Weather Gust Potential") and WindEx ("Microburst Gust Potential") parameters were 37 knots and 43 knots, respectively.

**Figure 4** - HRRR model sounding data in SkewT/LogP format for 1500 near the accident site, surface to 250 hPa.

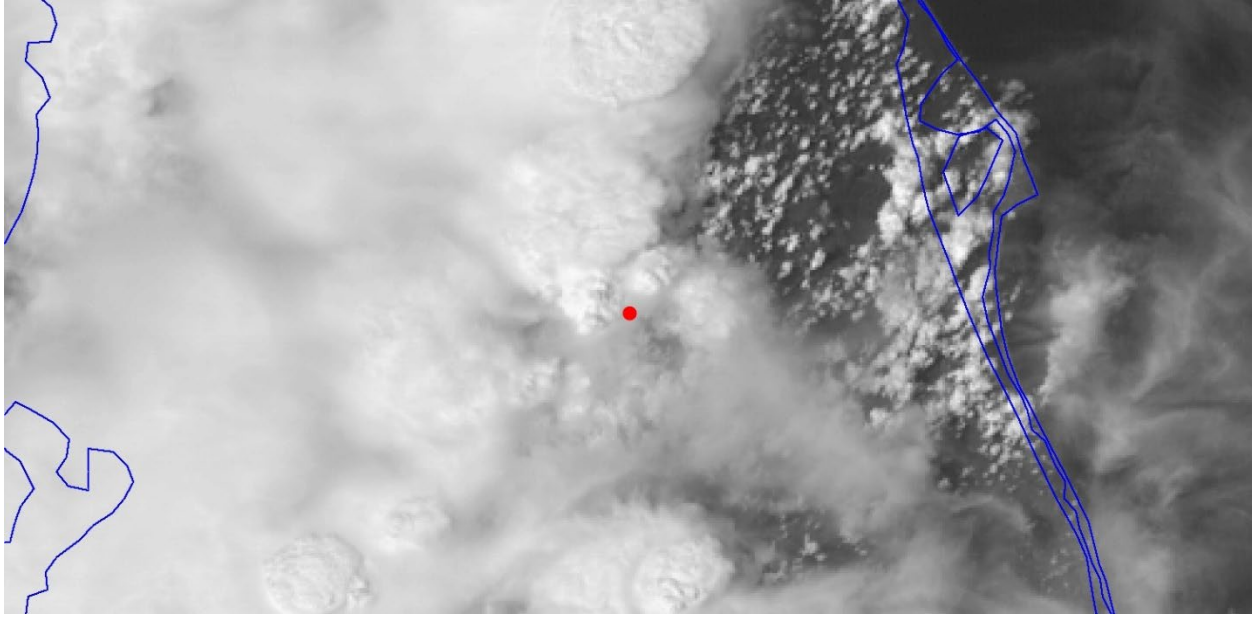
Geostationary Operational Environmental Satellite (GOES)-16 visible (0.64 $\mu$ m) and infrared (10.3 $\mu$ m) data were obtained from an archive at the Space Science Engineering Center at the University of Wisconsin-Madison. Images from 1501 are presented in Figures 5 and 6. The GOES-16 visible imagery depicted cloudy conditions over the accident region. Infrared cloud-top temperatures near the accident site ranged between -13°C and -67°C, which, when considering the 1500 HRRR sounding, corresponded to cloud top heights of about 24,000 and 47,000 feet, respectively (-67°C is not depicted in Figure 4).

**Figure 5** - GOES-16 visible imagery from 1501. Accident location denoted by the red dot. Image is not corrected for parallax error.

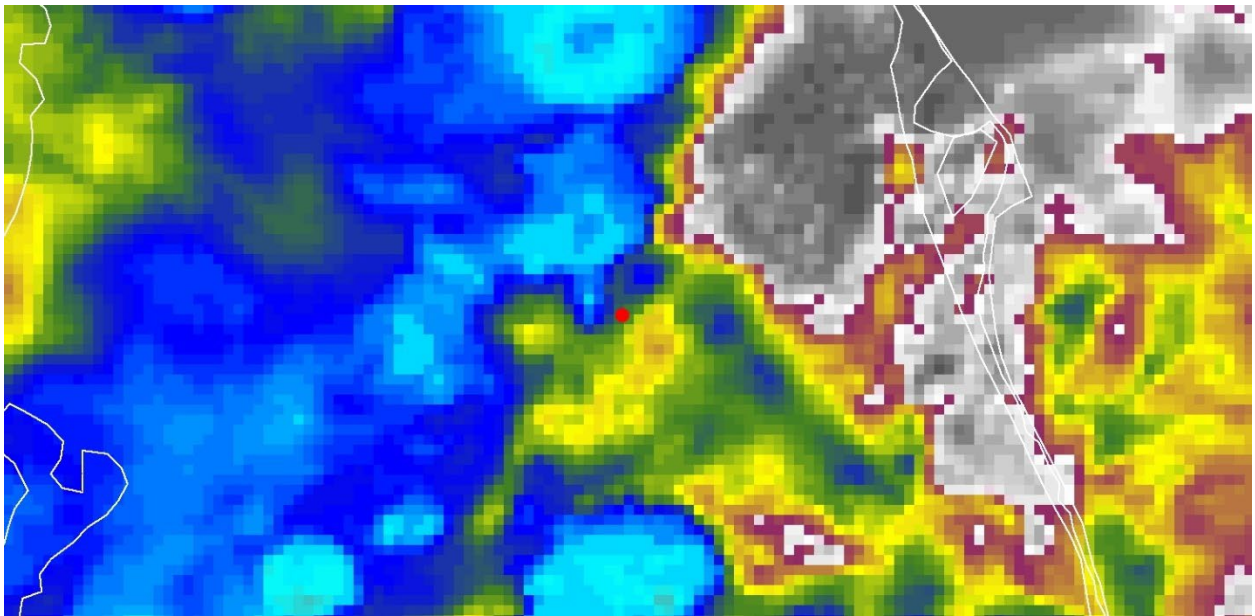
**Figure 6** - GOES-16 infrared brightness temperature imagery from 1501 Accident location is denoted by the red dot. This image is not corrected for parallax error.

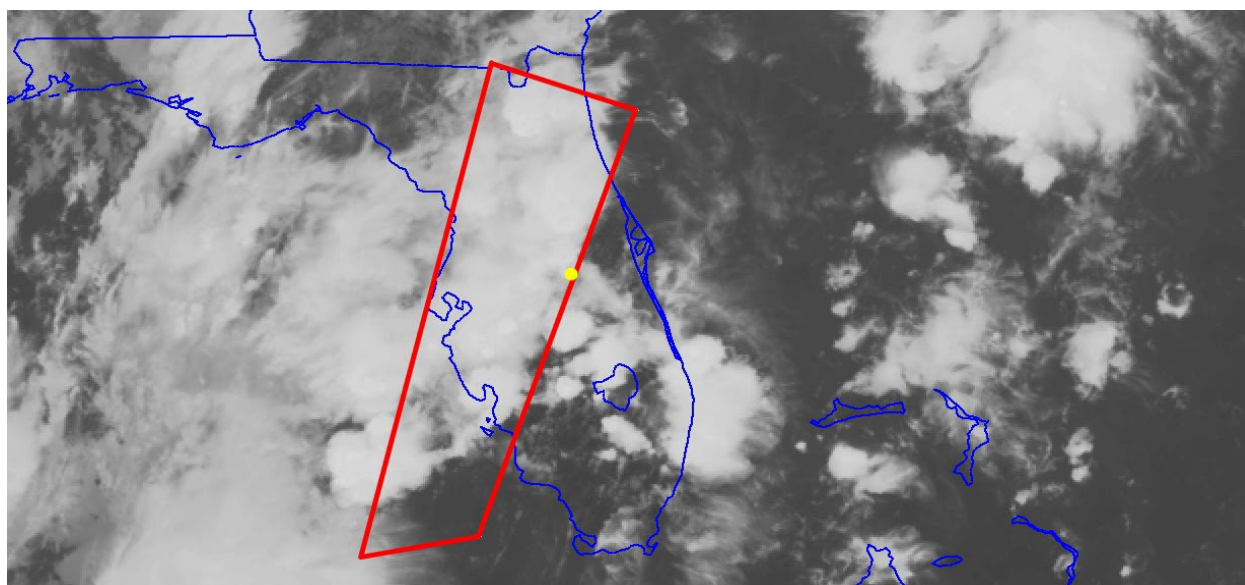
At 1455, the NWS Aviation Weather Center issued the following Convective SIGMET (#51E) that was active for the accident location and was valid until 1655 that advised of an area of thunderstorms (Figure 7).

**Figure 7** - Convective SIGMET #51E. Accident location is denoted by the yellow dot.

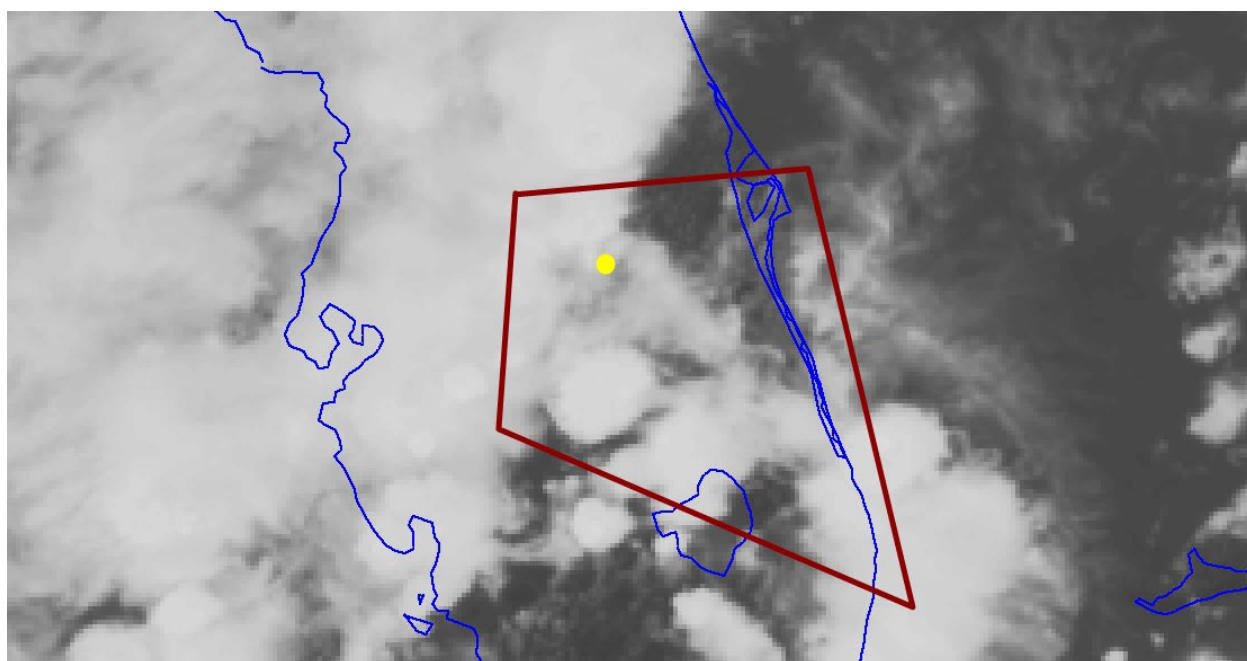
At 1435, the NWS Center Weather Service Unit at the Miami Air Route Traffic Control Center issued the following Center Weather Advisory (CWA) that was active for the accident location and was valid until 1535 that advised of an area of developing thunderstorms with heavy to extreme precipitation (Figure 8).

**Figure 8** - Center Weather Advisory issued at 1435. Accident location is denoted by the yellow dot.

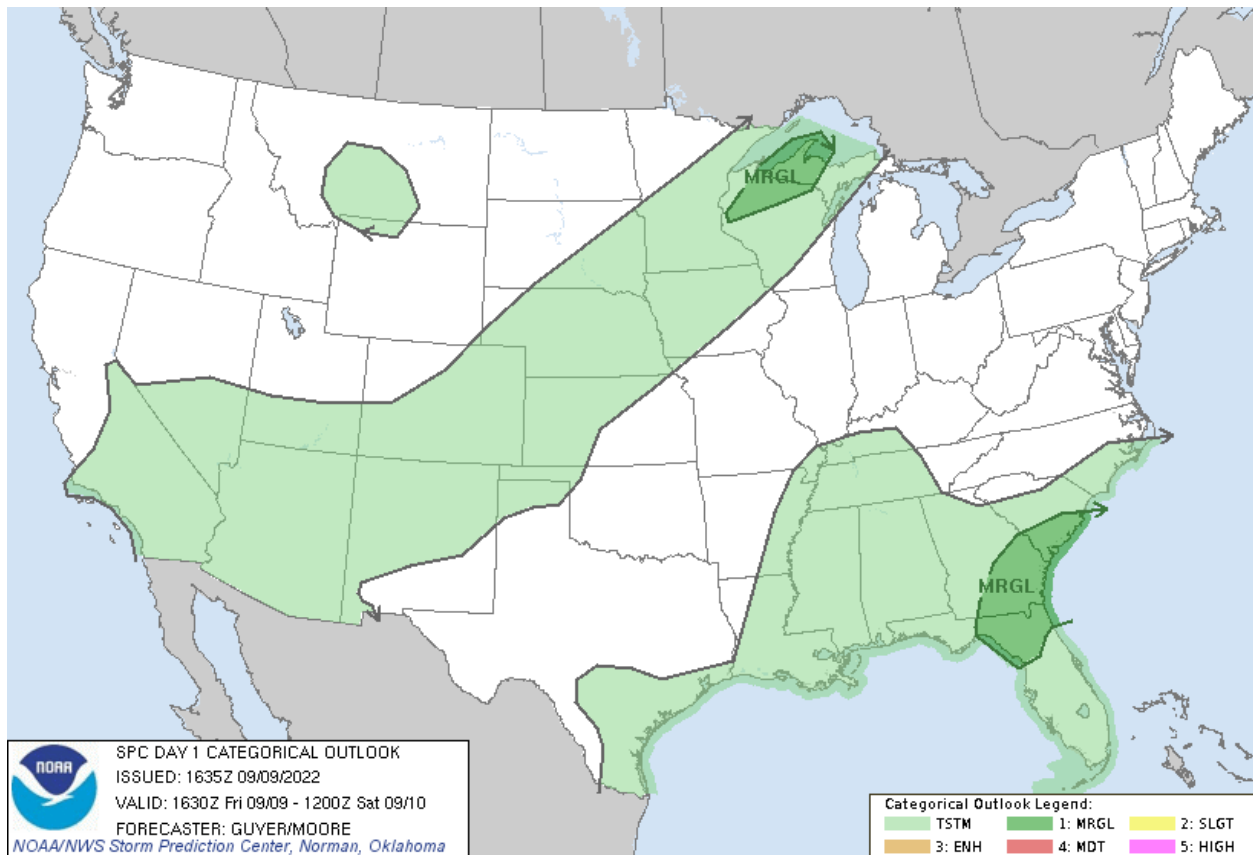
At 1235, the NWS Storm Prediction Center issued a Convective Outlook that identified a general “thunderstorm” risk for the accident site (Figure 9). Figure 10 provides a description of the different categories found in the Convective Outlook.

**Figure 9** - SPC Convective Outlook issued at 1235.
