# National Transportation Safety Board

ERA22LA404

## WRECKAGE EXAMINATION SUMMARY

Location: Saint Cloud, Florida  
Date: September 9, 2022  
Time: 1502 EDT  
1902 coordinated universal time (UTC)  
Airplane: N77VJ, Cirrus Design Corporation SF50

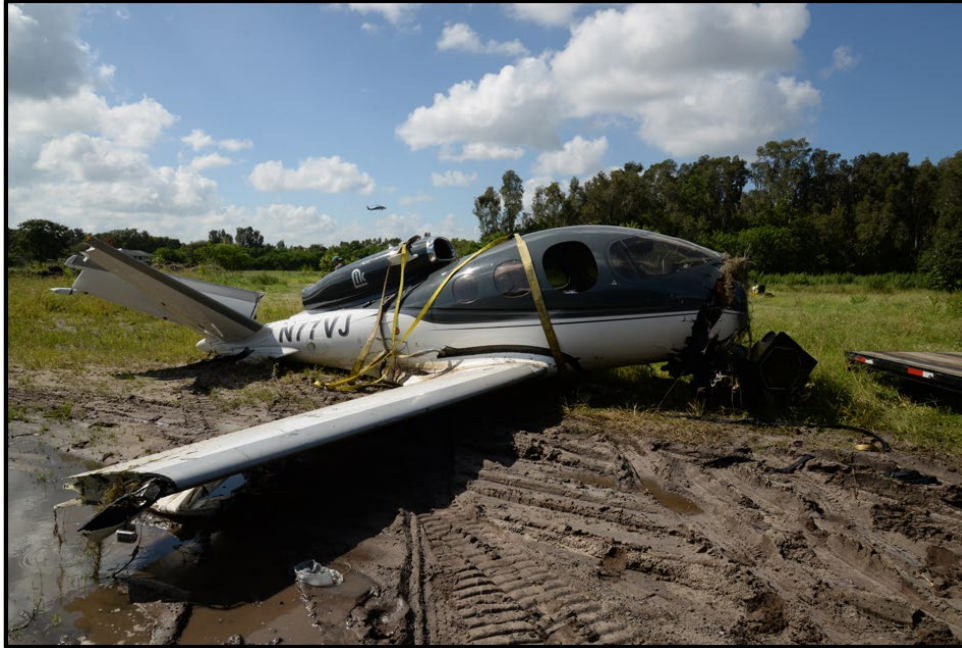
The airplane crashed in a marshy area behind a house. The main wreckage was located at 28.20477° north latitude and -81.372500° west longitude, or approximately 5.6 nautical miles and 146° from the approach end of runway 33.

**Figure 4: Right Side View of the Airplane After Being Airlifted from the Accident Site.**
