ERA22LA404

## IIC INVESTIGATIVE PHOTOGRAPHS

Photo Array<sup>1</sup>

August 19, 2024

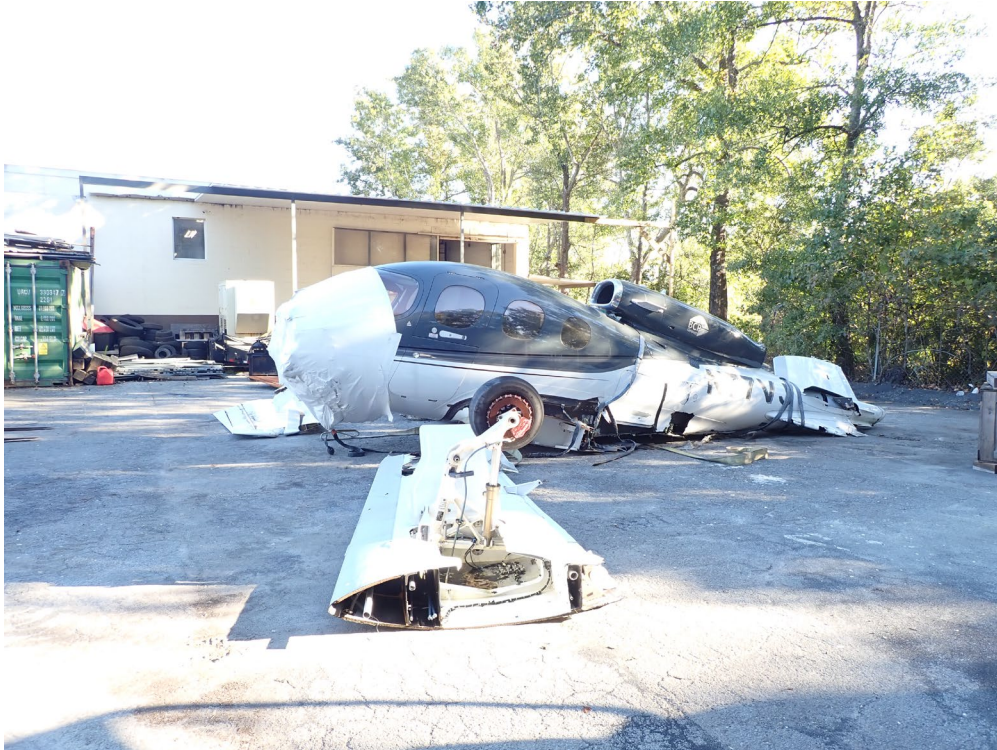
**Photo 1: NTSB Digital Photograph. Left Side View of the Airplane Following Recovery.**

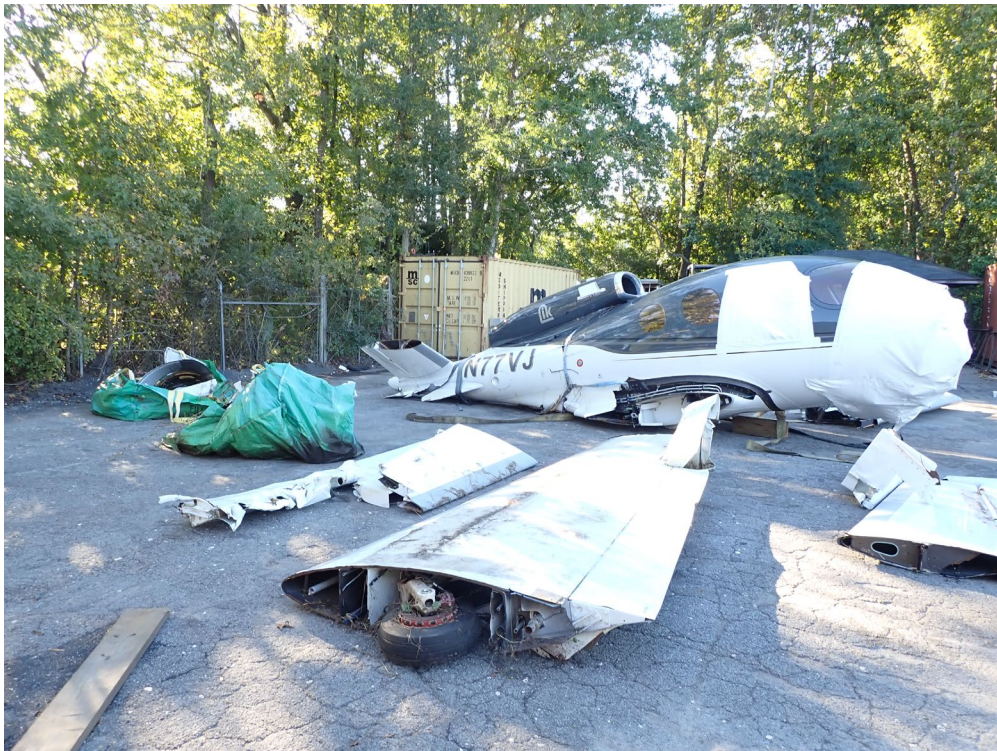
**Photo 2: NTSB Digital Photograph. Right Side View of the Airplane Following Recovery.**

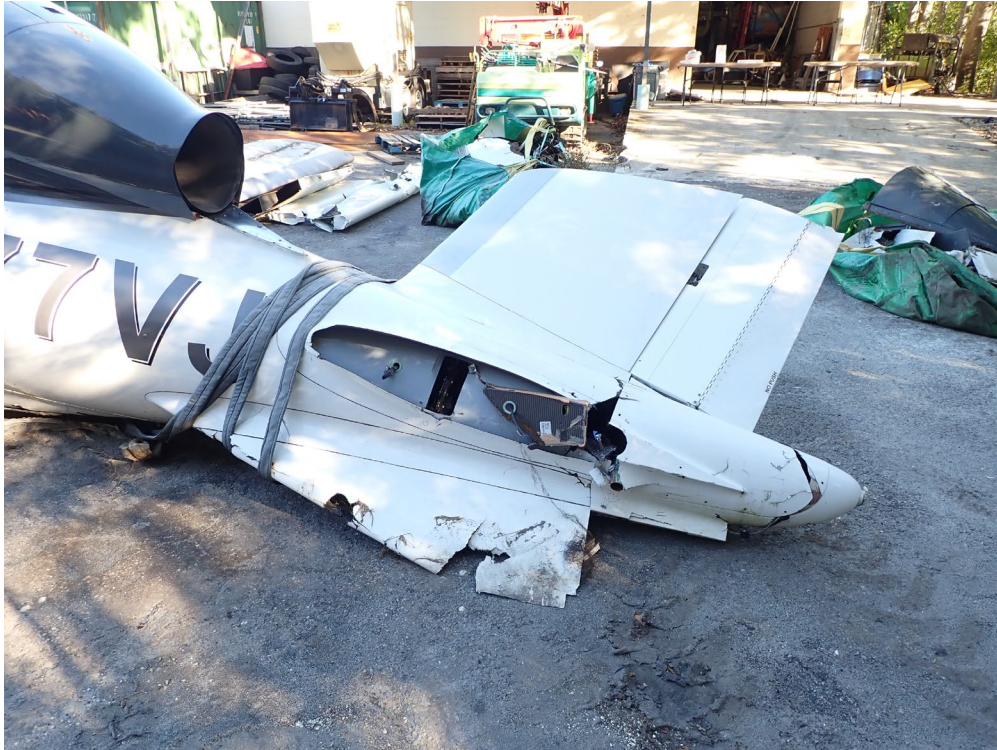
**Photo 3: NTSB Digital Photograph. Left Side View of the Aft Empennage.**

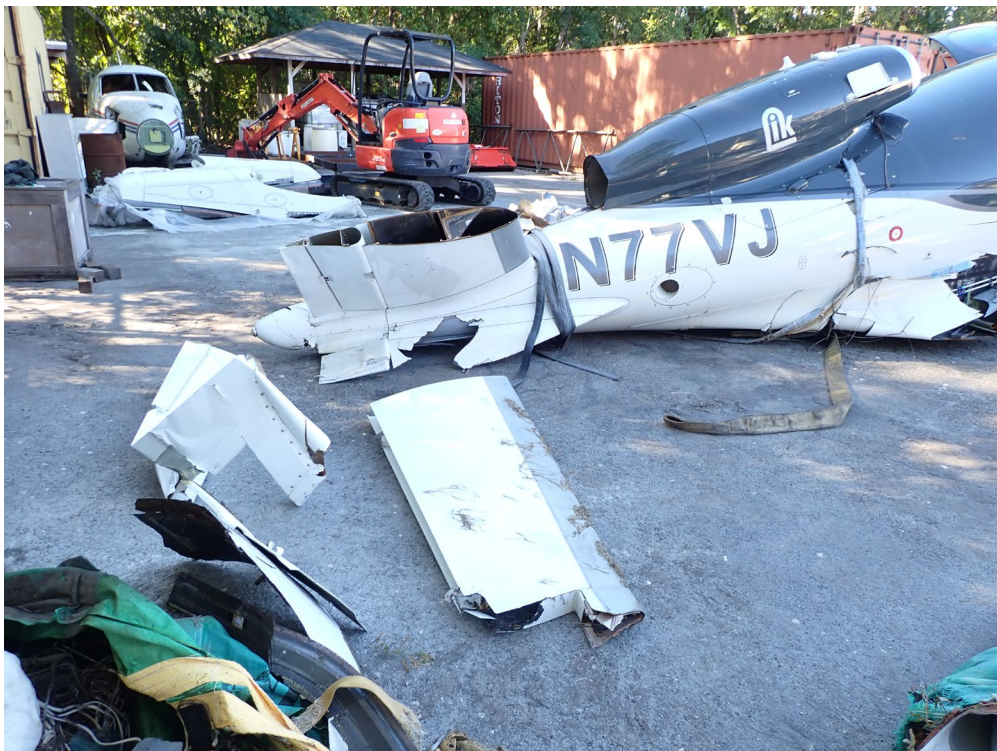
**Photo 4: NTSB Digital Photograph. Right Side View of the Aft Empennage.**

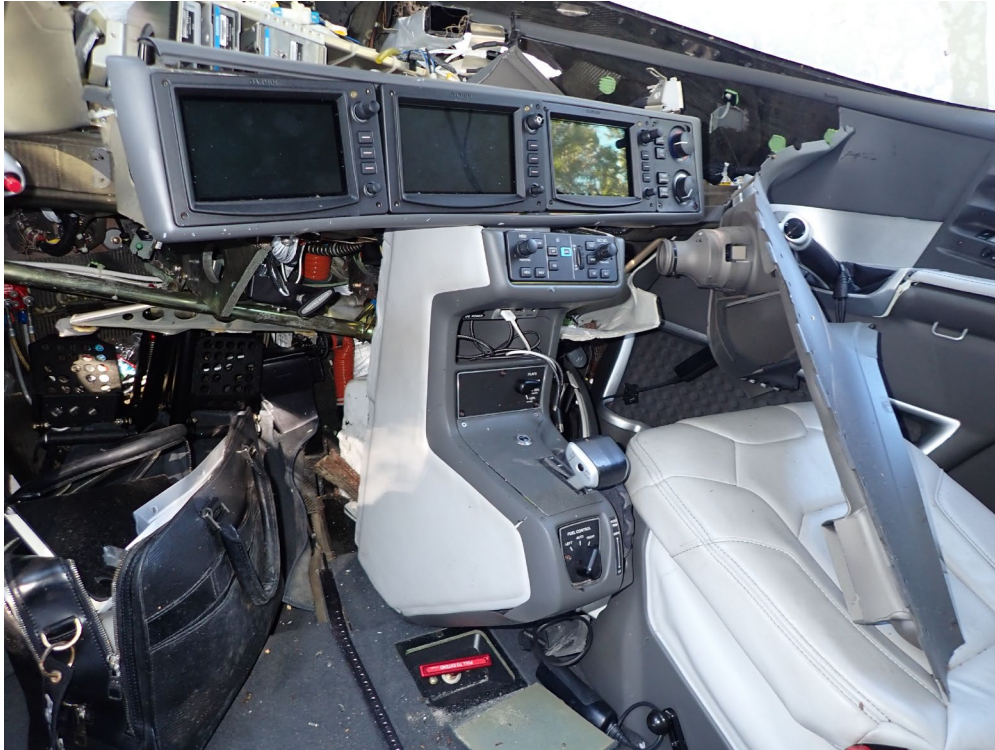
**Photo 5: NTSB Digital Photograph. View of the Instrument Panel and Portion of Co-Pilot Seat.**

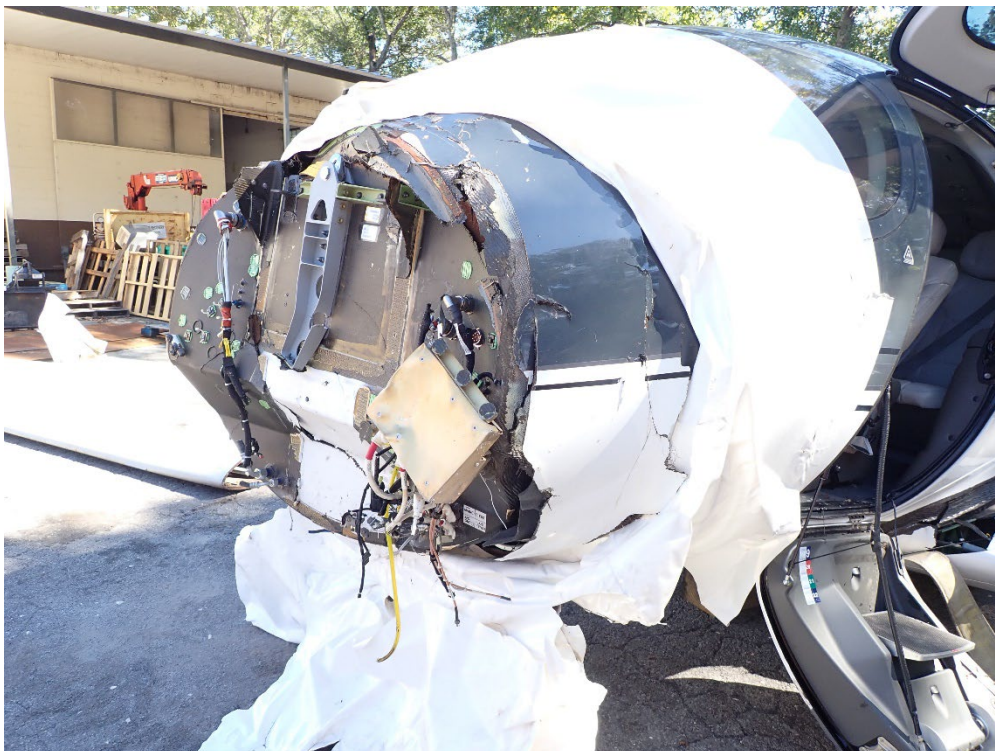
**Photo 6: NTSB Digital Photograph. Left Side View of the Front Pressure Bulkhead, and Fuselage Immediately Aft of it.**

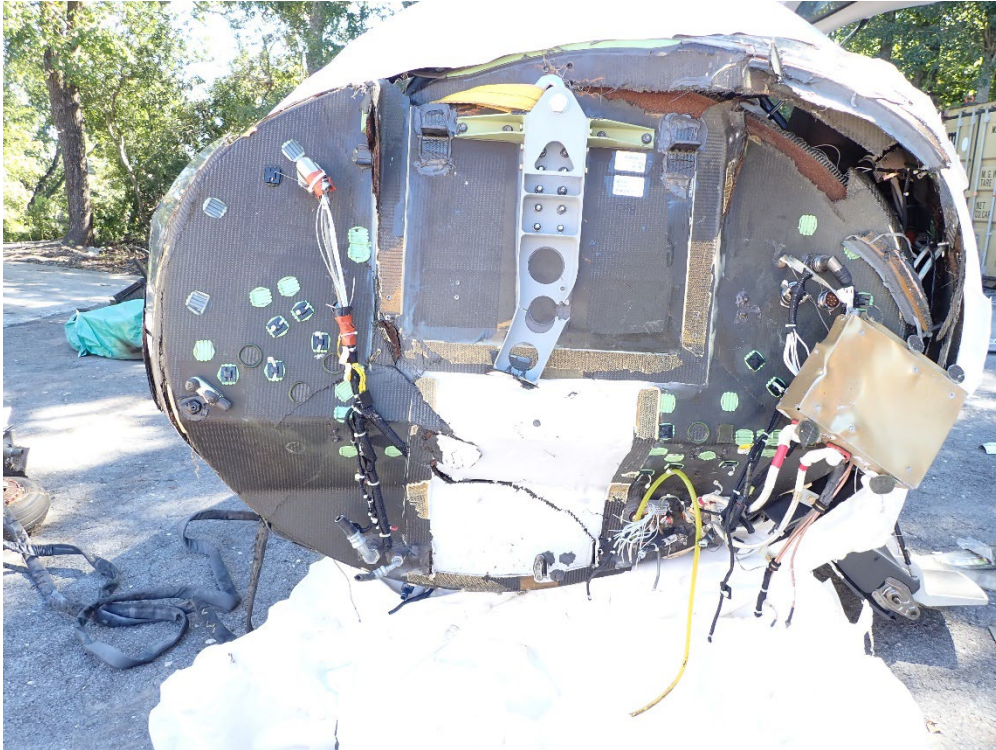
**Photo 7: NTSB Digital Photograph. Frontal View Looking Aft to Front Pressure Bulkhead. Note the Extensive damage.**

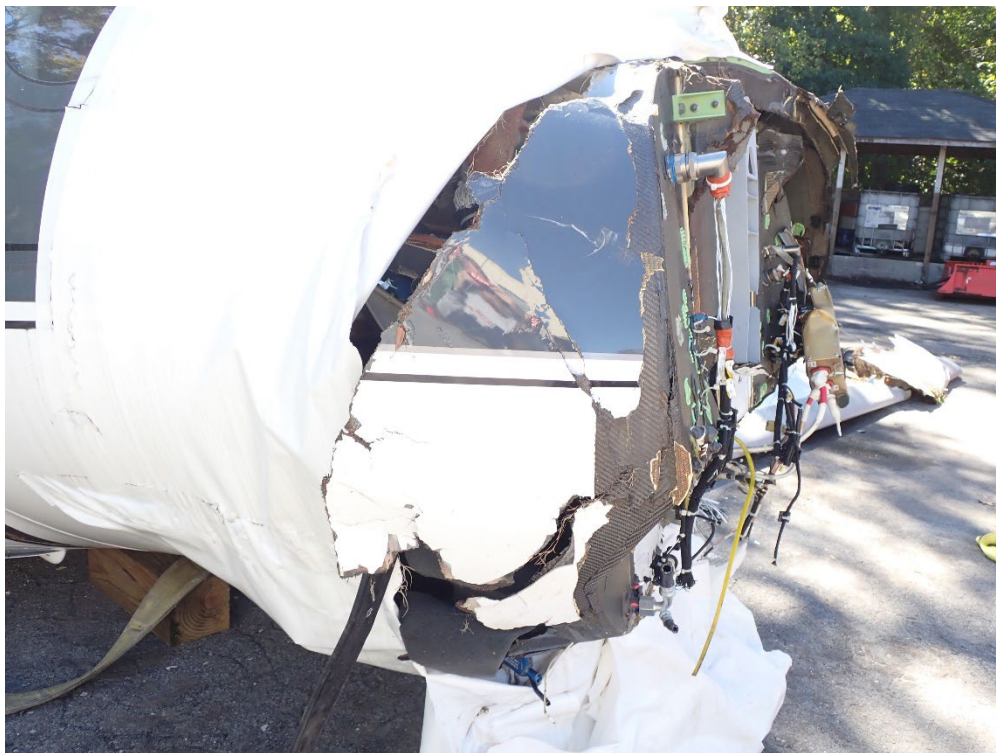
**Photo 8: NTSB Digital Photograph. Right Side View of the Front Pressure Bulkhead, and Fuselage Immediately Aft of it.**
