**NATIONAL TRANSPORTATION SAFETY BOARD**

**Photo Array**

**ERA22LA408**

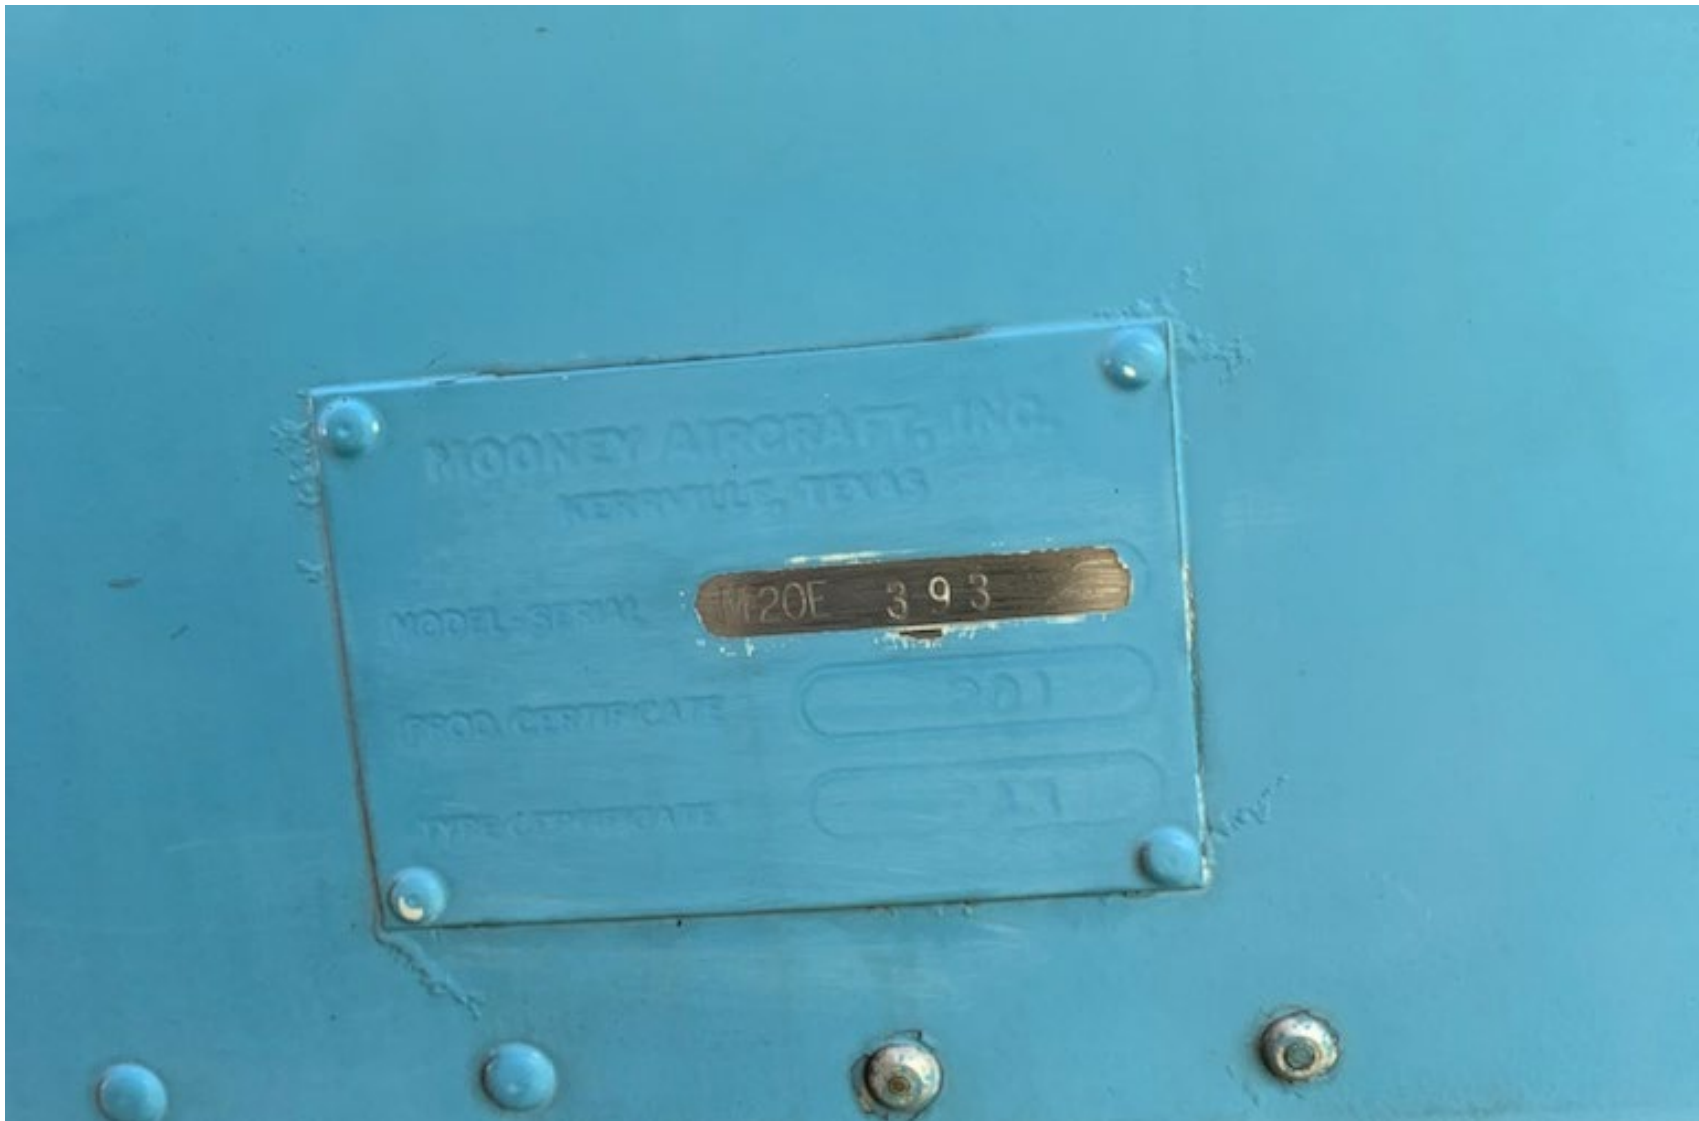
**Photo 1 – View of Airplane Dataplate (Courtesy of FAA)**

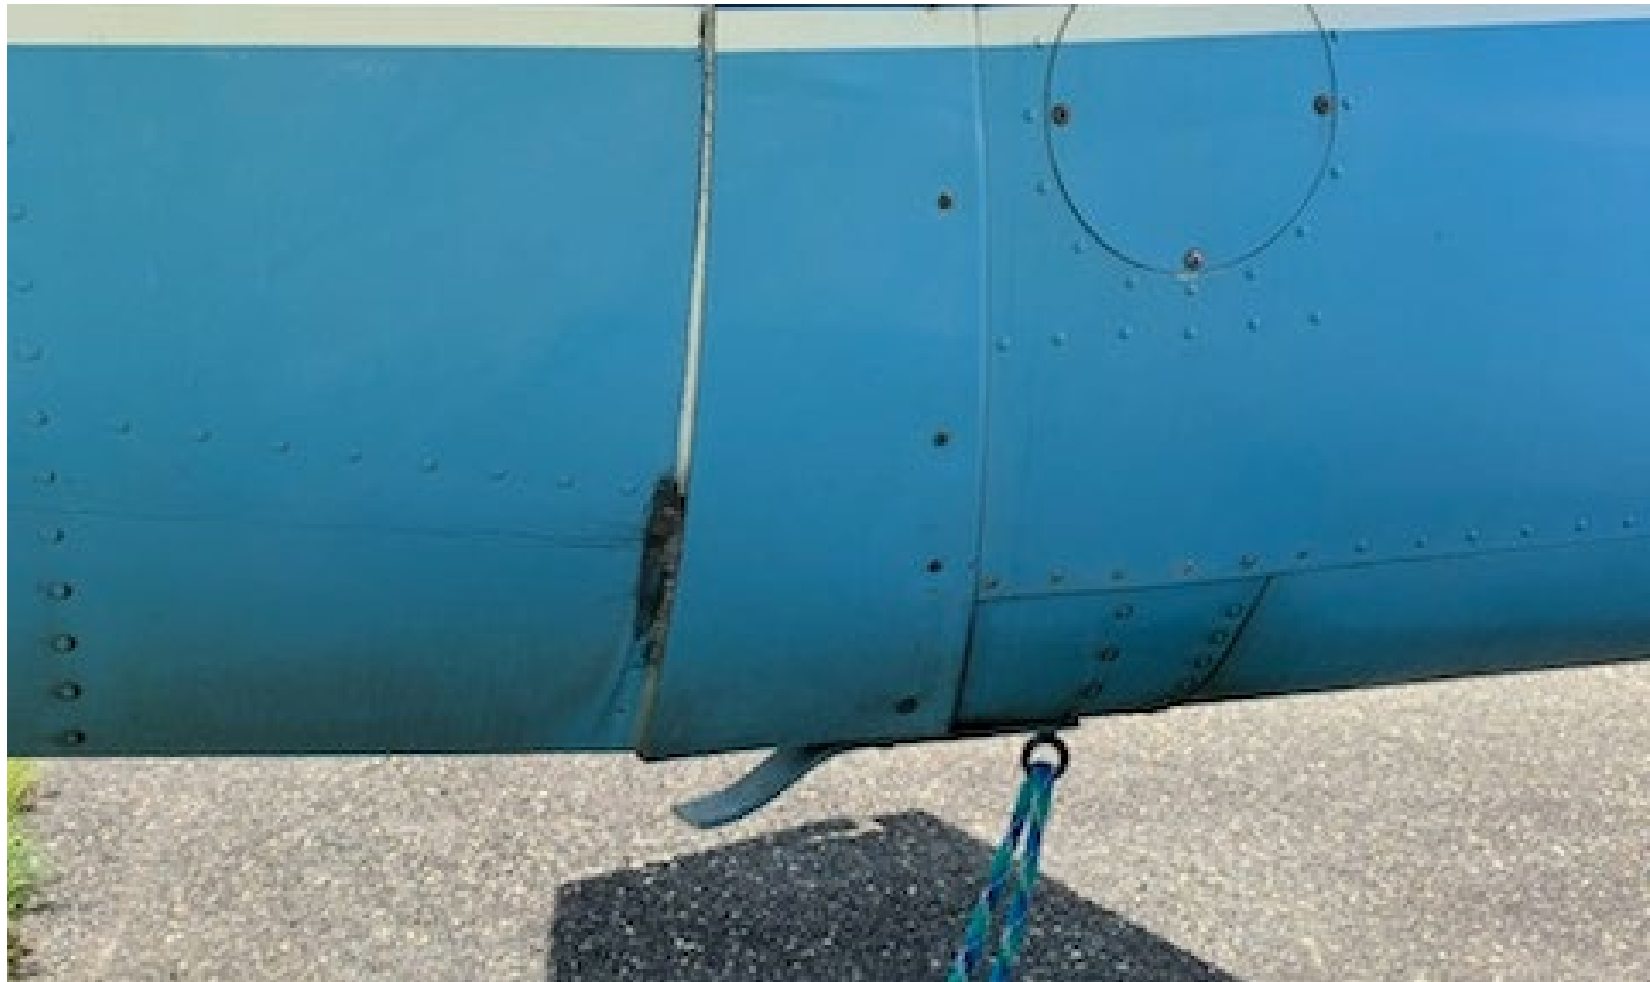
**Photo 2 – View of Empennage Left Side (Courtesy of FAA)**

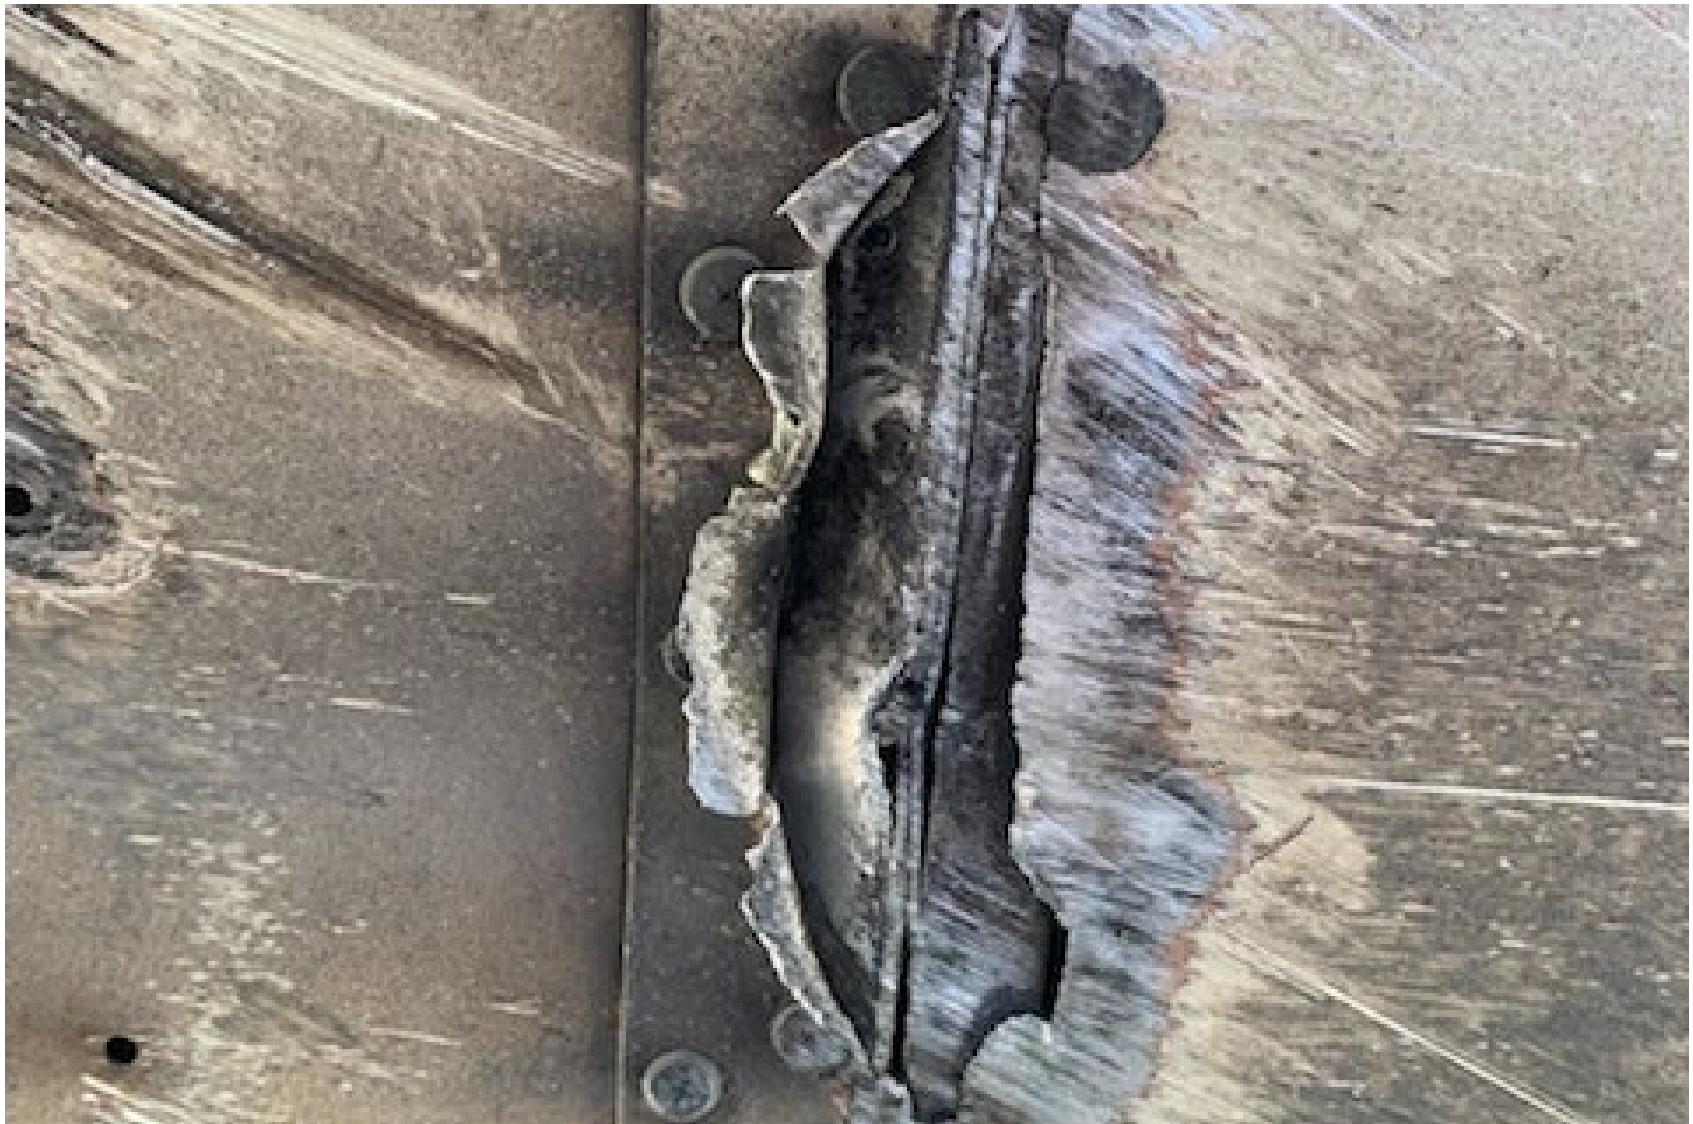
**Photo 3 – Closeup View of Stringer Damage (Courtesy of FAA)**

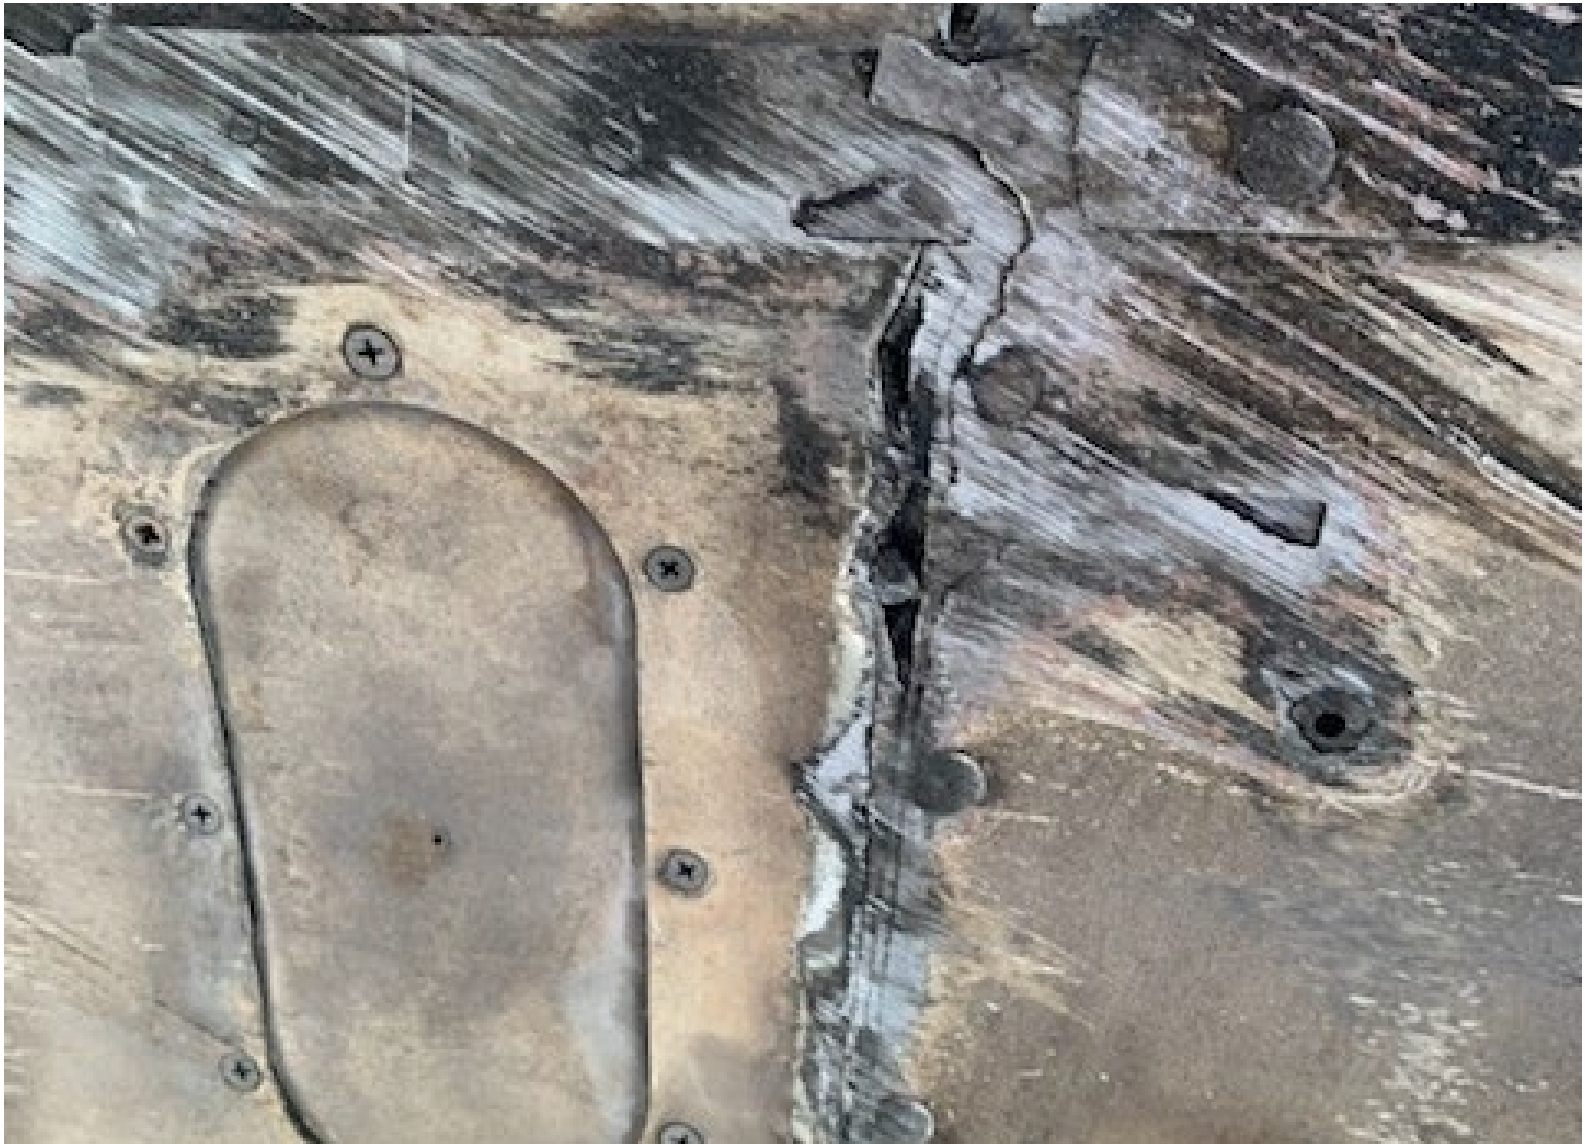
**Photo 4 – Closeup View of Stringer Damage (Courtesy of FAA)**
