# National Transportation Safety Board

ERA22LA410

## **ENGINE EXAMINATION SUMMARY**

Location: Anchorage, AK  
Date: September 9, 2022  
Time: 1530 AKDT  
Airplane: Cessna U206

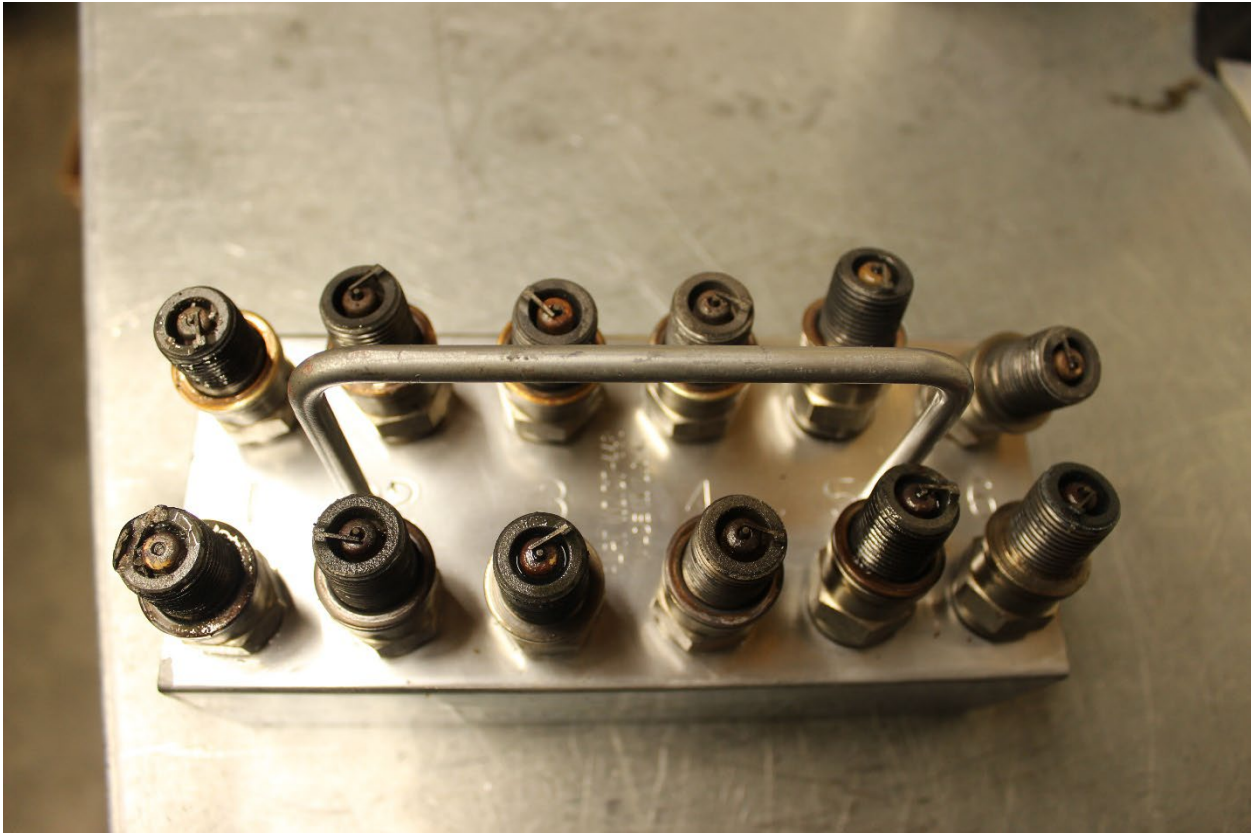
The air intake was removed, multiple fragments of metal debris were found in the intake. The spark plugs were removed, an elliptical impact deformation and metal debris was noted on around the top of the No.1 bottom spark plug.

**Figure 1 View of the spark plugs**

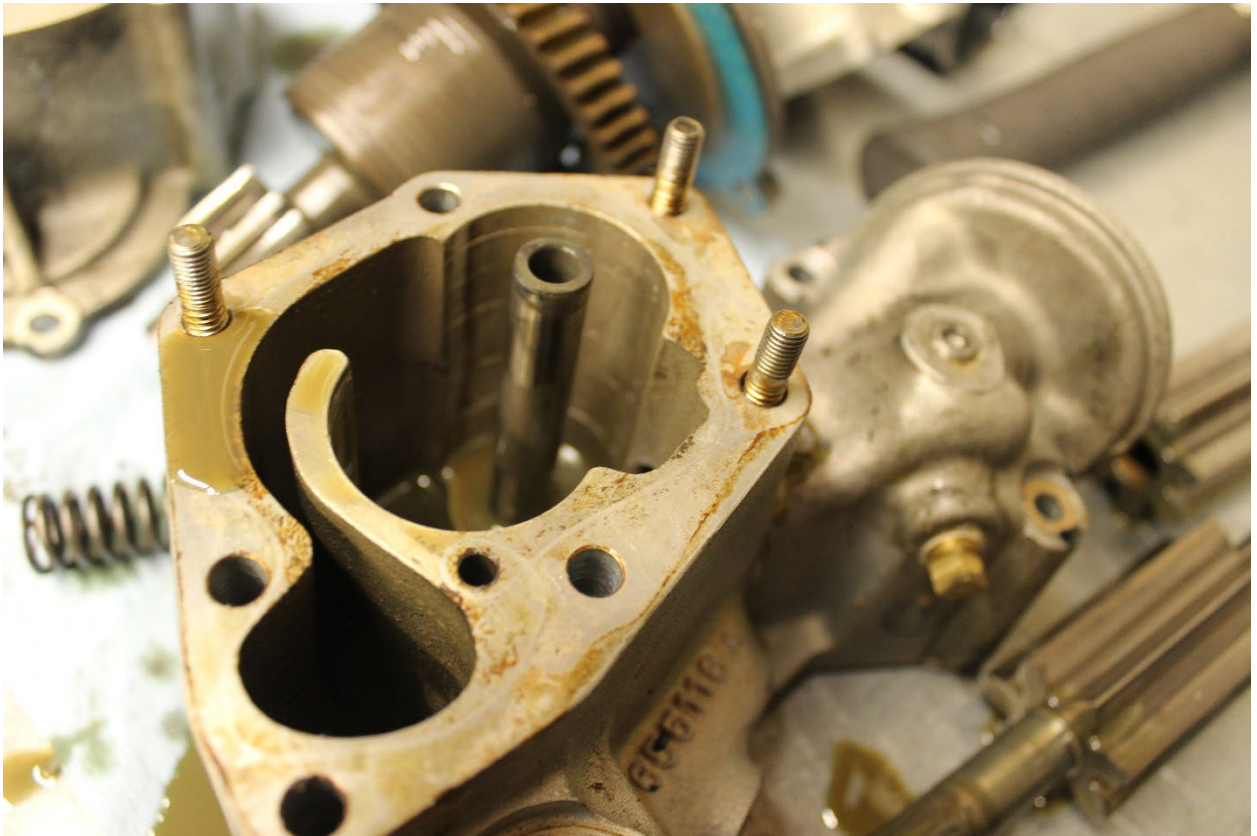
The oil pump was removed, rotational scoring was present in the oil pump housing.

**Figure 2 View of the rotational scoring on in the oil pump.**

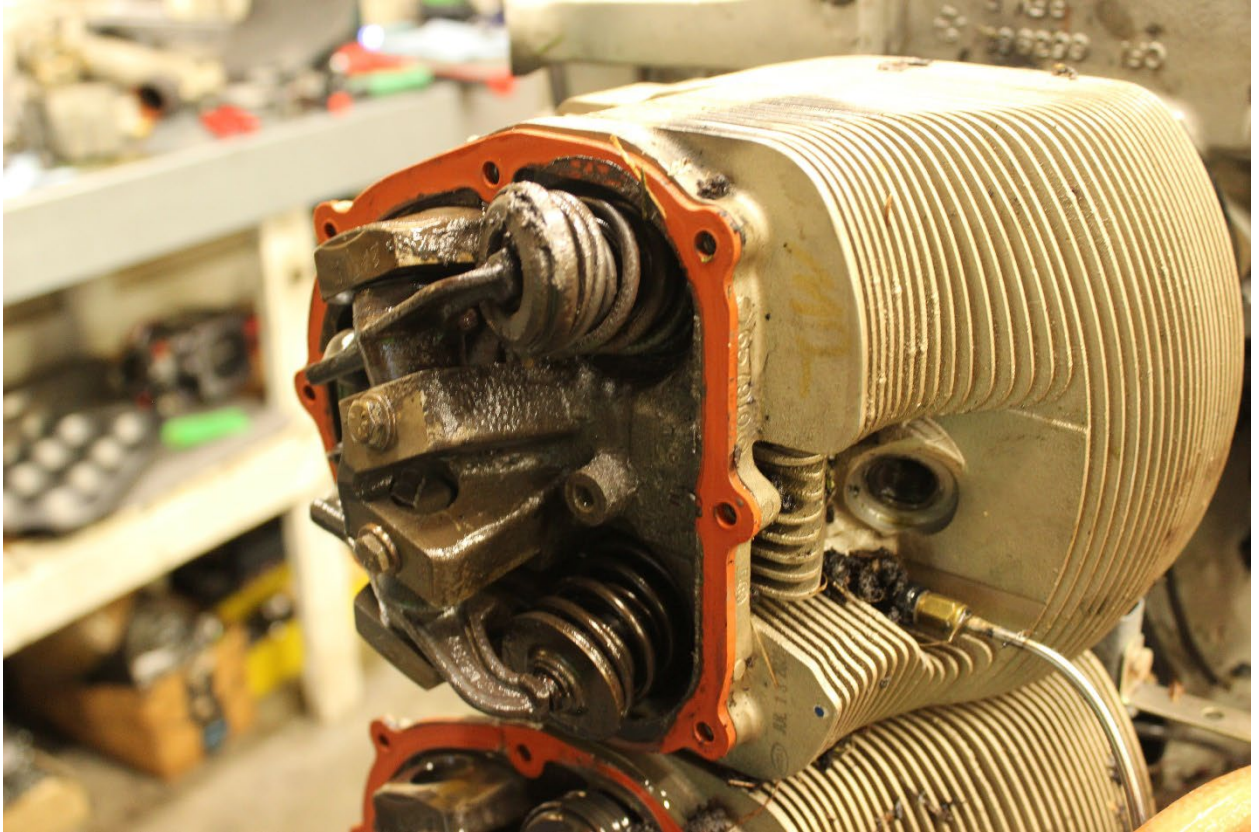
**Figure 3 No. 1 cylinder exhaust valve springs were deformed.**

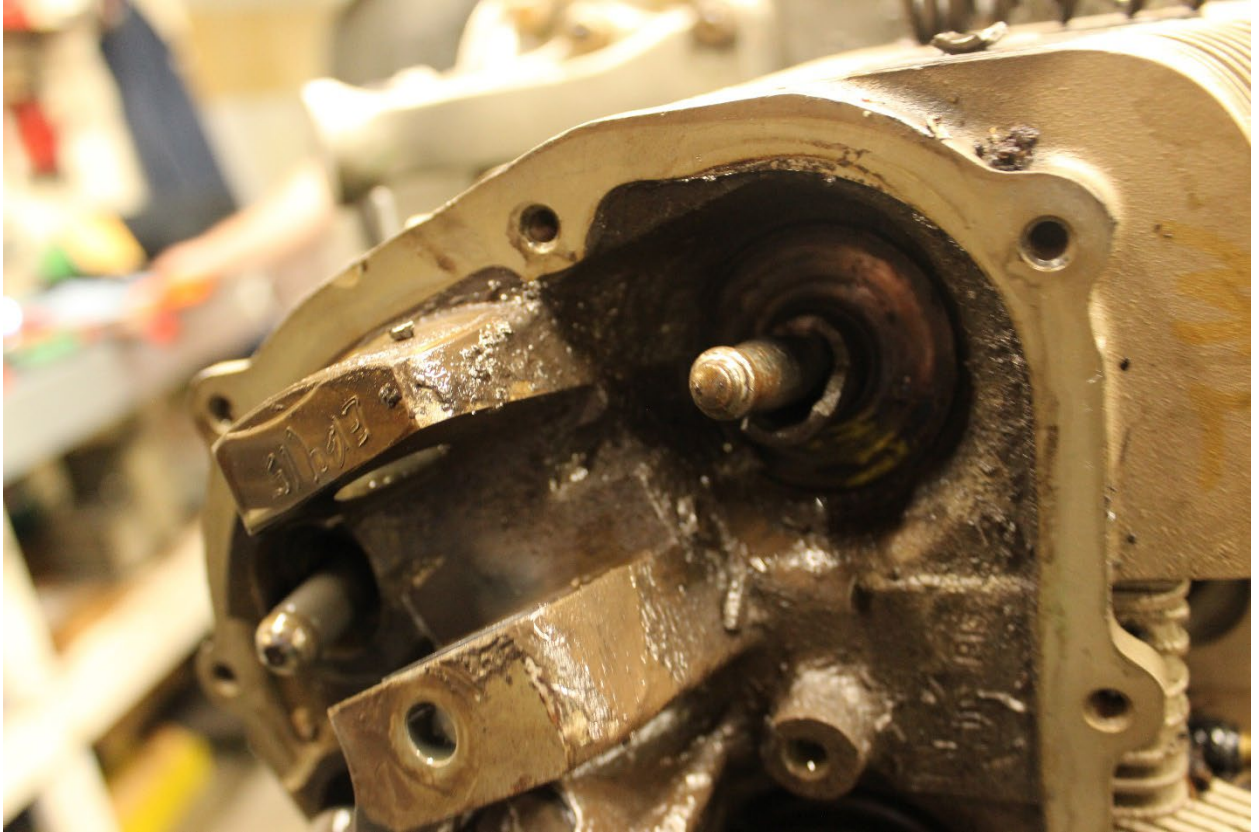
The No. 1 keeper on the exhaust valve was crushed, a portion of the keeper remained around the valve stem. The No. 5 exhaust valve keeper was fractured and bent in.

**Figure 4 No. 1 exhaust valve pin and the remaining fragments of the key.**

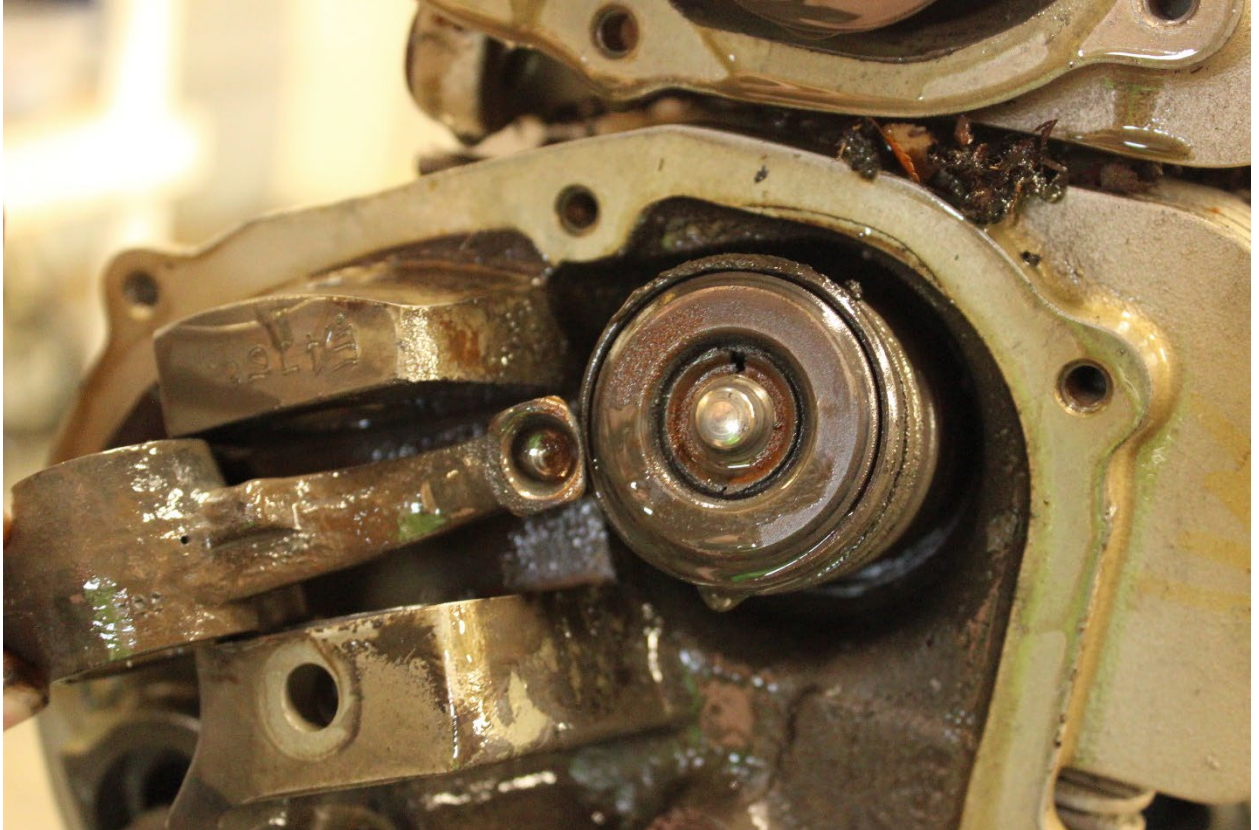
The No. 1 exhaust valve guide was damaged and fragmented. The No. 5 key was deformed inward and cracked. No deformities on other keys were observed.

**Figure 5 No. 5 exhaust valve stem and key.**

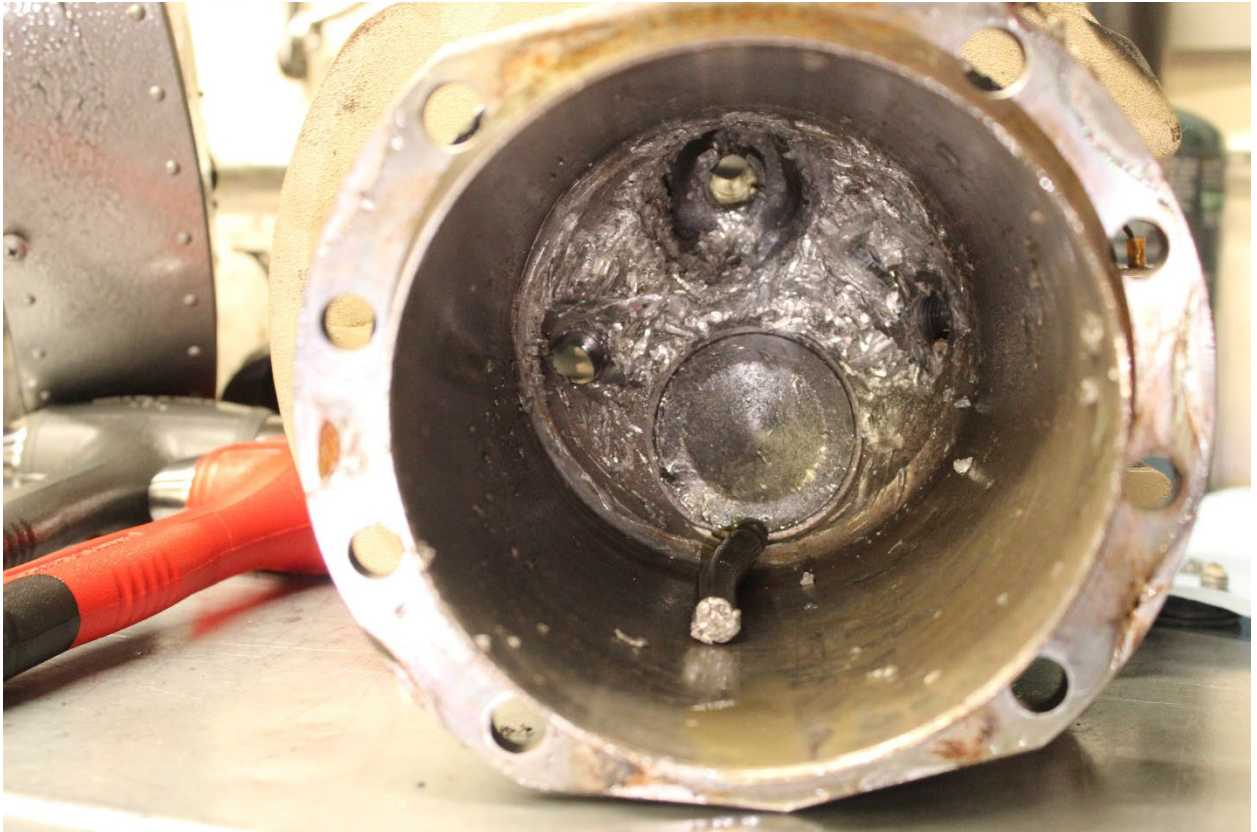
The No 1. cylinder had extensive deformation.

**Figure 6 Damage to the No. 1 cylinder.**

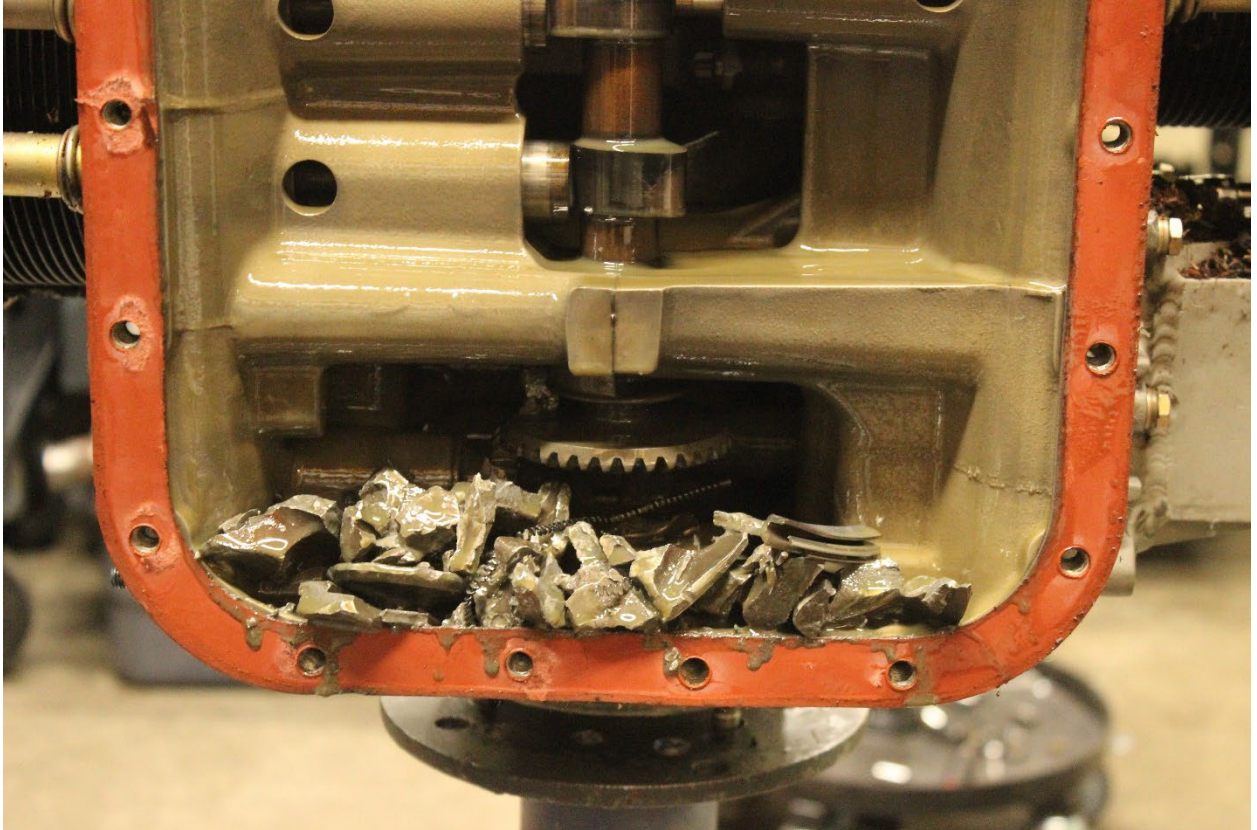
The oil sump was removed and there were numerous metal fragments present.

**Figure 7 Metal fragments found in the oil sump.**

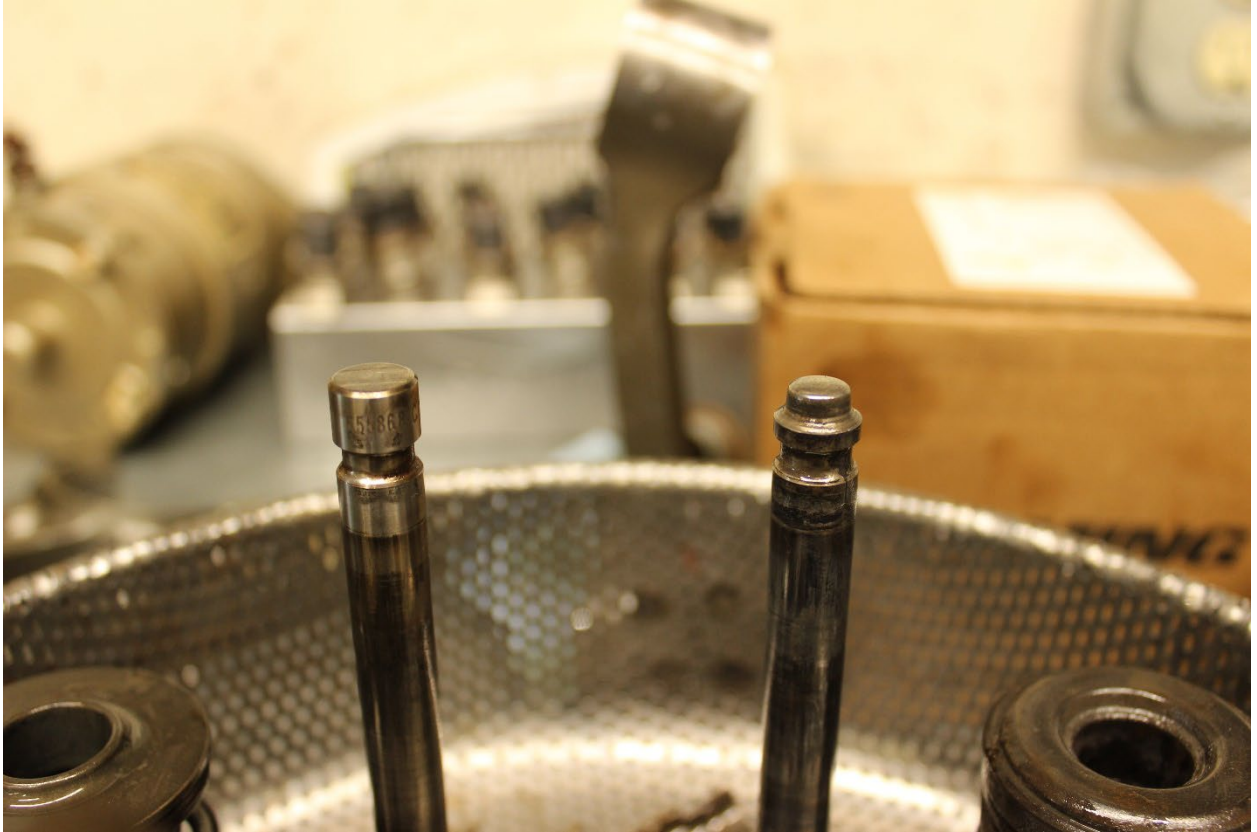
The exhaust valve rocker arms on cylinder Nos. 1 and 5 were deformed, along with the Nos. 1 and 5 valve stems.

**Figure 8 Exhaust valve stems from cylinders Nos. 3 and 1.**

Figure 8 shows the No. 1 stem compared to the No. 3, which was not deformed.

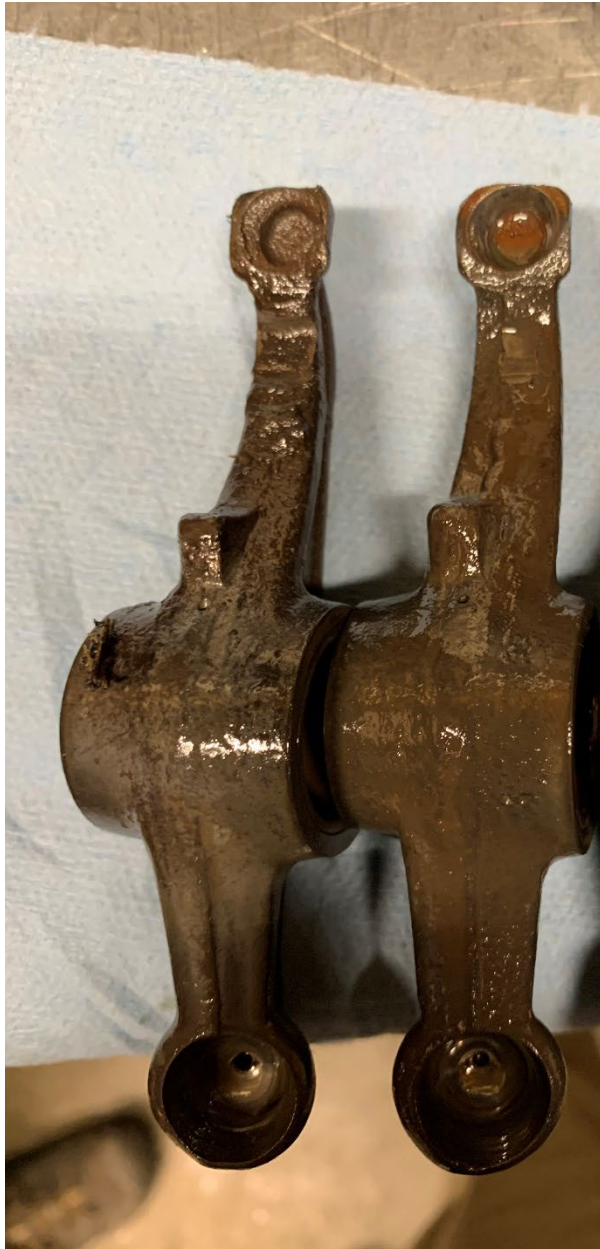
**Figure 9 Exhaust valve rocker arms, Nos. 5, 1.**
