# National Transportation Safety Board

ERA22LA410

## **MATERIALS LABORATORY**

Factual Report 23-098

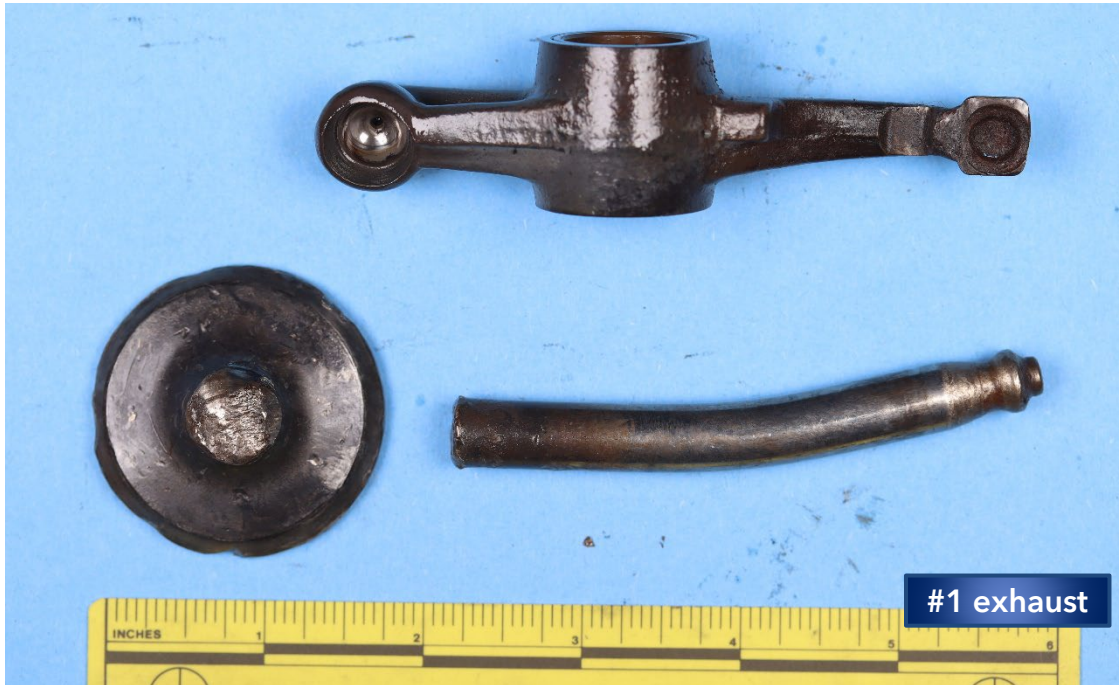
A closer view of the cylinder 1 exhaust valve and rocker arm is shown in figure 2. The exhaust valve stem was bent, and the stem was fractured adjacent to the fillet radius transitioning to the head. A closer view of the fractured end of the valve stem is shown in figure 3. Fracture features were obliterated by post-fracture impact damage on both sides of the fracture, so a fracture mechanism was not identified. Longitudinally-oriented dark streaks and galling damage were observed on the valve stem near the fractured end as indicated with arrows in figure 3.

**Figure 2.** Closer view of the exhaust valve and associated rocker arm from cylinder number 1.

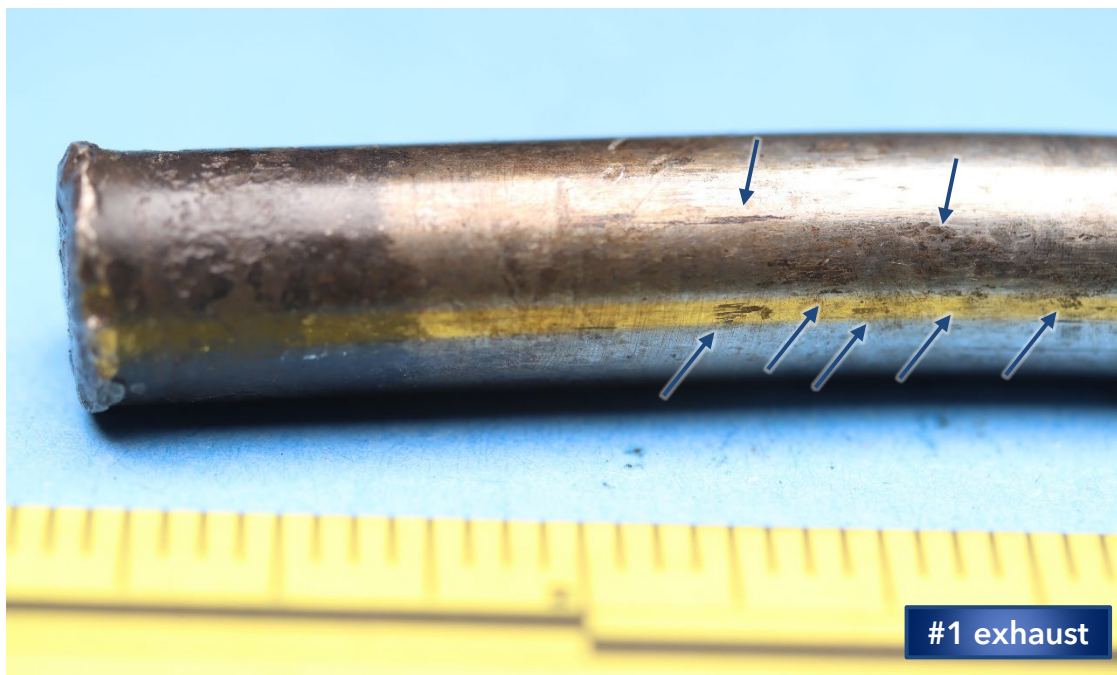
**Figure 3.** Fractured end of the number 1 cylinder exhaust valve stem. Longitudinally-oriented dark streaks and galling damage such as those indicated with unlabeled arrows were observed consistent with valve sticking.

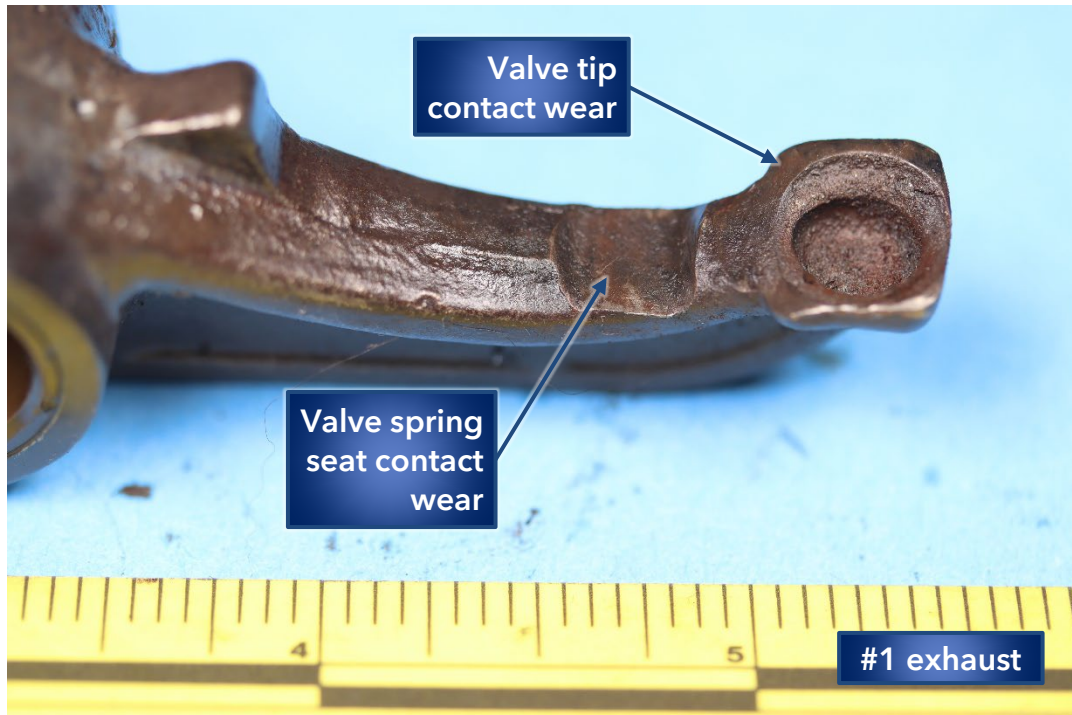
The tip end of the cylinder 1 exhaust valve was severely worn to a shape resembling a top hat, and any identifying marks on the tip were obliterated by the wear. The shoulder at the stem side of the keeper slot was also worn away to a cone-shaped slope transitioning from the stem diameter to the keeper slot diameter. The corresponding contact pad on the exhaust rocker arm was recessed from wear in a shape mirroring the valve tip wear as shown in figure 4. A portion of the arm adjacent to the pad was also worn consistent with contact with the valve spring seat. The pad end of the valve was tinted consistent with high heat exposure, and the worn areas of the pad were oxidized.

**Figure 4.** Valve contact pad for the number 1 cylinder exhaust rocker arm.

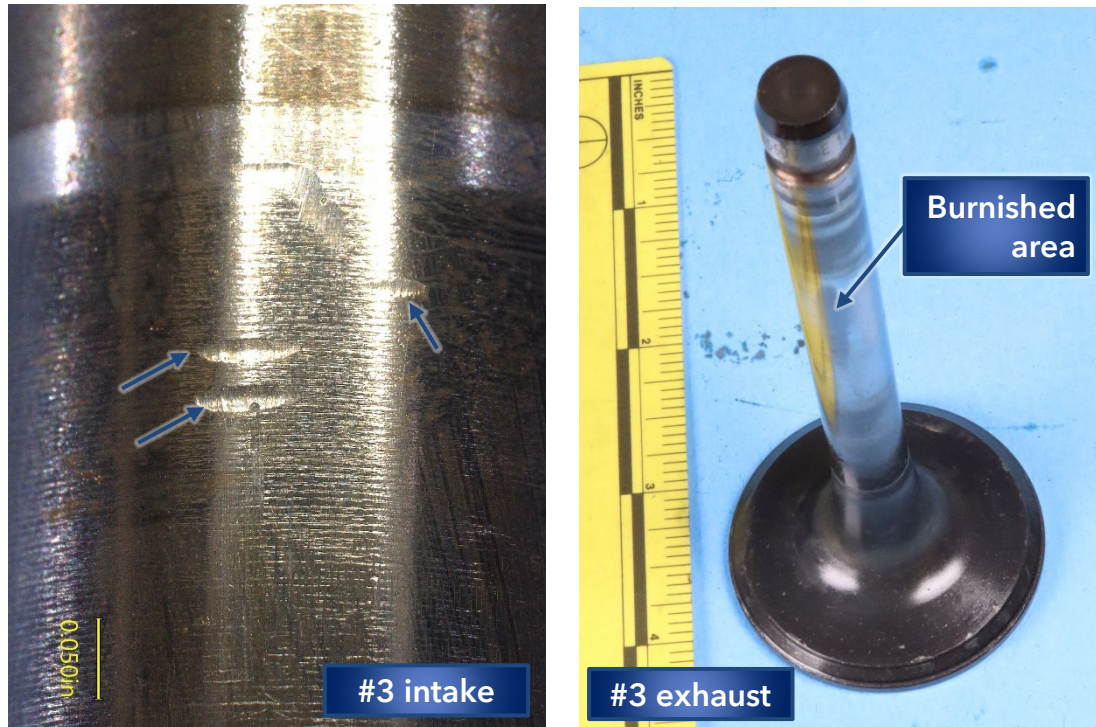
The number 3 cylinder intake valve was intact, and the valve tip had identifying markings that read "655868-C 19216G Z". The valve tip end face had a normal circular contact wear pattern. Isolated scuffs and longitudinal scratch marks were observed on the valve stem. Near the valve tip, multiple semicircular indents were observed on the stem as shown in figure 5.

The number 3 cylinder exhaust valve was intact, and the valve tip had identifying markings that read "655771-E 19119T Z". The valve tip end face was stained dark and had a normal circular wear pattern. Near the middle of the stem, the surface appeared burnished in 5 distinct longitudinally-oriented patches distributed around the circumference as indicated in figure 5.

**Figure 5.** Semicircular contact marks near the tip of the number 3 cylinder intake valve stem (left image) and view of burnishing marks on the number 3 cylinder exhaust valve stem (right image).

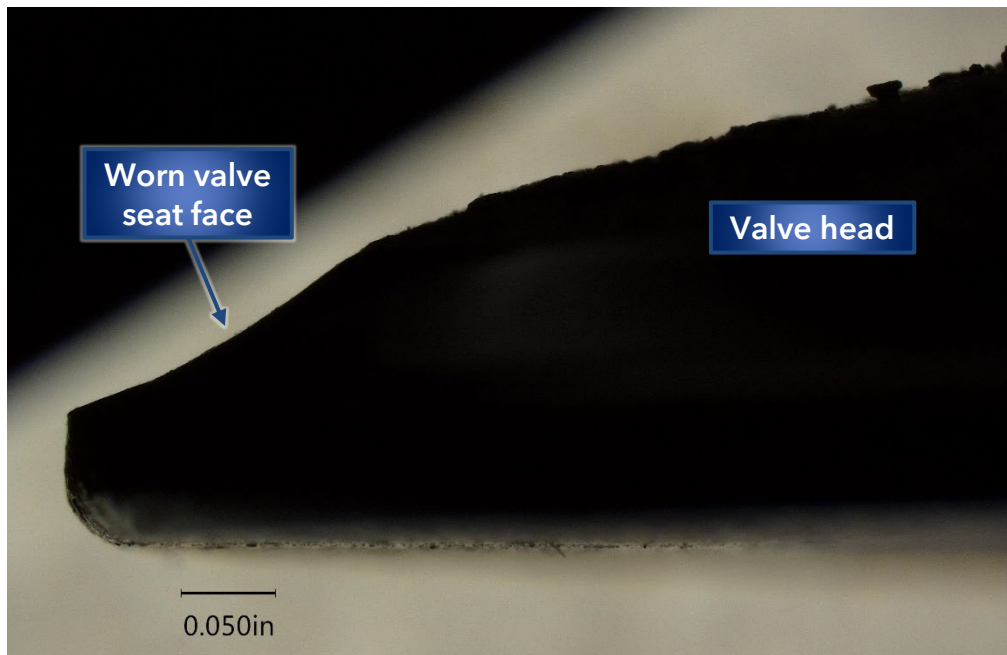
A backlit image of the number 3 cylinder intake valve head outer edge is shown in figure 6. The valve seat face had a concave shape consistent with substantial valve seat face wear. The extent of wear appeared relatively uniform around the circumference.

**Figure 6.** Backlit image of the number 3 cylinder intake valve head outer edge.

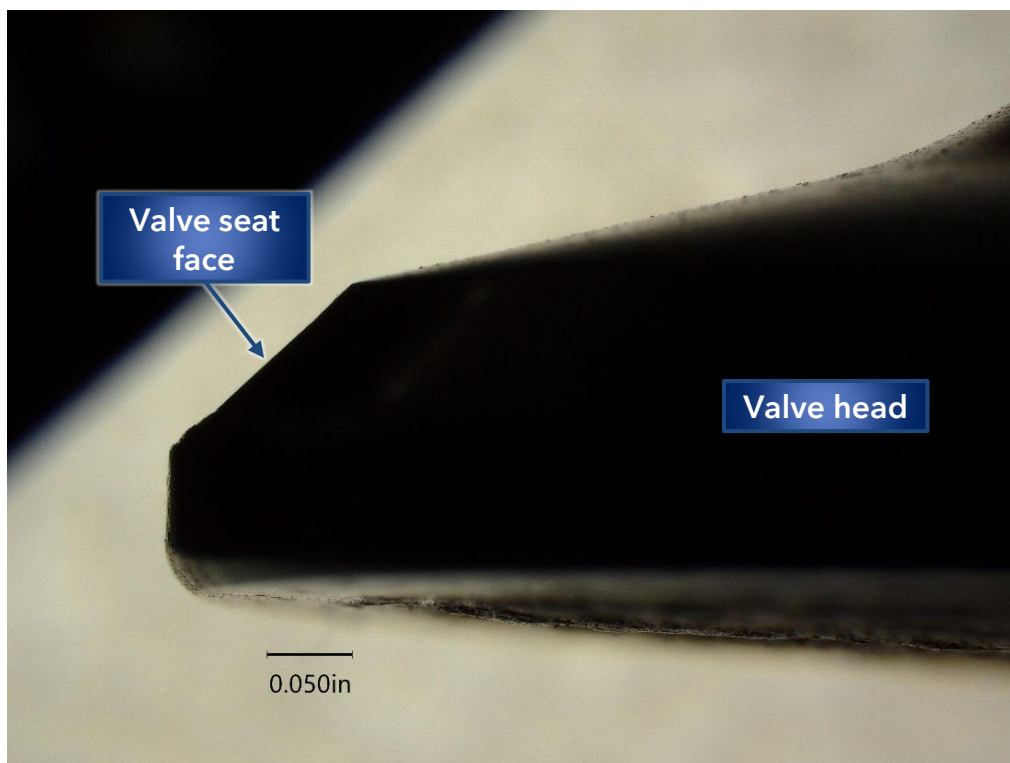
A backlit image of the number 3 exhaust valve head outer edge is shown in figure 7. The valve seat face had a relatively flat face that showed limited wear. The extent of wear appeared relatively uniform around the circumference.

**Figure 7.** Backlit image of the number 3 cylinder exhaust valve head outer edge.

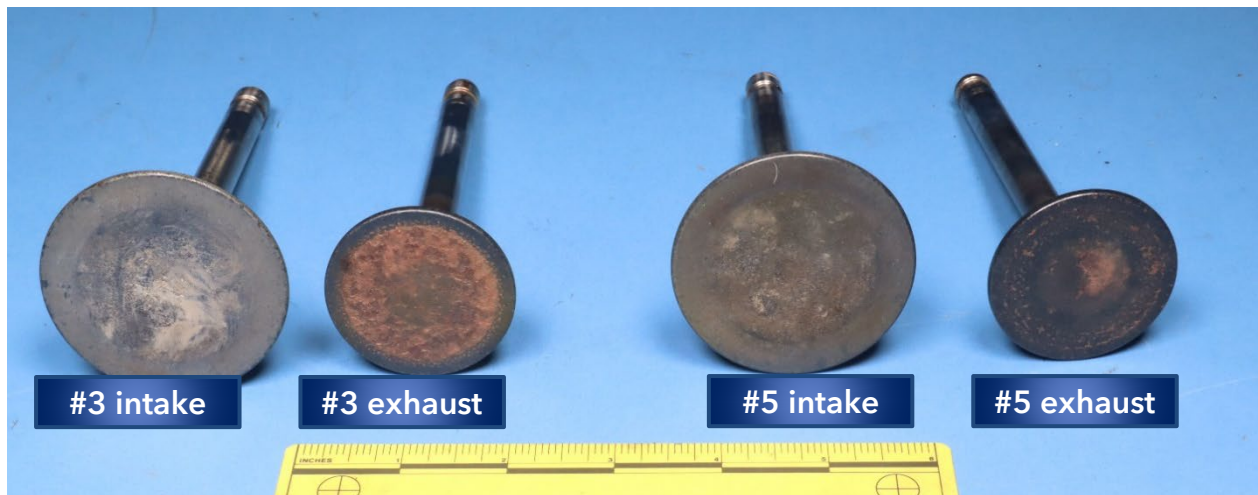
An overall view of the valve head faces from the number 3 cylinder is shown in figure 8 (left side). The valve heads had a uniform heat signature pattern around the circumference. A light coating of gray combustion deposits was observed on the

intake valve head face, and the exhaust valve had a thicker layer of reddish orange deposits.

An overall view of the valve head faces from the number 5 cylinder is shown in figure 8. The valve heads had a uniform heat signature pattern around the circumference. Both valve faces had limited deposits of combustion products.

**Figure 8.** Valve head faces from the number 3 and number 5 cylinders.

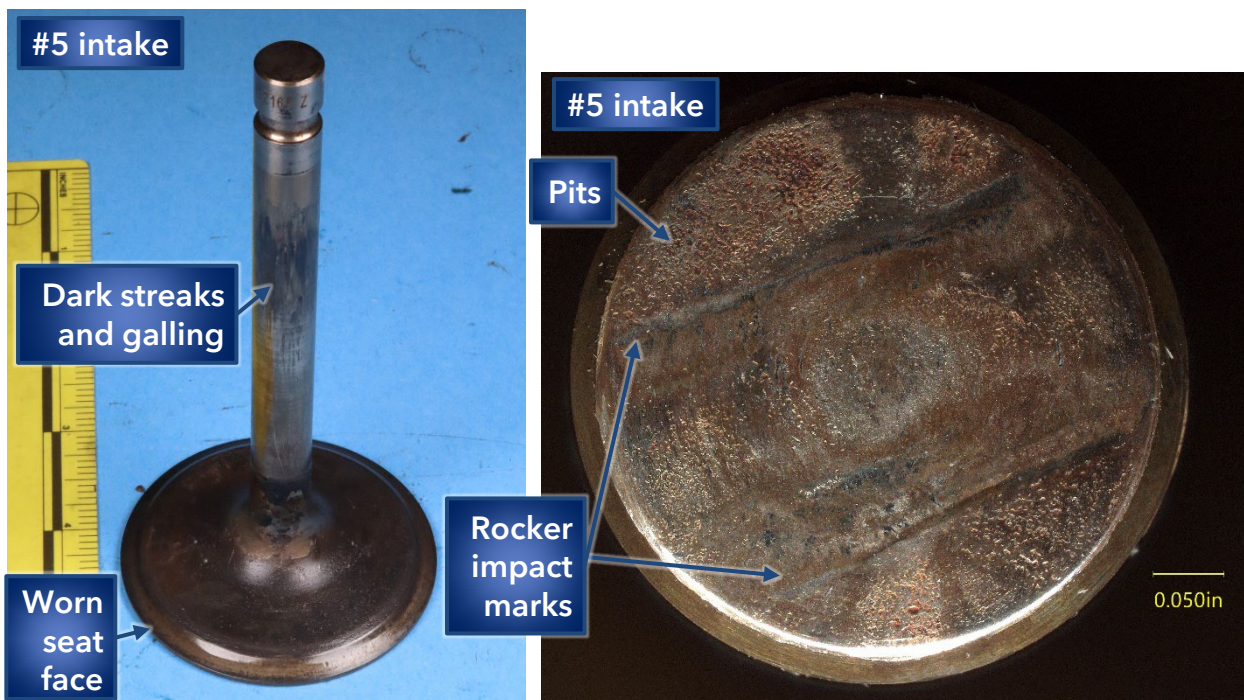
The number 5 cylinder intake valve was intact, and identification marks on the tip read "655868-C 19216F Z". Extensive longitudinally-oriented dark streaks and galling damage were observed on the valve stem as shown in figure 9. The valve tip end face is also shown in figure 9. Multiple rocker arm impact marks were observed on the end face as indicated in figure 9. Oxidation and pits were also observed across the surface as indicated.

**Figure 9.** Overall view of the number 5 cylinder intake valve (left image) with a closer view of the tip end face (right image). Longitudinally-oriented dark streaks and galling damage were observed on the stem, and impact marks were observed on the tip end face.

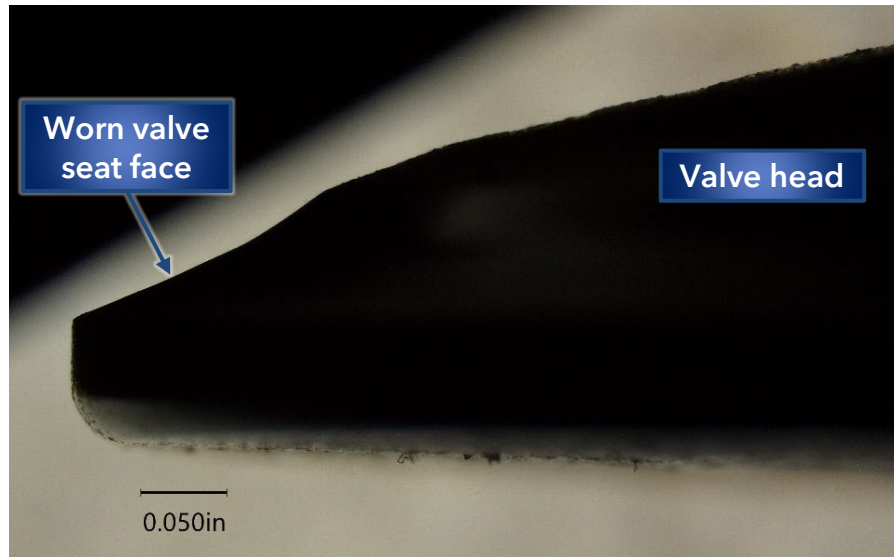
A backlit image of the number 5 cylinder intake valve head outer edge is shown in figure 10. The valve seat face had a concave shape consistent with substantial valve seat face wear. The extent of wear appeared relatively uniform around the circumference.

**Figure 10.** Backlit image of the number 5 cylinder intake valve head outer edge.

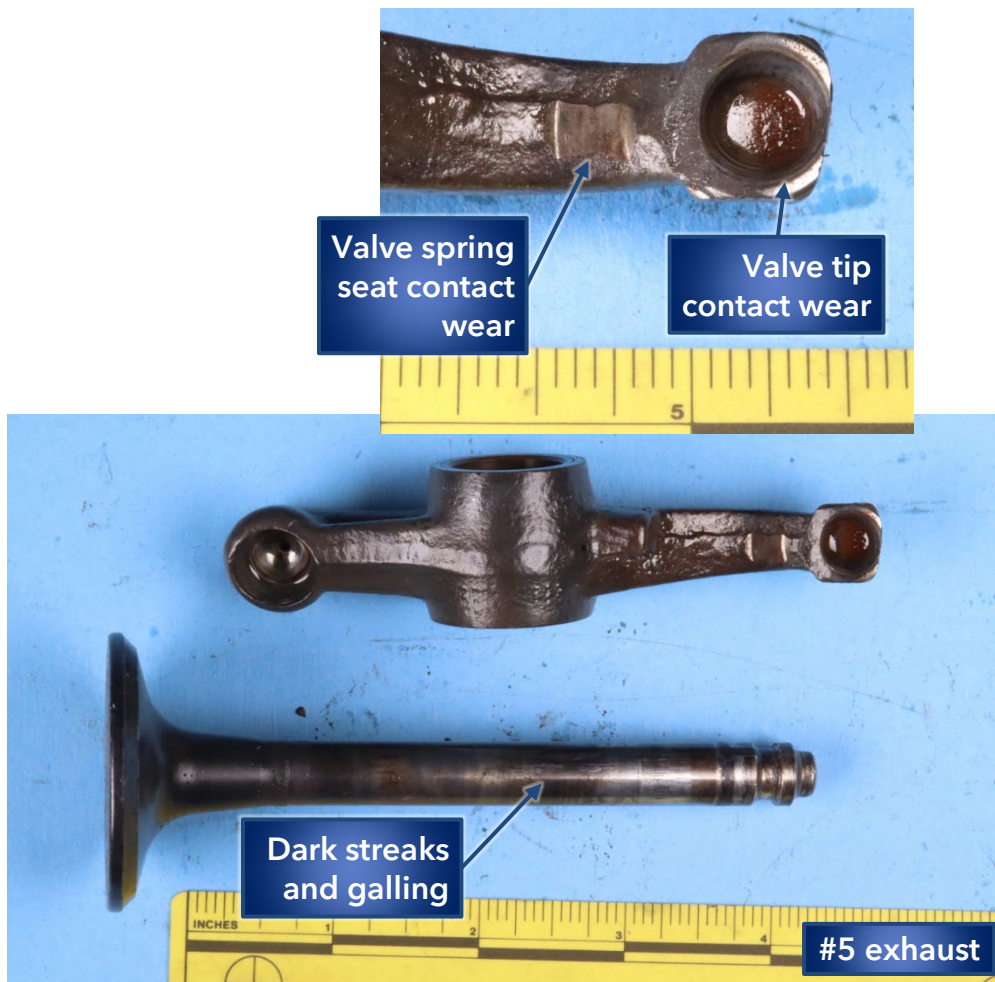
The number 5 cylinder exhaust valve and rocker arm are shown in figure 11. Extensive longitudinally-oriented dark streaks and galling damage were observed on the valve stem as indicated in figure 11. The tip of the exhaust valve was worn to a shape resembling a top hat, and any identifying marks were obliterated by the wear. The corresponding contact pad on the exhaust rocker arm was recessed from wear in a shape mirroring the valve tip wear as shown in the upper image in figure 11. A portion of the arm adjacent to the pad was also worn consistent with contact with the valve spring seat. The pad end of the valve was tinted consistent with high heat exposure, and the worn areas of the pad were oxidized.

**Figure 11.** Overall view of the number 5 cylinder exhaust valve and rocker arm (lower image) with a closer view of the valve contact pad on the rocker arm (upper image).

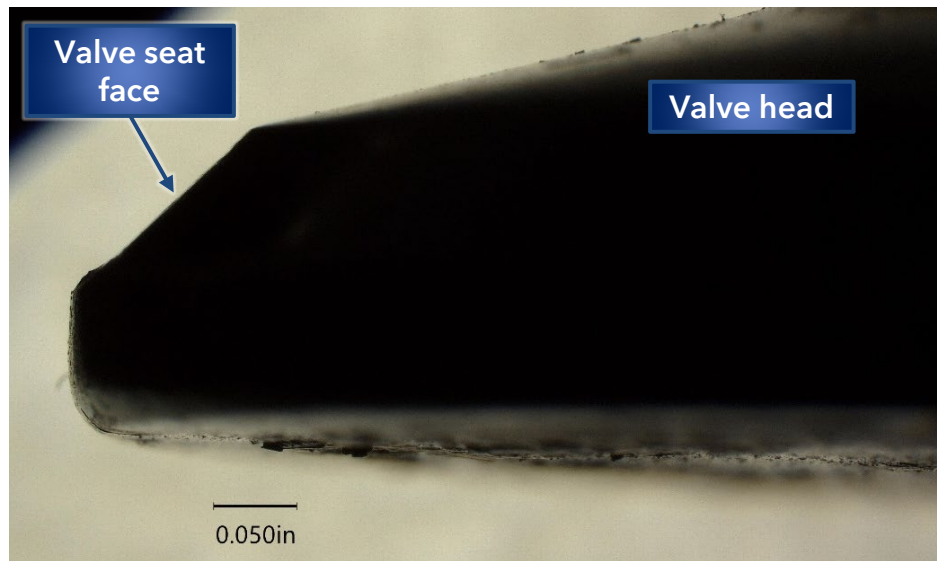
A backlit image of the number 5 exhaust valve head outer edge is shown in figure 12. The valve seat face had a relatively flat face that showed limited wear. The extent of wear appeared relatively uniform around the circumference.

**Figure 12.** Backlit image of the number 5 cylinder exhaust valve head outer edge.

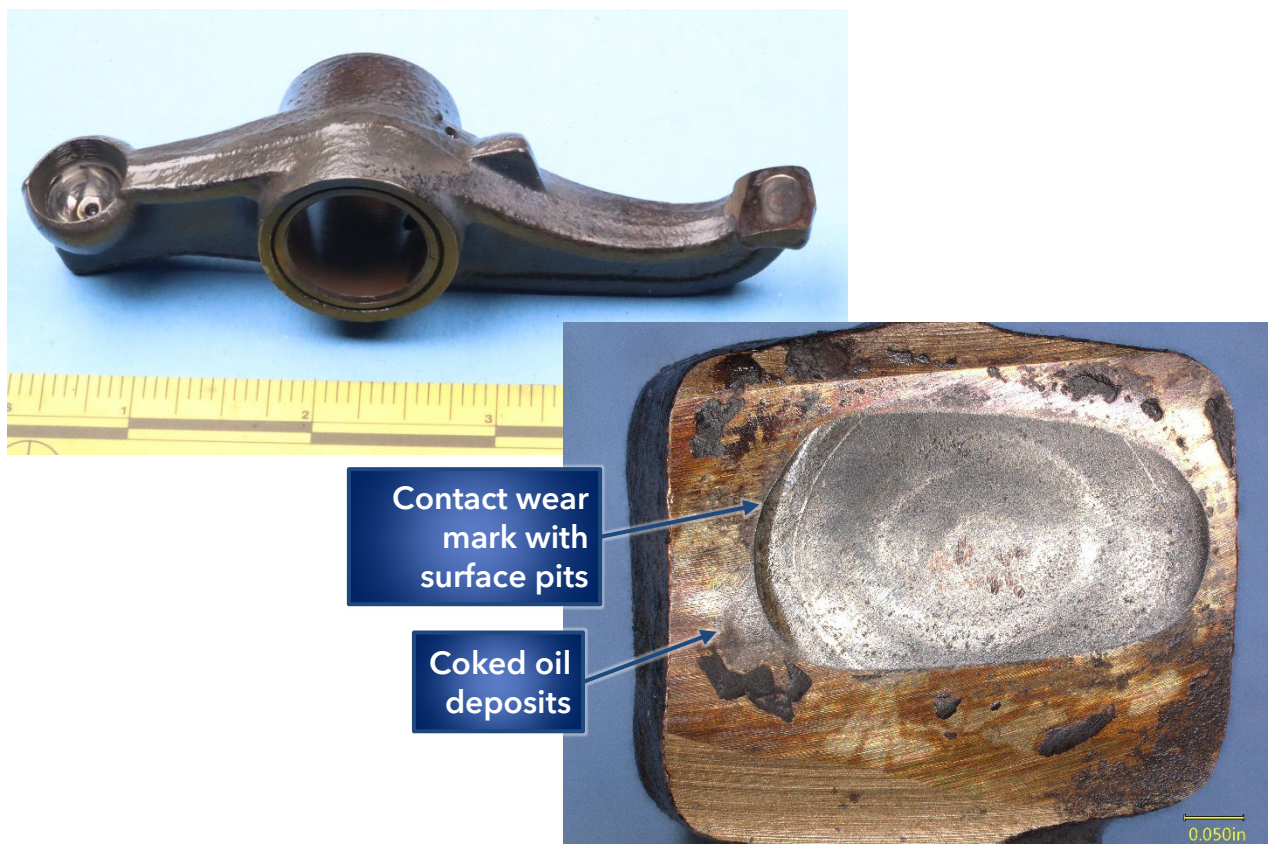
Two of the exhaust rocker arms that were not associated with a particular cylinder number are shown in figures 13 and 14. The rocker pads for both rocker arms were tinted dark consistent with high heat exposure, and coked oil deposits were observed on the rocker arm shown in the lower half of figure 13. A depression was observed in each pad consistent with impact and wear damage from contact with the corresponding valve tip. Pits were also observed on the pad surfaces within the contact areas.

**Figure 13.** View of an unlabeled exhaust rocker arm (upper image) with a closer view of the valve contact pad (lower image).

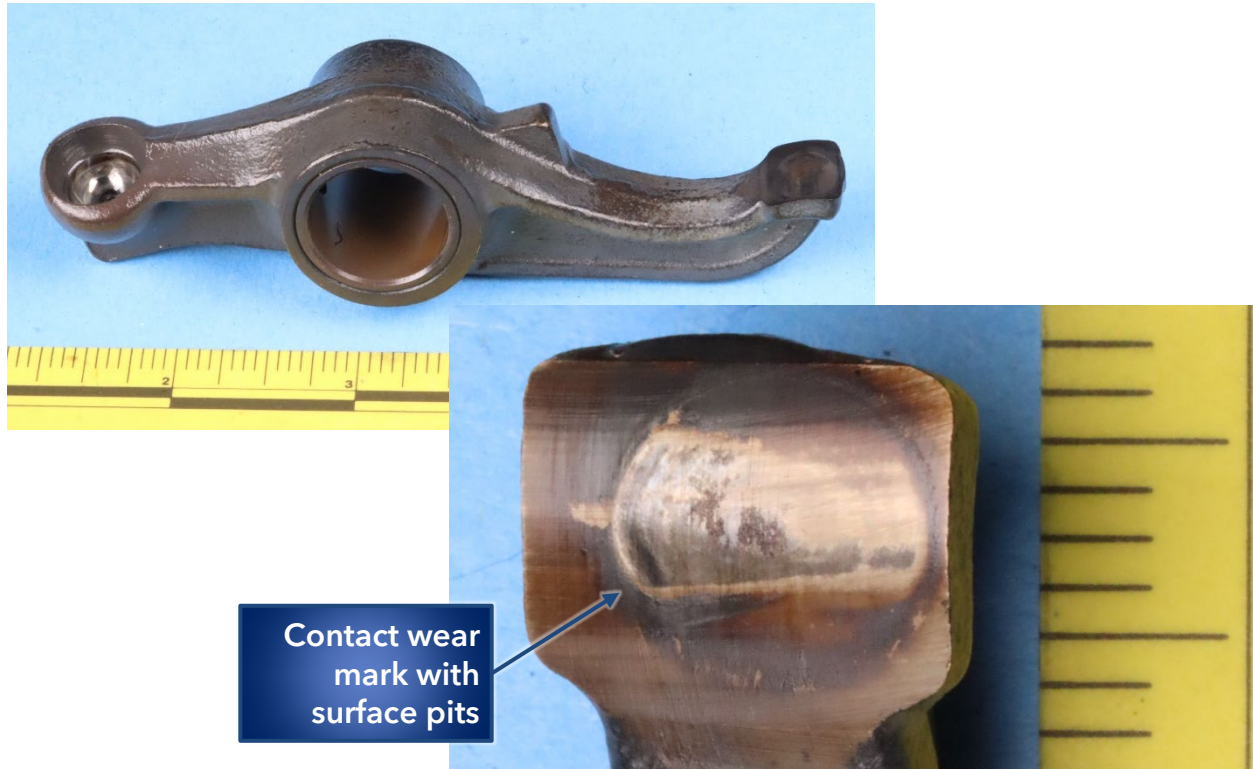
**Figure 14.** View of an unlabeled exhaust rocker arm (upper image) with a closer view of the valve contact pad (lower image).

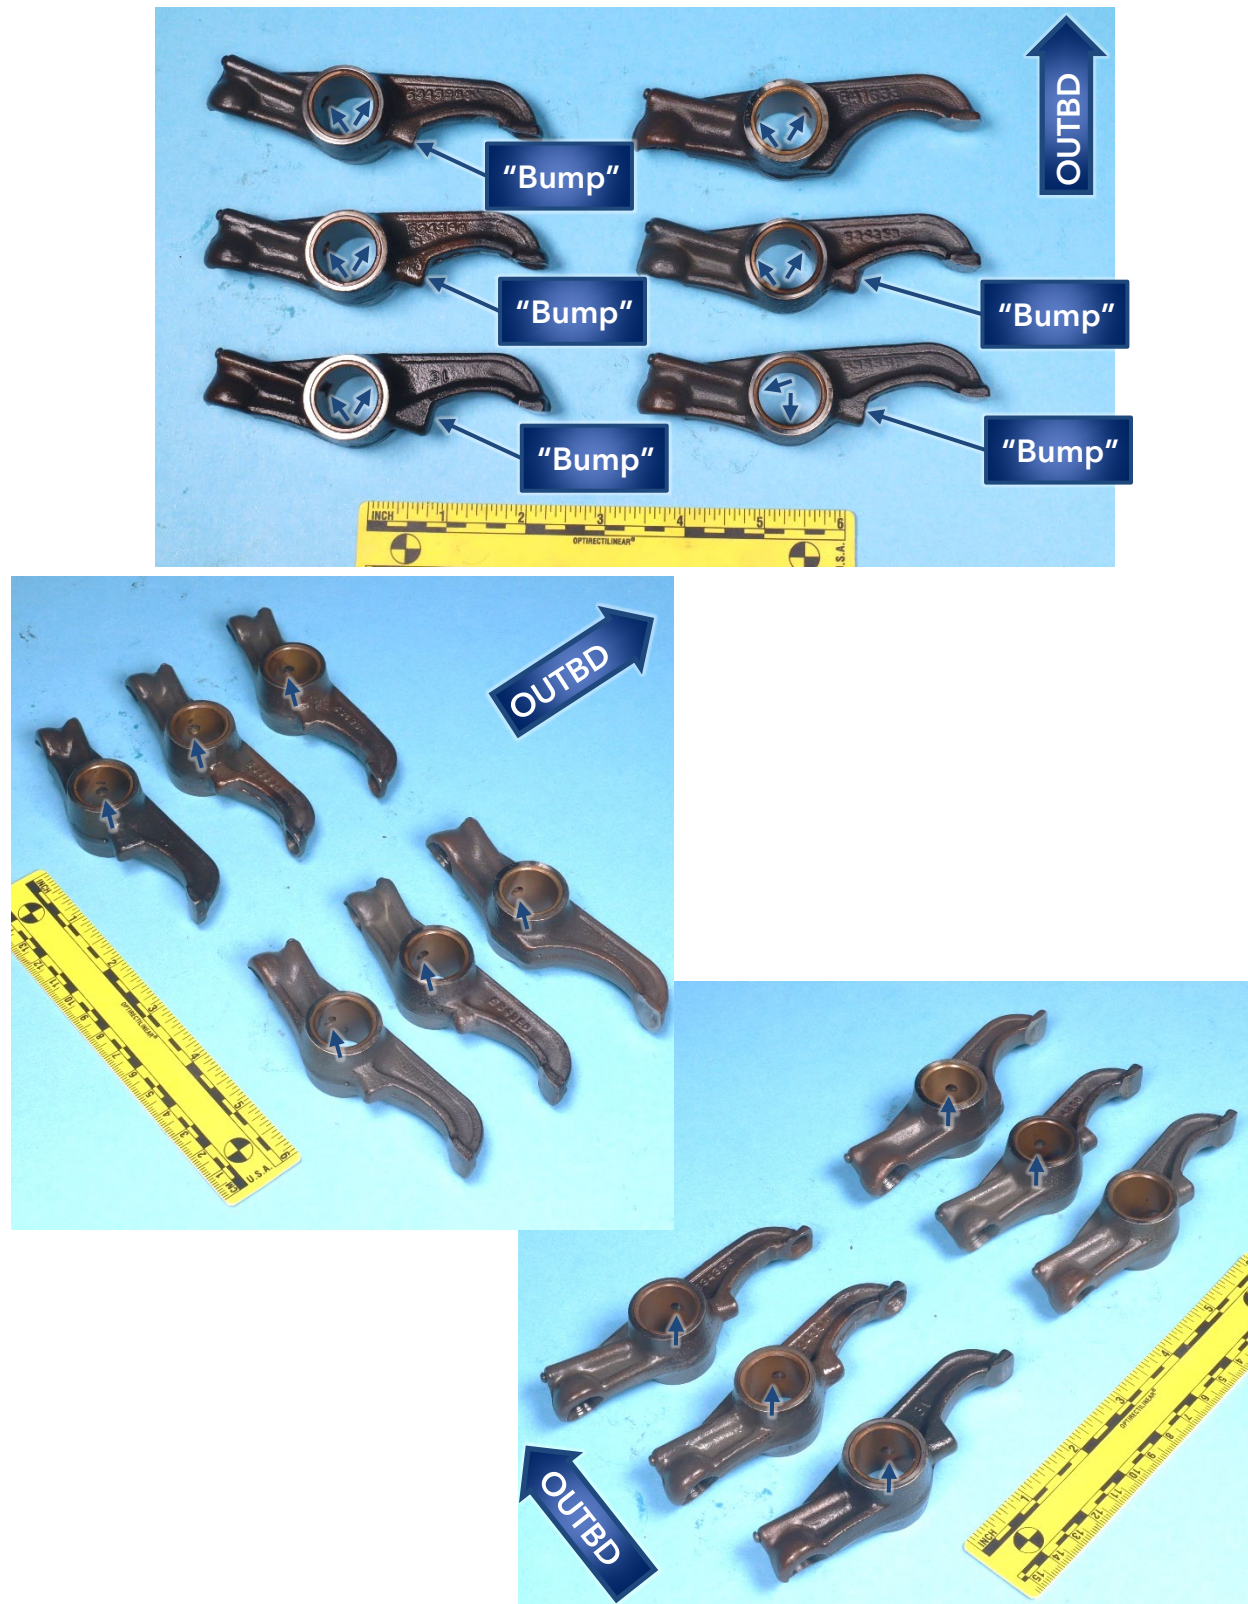
Views of the exhaust rocker arms are shown in figure 16. As noted in the upper image in figure 16, 5 of the 6 exhaust rocker arms had a bump on the inboard side of the valve arm, which was inconsistent with the drawing for the current exhaust rocker arm for the Continental IO-550-series engine as illustrated in the SPMM. Unlabeled arrows in figure 16 point to locations of oil passage holes in the installed bushings. None of the oil holes were located in the positions described in the SPMM or as shown in figure 15. In 5 of the 6 exhaust rocker arms including those from cylinders 1 and 5, both oil holes were located outboard of the bushing centerline. In the remaining exhaust rocker arm (shown at the lower right in figure 16), one hole was

located outboard of the bushing centerline, and the other hole was located directly inboard of the bushing centerline. In one of the rocker arms removed from a cylinder other than number 1 or 5, the bushing was also installed with the oil holes offset to the incorrect side relative to the arm's longitudinal axis.

**Figure 16.** Views of the exhaust rocker arms. Unlabeled arrows point to locations of oil passage holes in the rocker bushings.

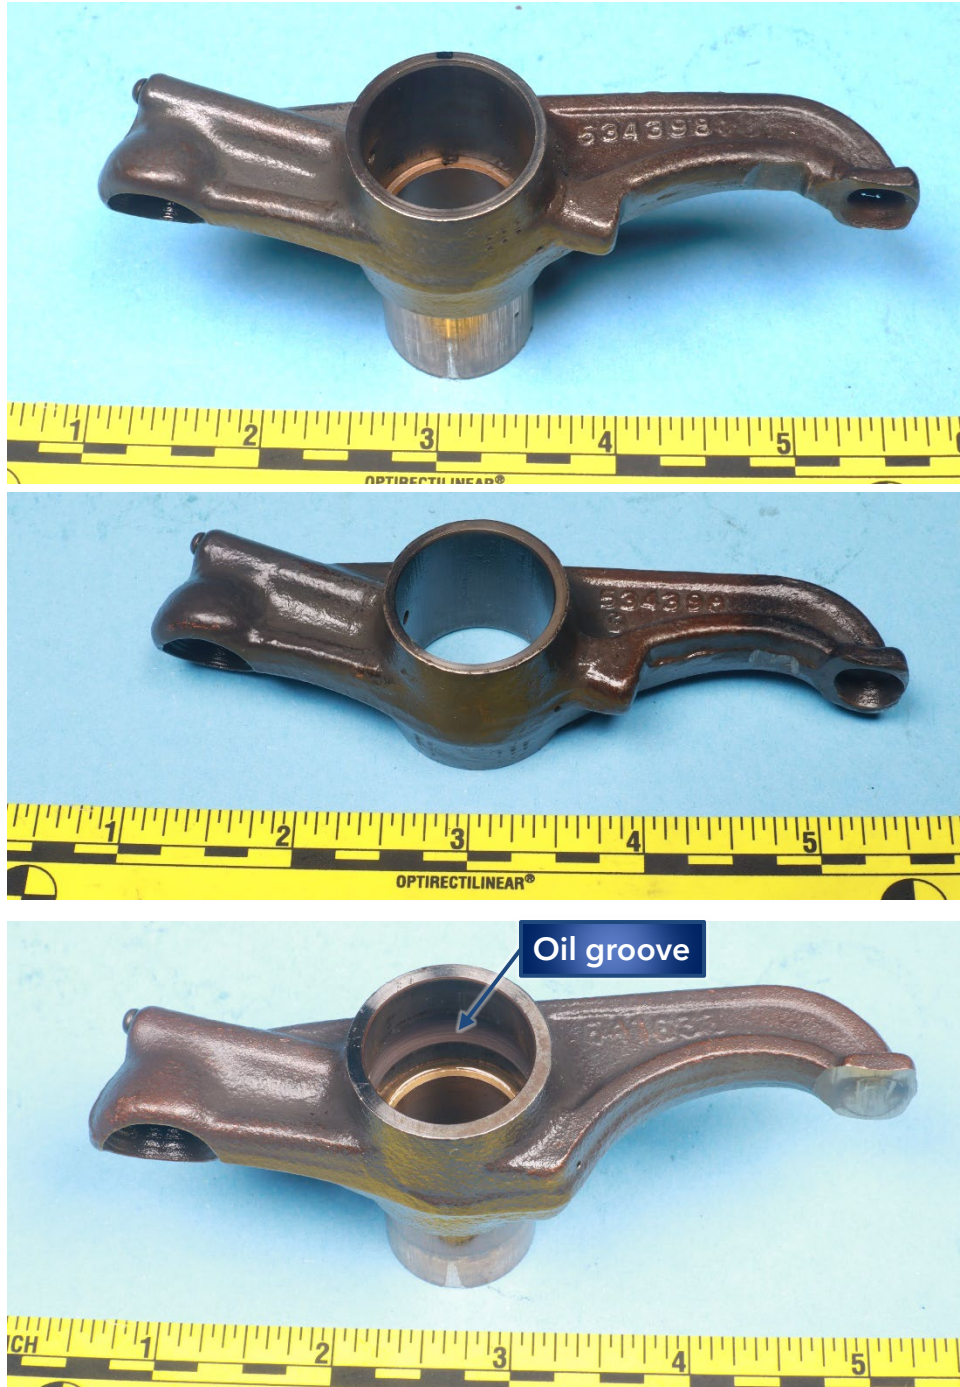
Bushings were pressed out of the rocker bore in each of the exhaust rocker arms, and representative results are shown in figure 17. Smooth rocker bores were observed in 5 of 6 exhaust rocker arms, including those from the number 1 and number 5 cylinders after the bushings were pressed out. For comparison, an oil feed groove was observed in the rocker bore of the exhaust rocker arm that did not have a "bump" as indicated in the lower image in figure 17.

**Figure 17.** Number 1 exhaust rocker arm (upper image), number 5 exhaust rocker arm (middle image), and unlabeled exhaust rocker arm that did not have a “bump” (lower image) after pressing the bushings from the respective rocker bore. A circumferential oil groove was present in the exhaust rocker arm without a bump as indicated in the lower image, and no oil groove was observed in the rocker bore for other exhaust rocker arms including from the number 1 and number 5 cylinders as shown.

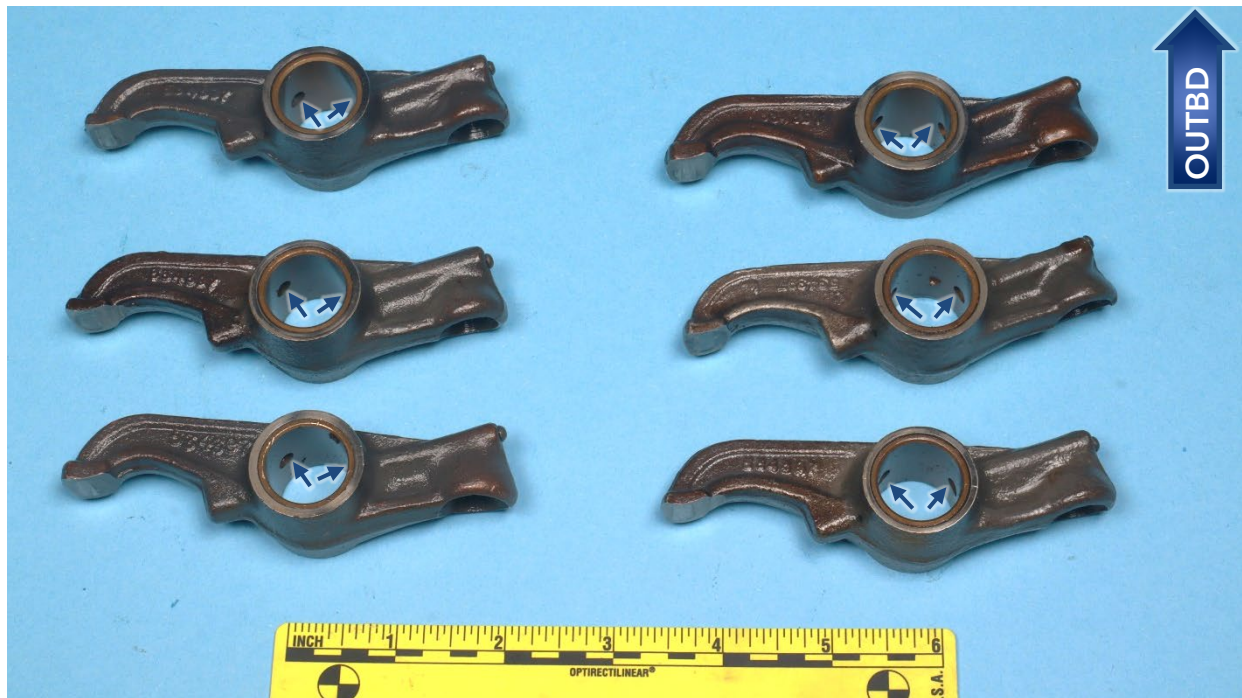
An overall view of the intake rocker arms is shown again for reference in figure 18. Unlabeled arrows in figure 18 point to locations of oil passage holes in the installed bushings. None of the oil holes were located in the positions described in the SPMM or as shown in figure 15. The oil holes in all 6 intake rocker arms were similarly located outboard of the bushing centerline. Additionally, the oil hole positions were offset to the incorrect side of the longitudinal centerline in 4 of the 6 arms.

**Figure 18.** Intake rocker arms with unlabeled arrows pointing to oil passage holes in the bushings.

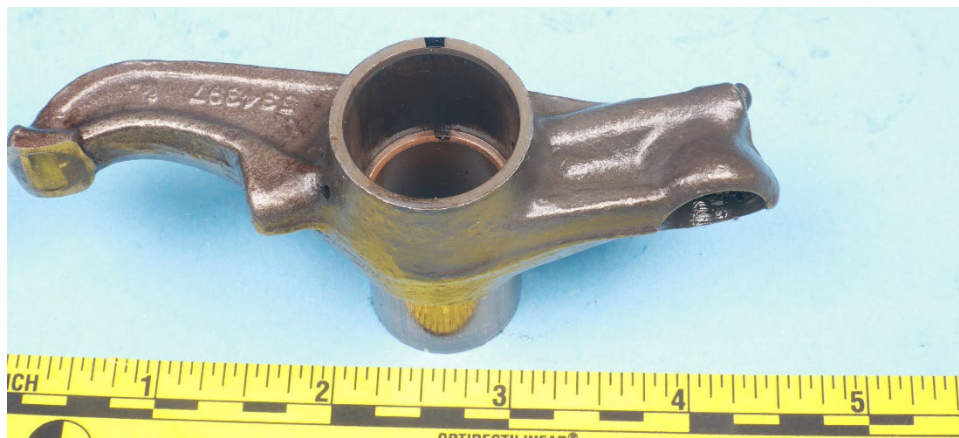
Bushings were pressed out of the rocker bore in each of the intake rocker arms. Two of the six intake rocker arms had a machined oil feed groove in the rocker bore while the remaining four intake rocker arms, including the representative arm shown in figure 19, had a smooth rocker bore.

**Figure 19.** Intake rocker arm with the bushing partially removed. No circumferential oil groove was observed in the rocker bore in 4 of the 6 intake rocker arms including the representative rocker arm shown here.
