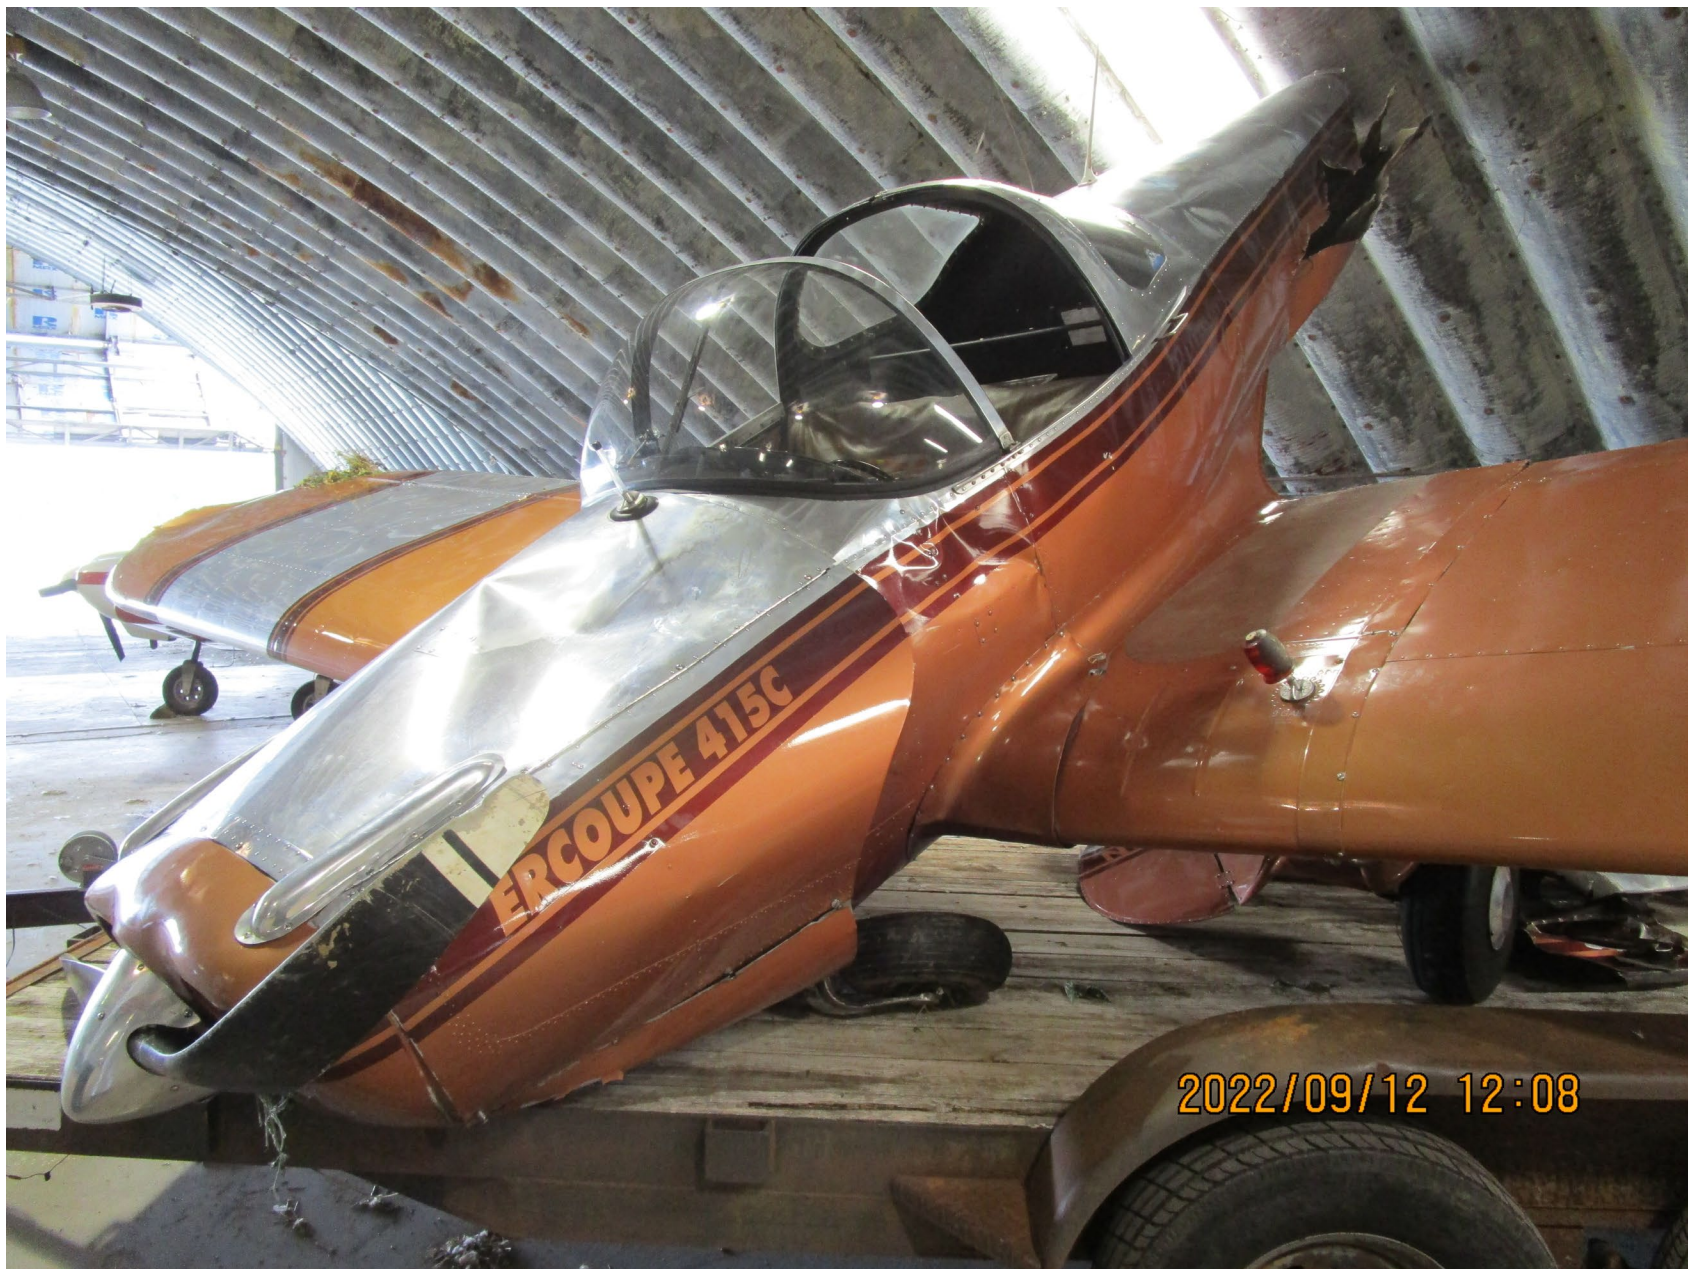
**Photo 1 – FAA Digital Photograph. Left Forward Quartering View of the Airplane Following Recovery. Note the Separated Aft Empennage.**

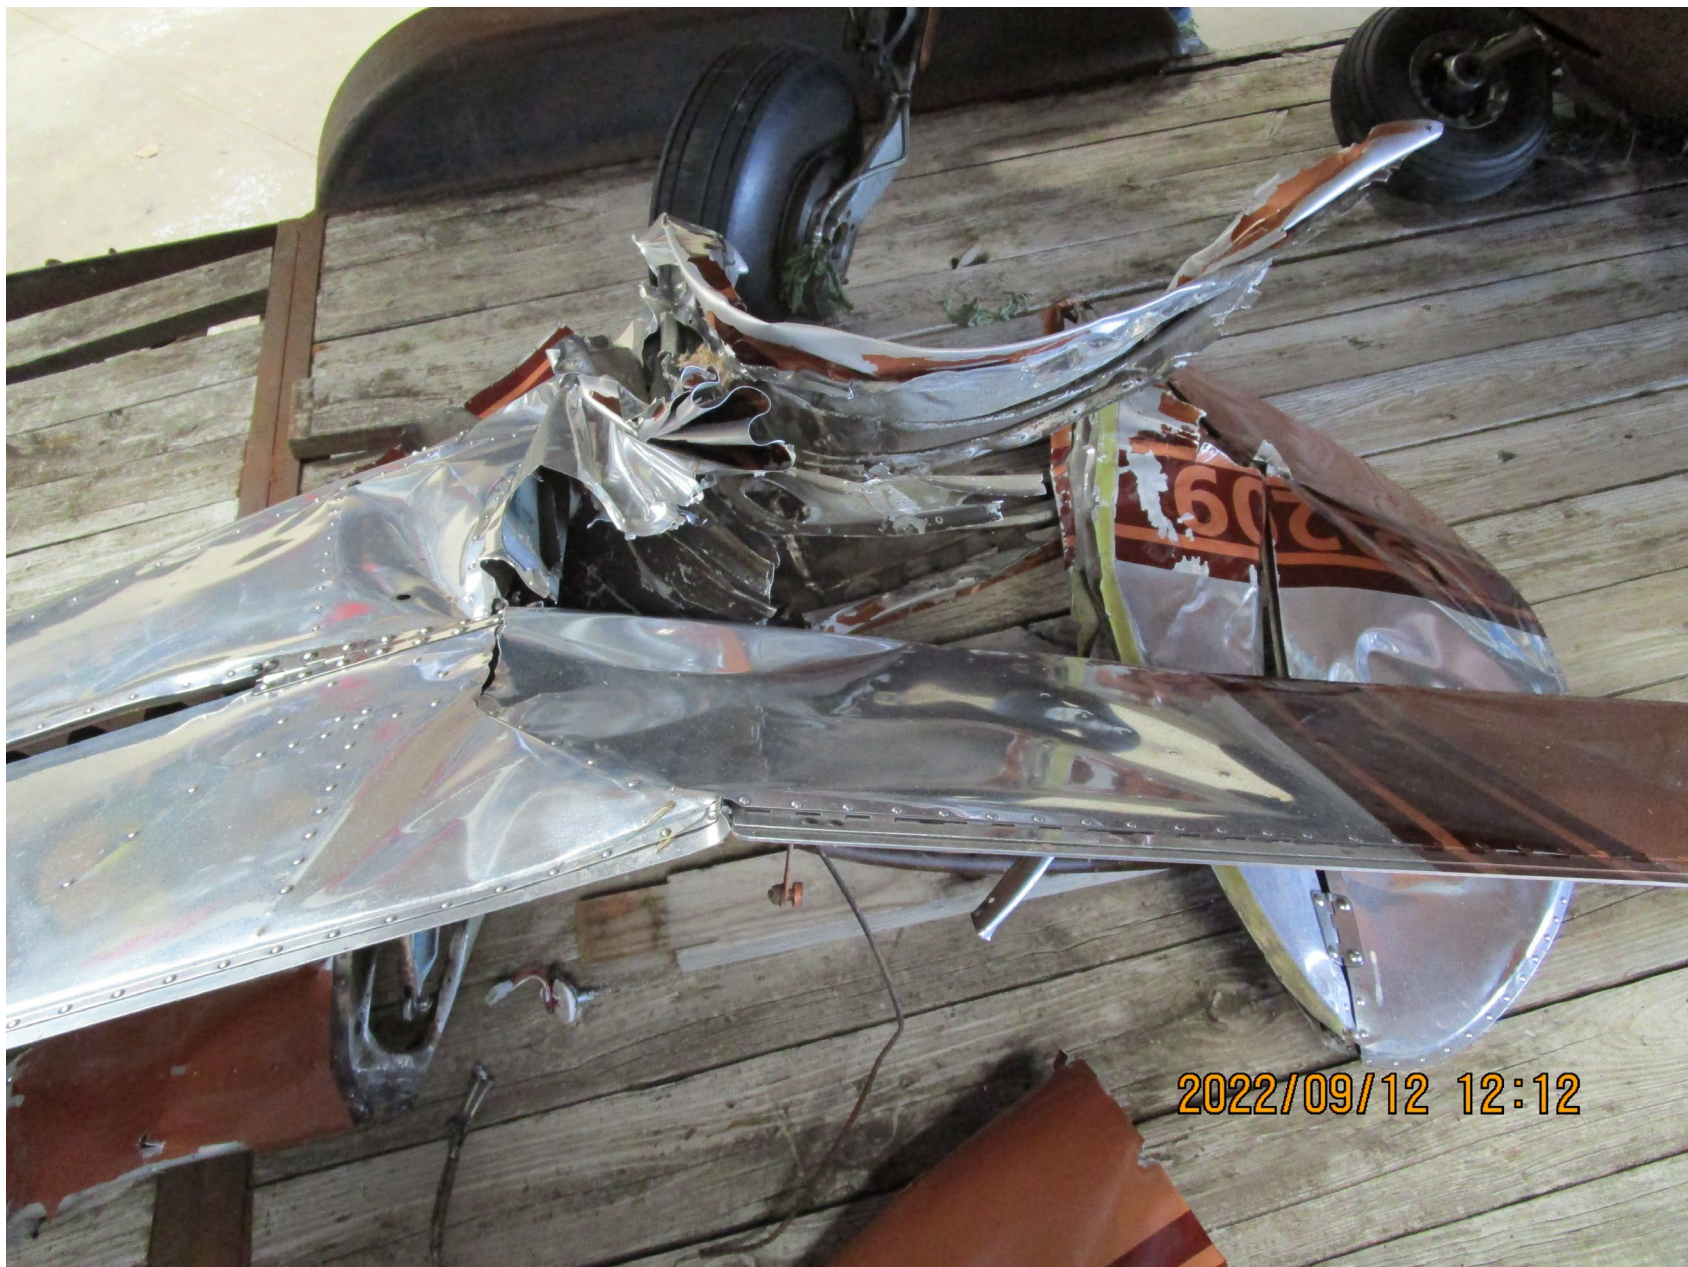
**Photo 2 – FAA Digital Photograph. View of the Structurally Damaged Aft Empennage.**

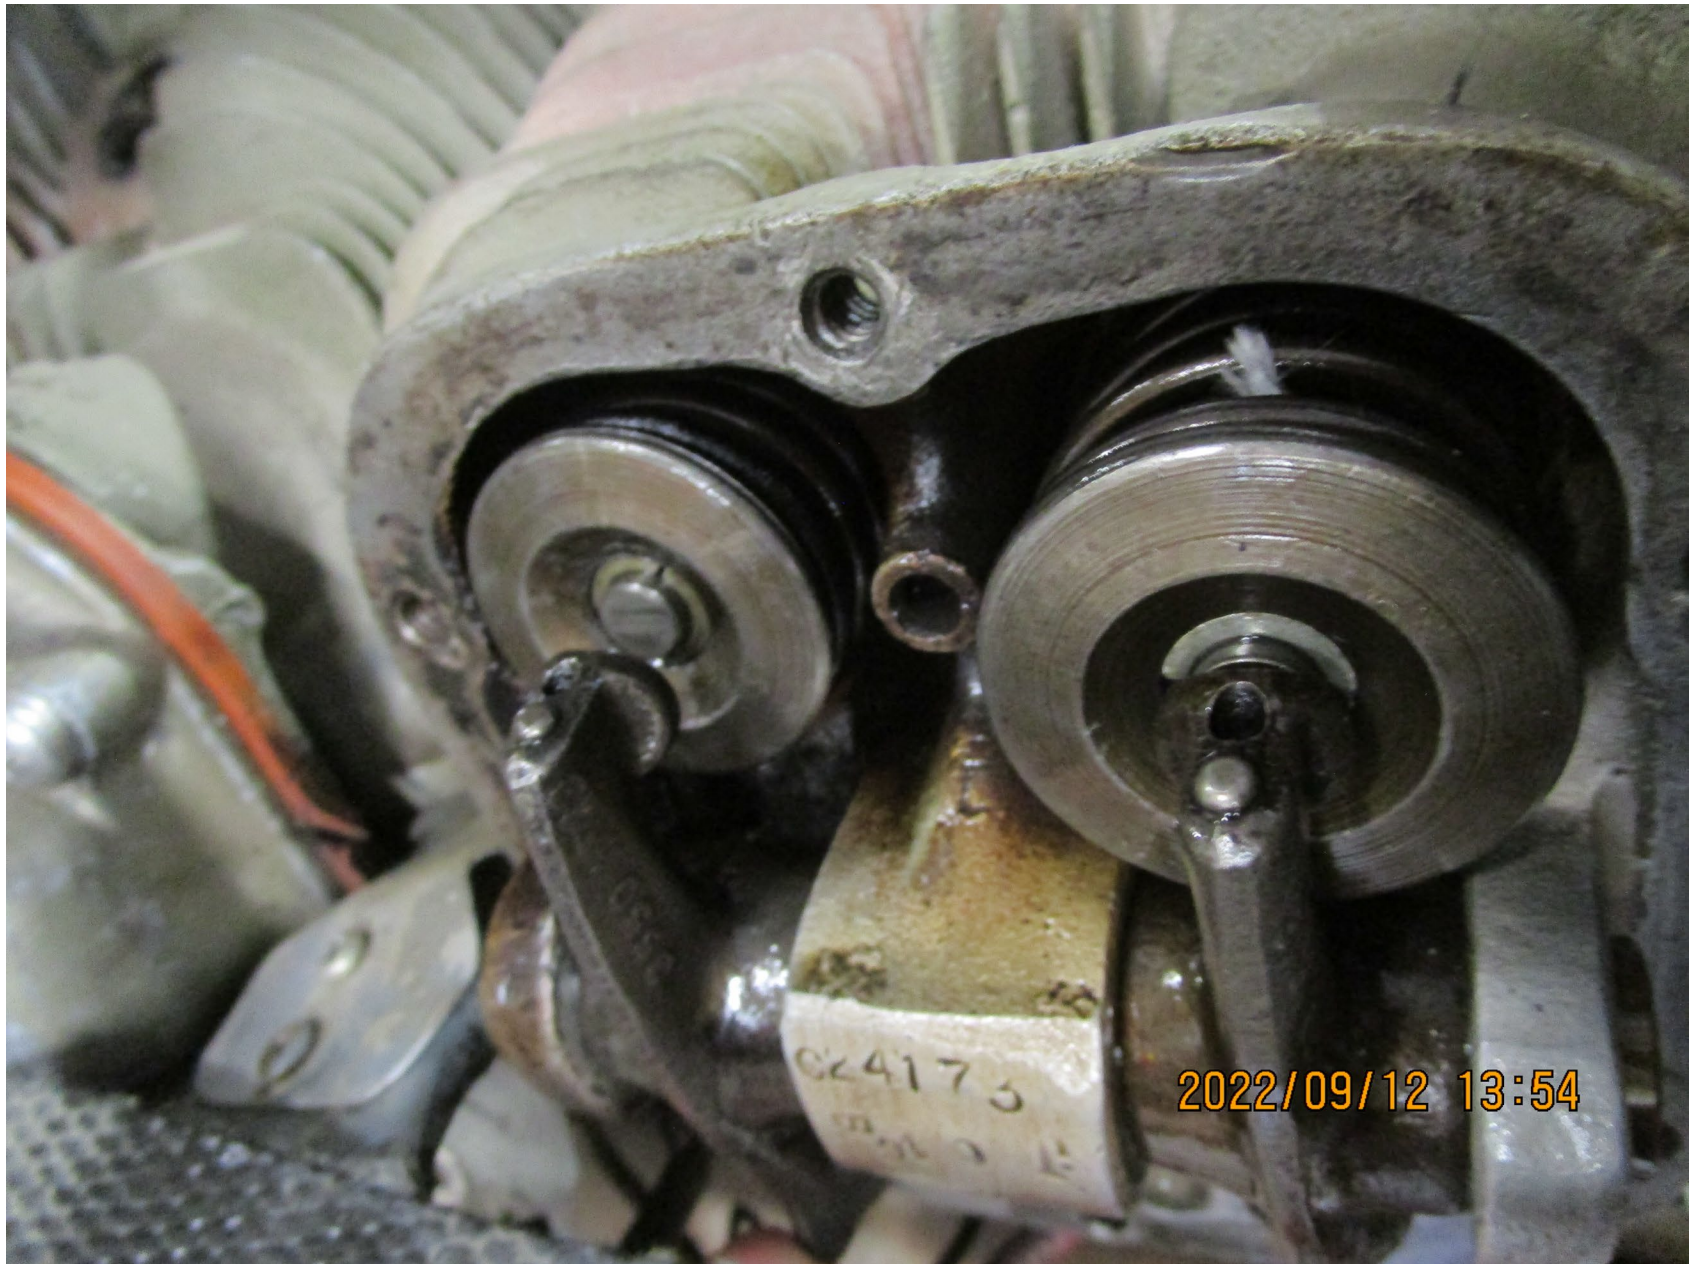
**Photo 3 - FAA Digital Photograph. View Showing the Open Exhaust Valve of the No. 2 Cylinder.**
