**NATIONAL TRANSPORTATION SAFETY BOARD**

**Photo Array**

**ERA22LA415**

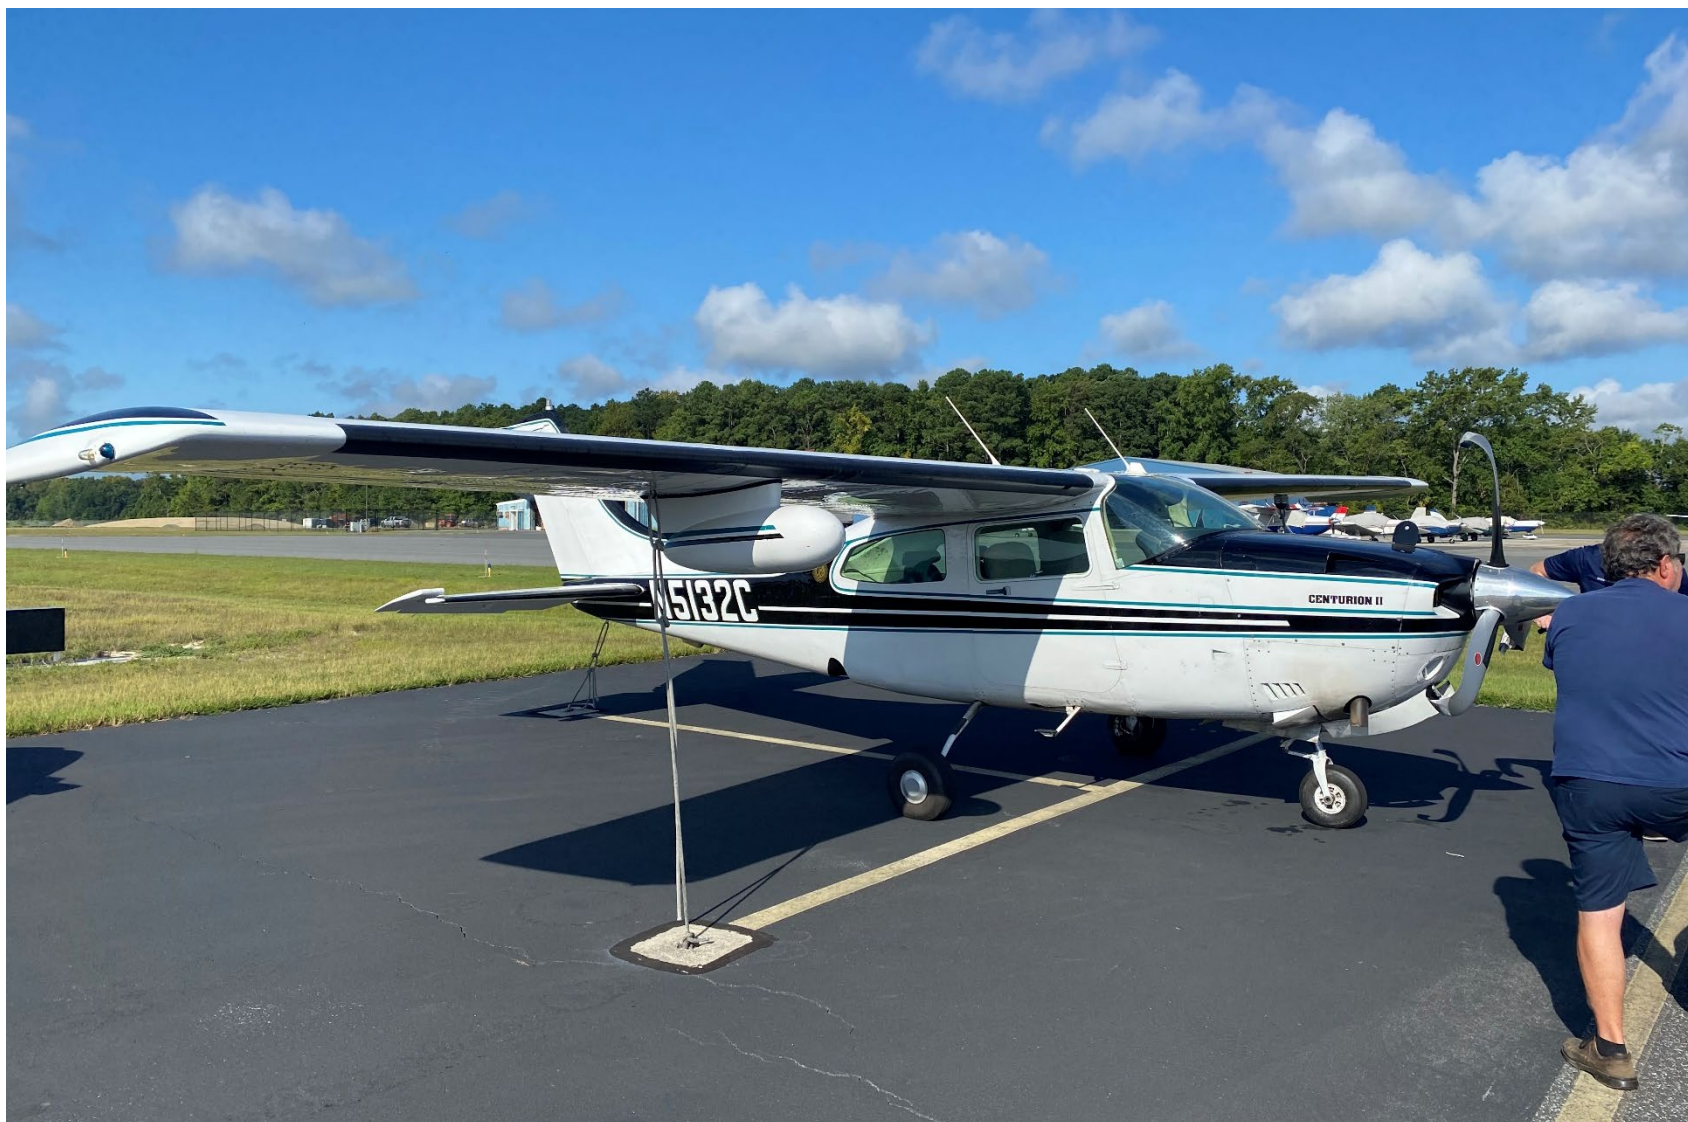
**Photo 1 – View of Accident Airplane (Courtesy of FAA)**

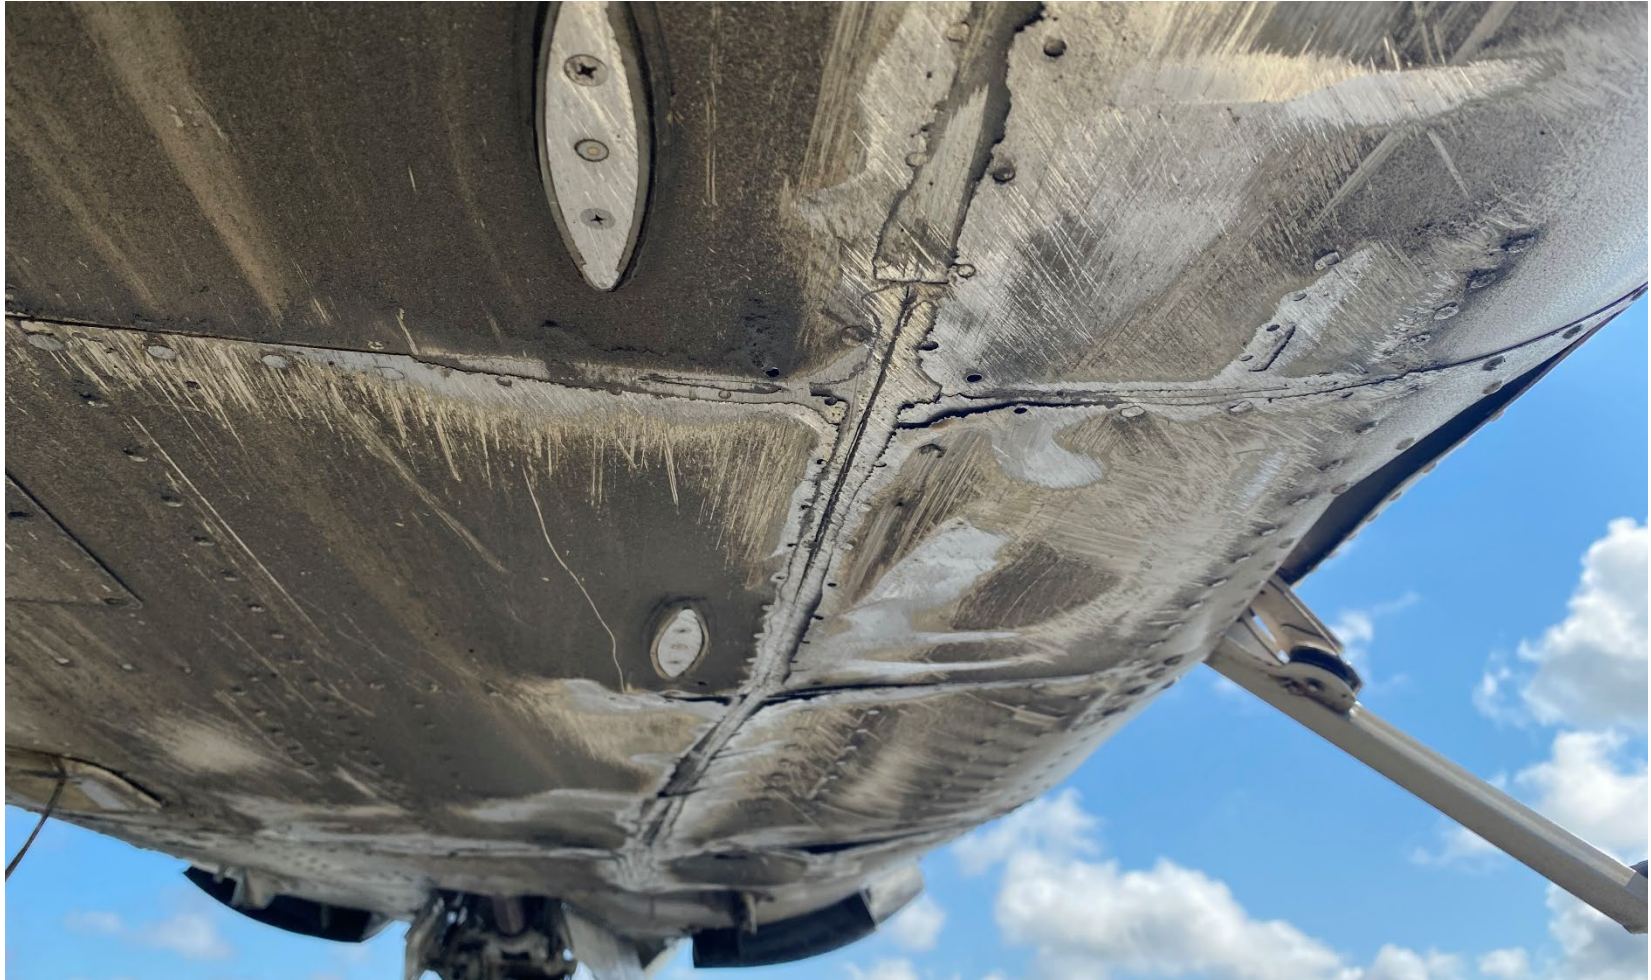
**Photo 2 – View of Airplane Underside – note damage (Courtesy of FAA)**

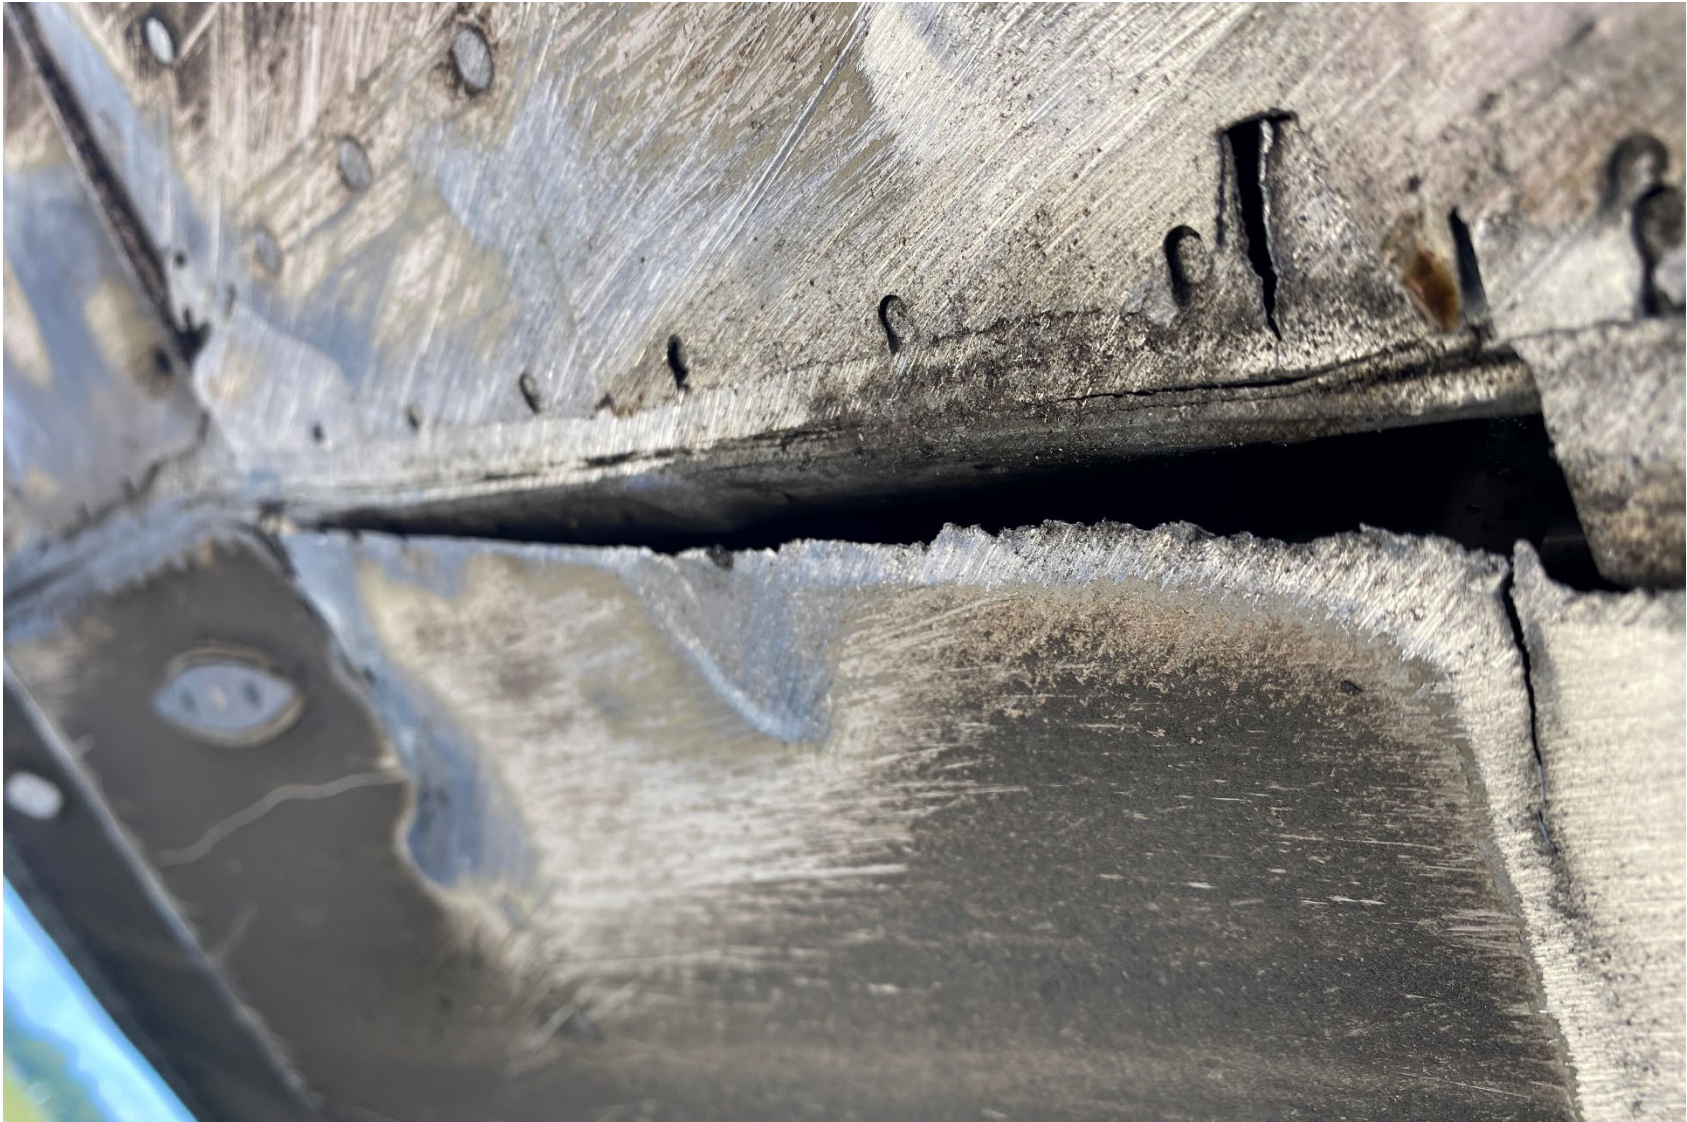
**Photo 3 – Closeup View of Fuselage Damage – note bent frame (Courtesy of FAA)**
