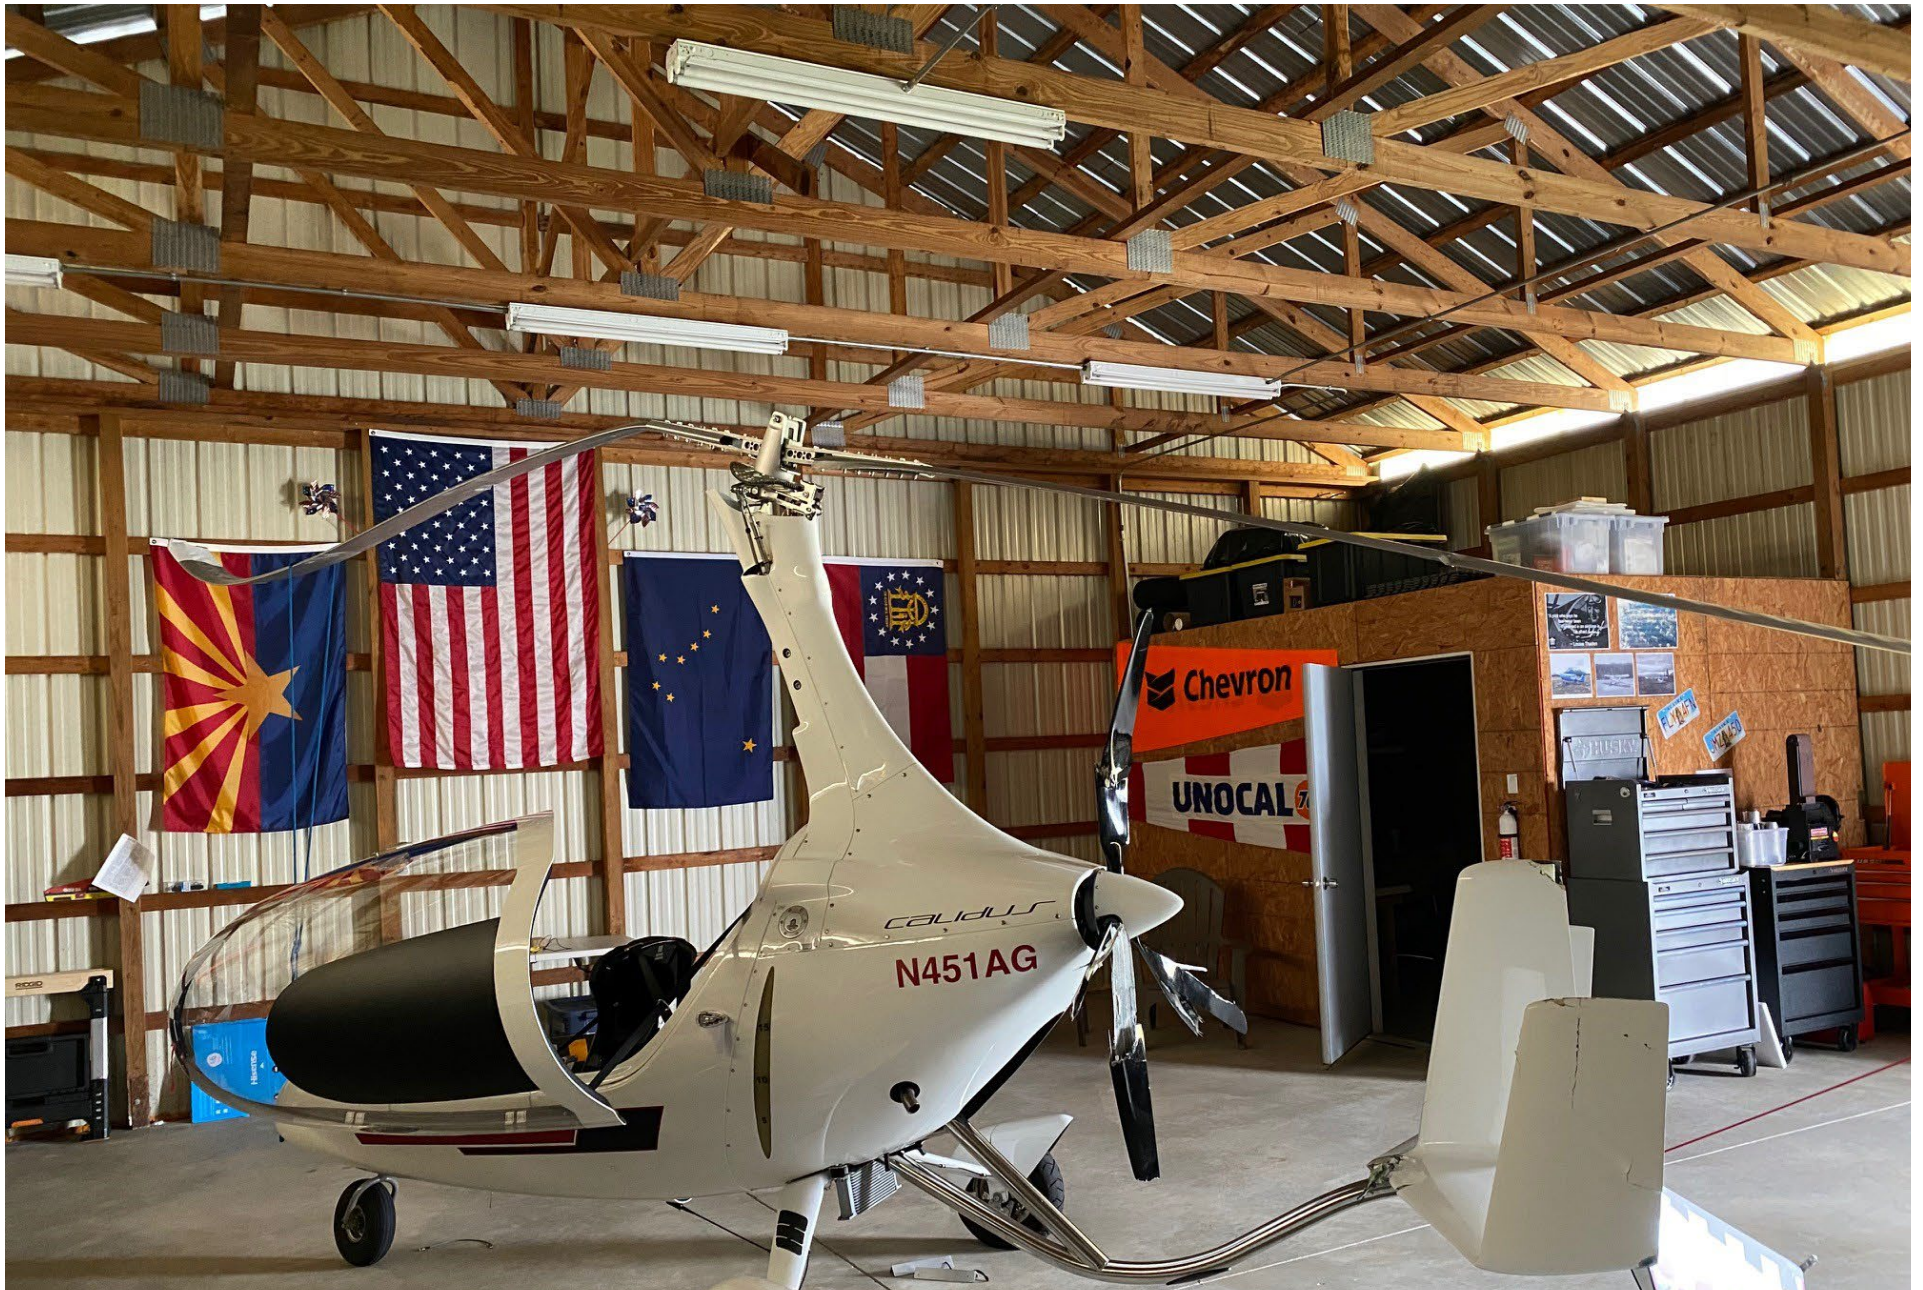
Photo 1 – main wreckage (Pilot)

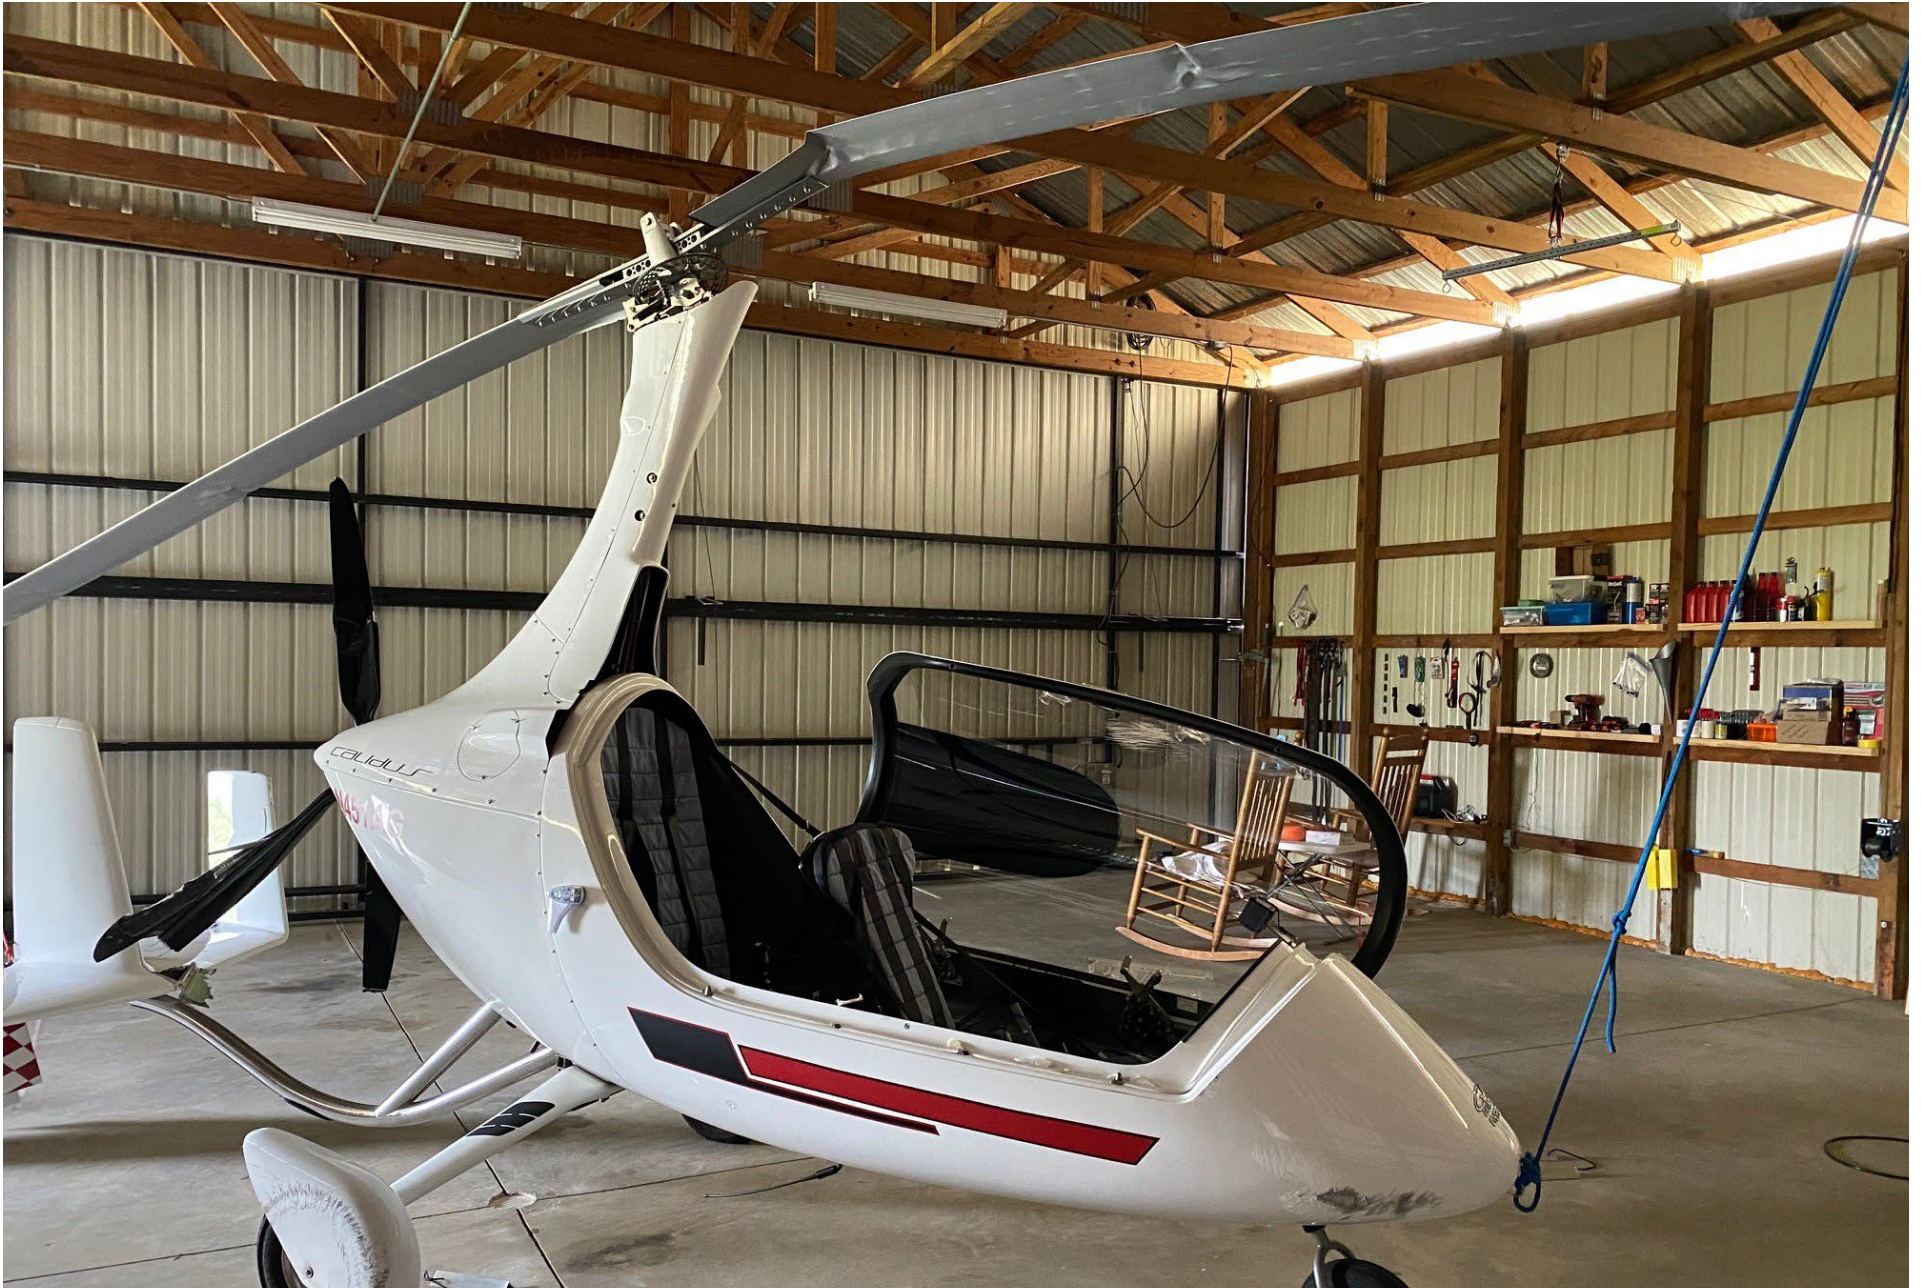
**Photo 2 – main wreckage, main rotor bent (Pilot)**
