# National Transportation Safety Board

ERA22LA427

## **WRECKAGE EXAMINATION SUMMARY**

Location: Southern Shores, North Carolina  
Date: September 21, 2022  
Time: 1000 EDT  
1400 coordinated universal time (UTC)  
Airplane: N3283N, Northwing Design Apache Sport Weight-Shift Control (WSC) Aircraft

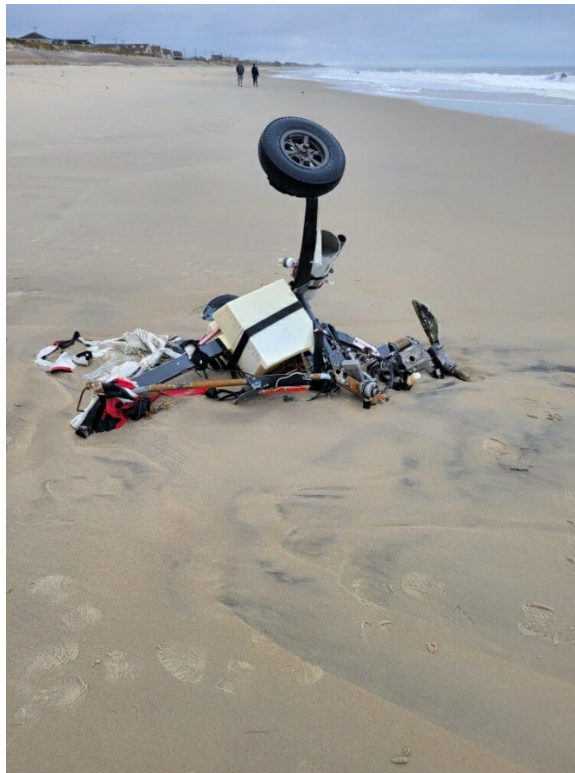
The lower root tube with attached engine assembly, attached propeller with fractured blades, and fuel tank washed ashore south of where the accident occurred and was first spotted on October 5, 2022 (Figure 1). No structural components of the wing were recovered. The wreckage was recovered for further examination by an airworthiness inspector of the Federal Aviation Administration.

**Figure 1: View of the Wreckage.**

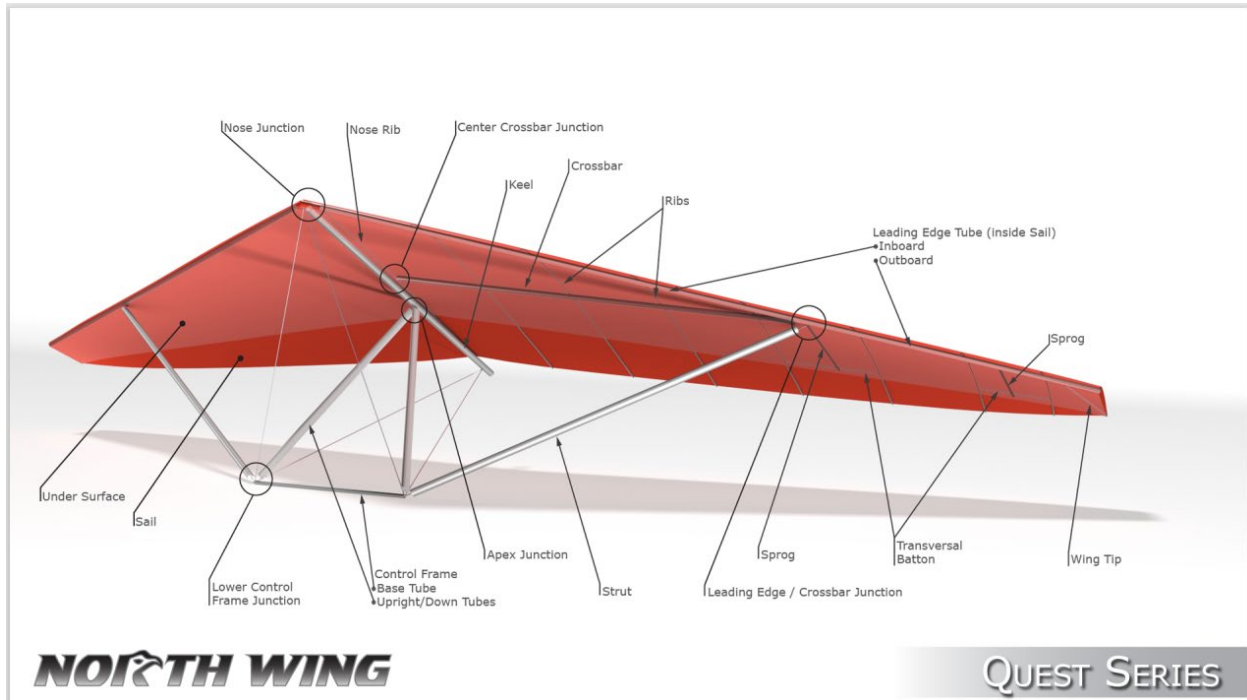
The NorthWing GT5 13.5m wing (Figure 5) was a strutted wing capable of a 45 mph range of speed from stall to top speed. The trim airspeed was reported to be 60-70 mph.

**Figure 5: View of Components of Quest Series Wing.**

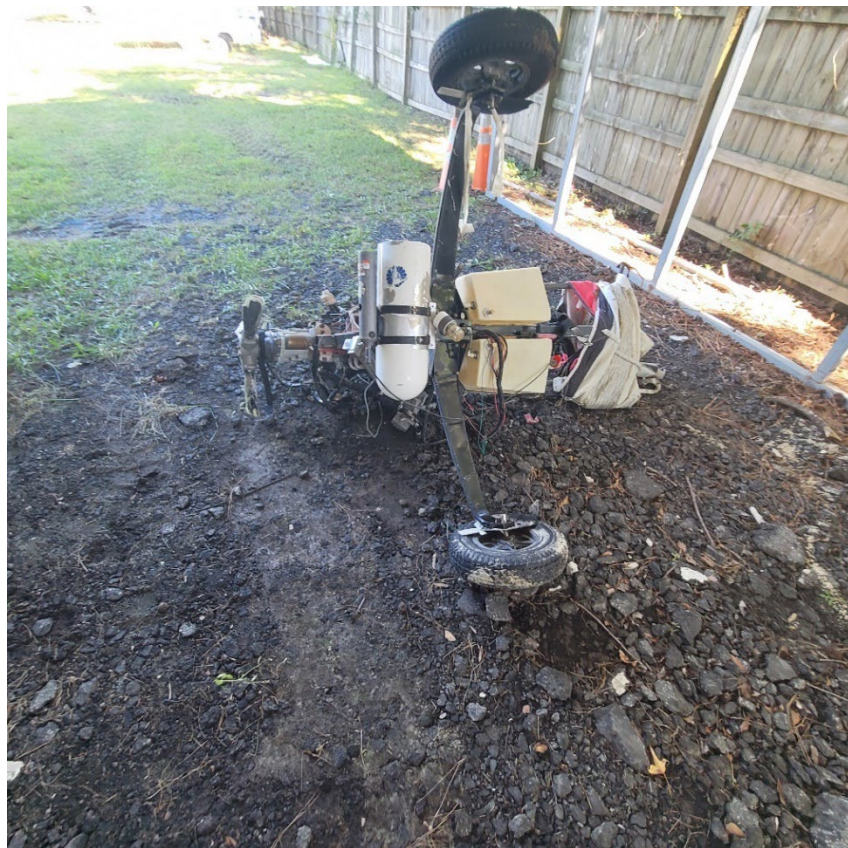
Examination of the wreckage following recovery was performed by an airworthiness inspector. The examination took place on October 6, 2022. As first viewed the wreckage was resting on its left side (Figure 6). The wreckage consisted of the lower root tube, both main landing gears with attached wheels and tires, the attached engine assembly with attached propeller assembly, fuel tank, and an empty canister of the airframe ballistic parachute (Figure 7). Also recovered was a section of wing sail wrapped around the front portion of the lower root tube, and both seat rails. No structural components of the wing assembly were located.

**Figure 6: View of the Wreckage as First Viewed.**

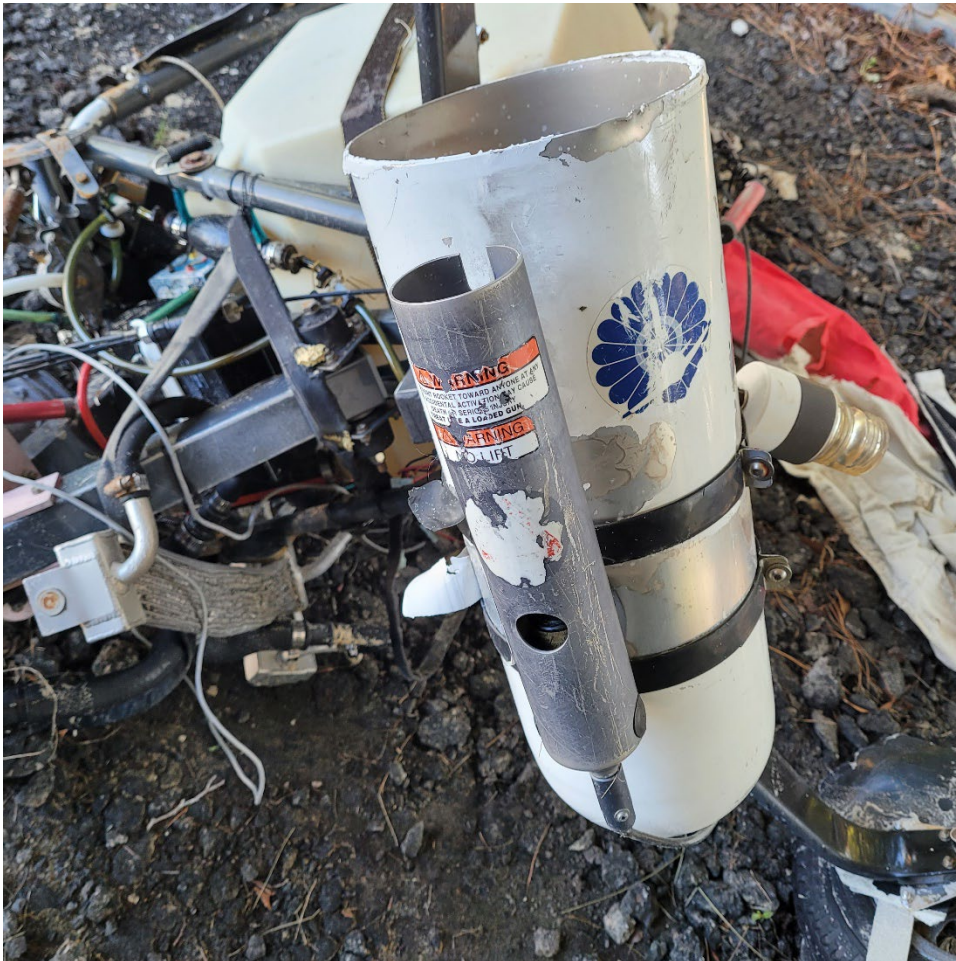
**Figure 7: View of the Airframe Ballistic Parachute Components.**

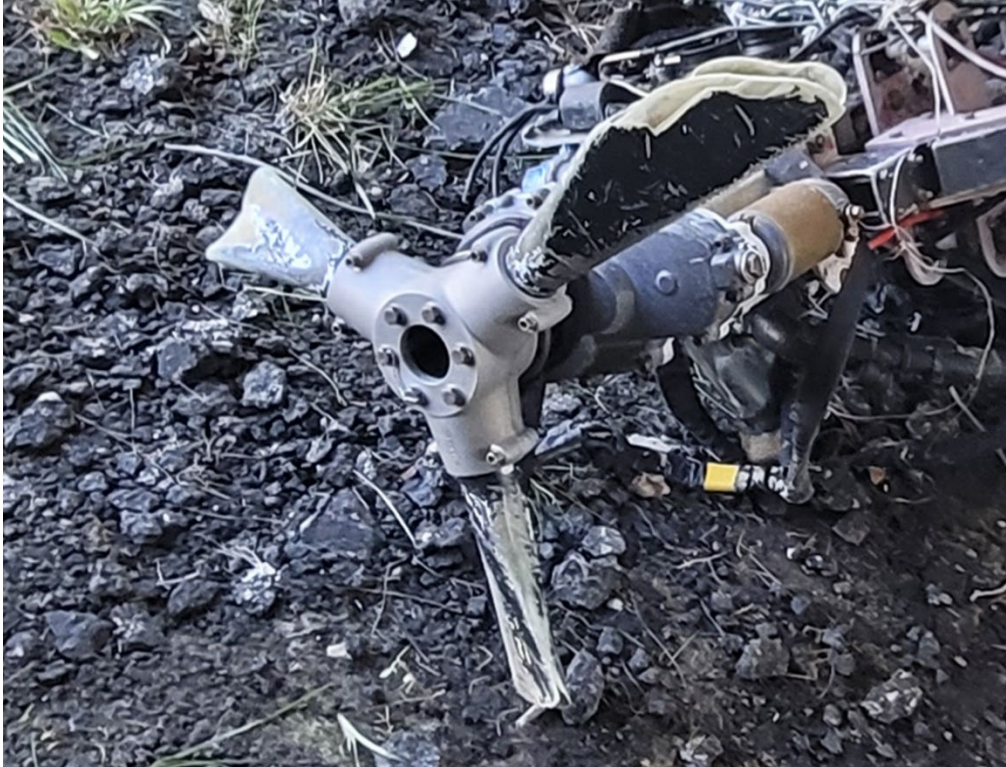
Examination of the propeller revealed all blades were fractured at varying lengths (Figure 8). A section of airframe parachute webbing was between the propeller assembly and the engine (Figure 9).

**Figure 8: View of the Propeller Assembly.**

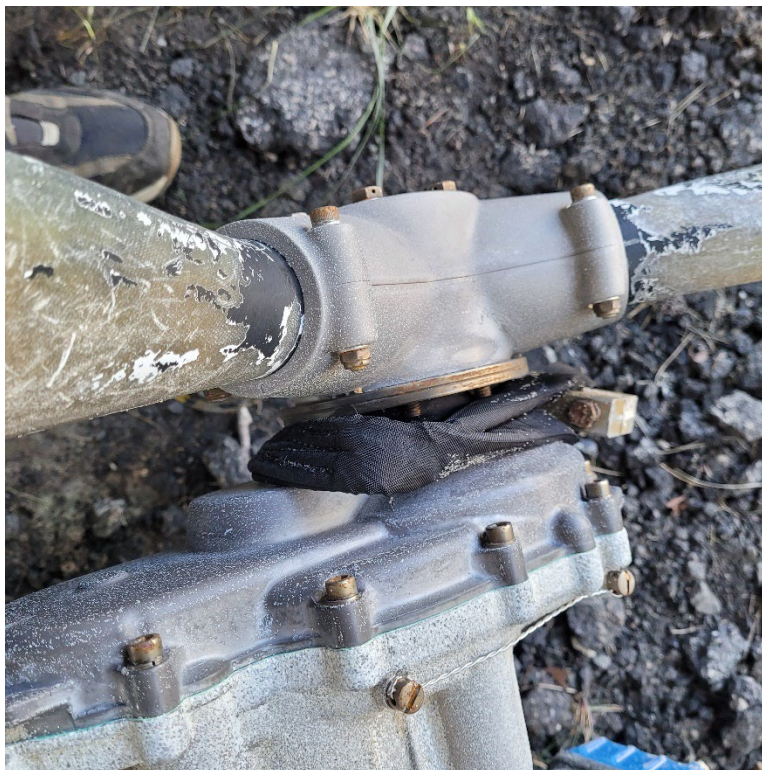
**Photo 9: View Showing the Airframe Ballistic Parachute Webbing Between Propeller and Engine.**

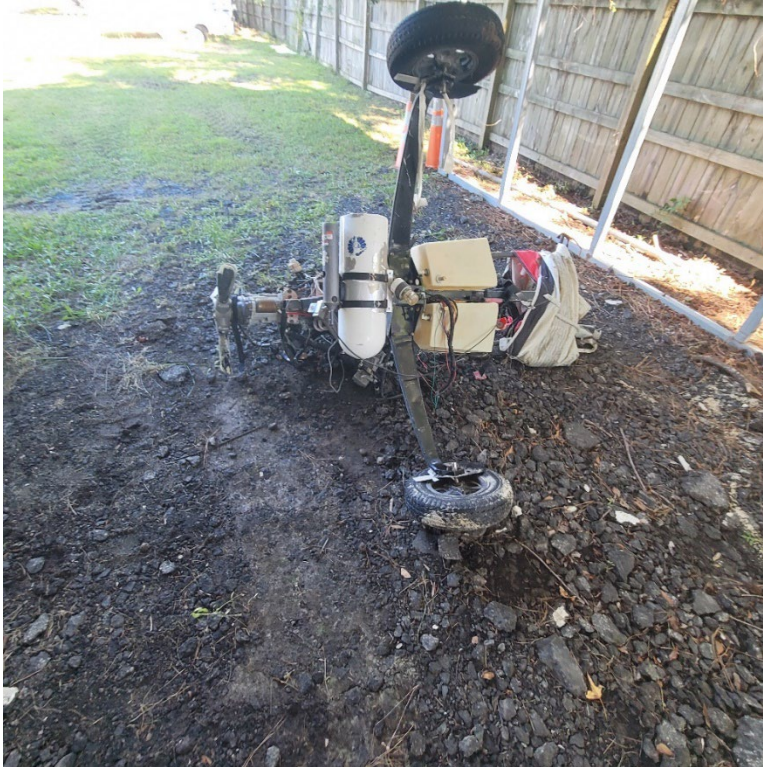
Both main landing gear remained structurally attached (Figure 10).

**Figure 10: View Showing Both Main Landing Gear.**

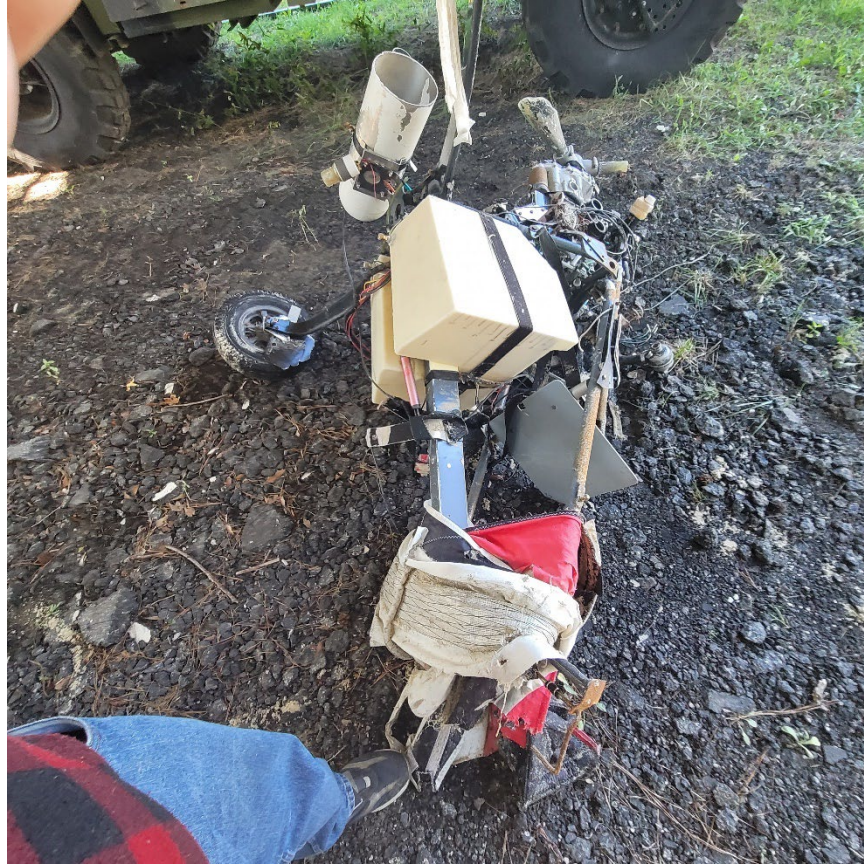
Examination of the wreckage revealed the fuel tank remained secured by one strap (Figure 11).

**Figure 11: View Showing the Fuel Tank Secured by One Strap.**
