Timothy W. Monville  
Sr. Air Safety Investigator  
Office of Aviation Safety-Eastern Region

**Subject:** ERA22LA427, Wing Sail Information

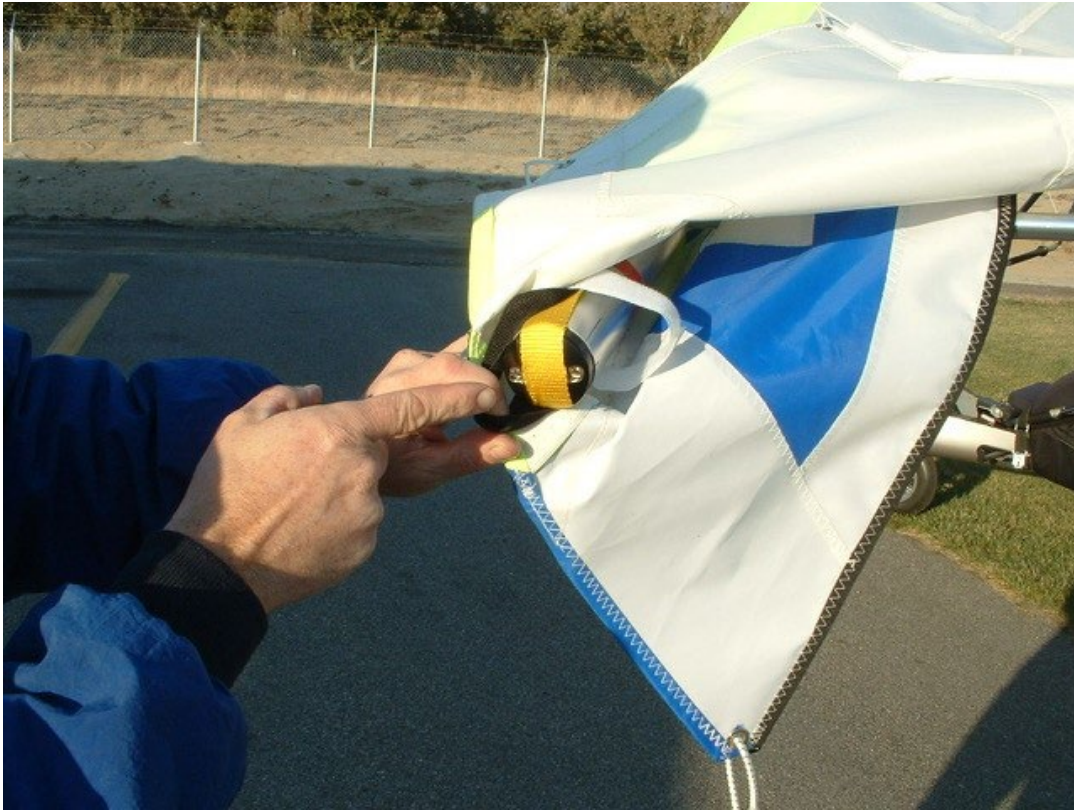
The manufacturer reported that the only way for the sail to move inboard along the leading edge tube was if the sail strap was not installed properly all the way over the leading edge tip cap. He added that once the strap was in the cap's groove, it could not come out. He also indicated that the only reason to remove the sail strap would be to tune the wing with shims.

**Figure 1: View Showing How Sail Strap Is Positioned over Leading Edge Tube Trim Tip Cap.**
