ERA22LA434

## INVESTIGATION PHOTOGRAPHS

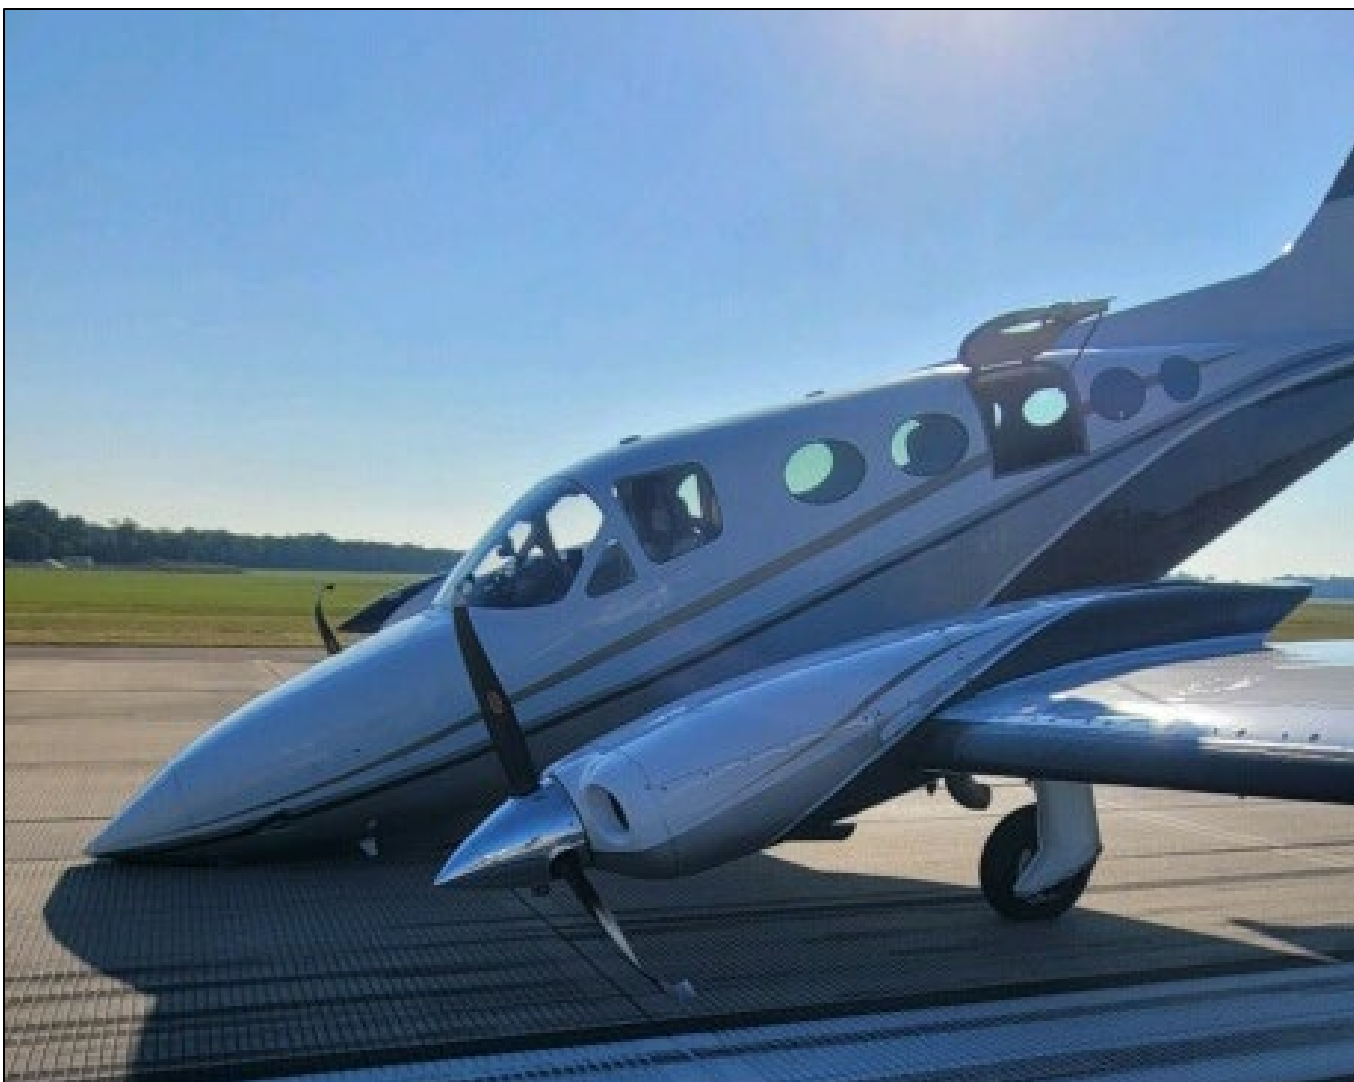
**Photograph 1 - View of the accident airplane with a collapsed nose landing gear on the runway  
(Photo courtesy of FAA)**

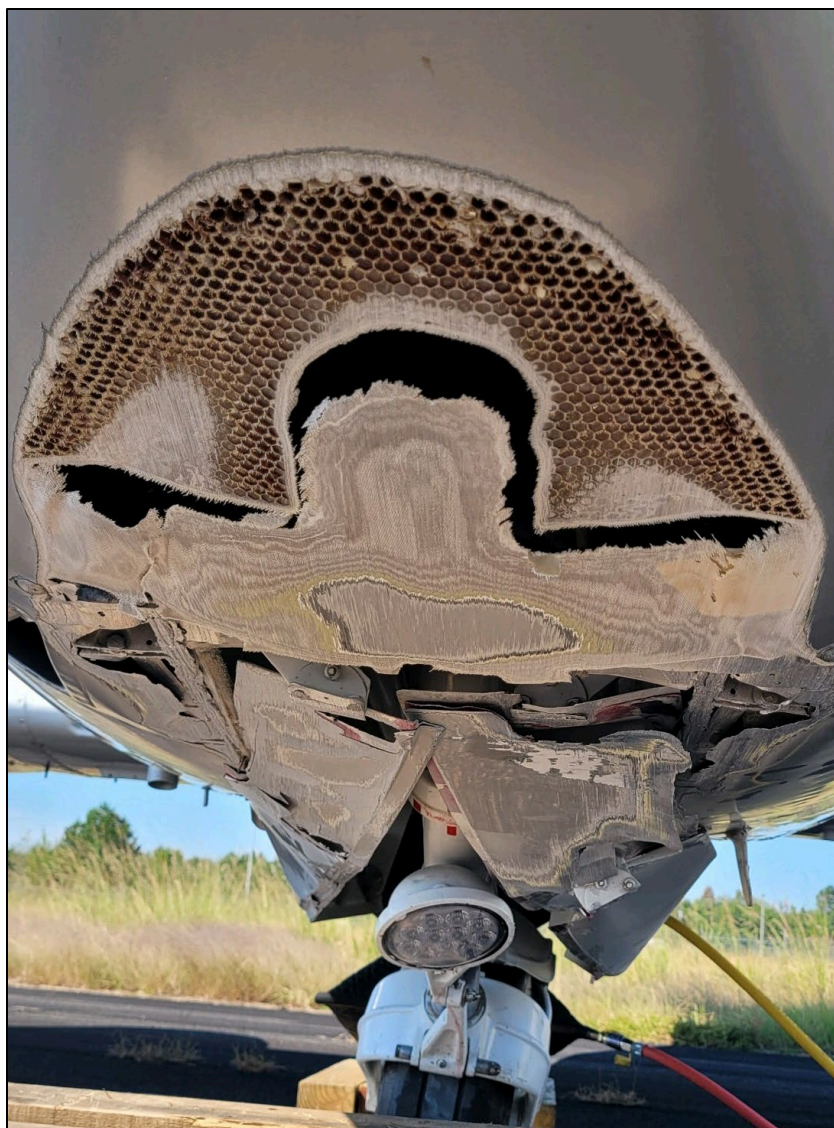
**Photograph 2 - Overview of the substantial damage sustained to the fuselage (Photo courtesy of FAA)**

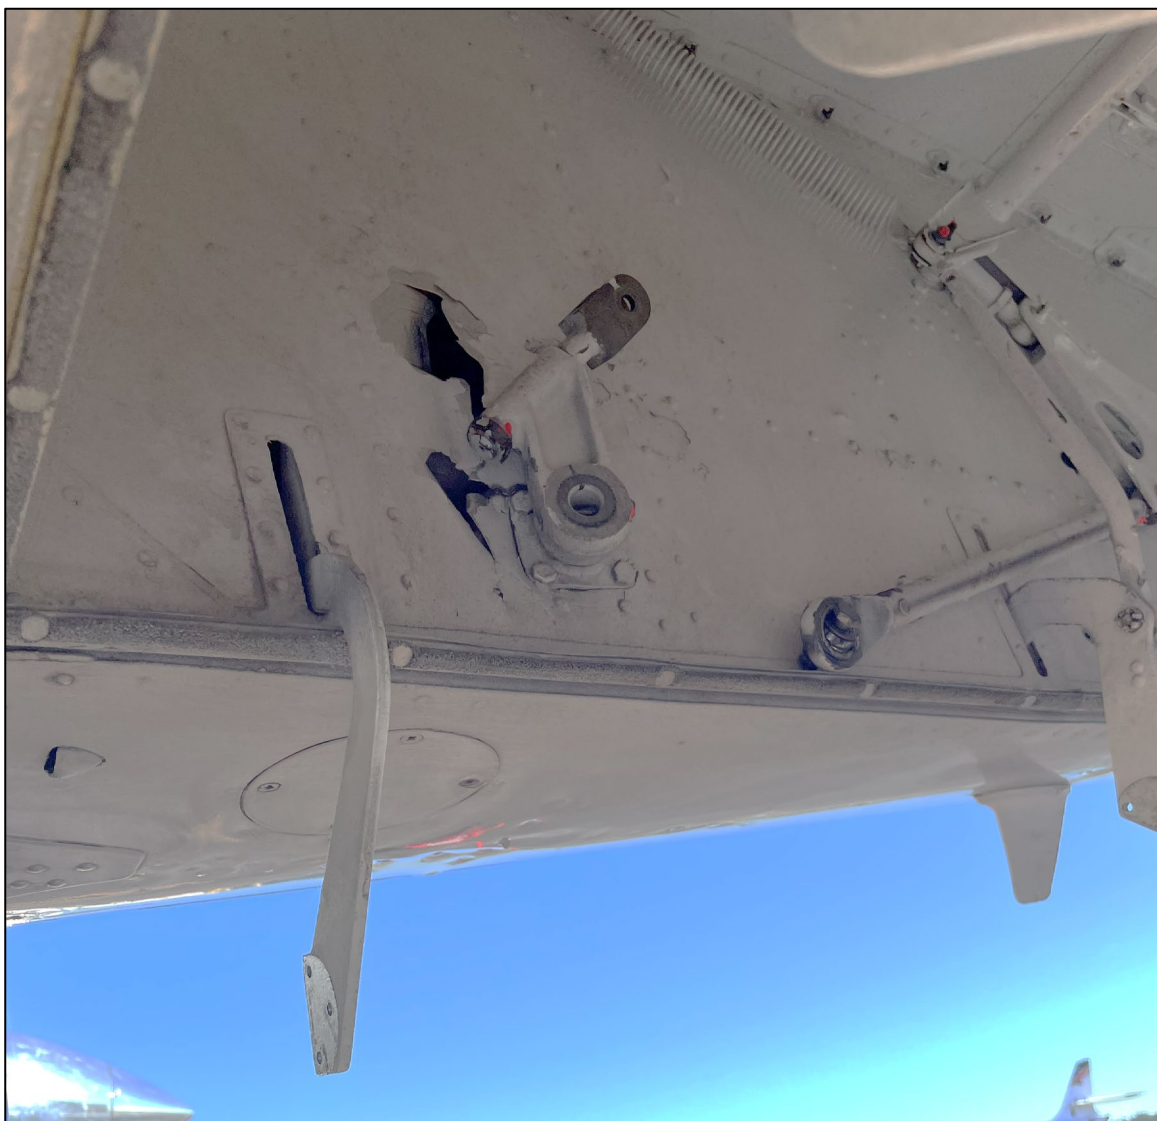
**Photograph 3 - View of the disconnected NLG torque tube (reportedly disconnected by maintenance personnel after the accident) (Photo courtesy of FAA)**

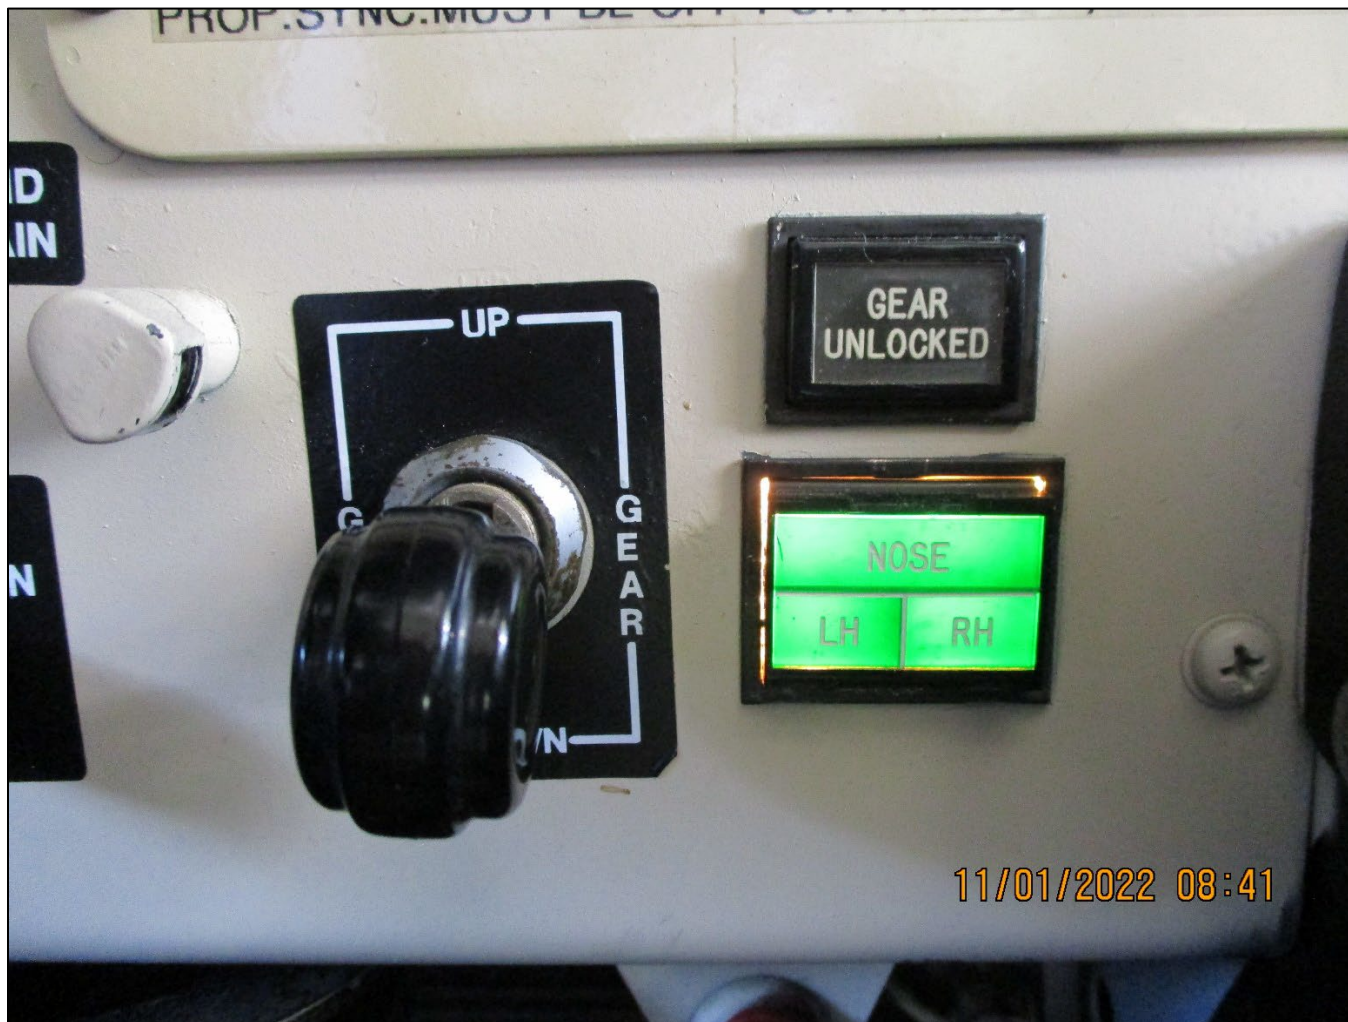
**Photograph 5 - View of the landing gear indicator lights displaying all three gear down and locked postaccident (Photo Courtesy of FAA)**

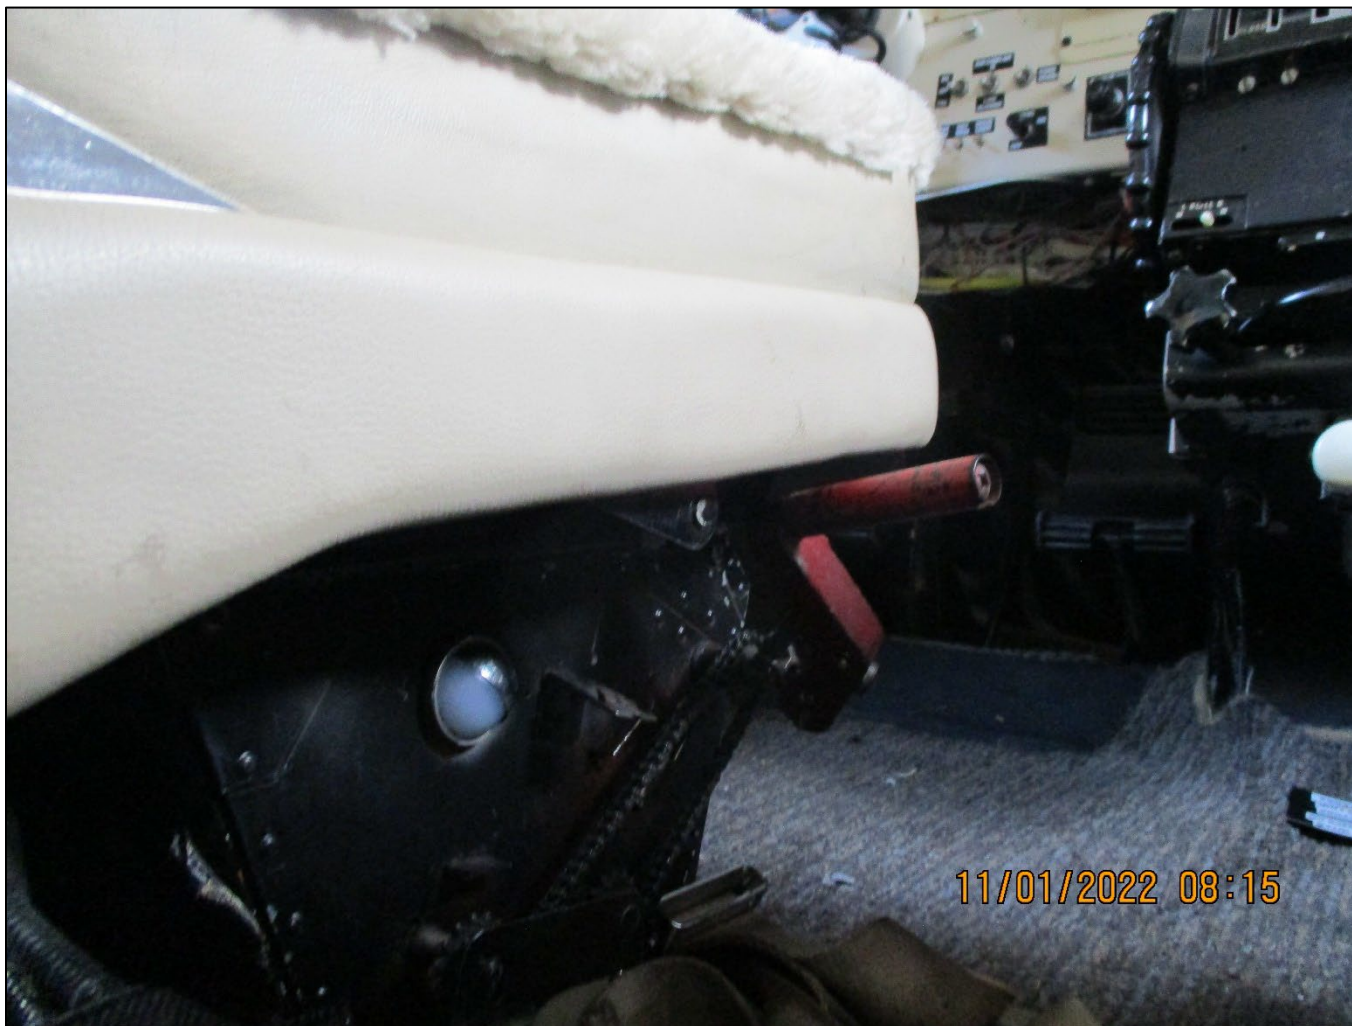
**Photograph 6 - View of the landing gear manual hand crank found in an intermediate position  
(Photo Courtesy of FAA)**
